**MARYLAND HISTORICAL TRUST
DETERMINATION OF ELIGIBILITY FORM**

Property Name: Baker House Inventory Number: CE-1561

Project: MARC Maintenance and Layover Facility Agency: MTA

Maryland Historical Trust Maryland Inventory of Historic Properties Form

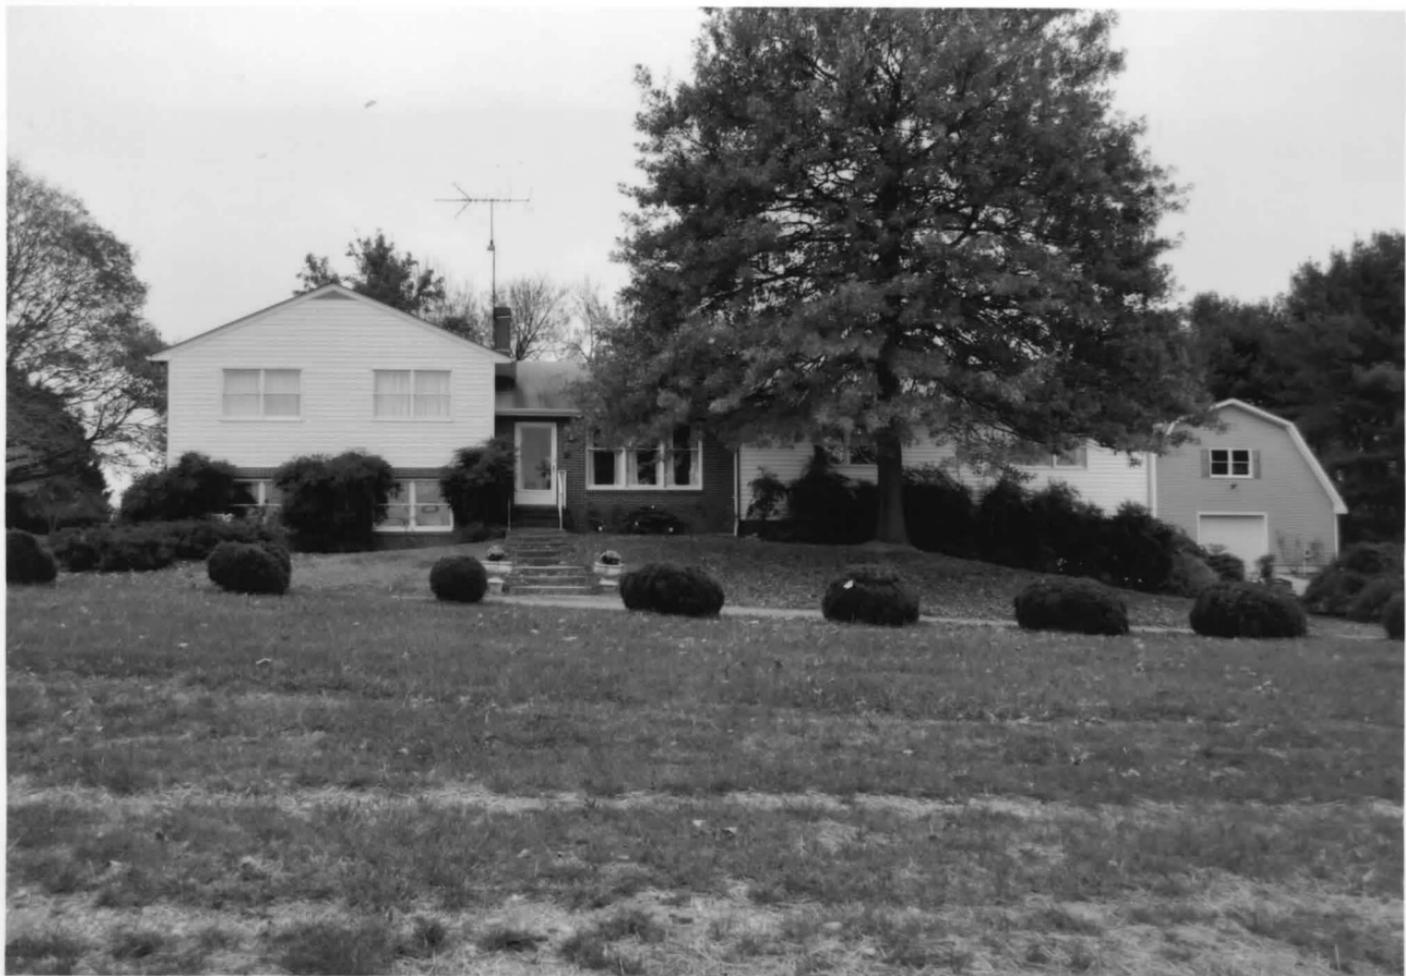
1/5

The one-story, center bay of the house façade has an off-centered main entry wood panel door (Attachment 2, Figure 1). Three brick steps access the entrance. East of the main entry is a band of three double-hung windows with brick sills. The west section of the façade is projecting two-stories, has a front-gable roof, and slightly projects out from the other facade wall planes. The first story is clad with brick and the second story is clad with horizontal siding. Both levels contain evenly spaced double-hung windows with brick sills. The front-facing gable has a triangular-shaped attic vent.

House, view North

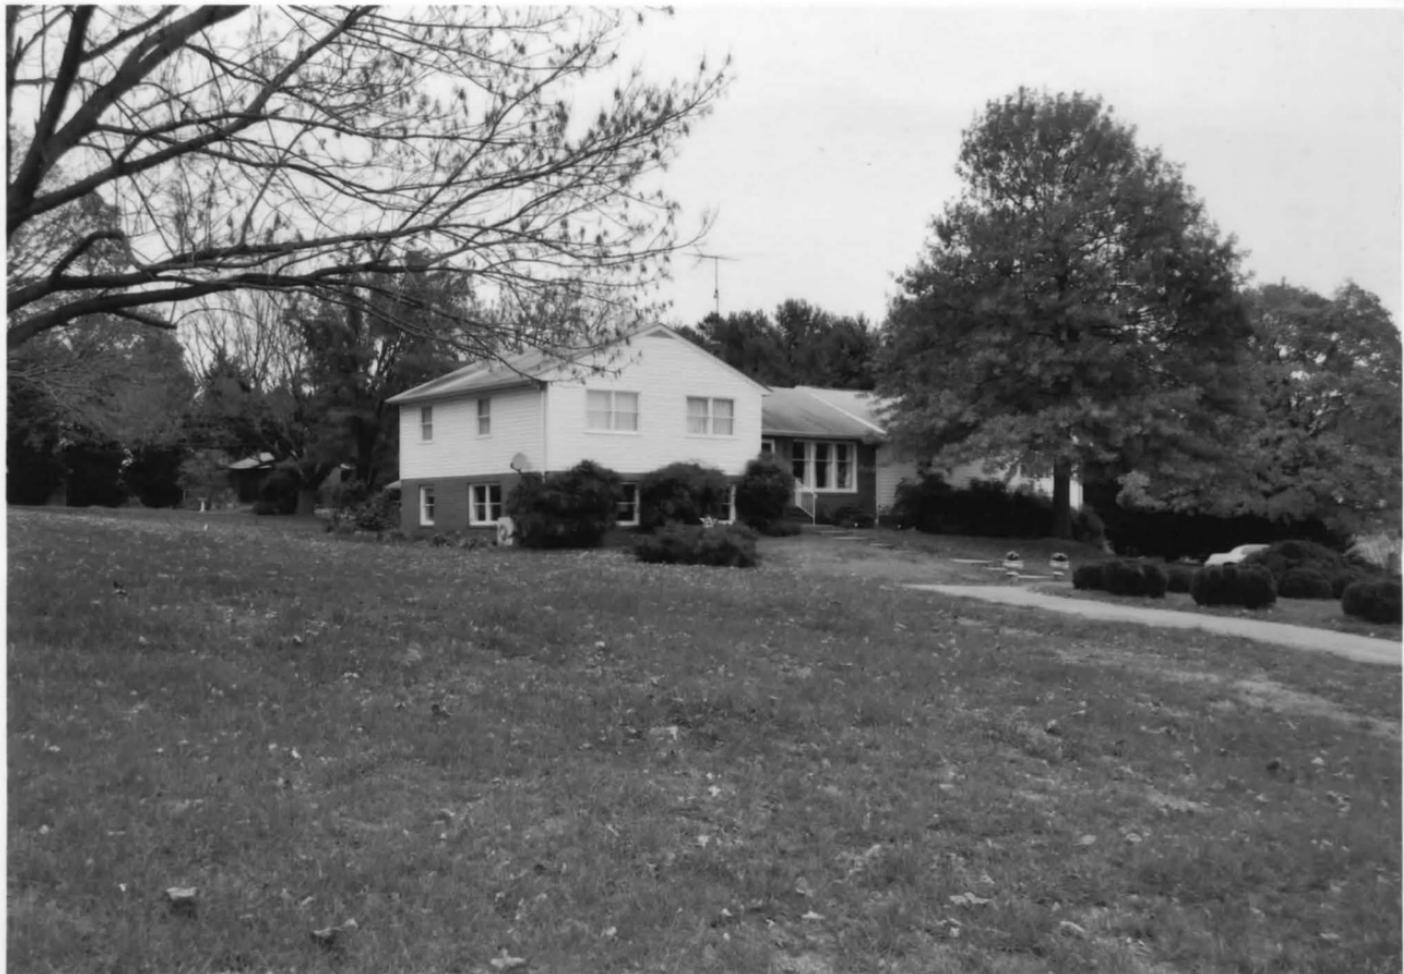
2/5

The west elevation's first story is clad with brick and contains a window and a pair of evenly spaced windows with brick sills (Attachment 2, Figure 2). The second story is clad with vinyl siding and has two evenly spaced windows. The north or rear elevation is not visible by the public-right-of-way or through aerial photographs.¹ The east elevation consists of the east side addition (Attachment 2, Figure 3). The ground story has a garage with panel overhead garage doors. The first story has a window.

House, view Northeast

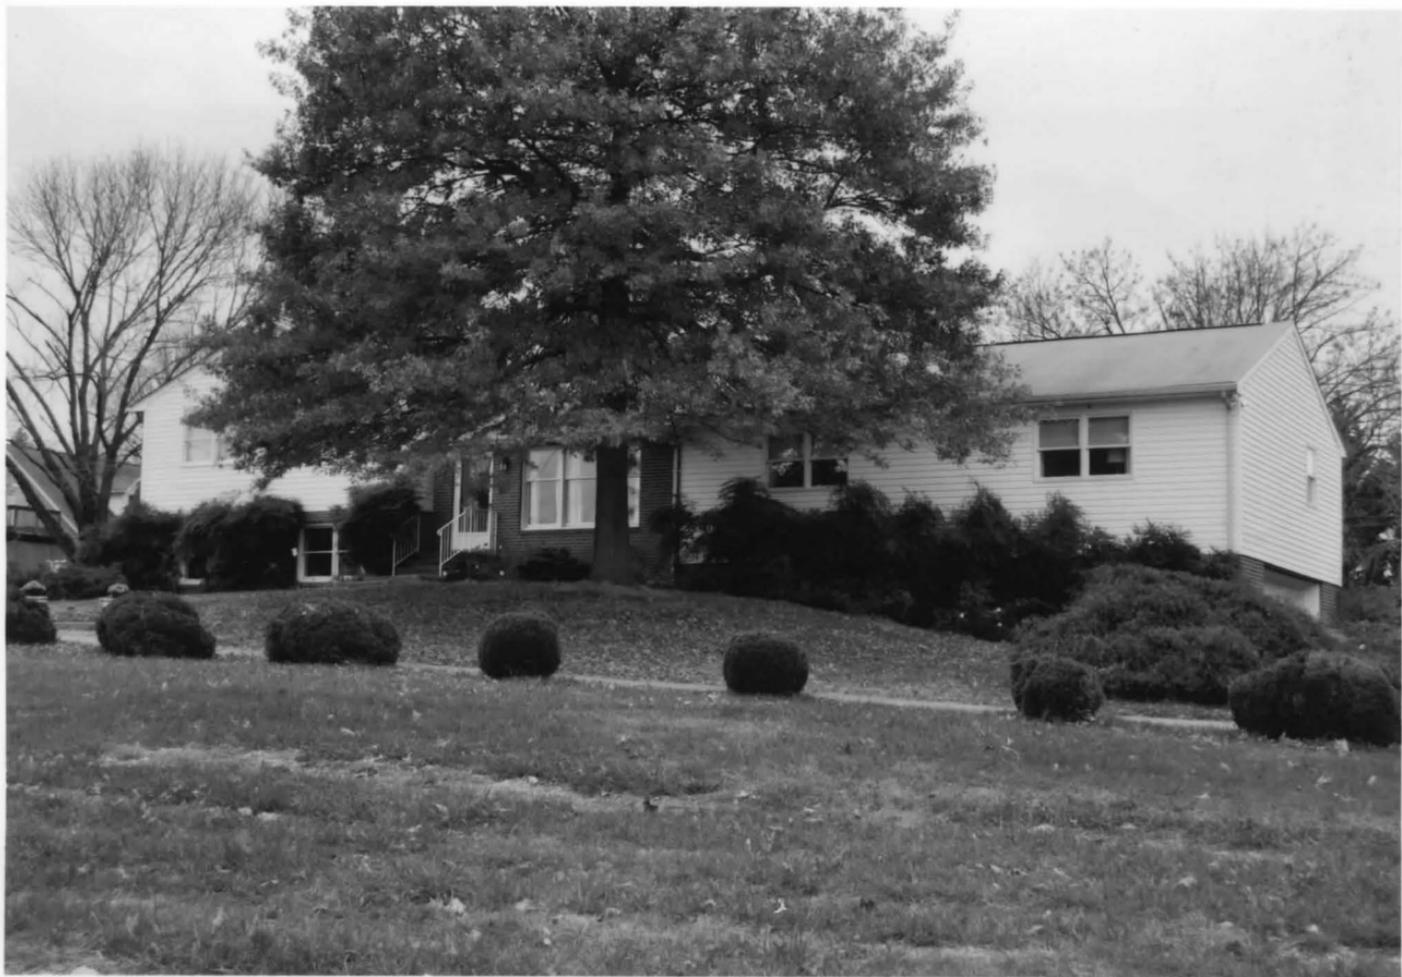
3/5

House, view North

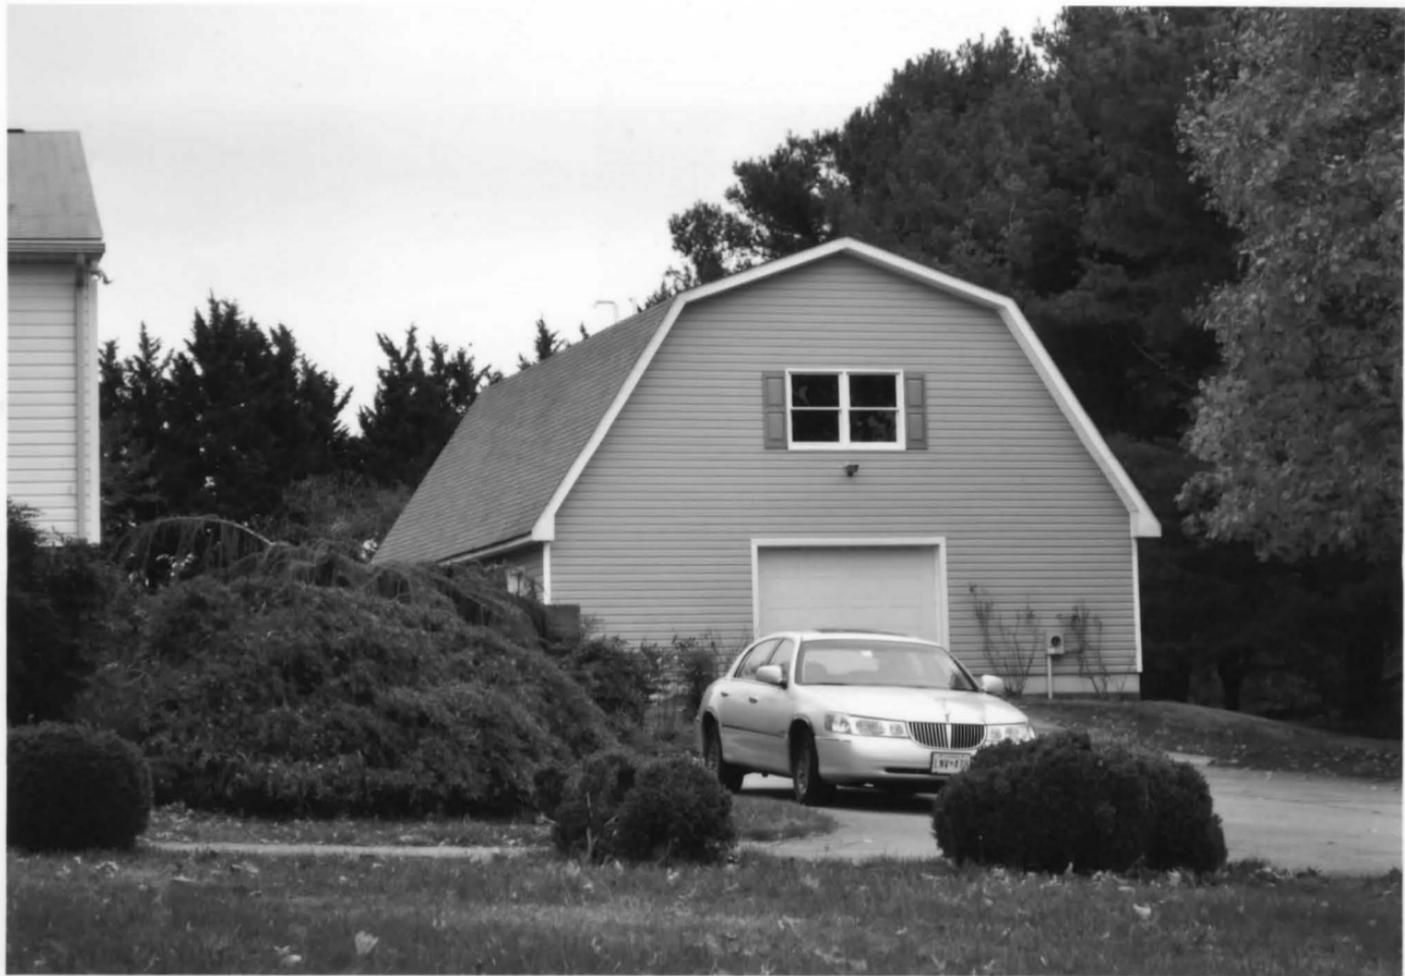
4/5

Northeast of the house is a two-story, one-bay by two-bay, detached garage with an exaggerated gambrel roof covered by asphalt shingles (Attachment 2, Figure 4). The garage is clad with horizontal vinyl siding. On the southeast elevation at the first story is a garage door and a pair of windows at the second story. The southwest side has a side entrance and a window. The northeast side has a window.

Garage, view Northeast

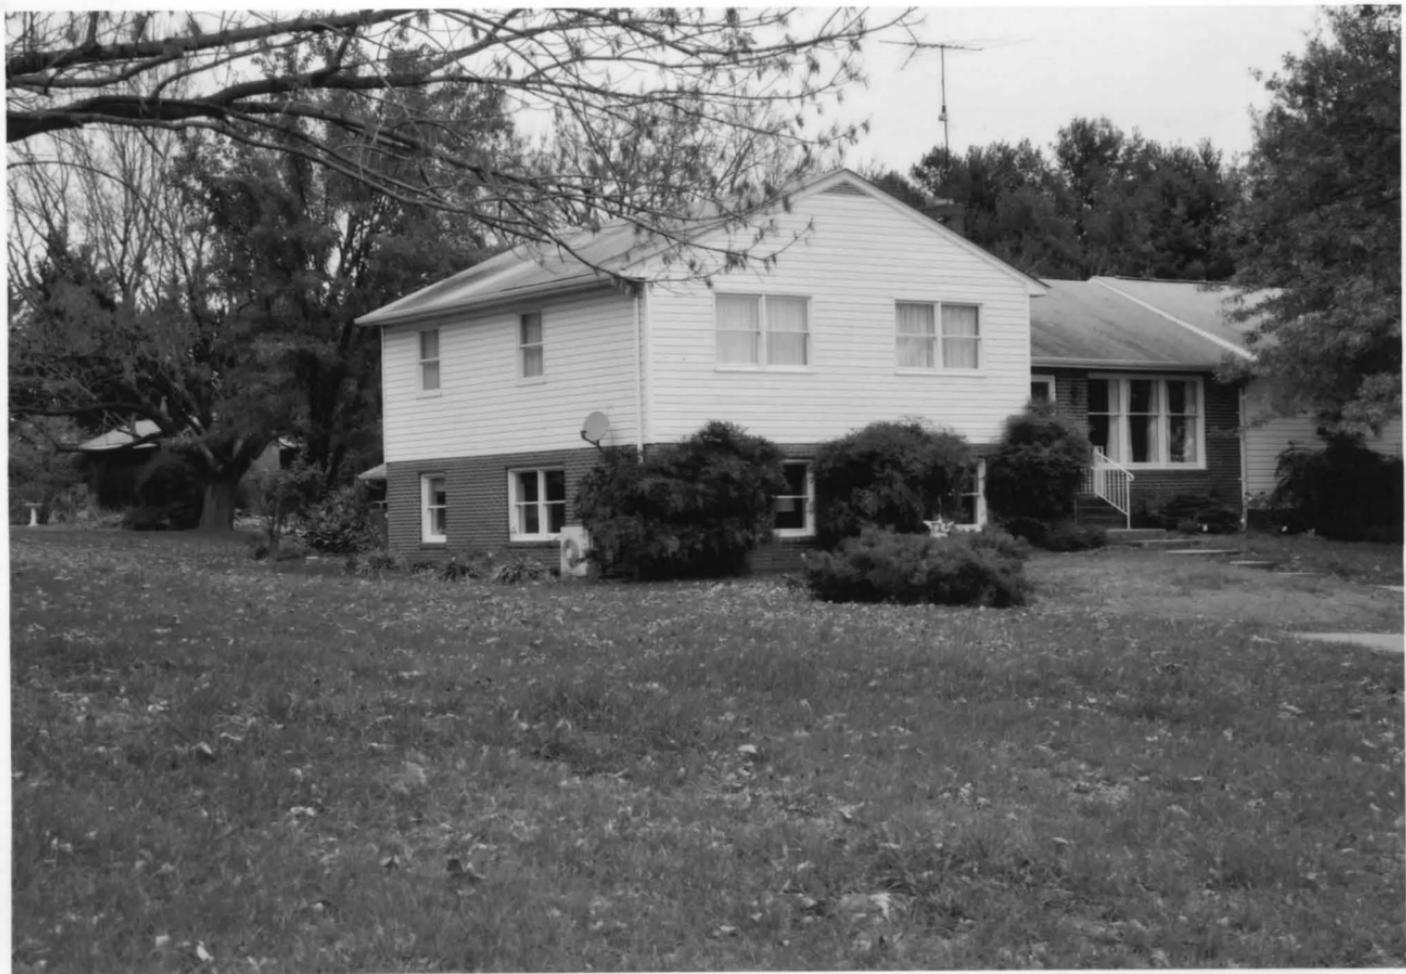
House, view Northeast
5/5
