National Register of Historic Places
Inventory—Nomination Form

and/or common Octorara Farm

Octorara Farm
Cecil County

SKETCH OF FARM PLAN

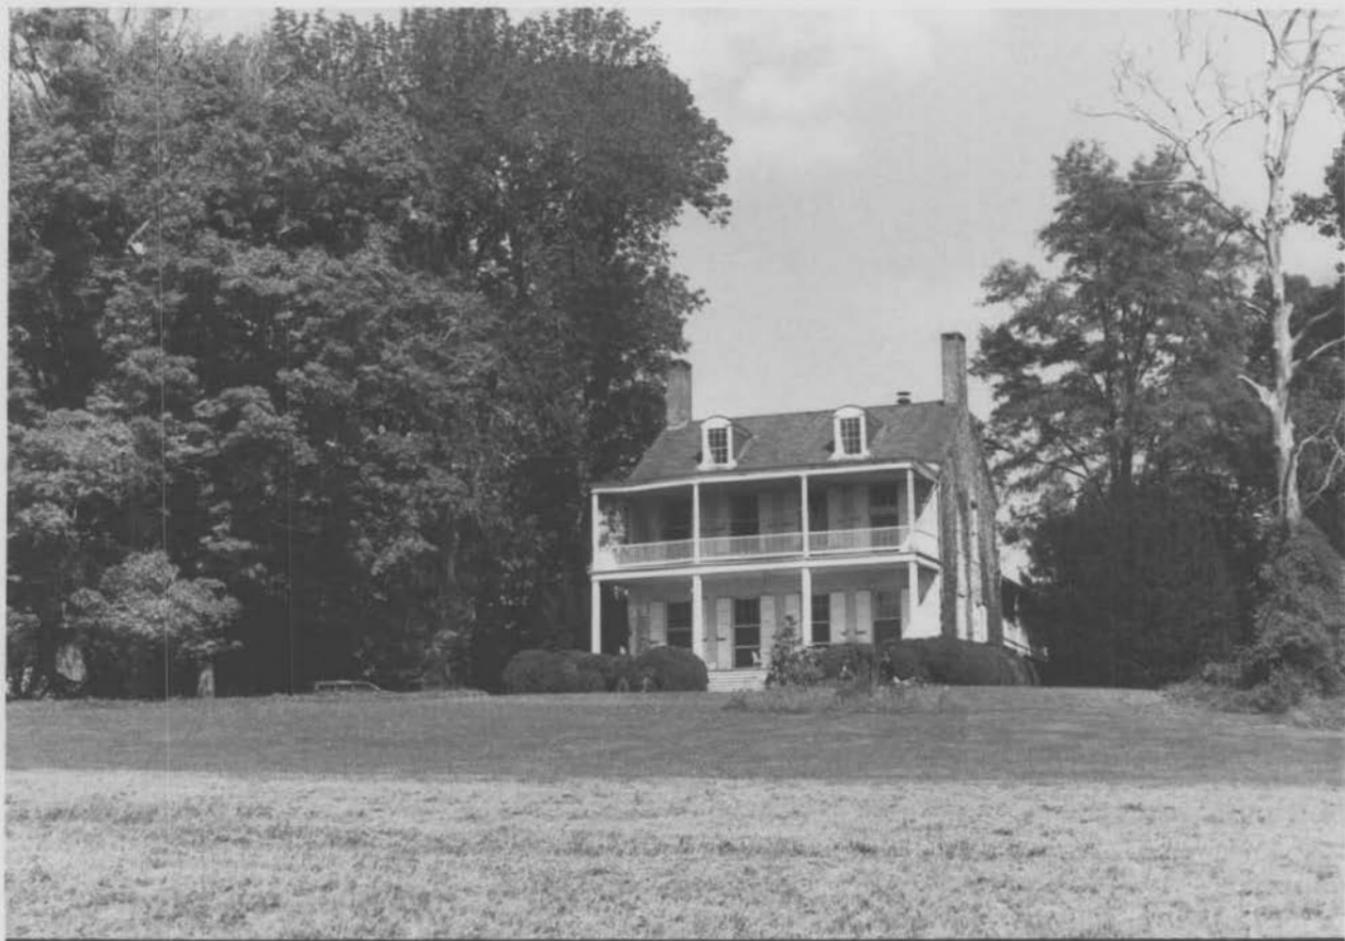
~~SAND~~ WEST ELEVATION
NE ROWLANDSVILLE, MD

The main block, which faces west, is a 2½-story, four-bay wide brick structure composed of four rooms on both the first and second floors; it was probably added to the rear section around 1830-1840. The rear section, with a principal axis perpendicular to the main block, has undergone two periods of rebuilding and alteration. The present kitchen, which constitutes the central room of the three rooms of the rear section, is the earliest section of the house. The stuccoed stone hall/parlor structure, as originally built, was three bays across by one room deep and 1½ stories high. A 2½-story fieldstone addition, three bays across by one room deep was attached to the eastern gable in the early to mid-19th century. Positioned perpendicularly to this latter addition is a contemporaneous two-bay by one room, 2-story fieldstone section joined to the latter addition at second story level with a passageway separating the sections on the first floor. This latter addition, three bays across by two deep with a medium sloped slate roof, contains an entrance in every wall except the north one where there occur two 4-pane windows similar to the small windows which illuminate the second floor.

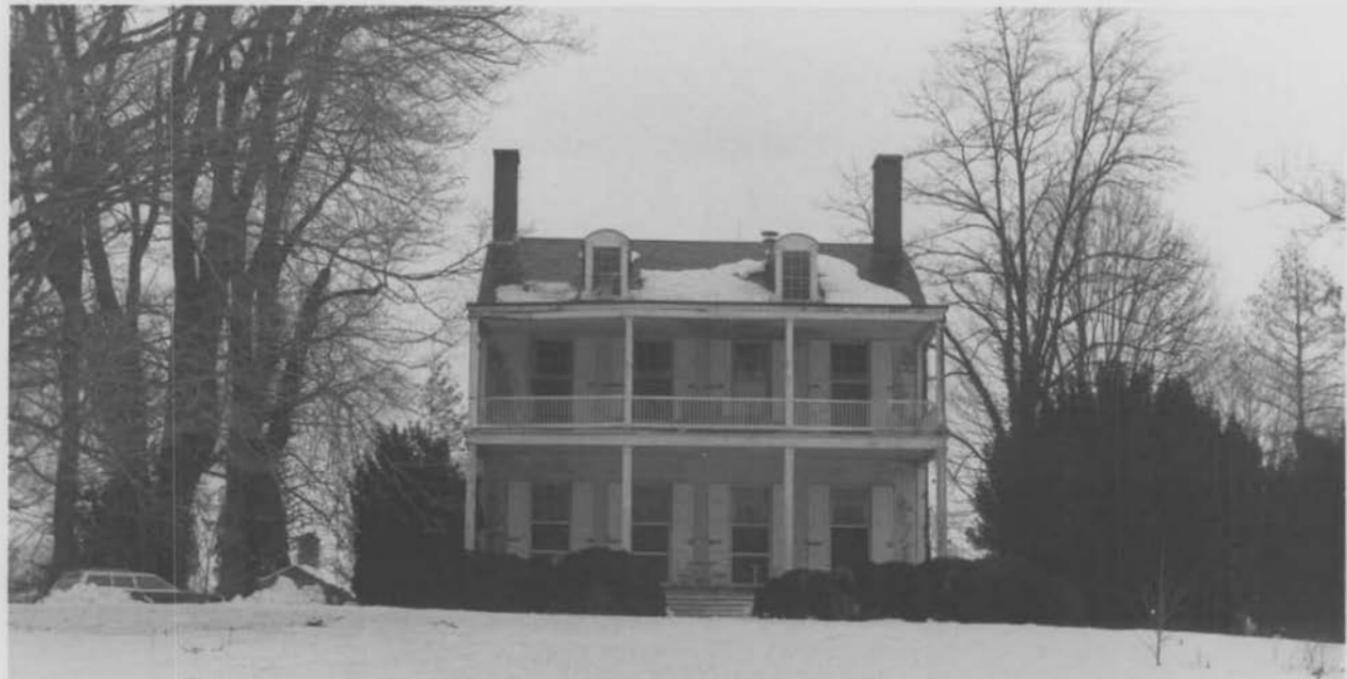
WEST ELEVATION

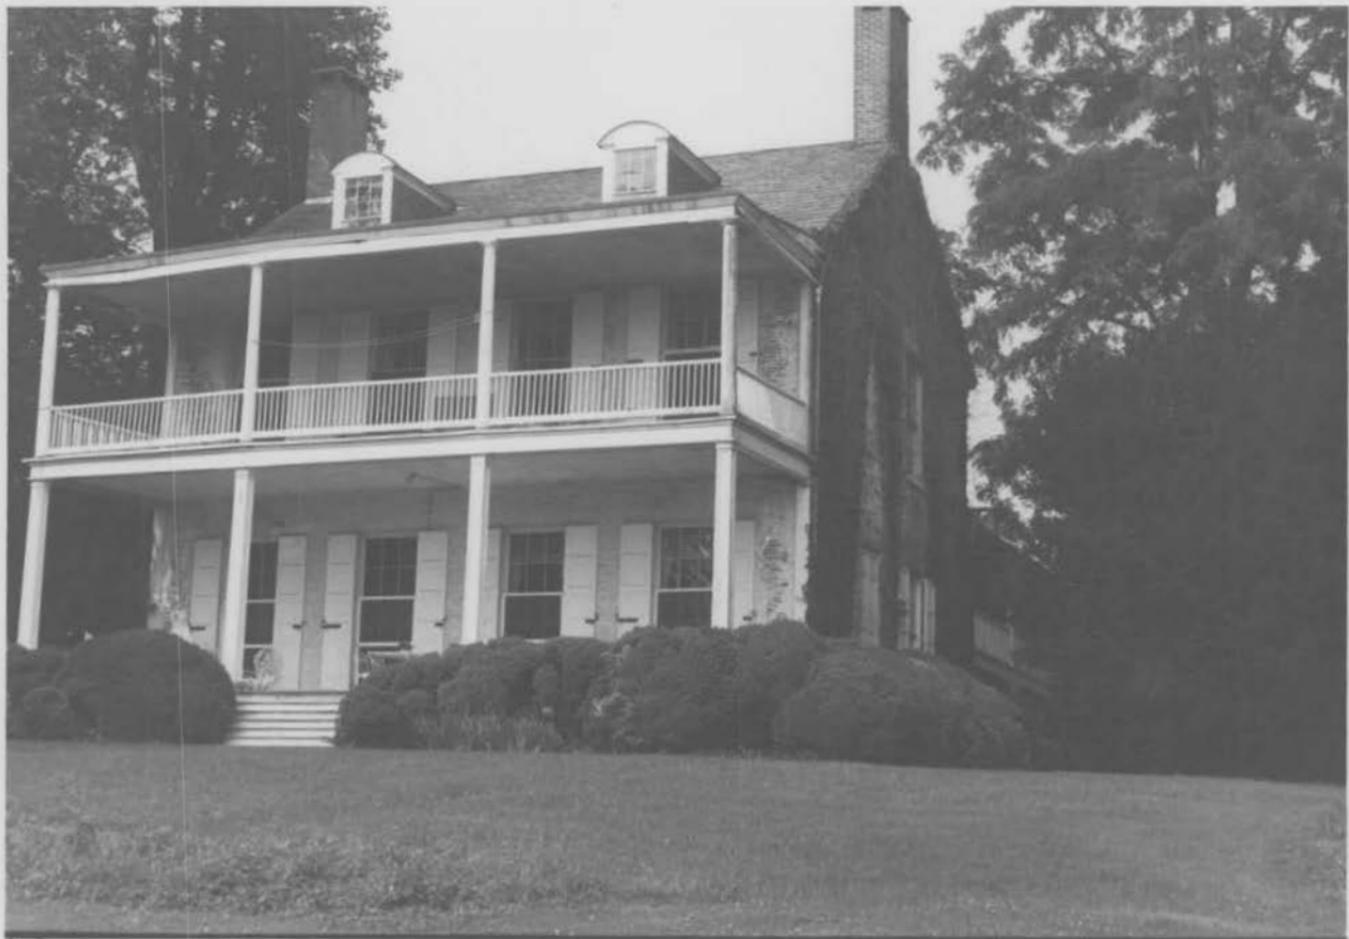
WEST ELEVATION

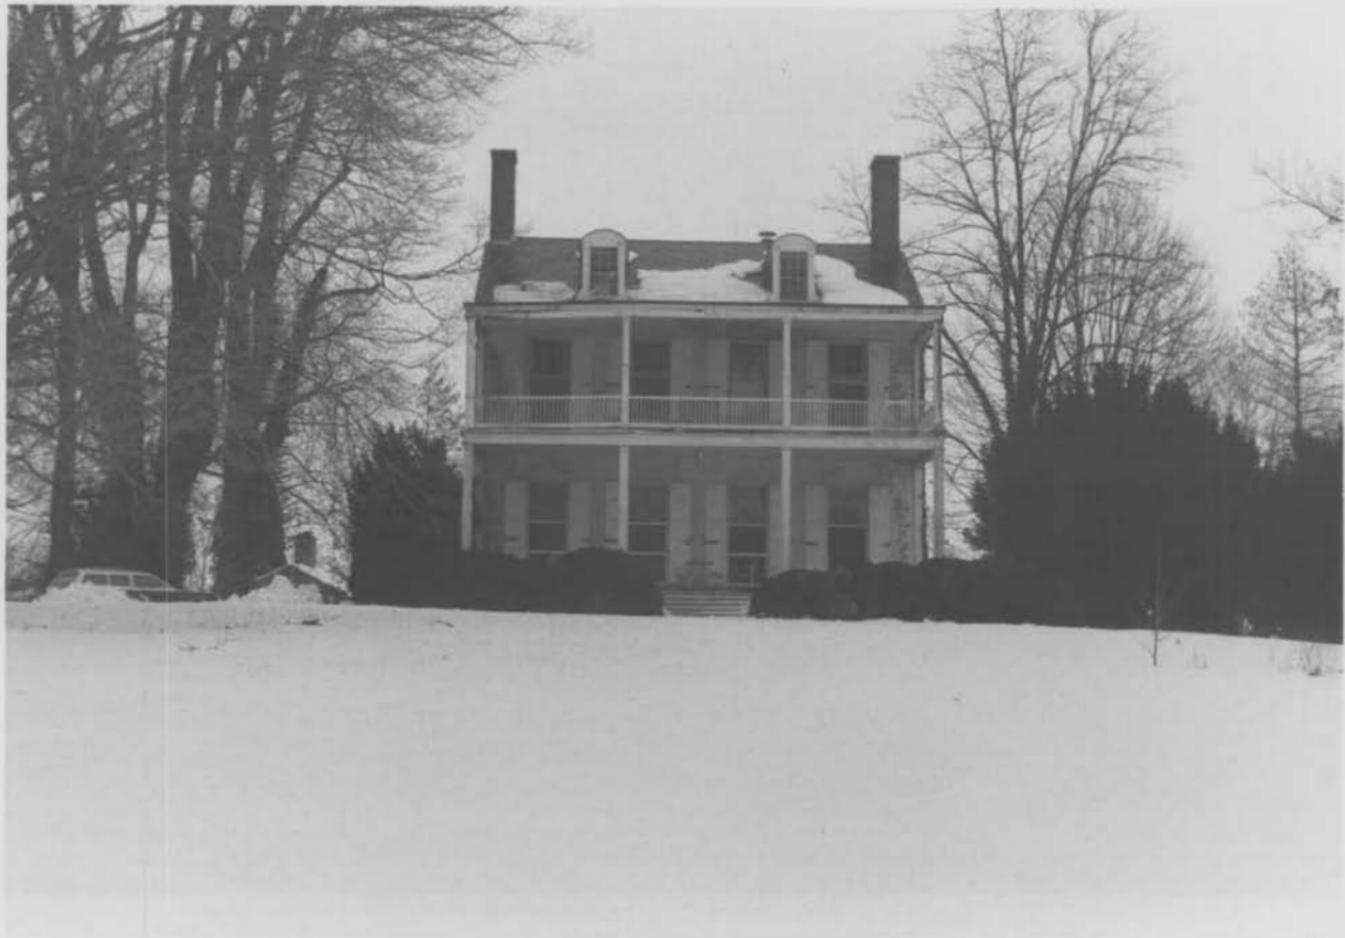
WEST ELEVATION

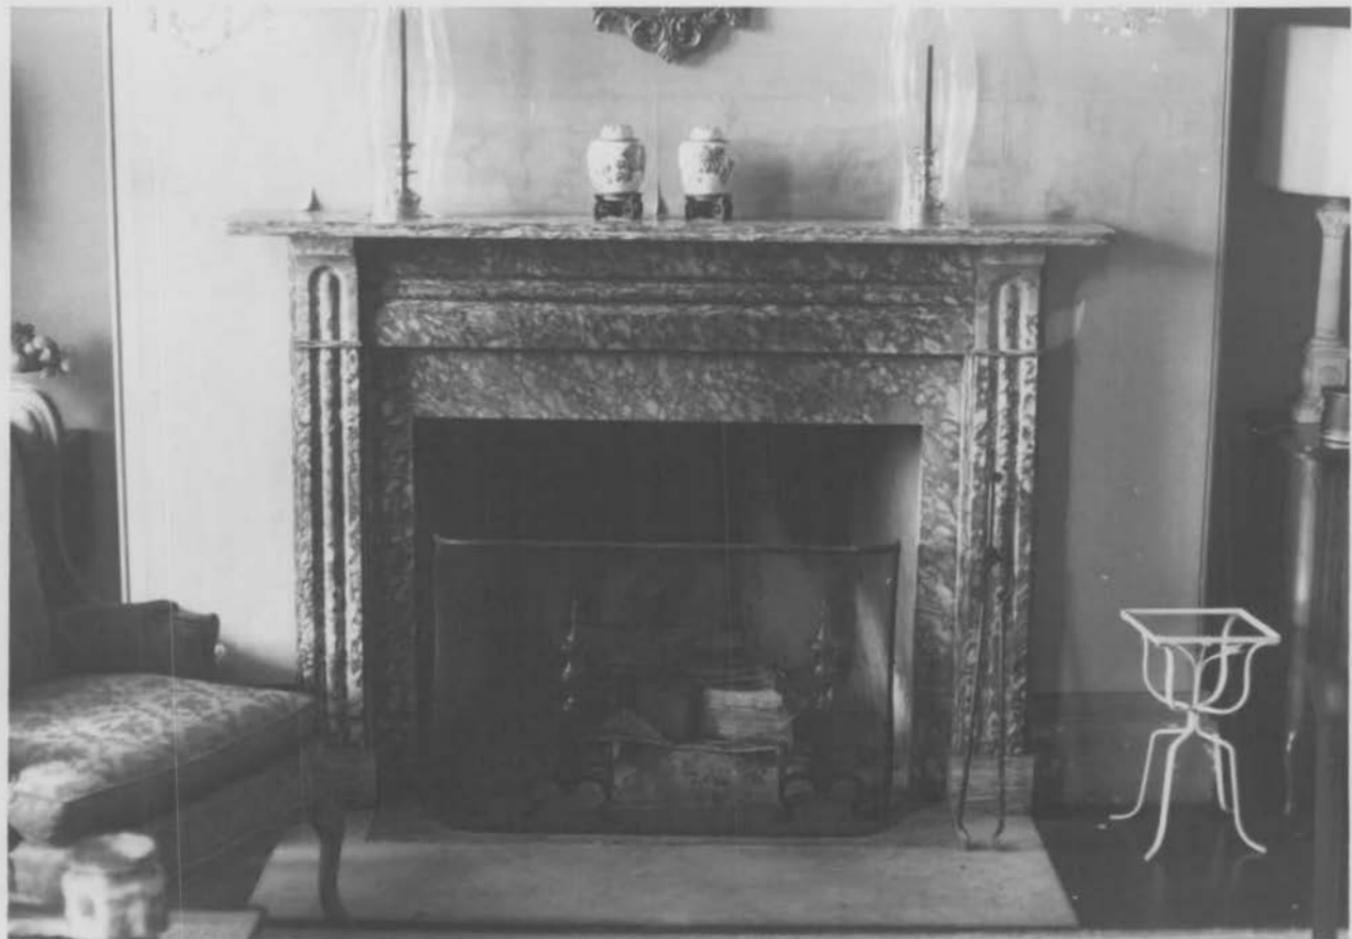
NORTH PARLOR MATEL

The northwest and southwest rooms are the front parlors which are separated by floor to ceiling double doors. The parlors' mantels are identically detailed, of grey mantels and characterized by two centrally cut grooves connected by a "u" in the end blocks underneath the brackets. The brackets themselves flare towards the top to resemble consoles and project forward from the frieze which is plain except for the same double grooves. The simple shelf possesses a double half round edge. Window and door surrounds are fluted featuring plaster rosette decorations on the corner blocks. The tops of the windows are further elaborated by decorative hoods.

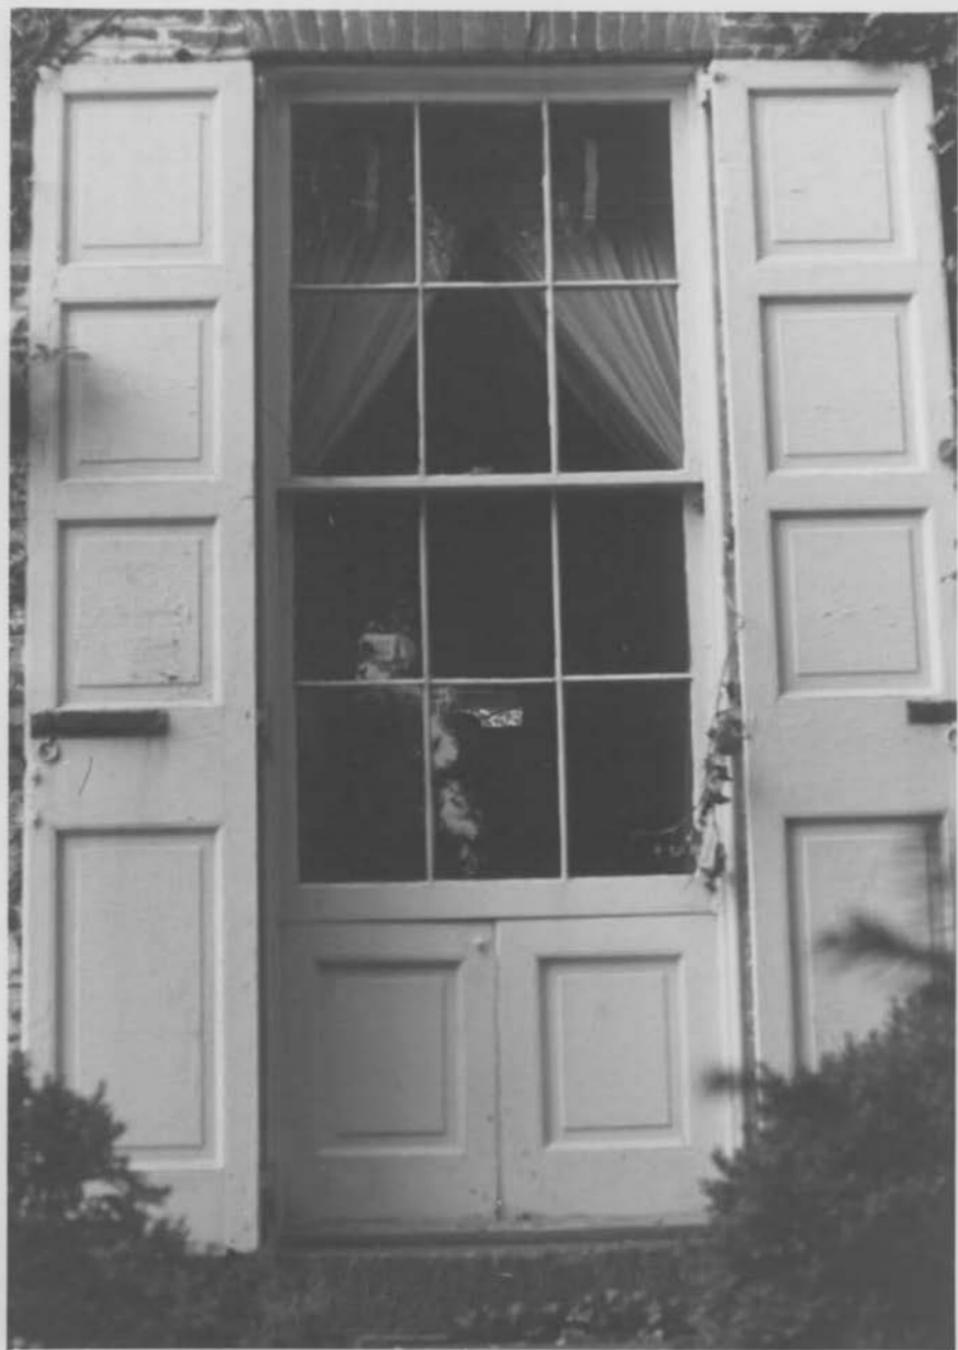
SOUTH ELEVATION -

JIB DOOR

The south facade of the main block is detailed like the north gable end except for a jib door which opens into the library. This entrance is approached by a brick stoop.

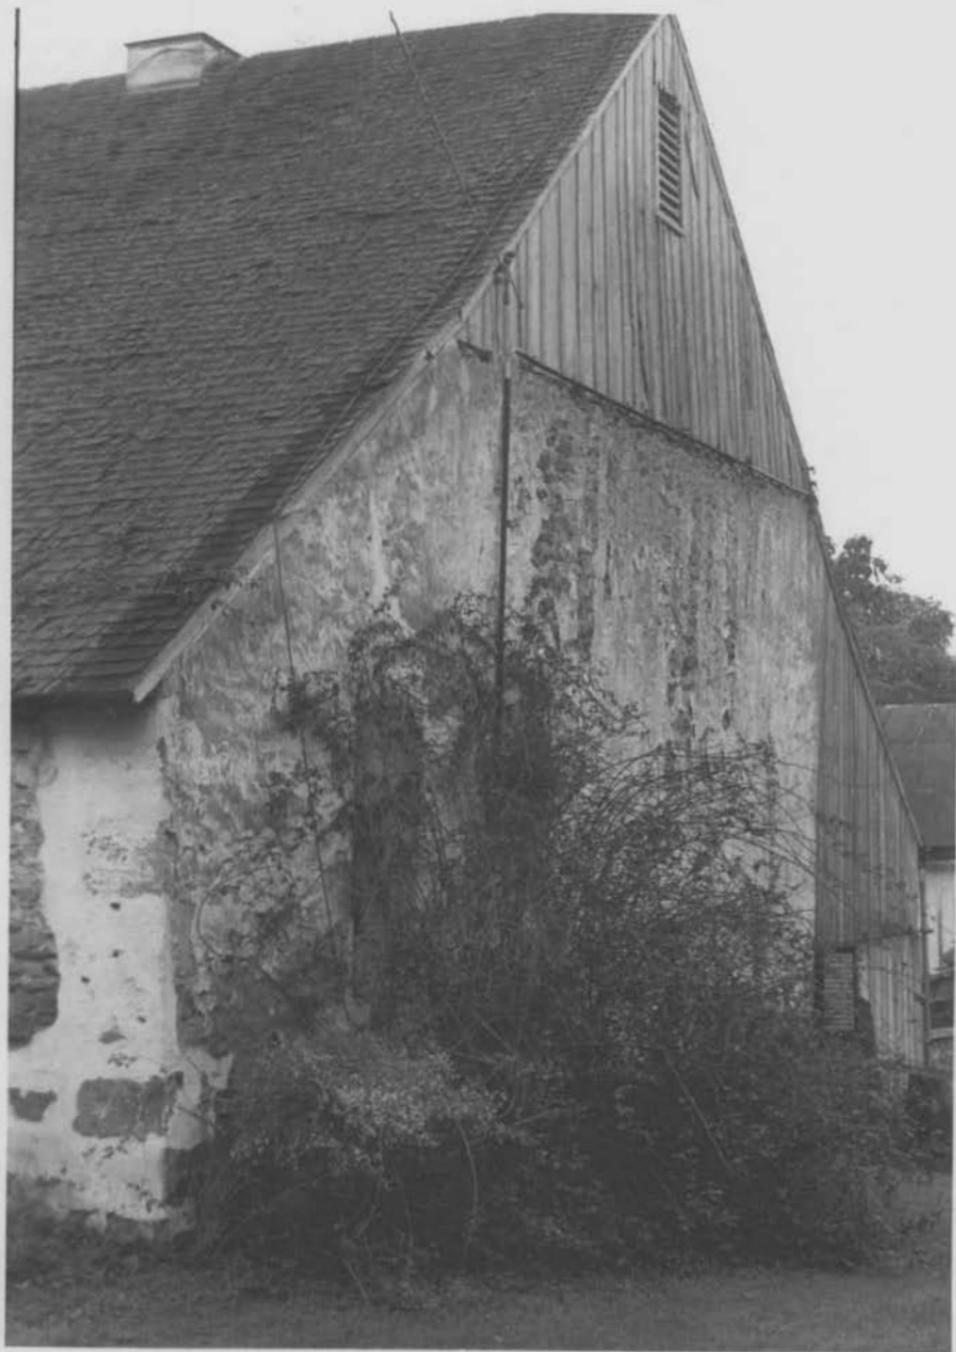
~~THE~~ SOUTH GABLE OF BARN

Outbuildings dating from the early to mid-19th century include a large four-bay, fieldstone barn, a wagon shed, dairy, smokehouse and tenant houses. The four-bay barn is augmented by an outshut on the western side and subsequent shed extension additions to the eastern side. The end walls and outshut are constructed of fieldstone while the peaks of the gable ends and the sides are frame with board and batten siding.

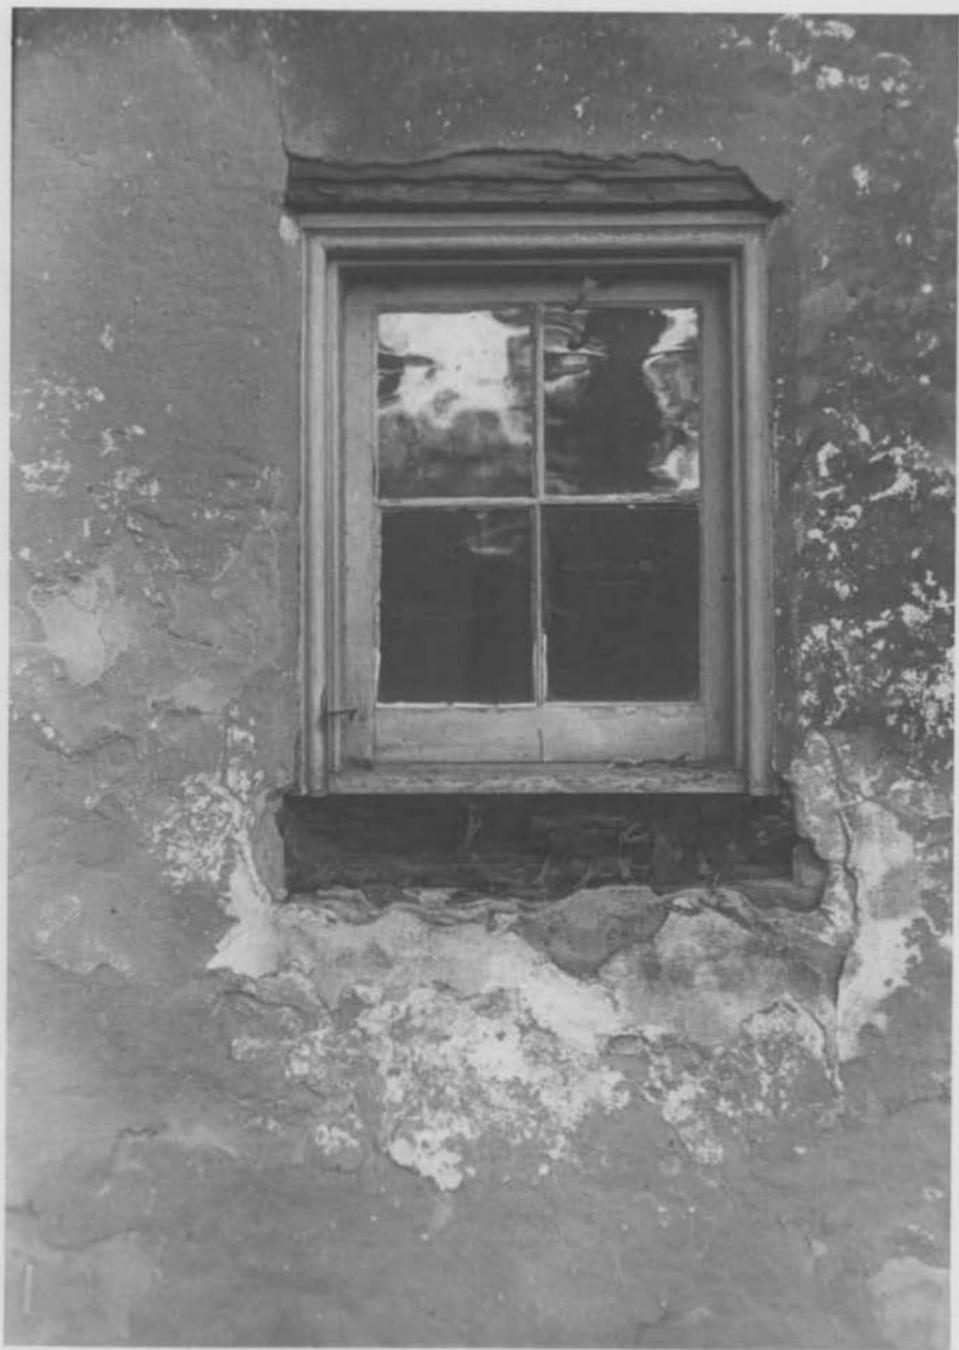
WINDOW OF STONE OUTBUILDING NORTH OF
REAR WING OF MAIN BLOCK
NORTH SIDE

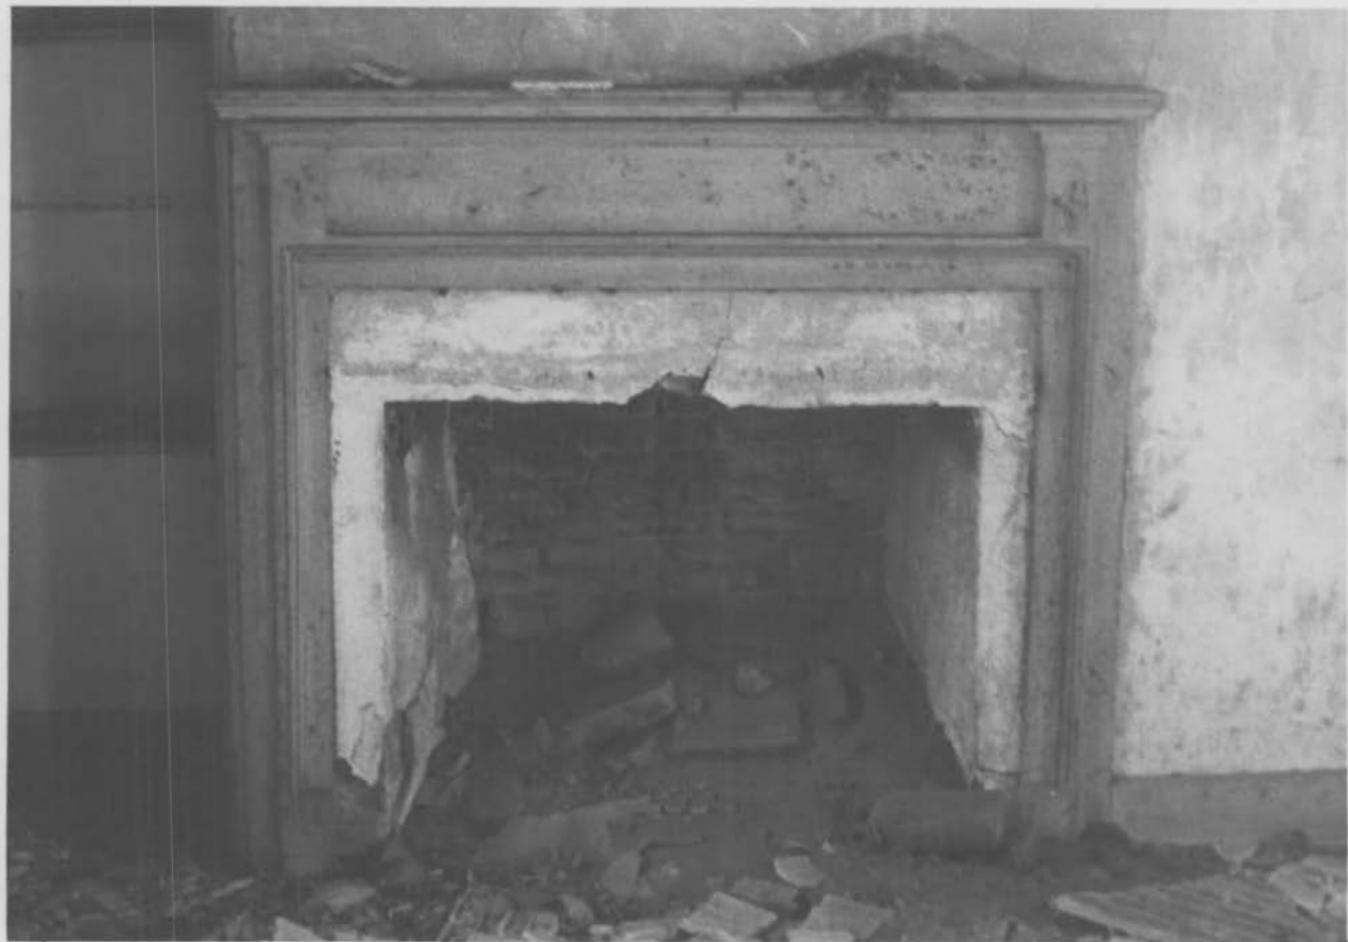
TENANT HOUSE MANTEL
WEST PARLOR
NR ROWLANDSVILLE, MD

On the interior of the tenant house, the large fireplace in the west room of the basement indicates that the basement level constituted the cooking area. A smaller basement occurs in the east basement area. The first floor is divided into three rooms with an enclosed central stair that rises from the basement and then continues to the attic. The principal room on the first floor is approximately square, its fireplace located on the west wall and elaborated by a mantel with molded architrave with projecting blocks at the ends of the frieze that support a molded shelf. A paneled side closet flanks the fireplace to the left. Two rooms occupy the other half of the first floor, both of which are very plain although the southeast room possesses a small Empire mantel. The wide floorboards have been partially removed. The center stair rises to the unfinished third floor.

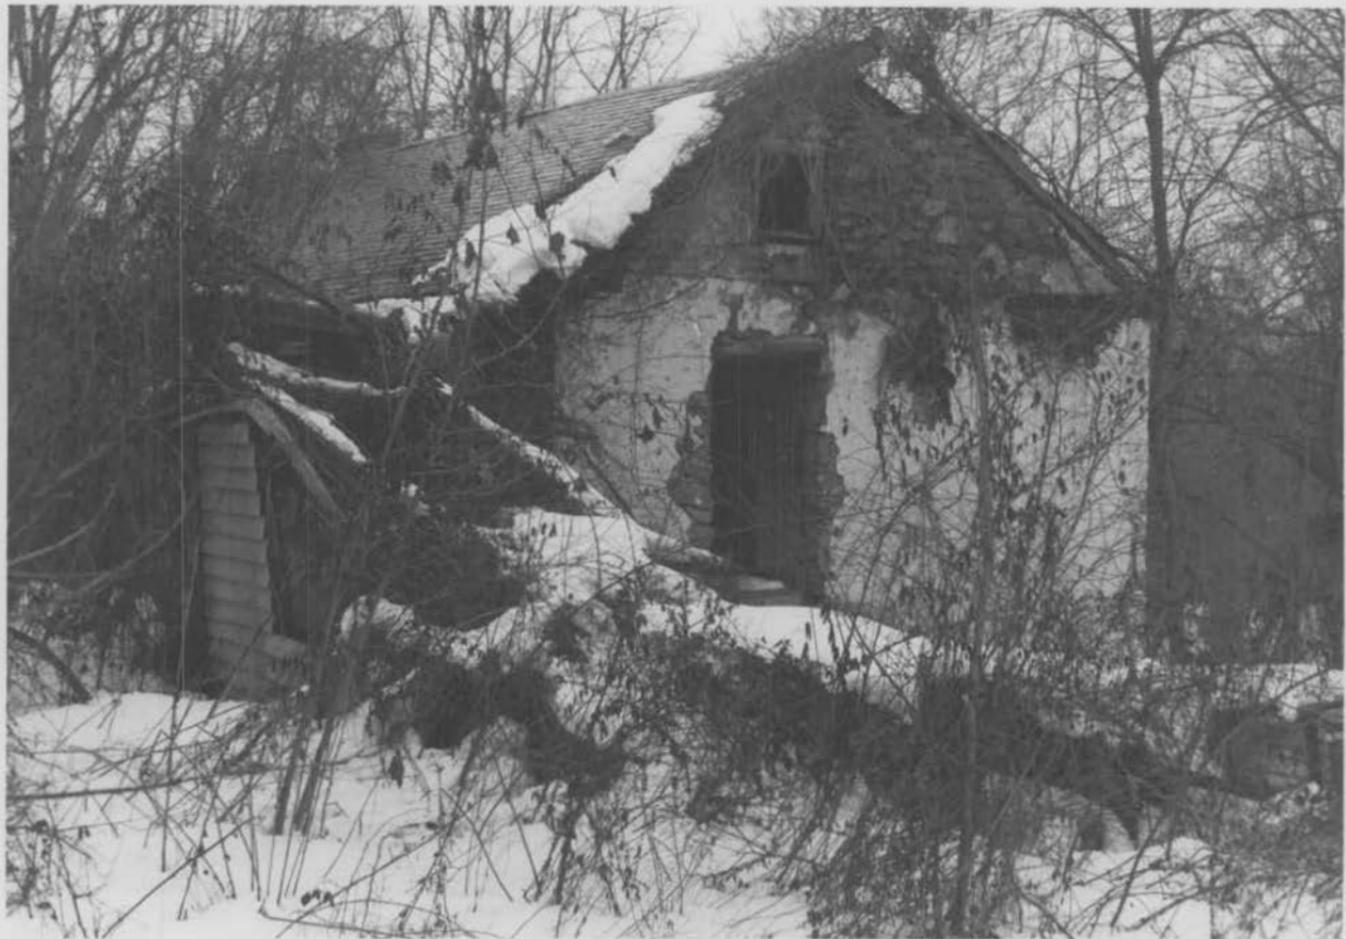
NORTH ELEVATION - TENANT HOUSE

is exposed on three sides. The three bay north facade contains a central door distinguished by a granite sill, four-light transom and surround with small corner bead. The main door has been removed and the 6/6 sash windows have been broken out. The west gable end possesses a doorway in its northern bay which formerly led into a now collapsed frame section. The south side of the tenant house contains three windows and one door at basement level. The iron brackets which supported a single story porch still remain in place between the basement and first floor levels.

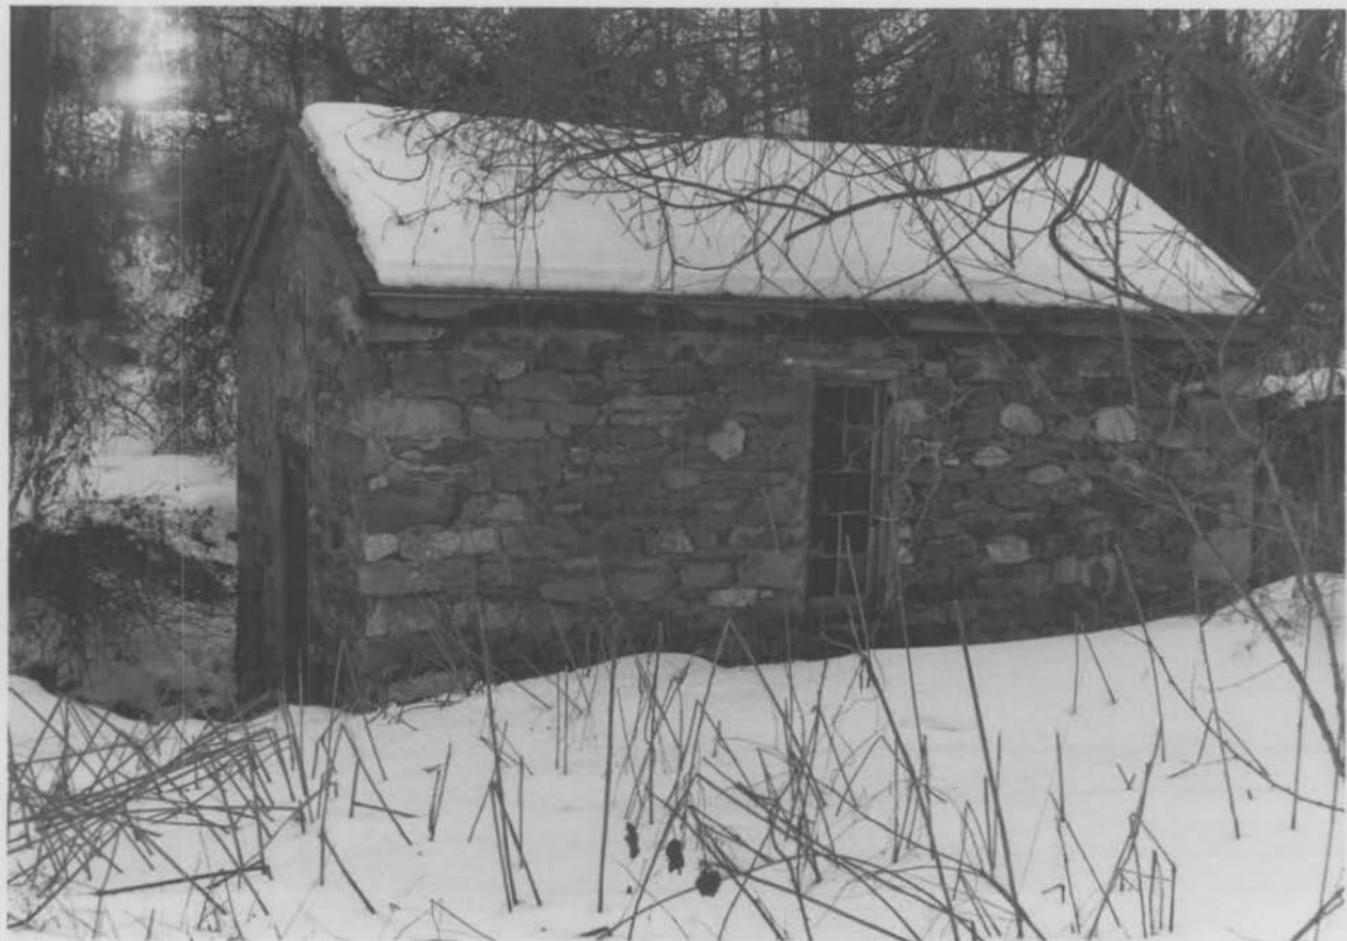
SPRING HOUSE

EASTERN ELEVATION

Two uncoursed field-stone structures stand at the southern extremity of Octorara Farm, a springhouse and a probable tenant dwelling. The springhouse is a single-story, one bay by one bay structure topped by a wood-shingled, gable roof of medium slope. Access to the interior is gained through a board door in the south gable end. A narrow, ten-pane window with a single beaded surround punctuates the east facade.
