**National Register of Historic Places
Inventory—Nomination Form**

historic Rock United Presbyterian Church (preferred)

street & number MD Route 273 at Rock Church Road n/a not for publication

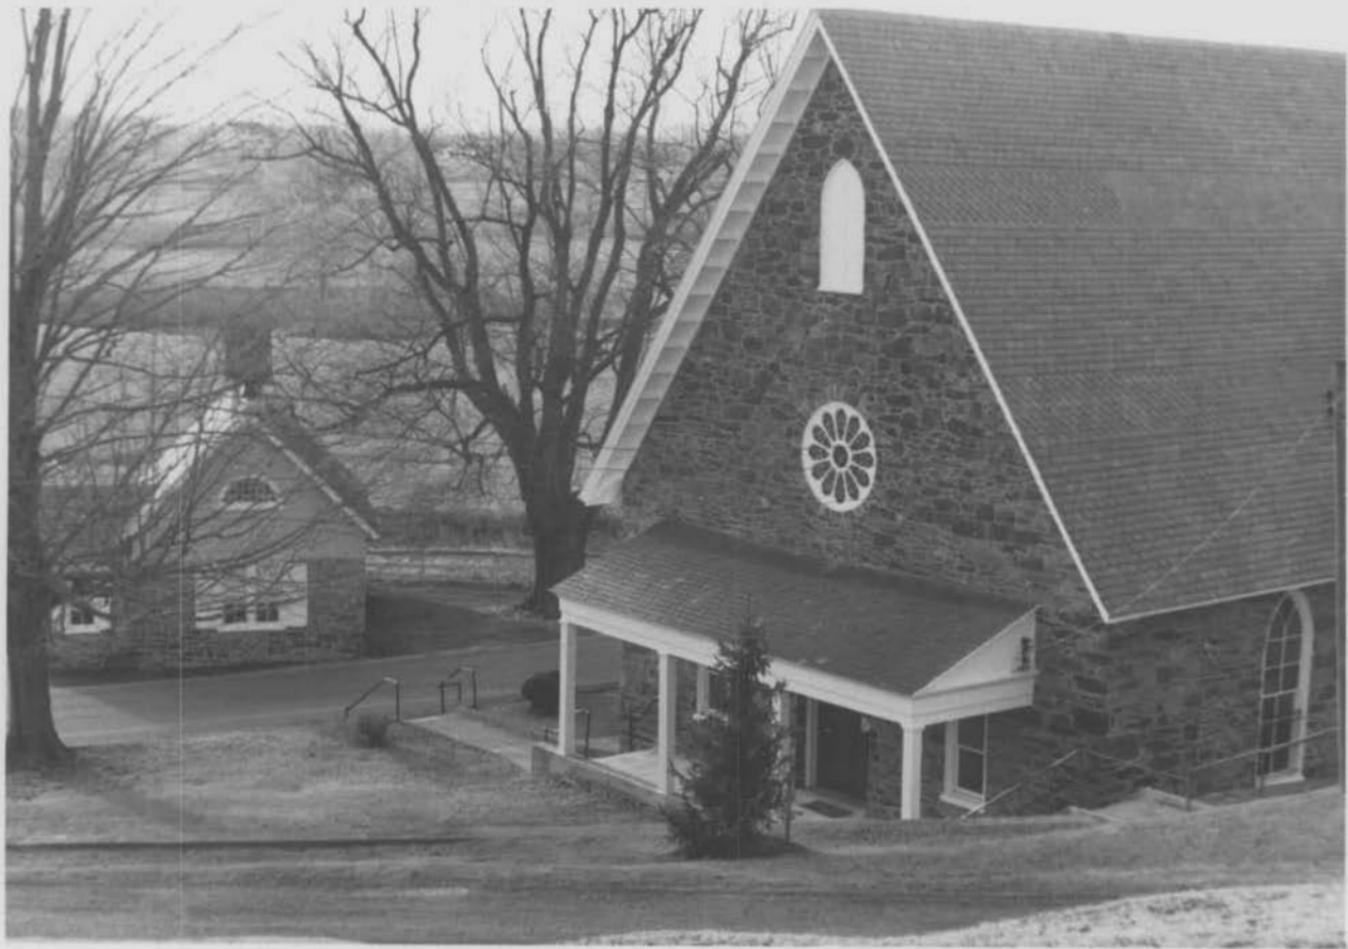
VIEW OF CHURCH AND SESSION HOUSE

EAST ELEVATION
