CE - 796

Doordan Frame House

MARYLAND HISTORICAL TRUST

INVENTORY FORM FOR STATE HISTORIC SITES SURVEY

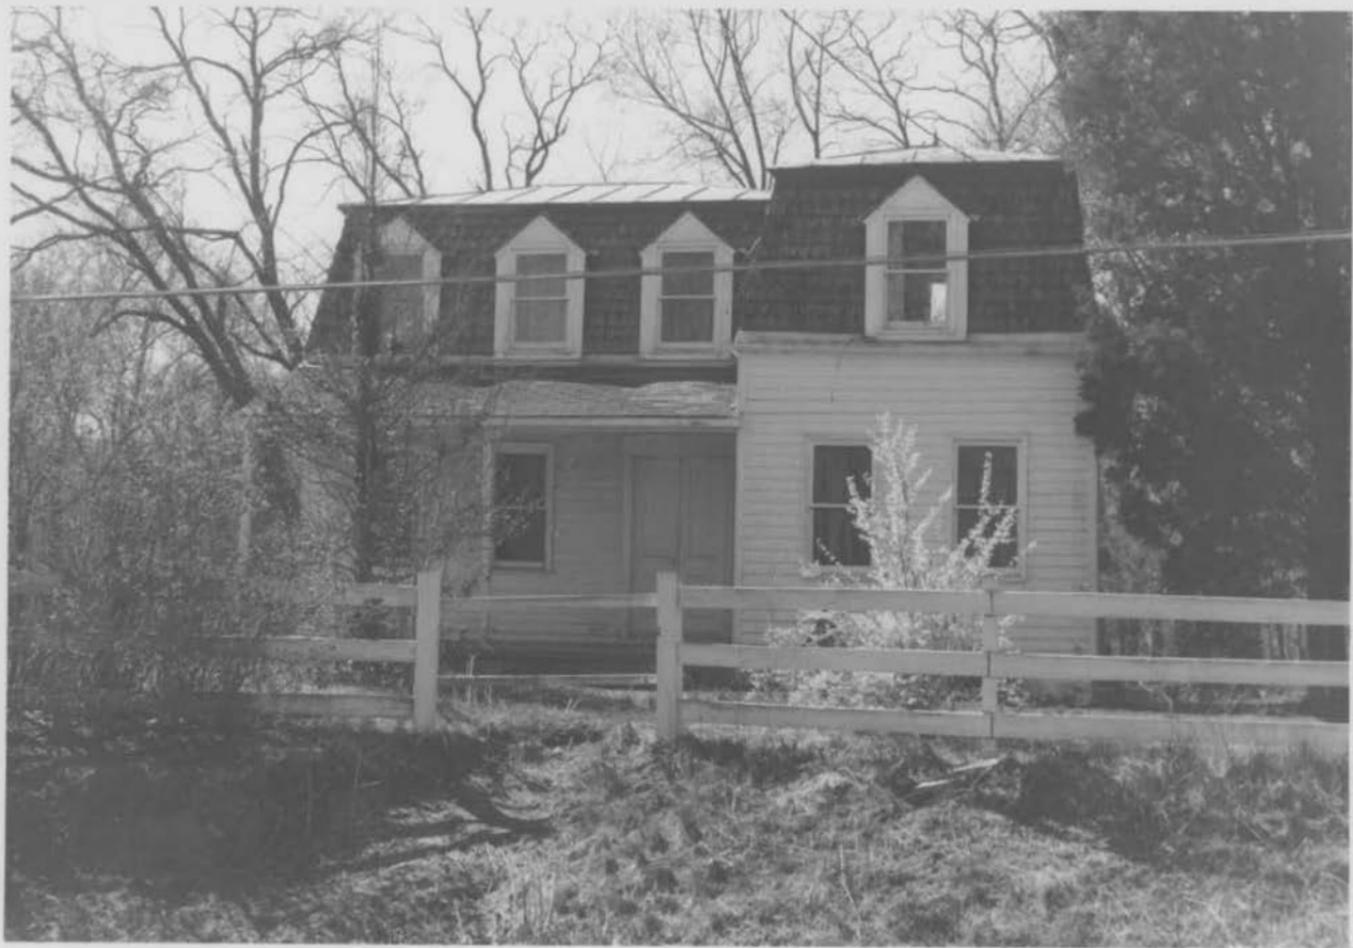
CE-796

The Doordan House c. 1870 is a 2 story frame dwelling on Hances Point Road a $\frac{1}{2}$ mile south of the fork from Route 272. The house faces east with the main axis going north/south.

The Doordan House consists of two offset rectangles, the northern block set to the east five more feet than the southern block. These two sections are supported by an uncoursed stone foundation and covered with a manard roof. The northern block is 2 bays across by one room deep and the southern rectangle, 3 bays across by one room deep. A 1 story porch fills the front offset. A shed kitchen extends to the west of the southern section. The house has a weatherboard sheathing with beaded end boards which terminate the weatherboards. The wooden roof shingles have a fishscale design. Two chimneys rise out of each end wall and only provide for individual stove stacks.

The windows are symmetrically placed and have brick molding surrounds and 1/1 sash windows. There are small gabled dormers on the main facade with 1/1 sash windows. The double late 19th century front door is located in the third bay from the south.

EAST ELEVATION

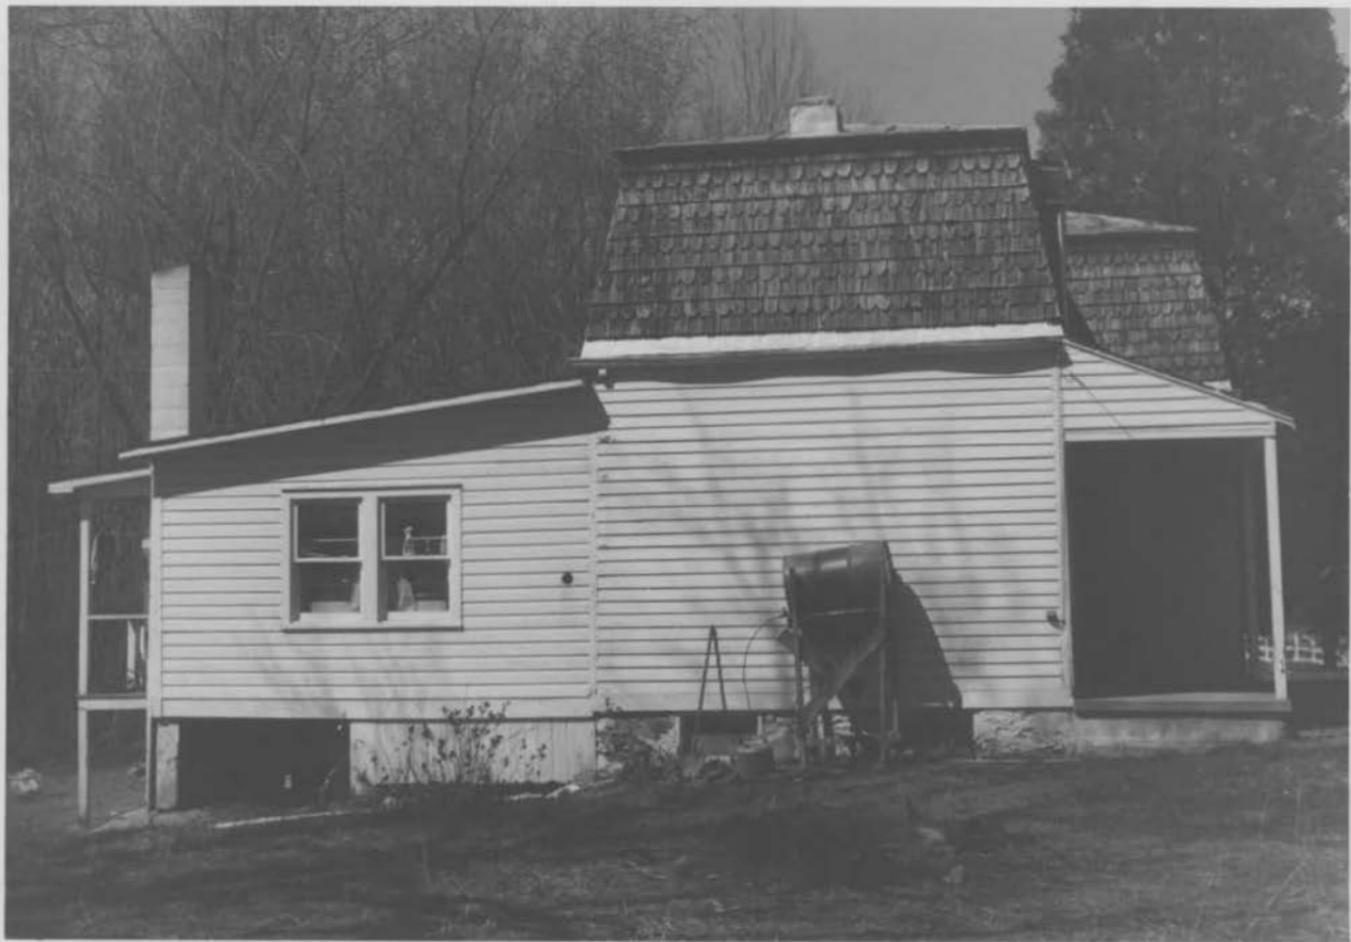
CE- 796

SOUTH ELEVATION
