CE-810
HAASE HOUSE
Elkton
Private

INVENTORY FORM FOR STATE HISTORIC SITES SURVEY

Haase House

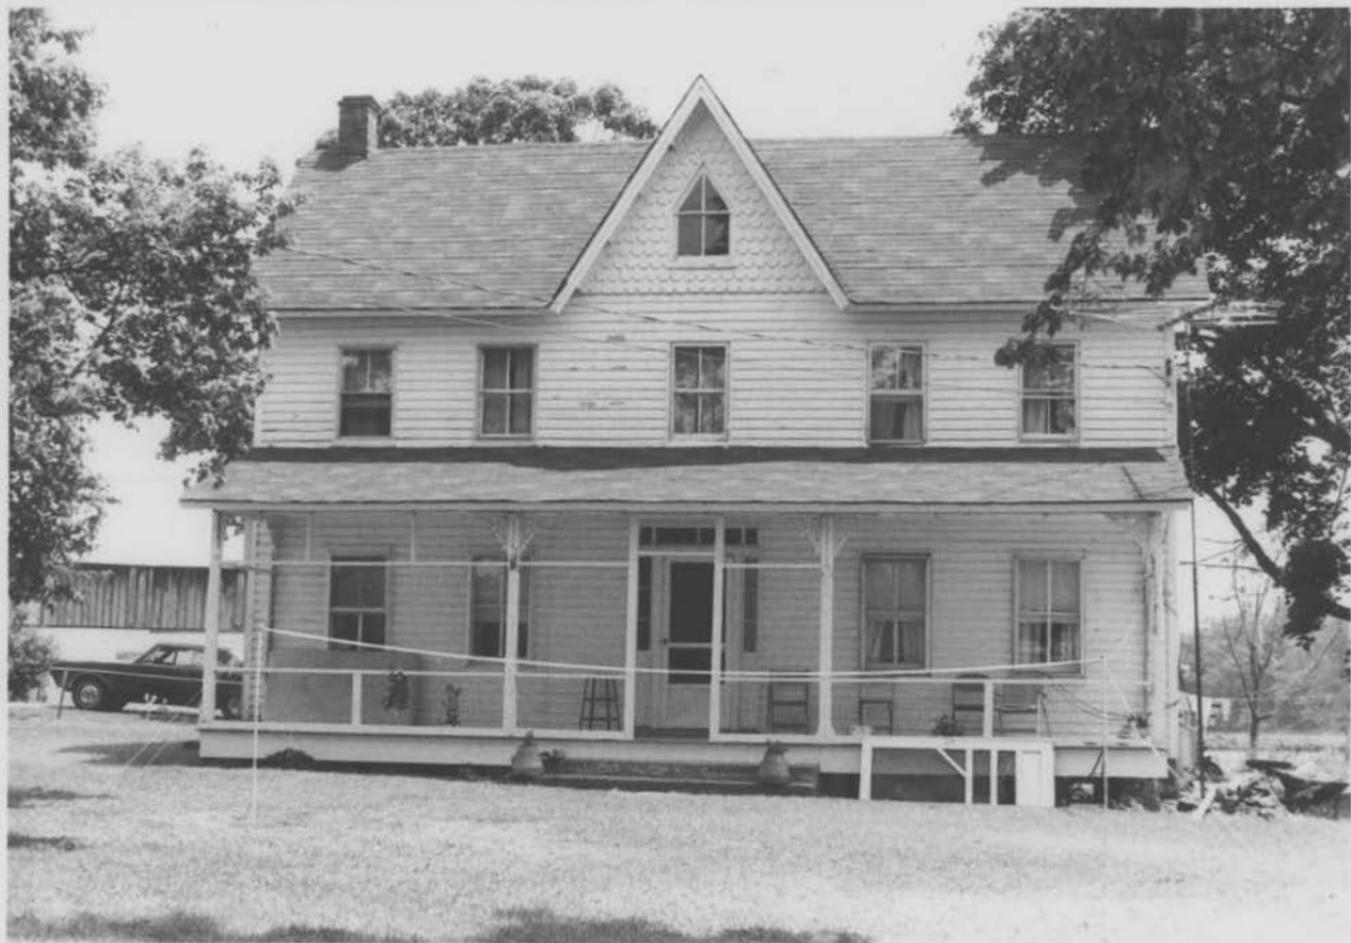
WESTERN ELEVATION

The east and west gable end are similar with 2 2/2 sash on each floor and 2 four pane attic lights that flank the stretcher bond stove stacks.
