CE-963

Lusby-Sheeler ~~House~~ ^{Tenant} House

C. 1860

INVENTORY FORM FOR STATE HISTORIC SITES SURVEY

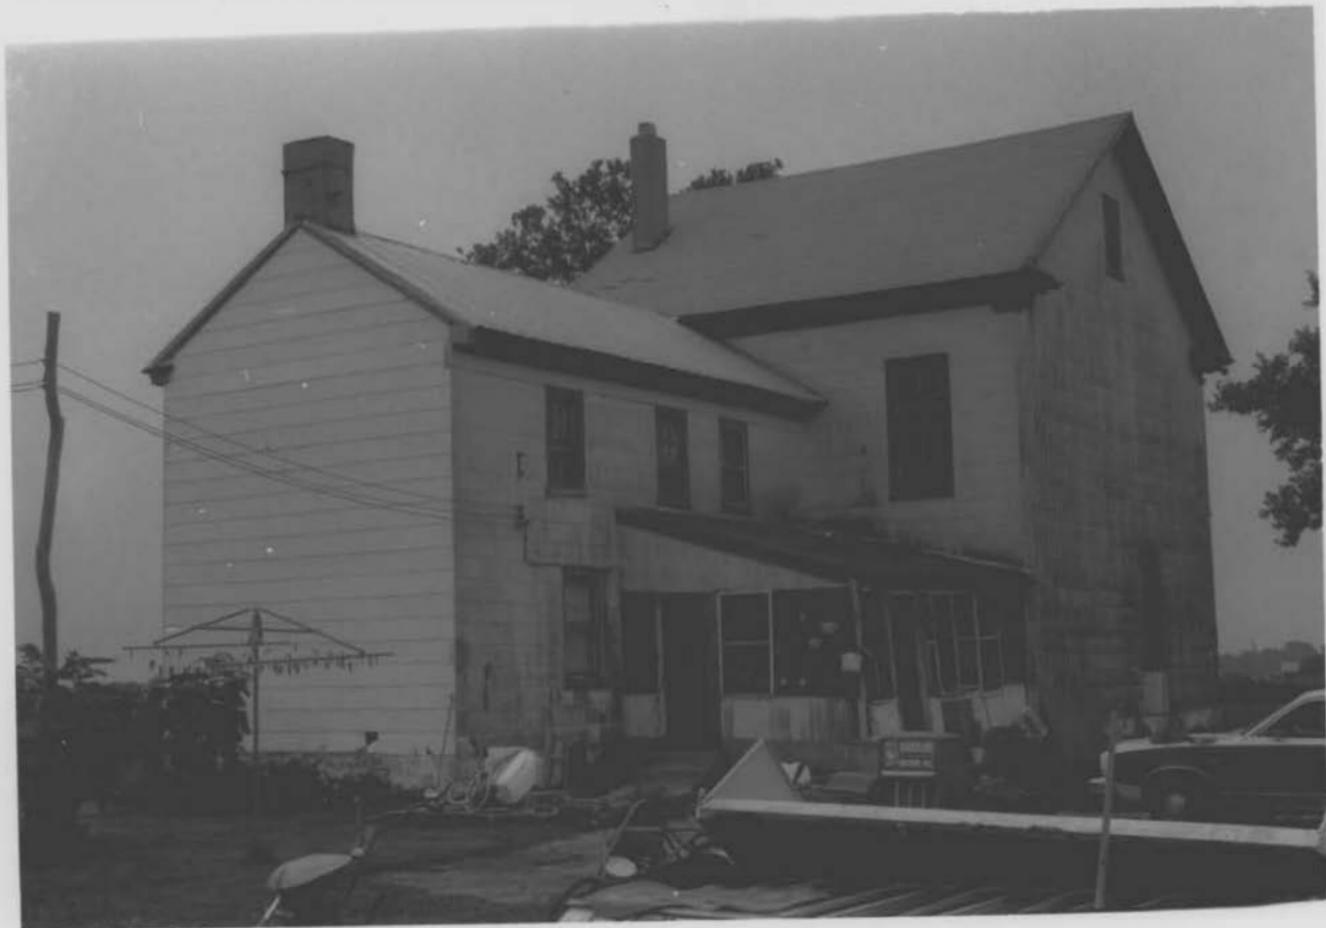
CE-963

The unfortunate removal of the front porch from this house has revealed the internal mid 19th Century braced timber frame with closely set vertical studs. This type of construction has a long history of development which begins with early timber frame techniques. This structure exemplifies the third quarter of the 19th Century in both construction and architectural detail. The side hall double parlor plan, the moldilioned cornice, long 4/4 sash windows, and two rooftop gabled dormers sets this structure apart from the typical in this area of Cecil County.

Lusby STEELE House
ON EAST ELEVATION
