INVENTORY FORM FOR STATE HISTORIC SITES SURVEY

GIBSON'S GREEN FARM

CE-964

The farmhouse on Gibson's Green Farm circa 1856 is a two and one-half story three bay by four bay frame three room plan house on Route 213 just north of Cecilton, Maryland. The house faces south with the main gable running on a north/south axis.

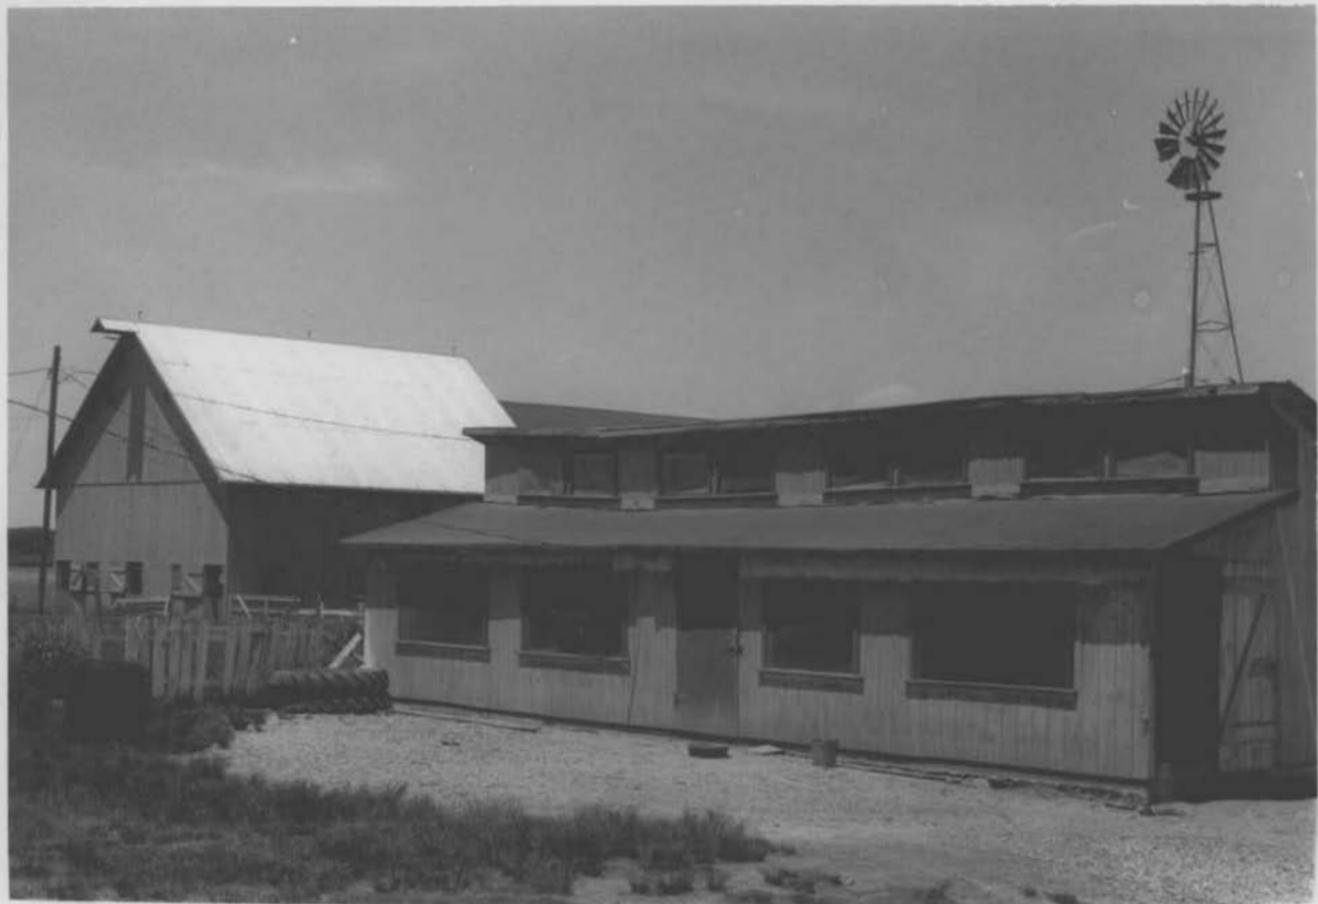
(35)

A granary is found down the lane to the north of the house and is a typical two story form with side cribs and central passage. Other more recent chicken coops and cow barn are found directly north of the house. An iron windmill is located in the midst of these later structures. Thorn hedge fences line some lanes and according to the owner was the accepted mode of outlining fields and property lines.

GIBSON'S GREEN FARM
SOUTHERN ELEVATION OF
CHICKEN HOUSES
