Phoenix Hall
CH-216
Bryantown vic.
Private

Inventory No. CH-216

Maryland Inventory of Historic Properties Form

Name Phoenix Hall (preferred)

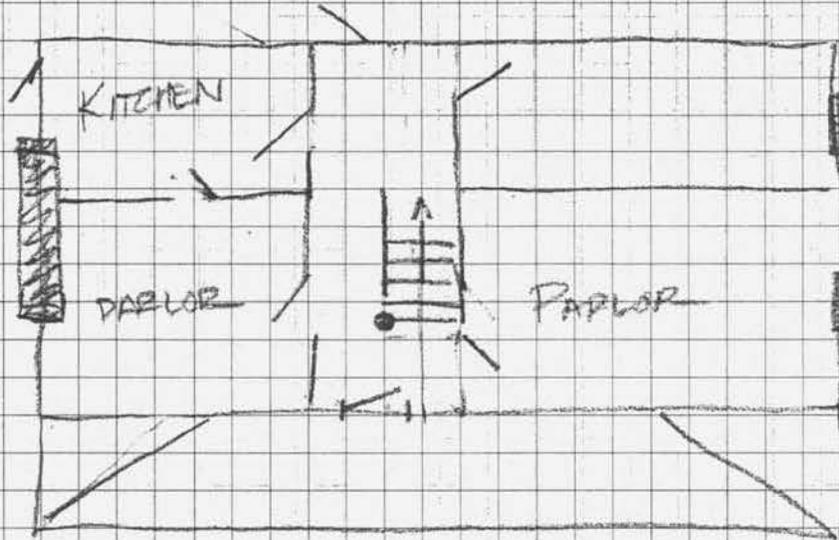
FIRST FLOOR

Phoenix Hall has a center hall, double-pile plan. Interior evidence confirms that the house has been extensively altered and contains a wide variety of materials from different time periods. (1) The house is without significant ornamentation with the exception of a massive, mid-19th century newel in the hall. The front rooms are larger than those to the rear and the east rooms are larger overall than their counterparts to the west. Mantles appear to be late Victorian in style.

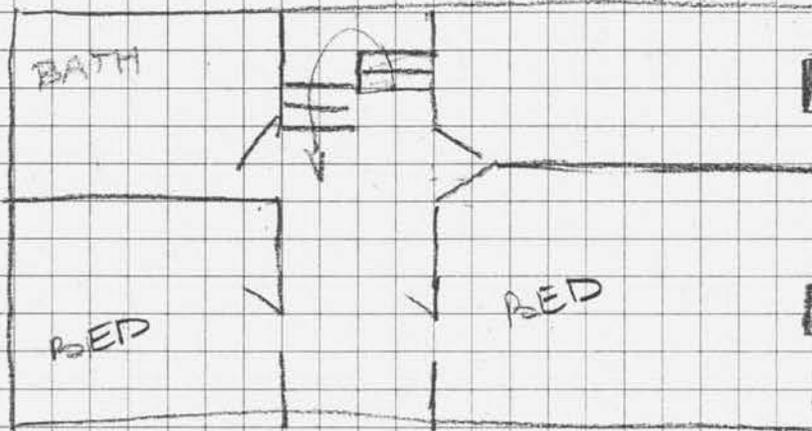
SECOND FLOOR

An unusual feature was noted on the second floor east wing. While the doors giving access to these rooms from the hall are symmetrical, the interior wall has been moved to enlarge the size of the front room. However, because the rear door could not be placed any further north due to the stair configuration, the interior wall is angled at the entrance to accommodate the opening and closing of this door.

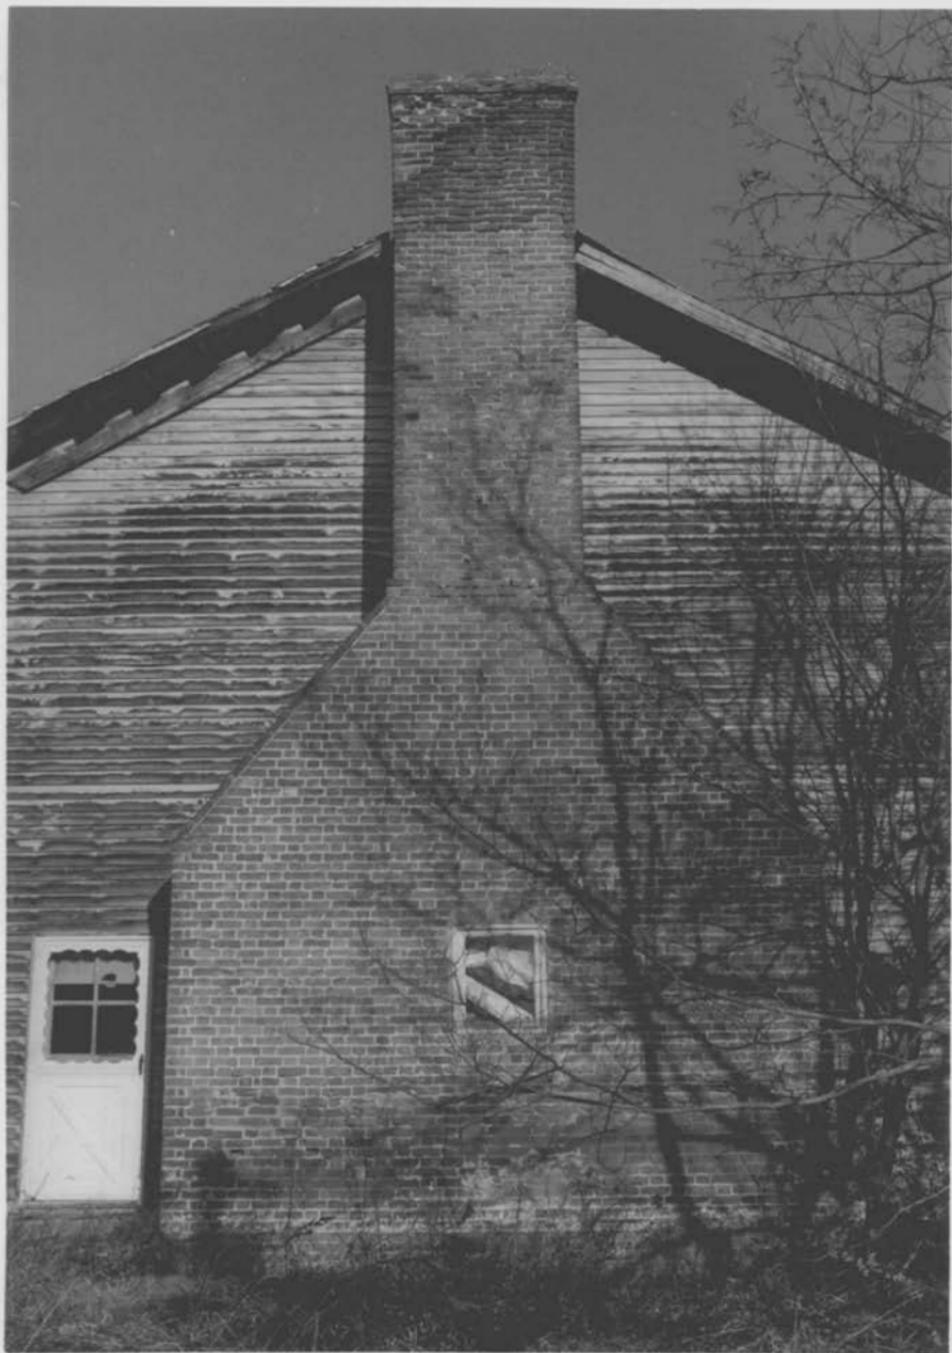
2 of 7

The east elevation includes the massive exterior brick chimney, laid in Flemish bond with paved shoulders and a corbelled cap. A square replacement window lies in the center of the chimney. To the left is a rear 4-light and panel door found near the north wall. The roofline on this elevation includes pieces of wood trim which may indicate that at one time the exposed rafters were partially enclosed.

WEST CHIMNEY

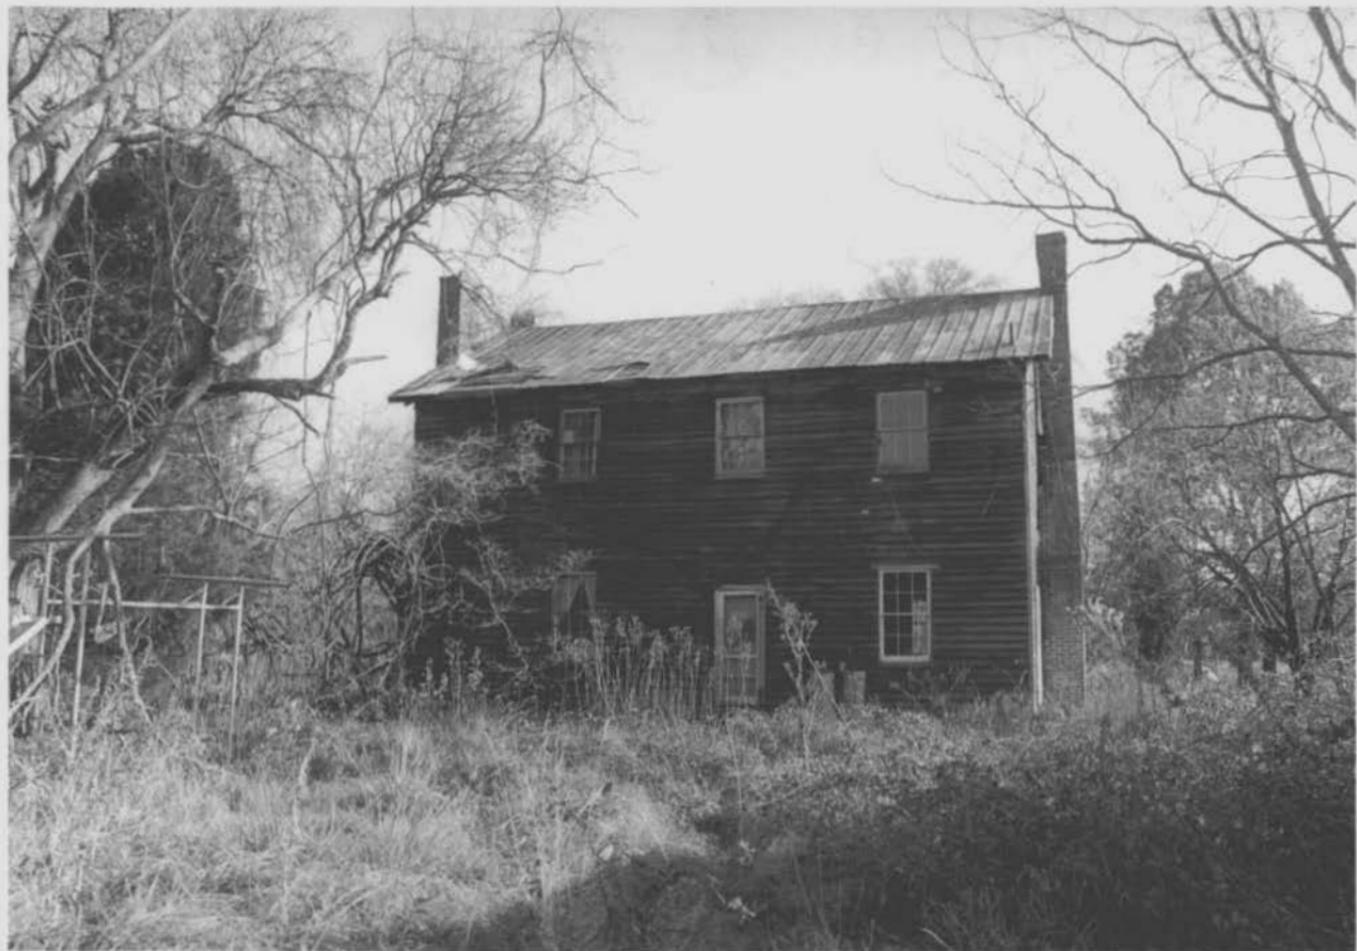
30F7

The rear of the dwelling has asymmetrical fenestration consisting of three windows on the first floor and two windows and a door below. Windows are 6/6 light double hung wood sash.

CH-216
PHOENIX HALL
CHARLES CO, MD
11/2000
C. CURREY
MD SHPO
REAR ELEVATION, LOOKING SOUTH

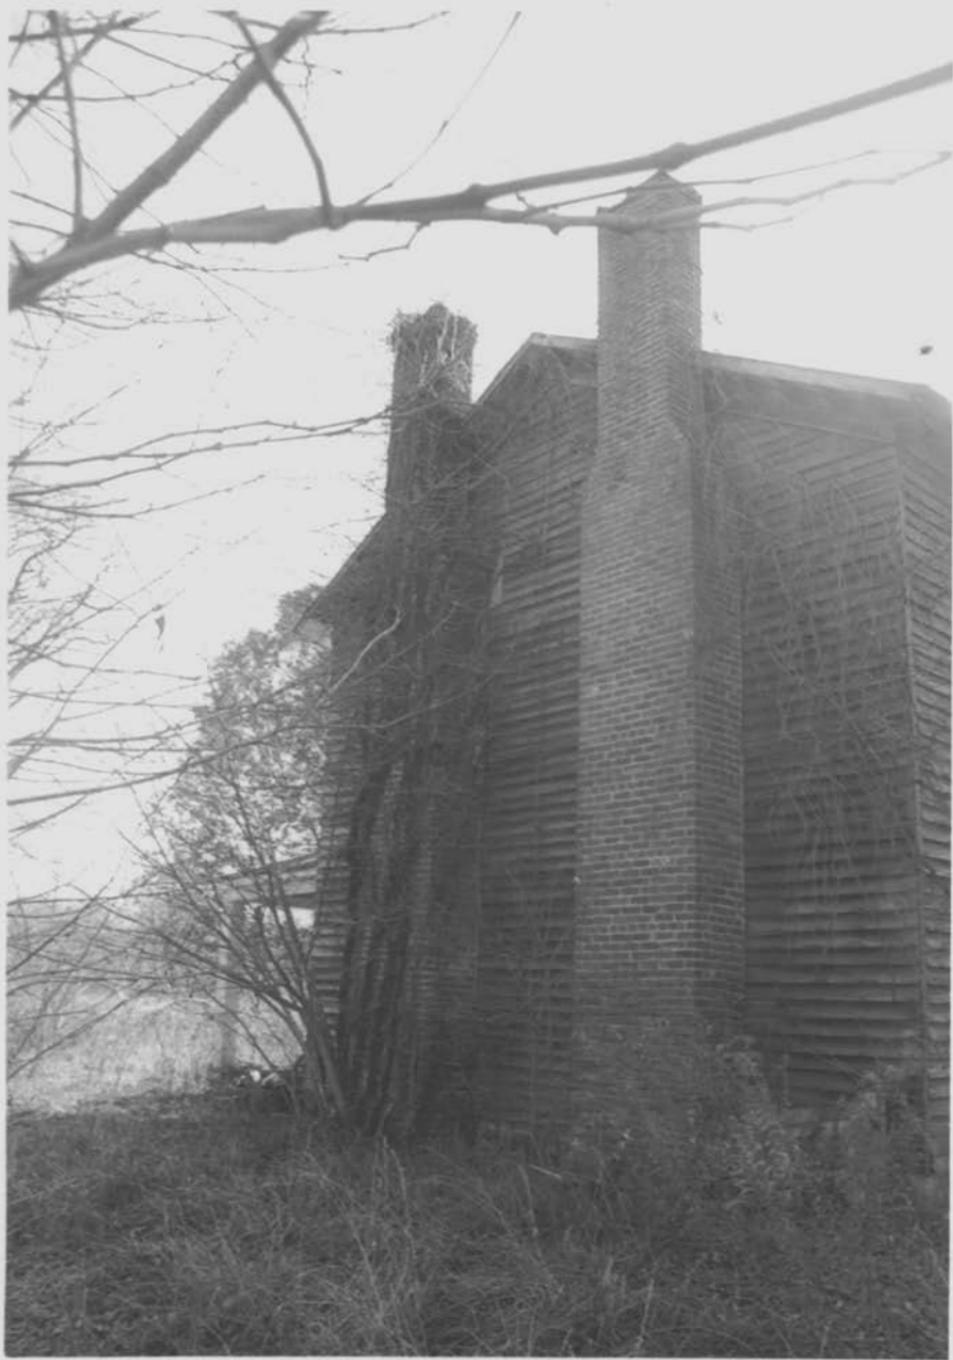
4 of 7

Paired chimneys found on the east elevation include stepped shoulders and corbelled caps and are laid in an irregular bond. Earlier cornice treatment, as found on the opposite elevation is most visible on this elevation consisting of a piece of wood trim covering the end of the rafters and a second line of trim under the rafters attached to the eave wall.

PAIRED CHIMNEYS, LOOKING SOUTHWEST

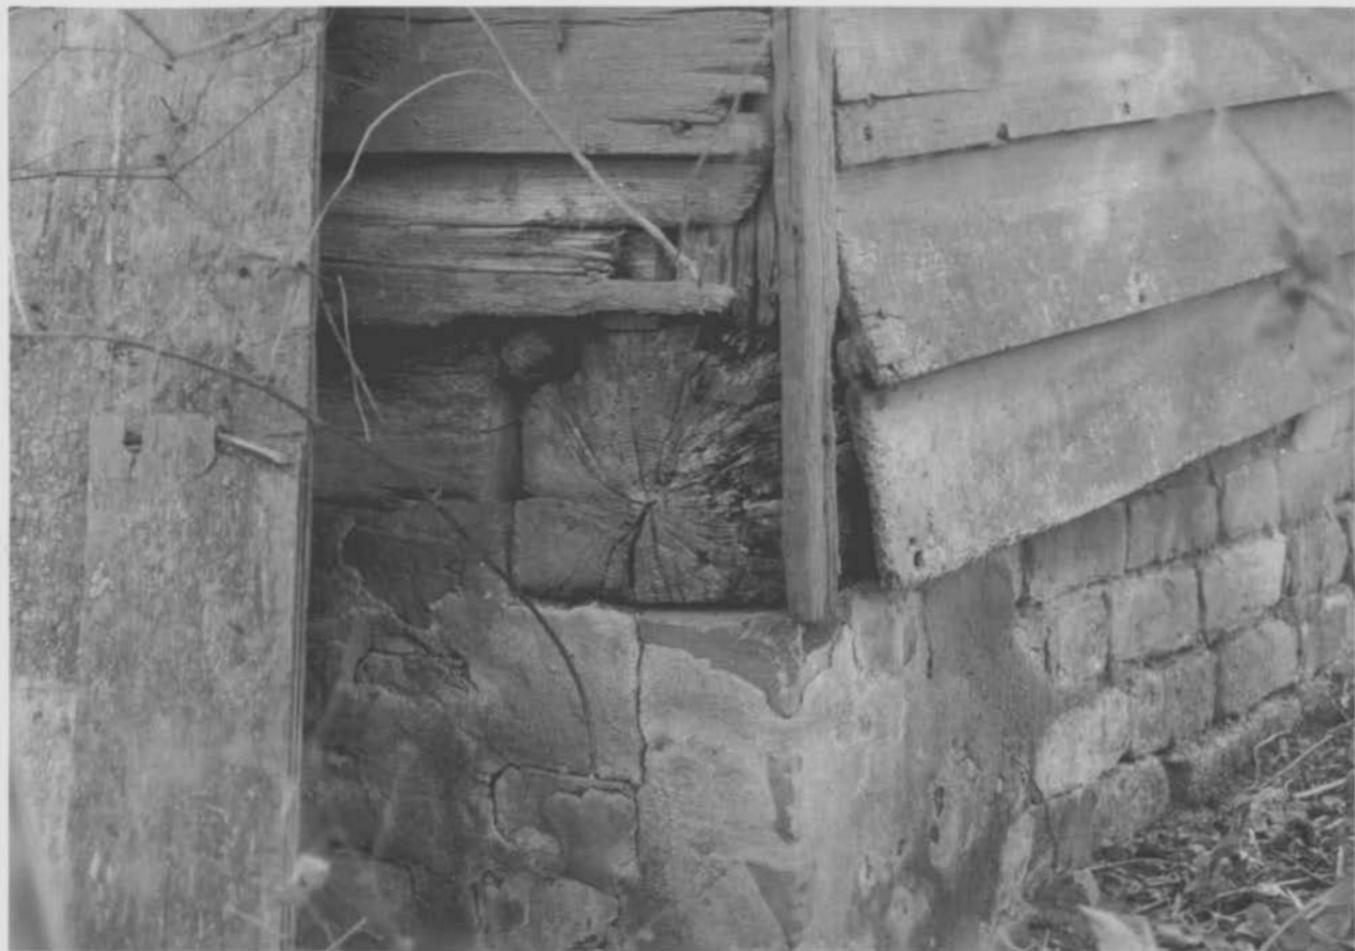
C. CURREY
MD SHPO NE FOUNDATION DETAIL
5 OF 7

The dwelling rests on a continuous brick foundation and currently has a metal seam roof currently resting on exposed rafters. The metal sheathing has come up on the northeast corner, causing significant damage to the interior.

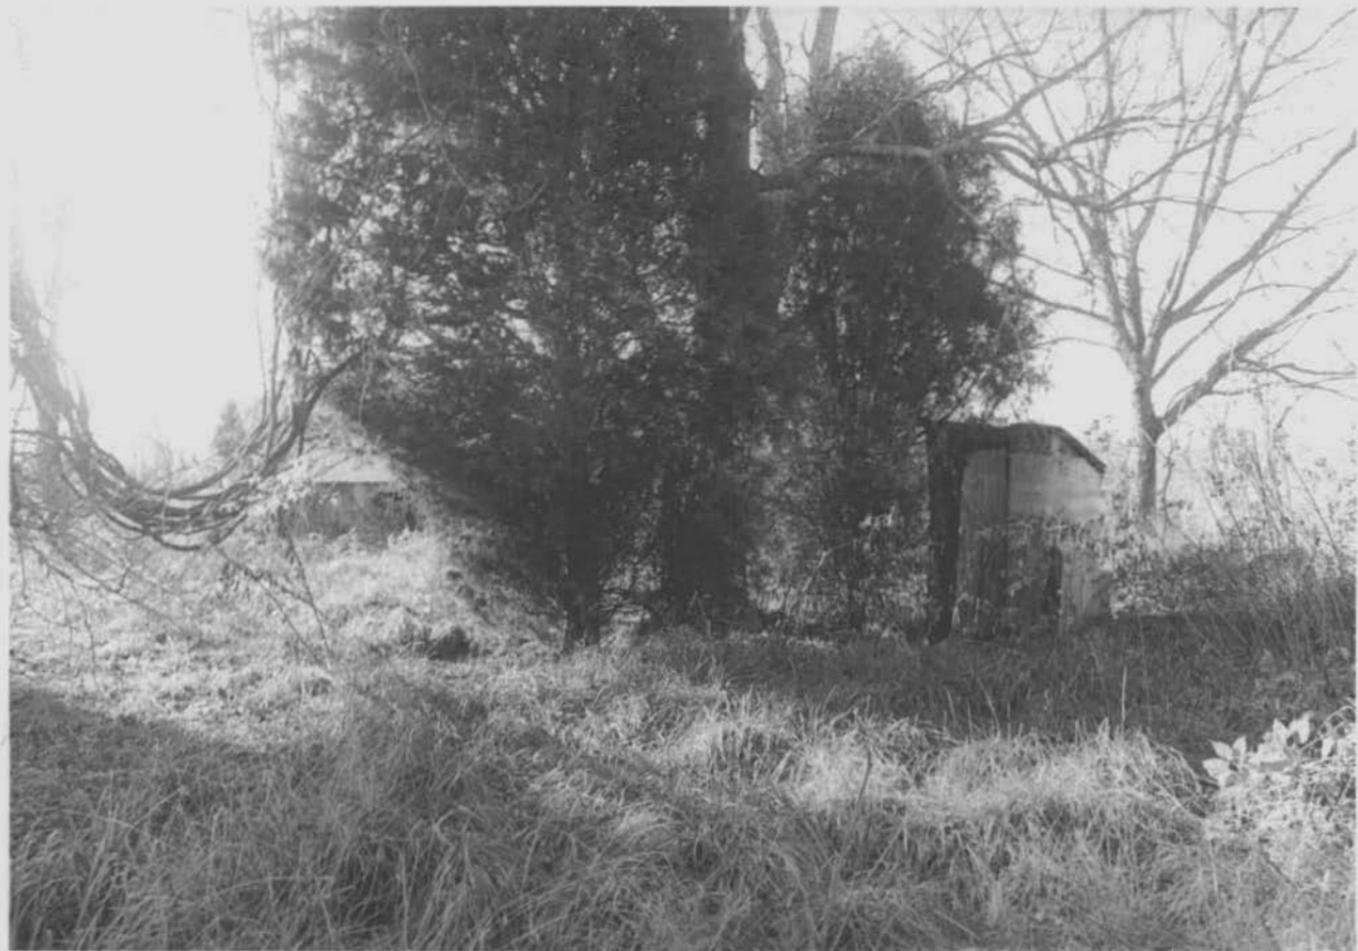
6 OF 7

Outbuildings consist of a small shed roof outhouse and a vertical board shed with a steeply pitched metal roof.

REAR YARD & OUTHOUSE, LOOKING NW

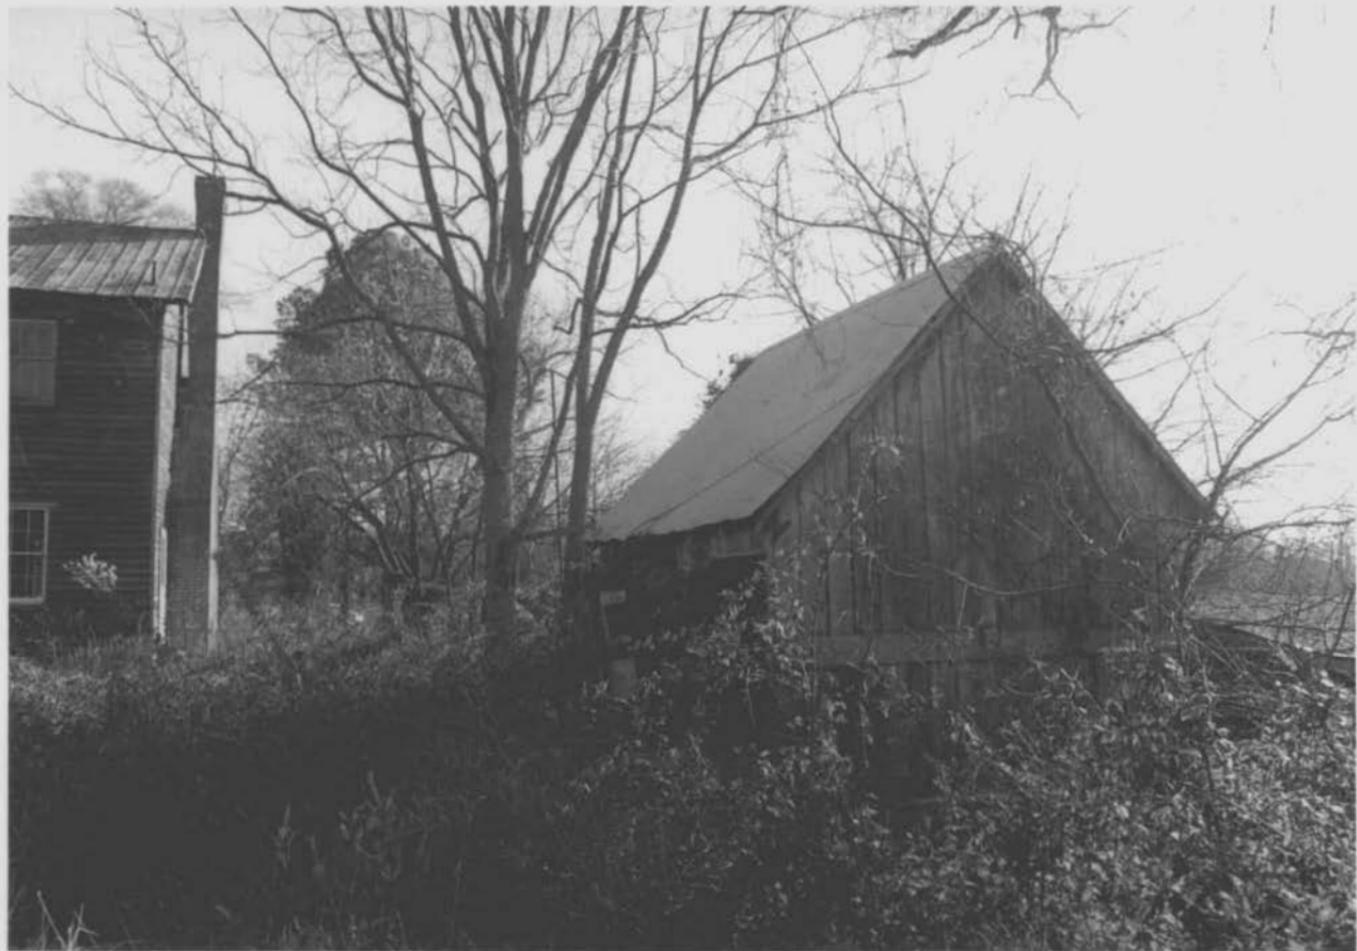
7 OF 7

SHED, LOOKING SOUTH

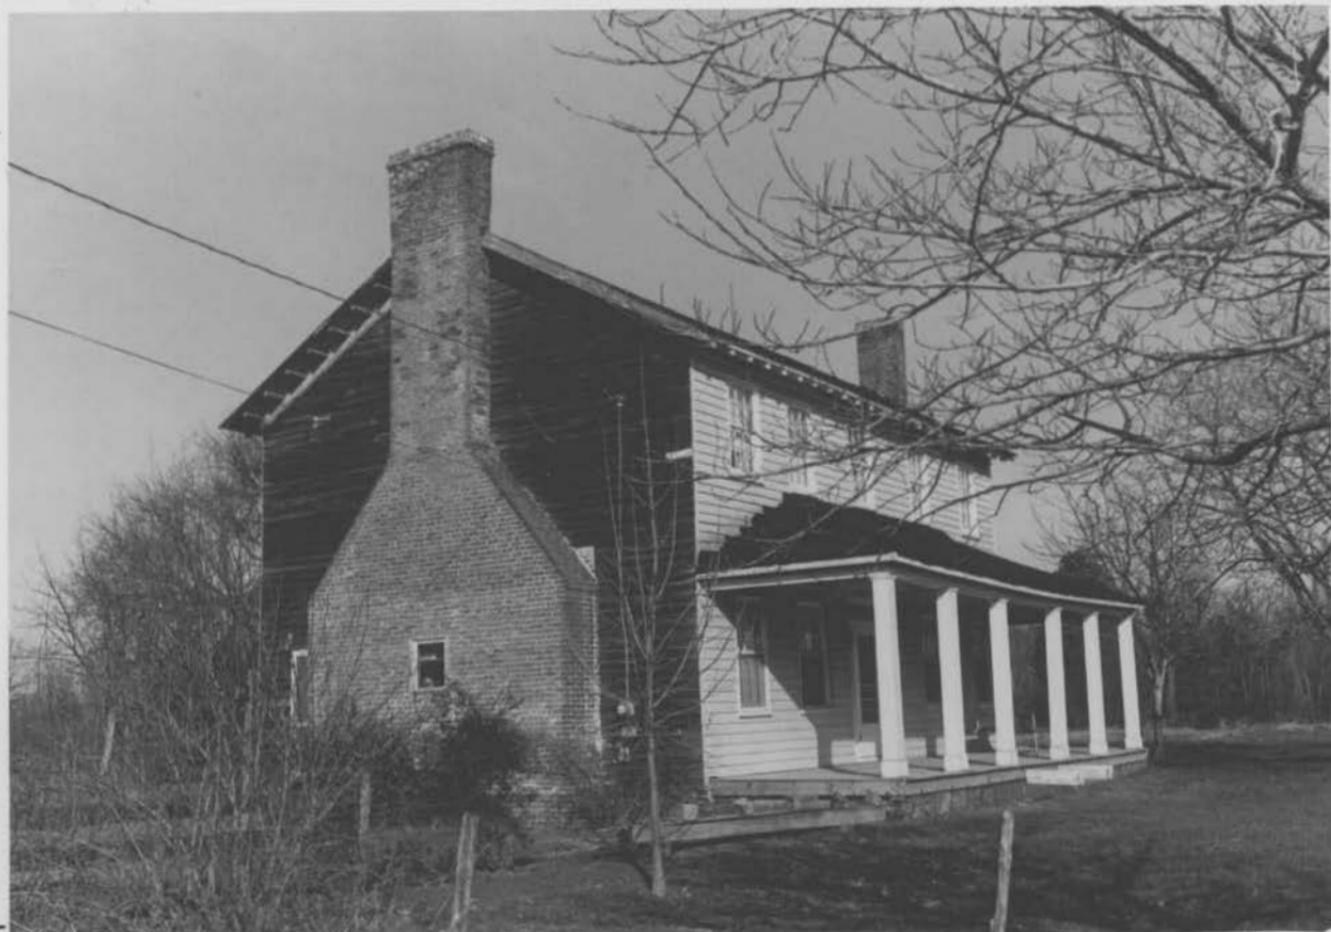
2/5

It appears probable that the initial stage of this two-story frame house was a two-room, one-story frame structure having a single massive chimney at the west end. In the mid-19th century, the house was extended to the east end and the roof raised to a full two-story height. The two exterior chimneys of the east end elevation date from this alteration. The house was again renovated around 1900 by replacing the roof framing, replacing the exterior sheathing and trim, and erecting a one-story farm porch with square columns at the principal (south) facade. The most interesting feature of the house is the west chimney with its elongated tapered weatherings and enclosed, windowed pent closet between the first-floor fireplace openings. The house now has a low-pitched roof with exposed rafter feet.
