CAPSULE SUMMARY SHEET

Survey No.: CH-448 (PACS B13) Construction Date: 1917

Name: Sarah V. and Stouten H. Canter Property

Location: 6837 Carrico Mill Road, Hughesville vicinity, Charles County

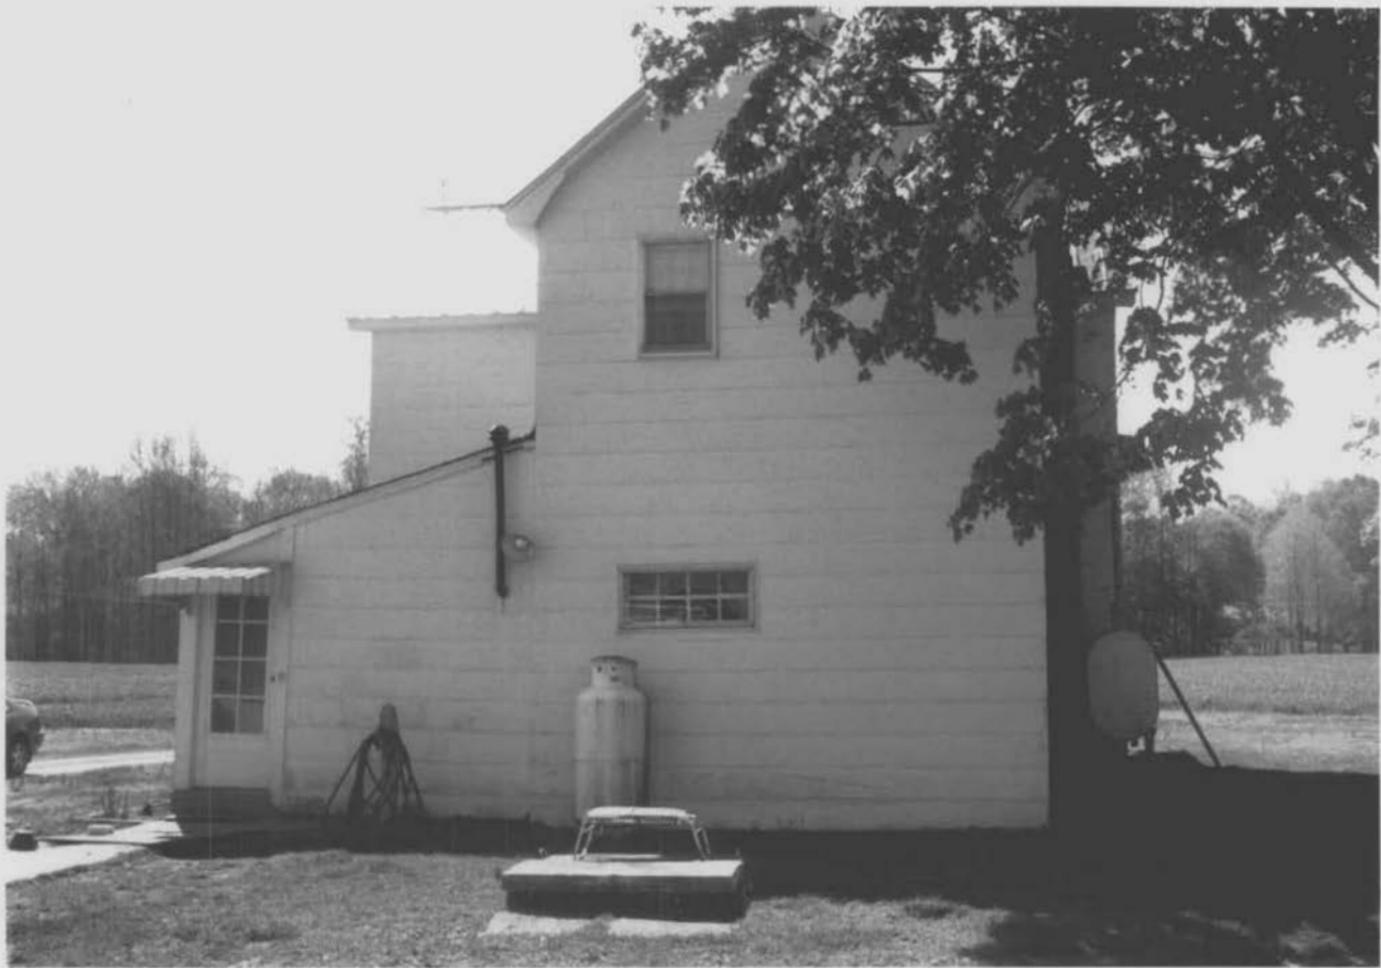
The north elevation of the I-house is partially concealed by the ell. The visible parts of the I-house has no fenestration. The ell has a 2-light sliding window on the first story and a 2/2 double-hung window on the second story.

- 1 CH-448
- 2 Sarah and Stouten Canter Property
- 3 Charles County, MD
- 4 Eric F Griffiths
- 5 April 1997
- 6 MD SHPO
- 7 I-house North Elevation, View South
- 8 1 of 13

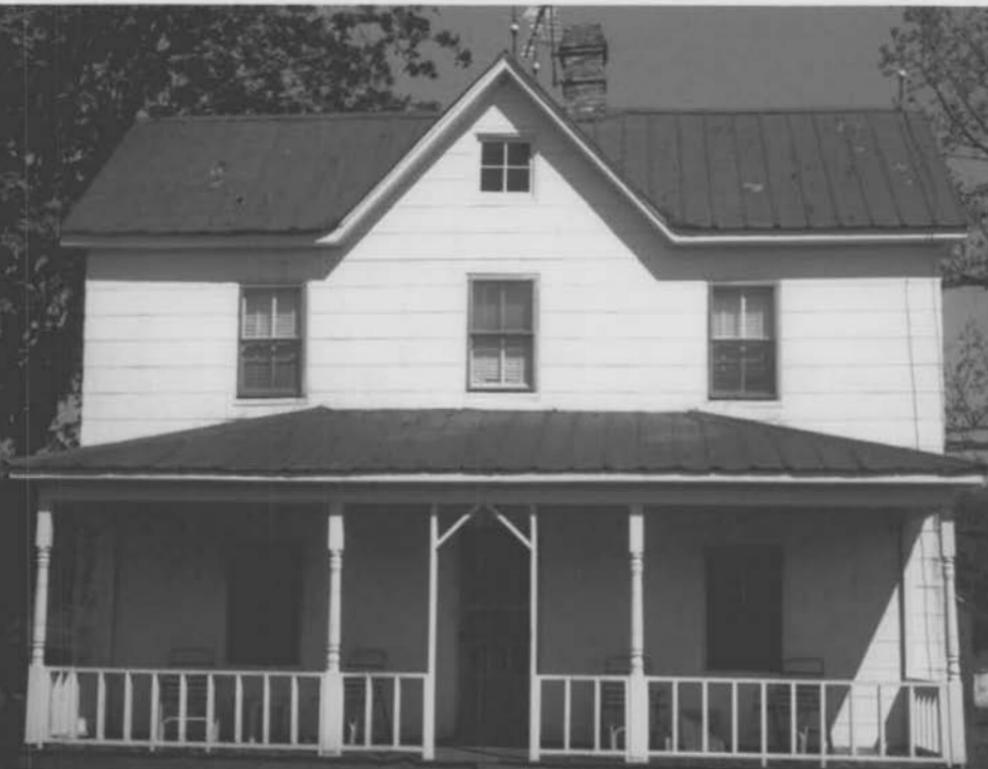
The south, or front elevation has a standing seam metal, hipped roof entry porch. The roof of the porch is supported by the original tapered wood posts. The porch has the original wood floor and wood replacement railings. The fenestration pattern is symmetrical with a centered wood door and two 2/2 double-hung windows on the first story, and three 2/2 double-hung windows on the second story. The roof has a center gable with a 4-light window.

- 1 CH-448
- 2 Sarah and Stanton Canter Property
- 3 Charles County, MD
- 4 Eric F Griffiths
- 5 April 1997
- 6 MD SHPO
- 7 F-house, south elevation, view North
- 8 2 of 13

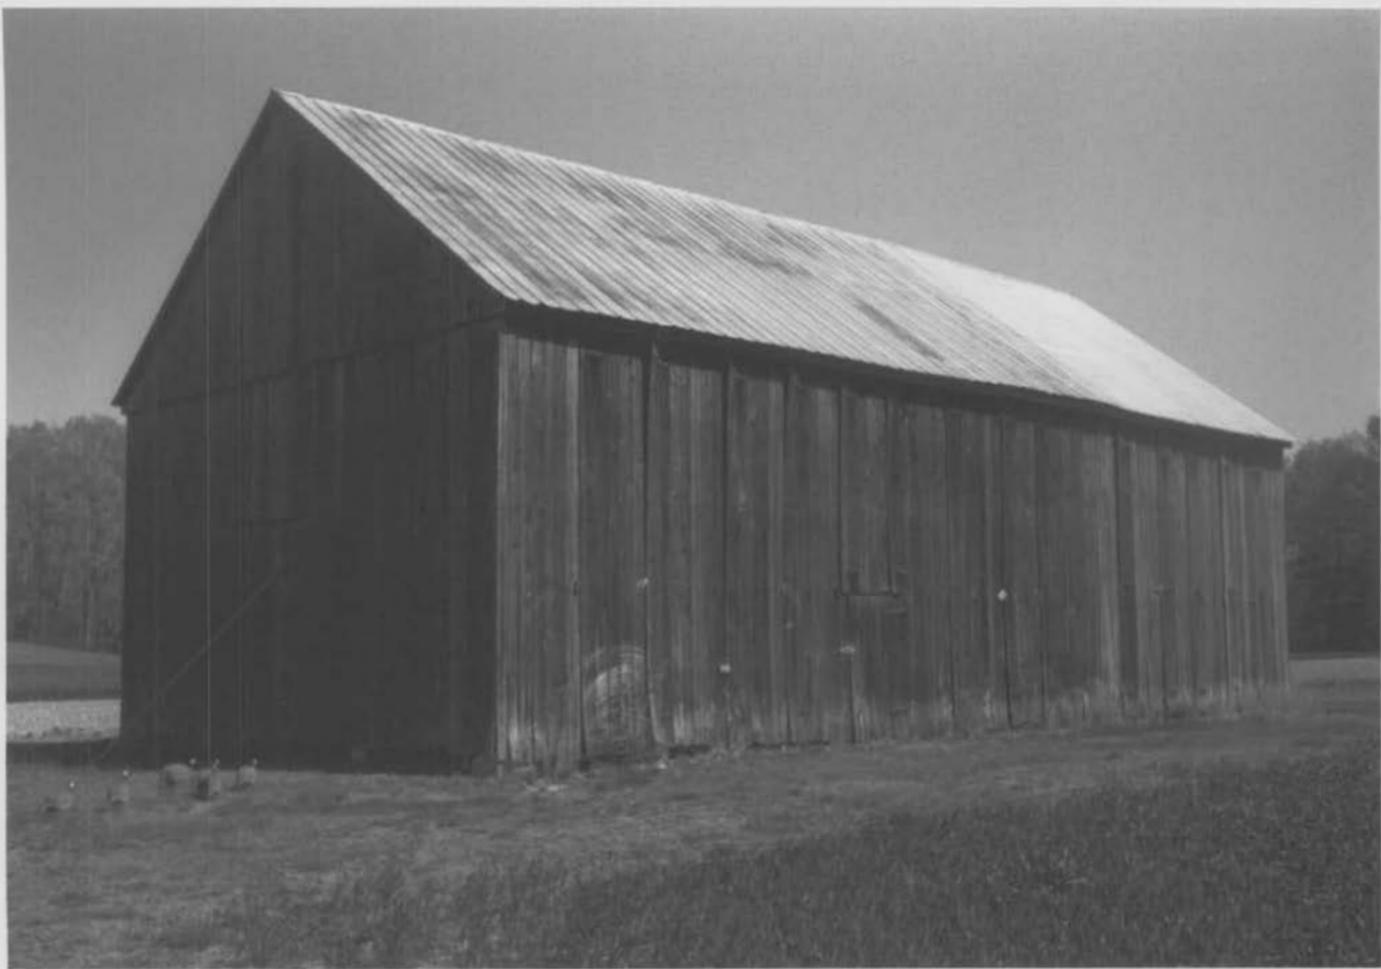
The eighth outbuilding is a tobacco barn with a standing seam metal, front-gable roof. Constructed circa 1920, the barn is of wood-frame construction with wood siding, and it is located approximately 400 meters (1300 feet) northeast of the I-house and other outbuildings, and east of the tenant house and privy.

7 Barn, view Northeast

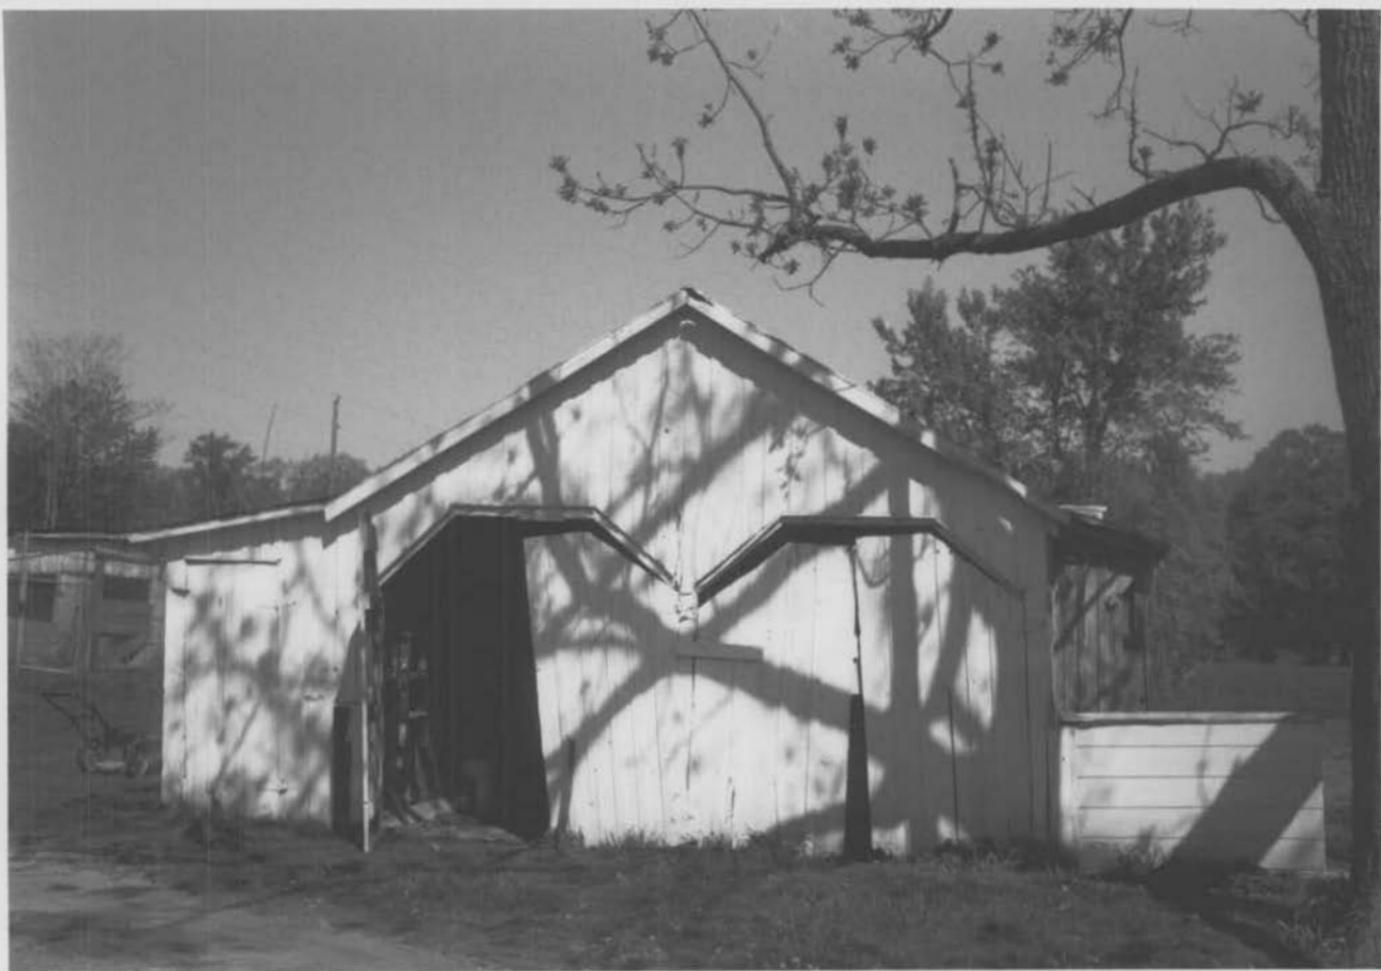
There are eight outbuildings associated with this property. The first outbuilding is a garage with a standing seam metal front-gable roof. Constructed circa 1920, the garage is of wood-frame construction with wood siding, and it is located northeast of the I-house.

- 1 CH-448
- 2 Sarah and Stouten Center Property
- 3 Charles County, MD
- 4 Eric F Griff, Hs
- 5 April 1997
- 6 MD SHPO
- 7 Garage, view North
- 8 4 of 13

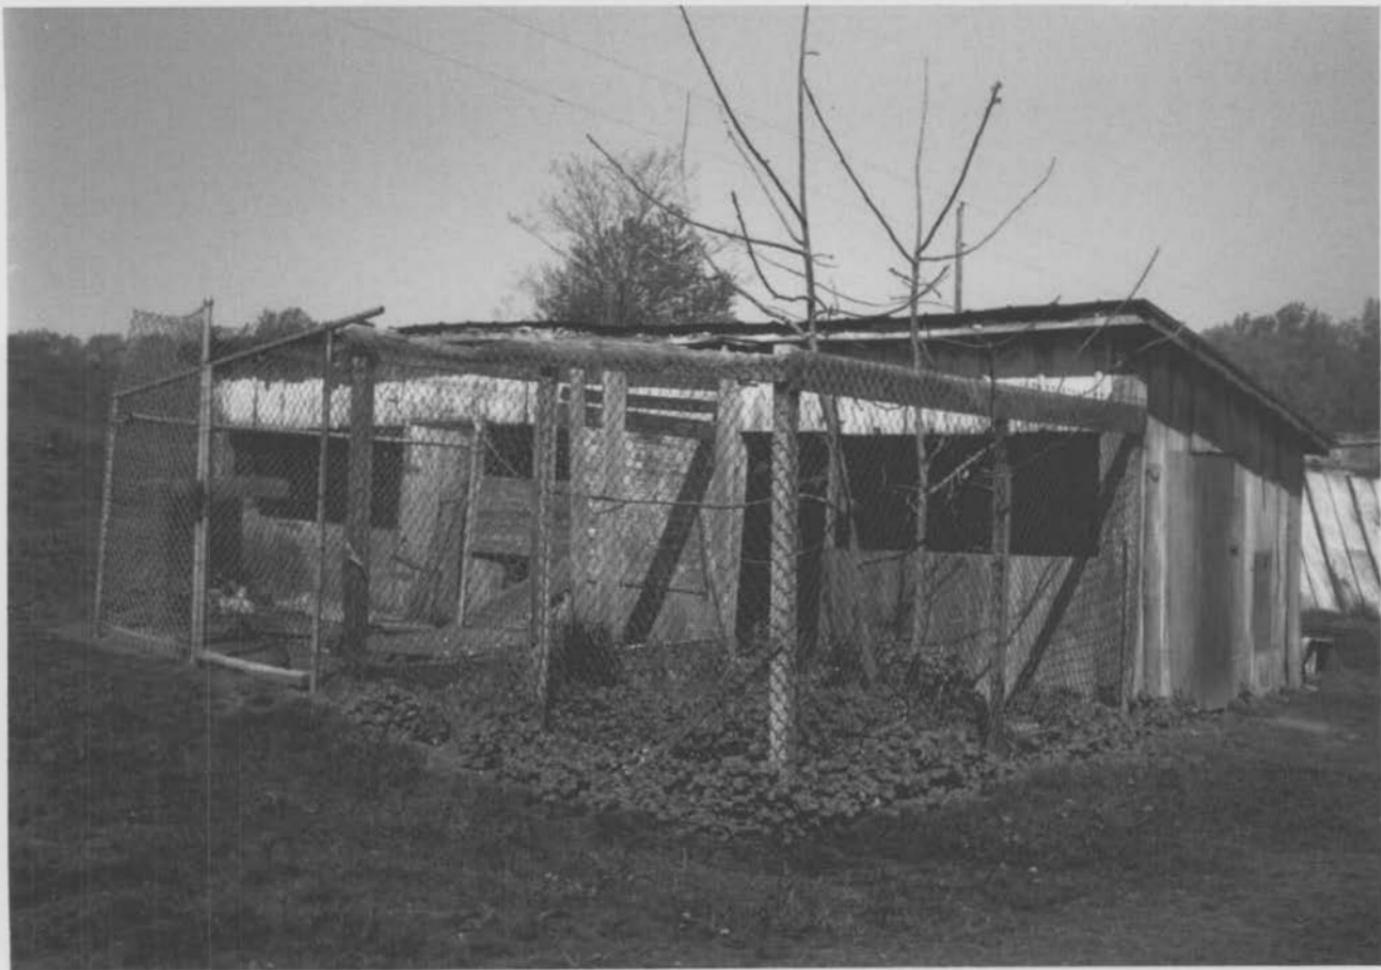
The fourth outbuilding is a chickenhouse with a standing seam metal shed-roof. Constructed circa 1940, the chickenhouse is of wood-frame construction with wood siding. The chickenhouse is located north of the I-house and northwest of the garage and two sheds.

- 1 CH-448
- 2 Sarah and Stauten Center Property
- 3 Charles County, MD
- 4 Eric F Griffiths
- 5 April 1997
- 6 MD SHPO
- 7 Chicken House, View North
- 8 5 of 13

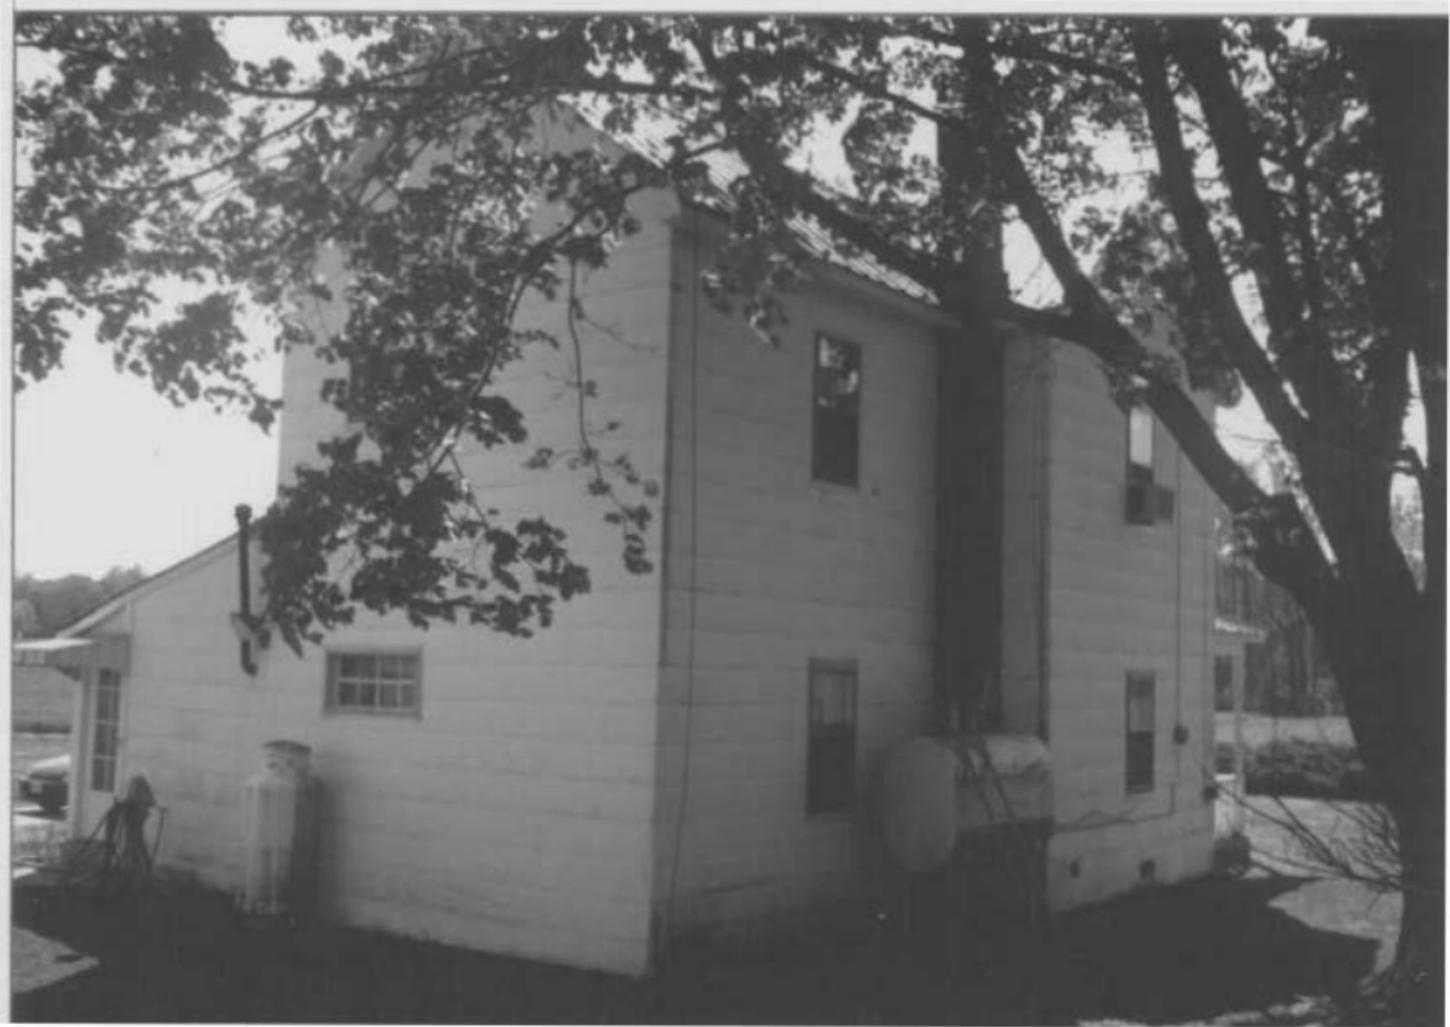
8 6 of 13

The west elevation has a symmetrical fenestration pattern. The I-house and the ell each have one 2/2 double-hung window on both the first and second stories.

7 West Elevation, East View

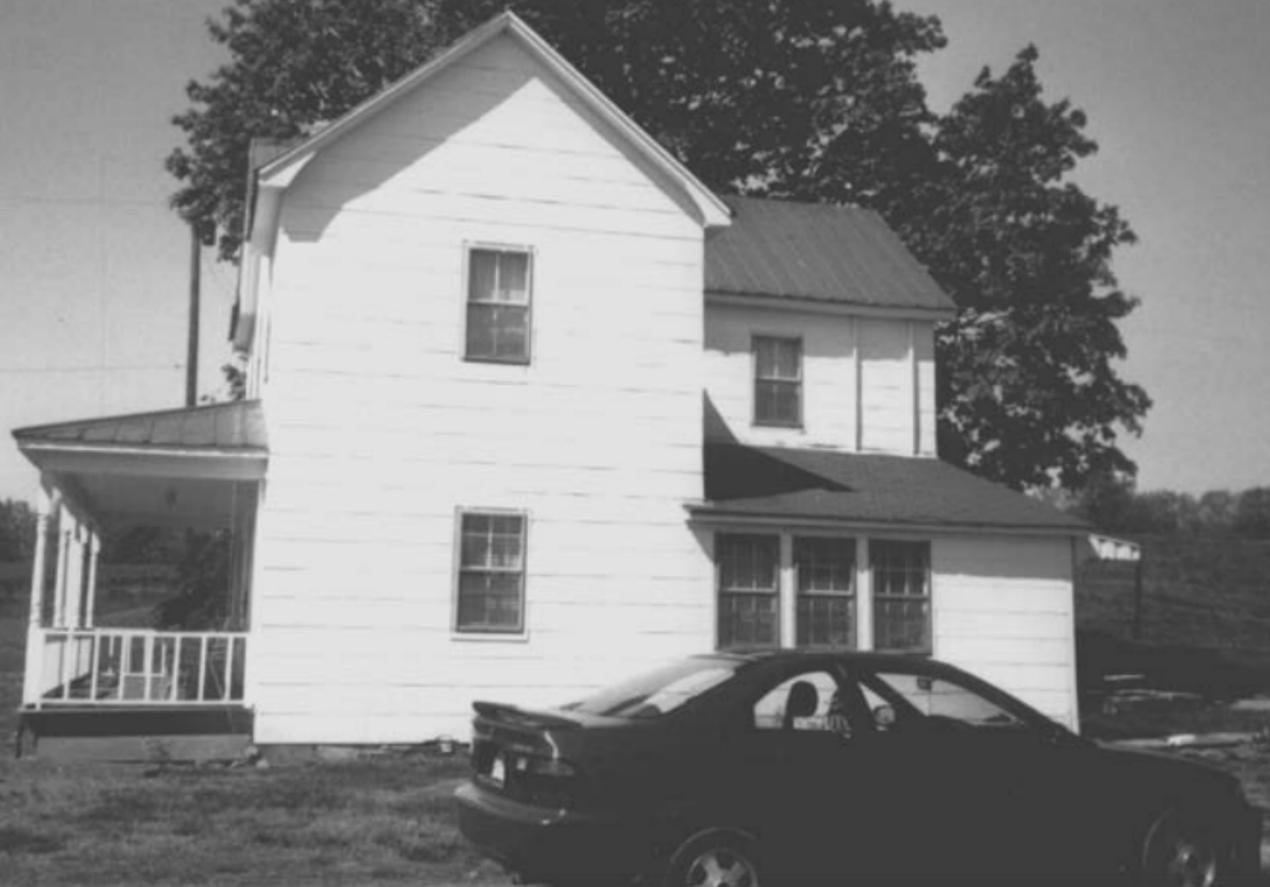
The east elevation of the I-house has a symmetrical fenestration pattern with one 2/2 double-hung window on both the first and second stories. The ell is concealed on the first story by a 1-story shed-roof addition. The addition has an asphalt shingle roof and three 6/6 double-hung windows on the east elevation, and a wood door on the north elevation. The ell has a single 2/2 double-hung window on the second story.

- 1 CH-448
- 2 Sarah and Stouten Canter Property
- 3 April, 1997
- 4 Charles County MD
- 5 Eric F Griffiths
- 6 MD SHPO
- 7 East elevation, view west
- 8 7 of 13

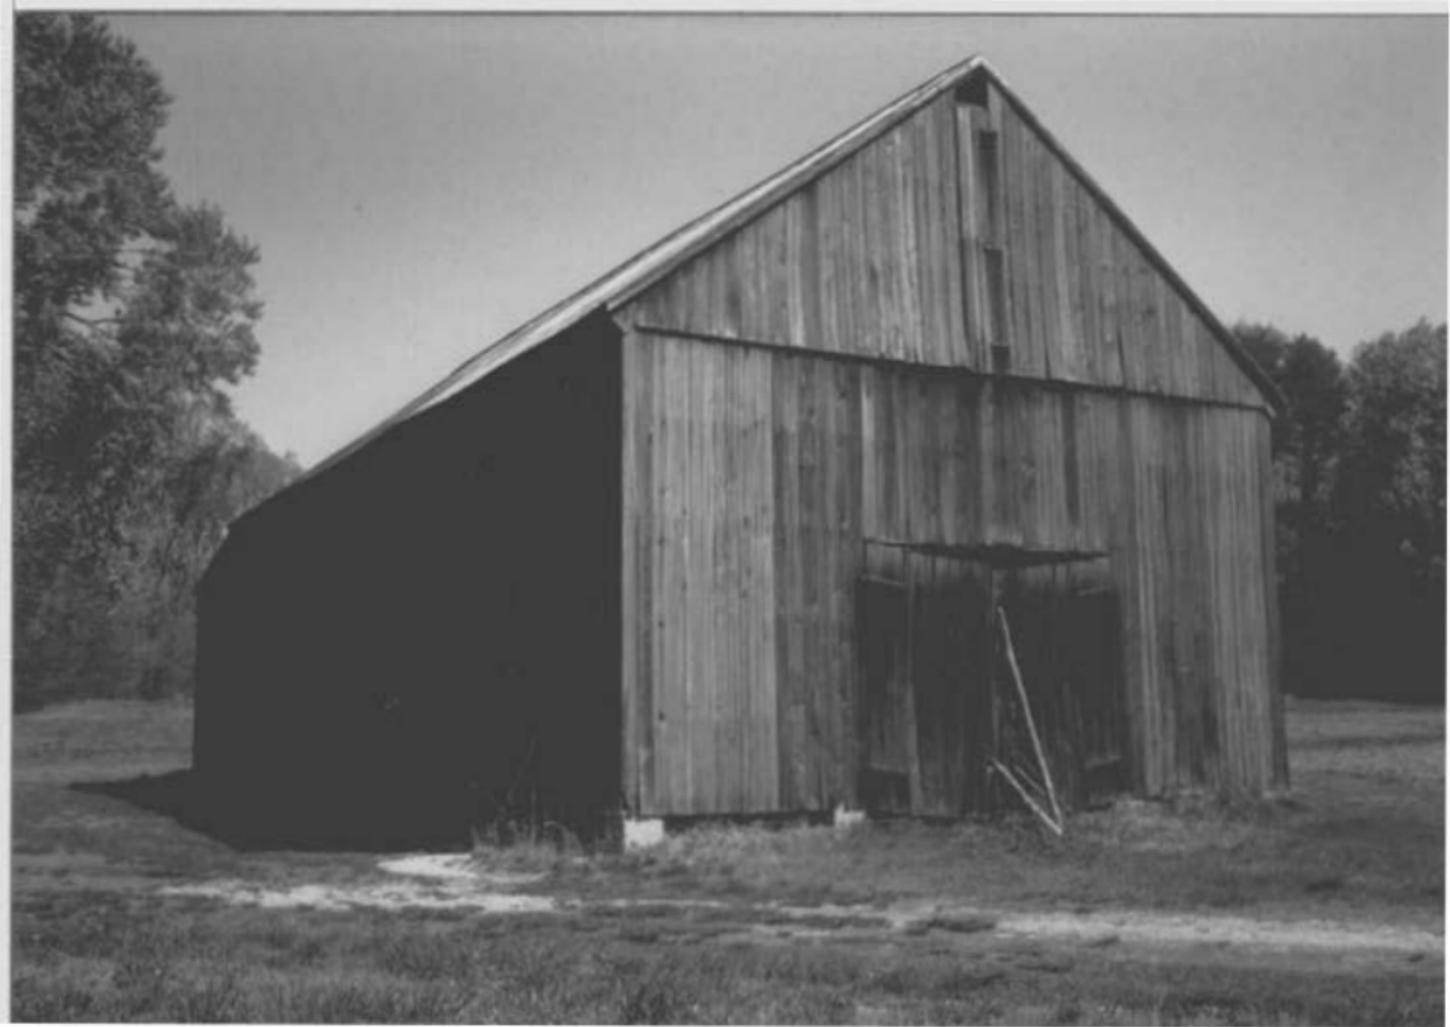
8 8 of 13

7 Barn 2, View North

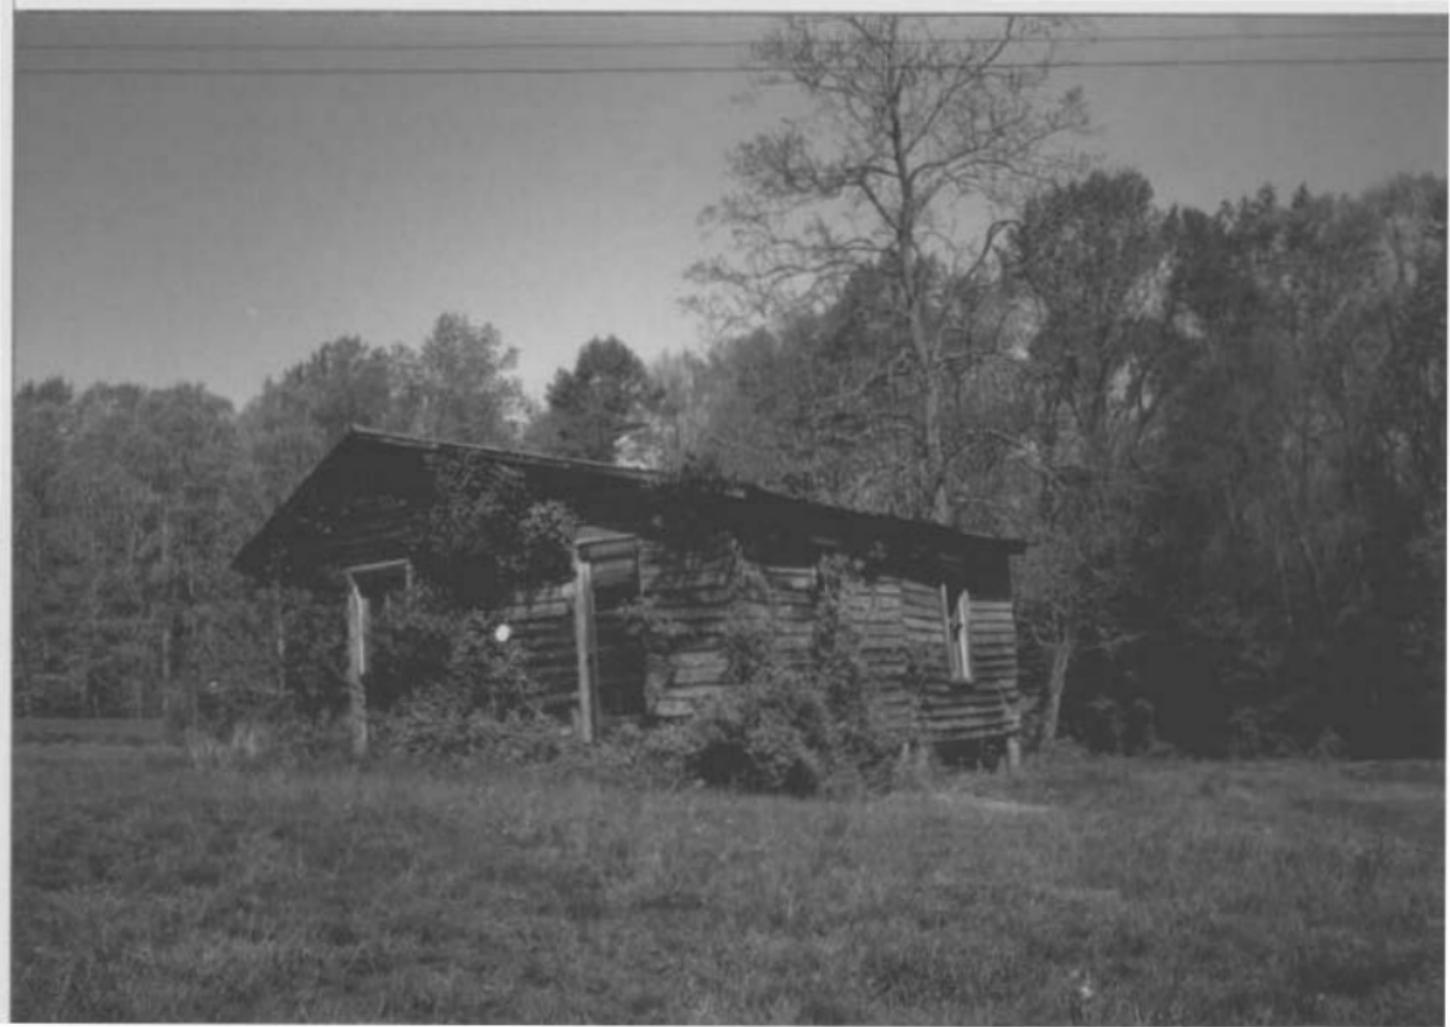
8 9 of 13

The sixth outbuilding is a partially-collapsed tenant house with a standing seam metal, side-gable roof. Constructed circa 1920, the tenant house is of wood-frame construction, with double-hung windows and a wood door. The tenant house is located approximately 400 meters (1300 feet) north of the I-house and other outbuildings, and is overgrown with foliage.

7 Tenant house, View North

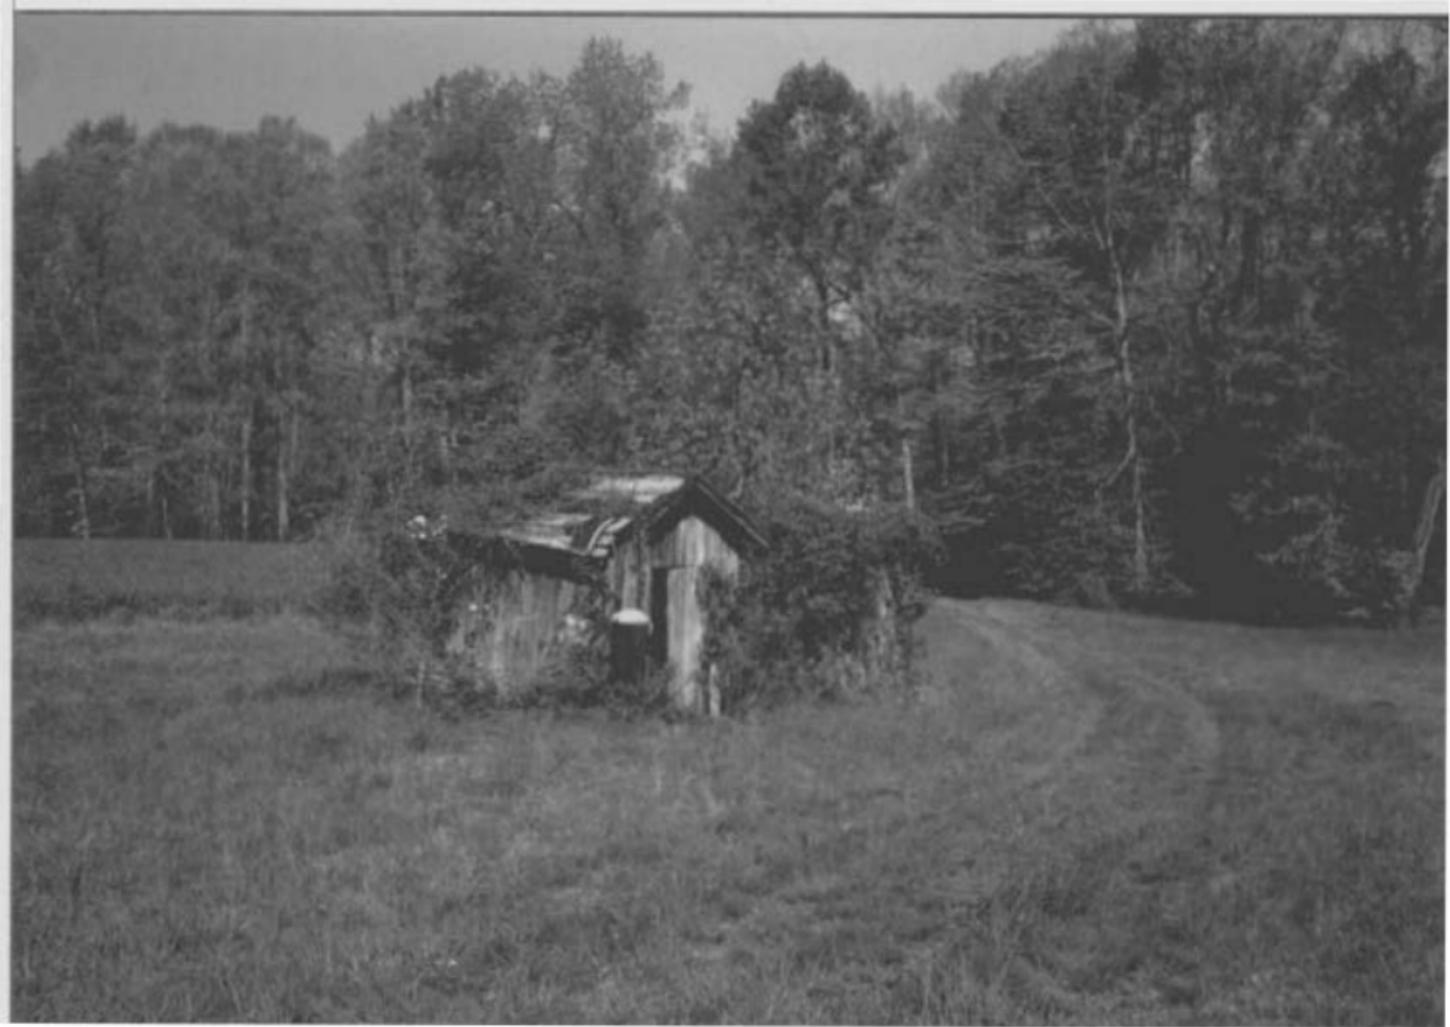
The seventh outbuilding is a privy with a standing seam metal, front-gable roof. Constructed circa 1920, the privy is of wood-frame construction and is partially collapsed and overgrown. is located adjacent to the tenant house.

- 1 CH-448
- 2 Sarah and Stouden Canter
Property
- 3 Charles County, MD
- 4 Eric F Griffiths
- 5 April 1997
- 6 MD SHPO
- 7 Privy, View North
- 8 10 of 13

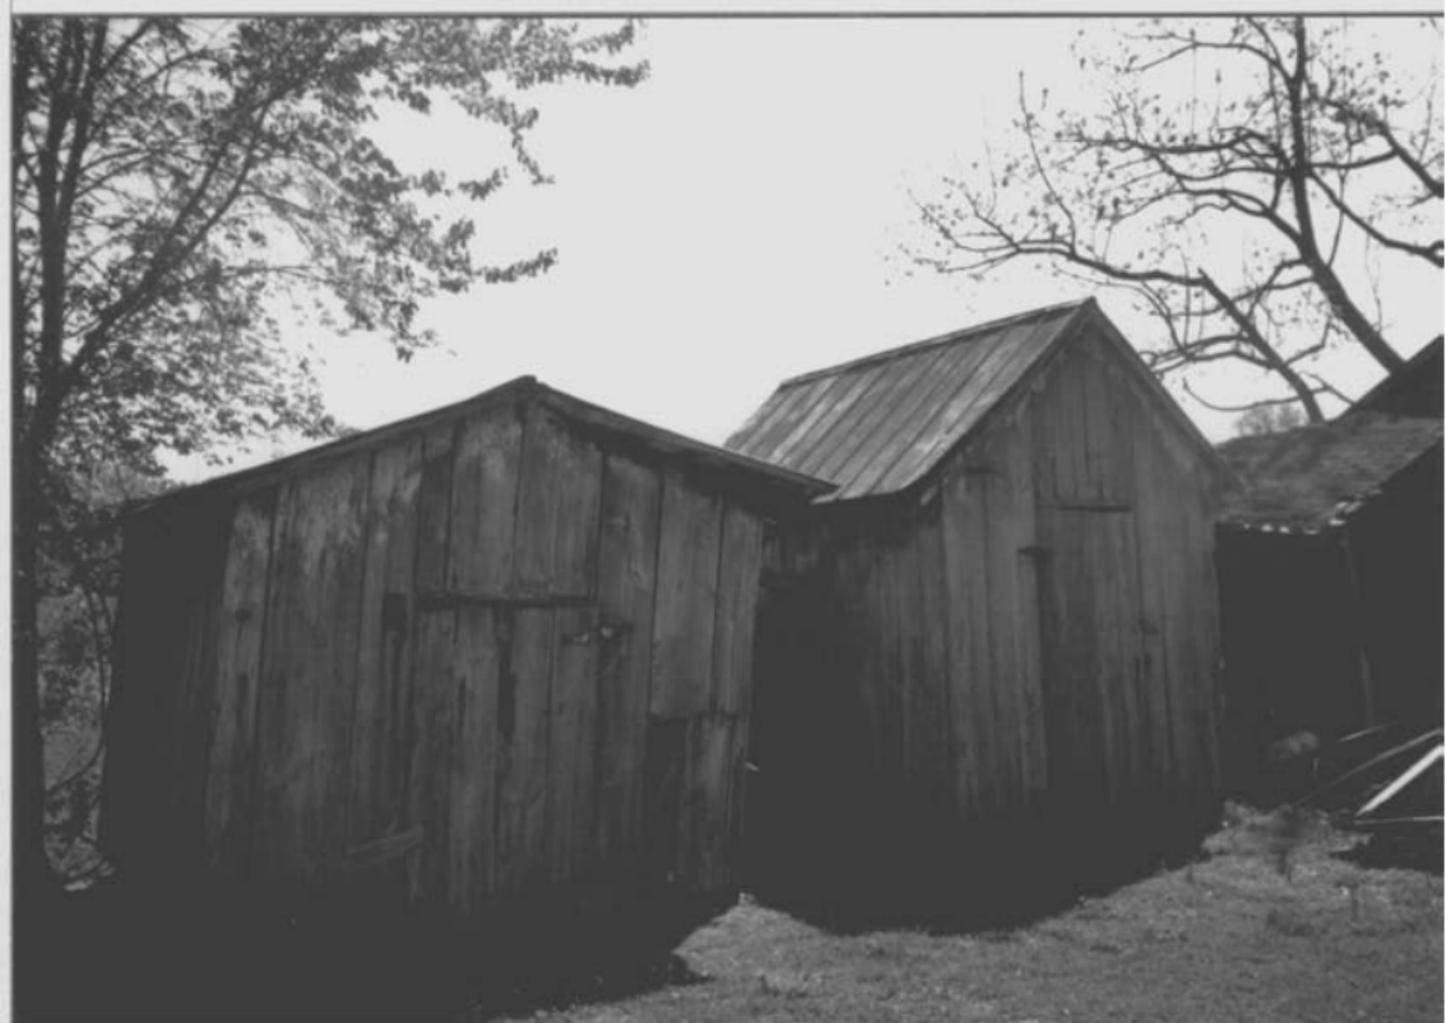
The second and third outbuildings are two sheds with standing seam metal, front-gable roofs. Constructed circa 1940, the sheds are of wood-frame construction and are located northeast of the I-house and adjacent to the garage.

- 1 CH-4418
- 2 Sarah and Stanton Center Property
- 3 Charles County, MD
- 4 Eric F Griffiths
- 5 April 1997
- 6 MD SHPO
- 7 Two sheds, view southeast
- 8 11 of 13

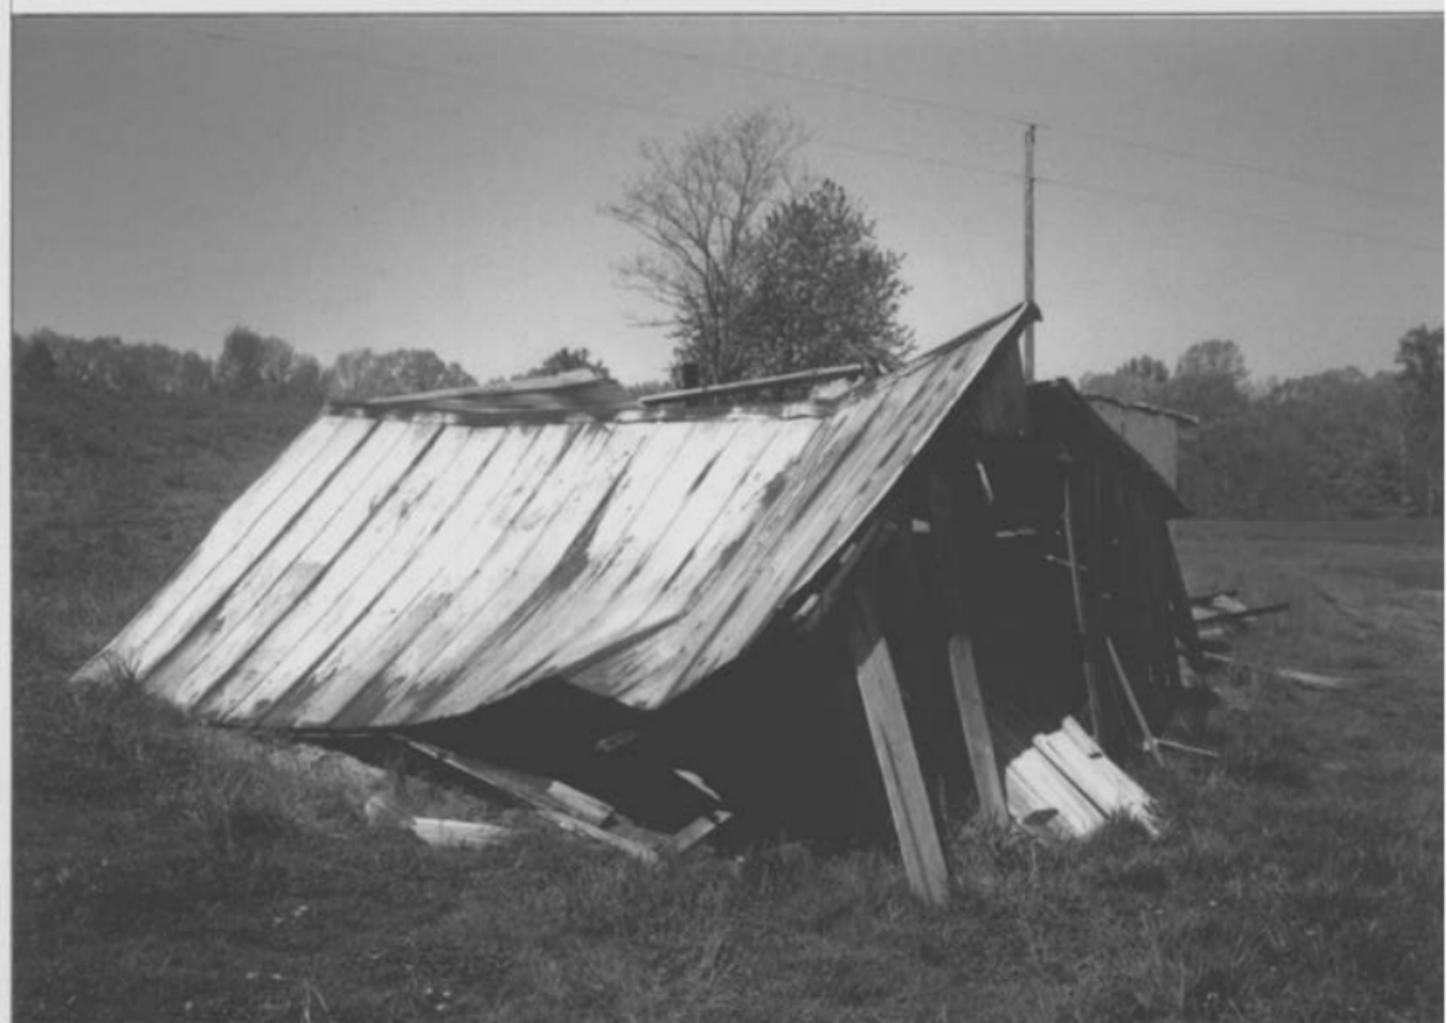
8 12 of 13

The fifth outbuilding is a barn that collapsed in January 1996. Constructed circa 1920, the barn is of wood-frame construction with a standing seam metal, front-gable roof. The ruins of the barn are located north of the I-house, northwest of the garage, two sheds, and north of the chickenhouse.

7 Collapsed Barn, View Northwest

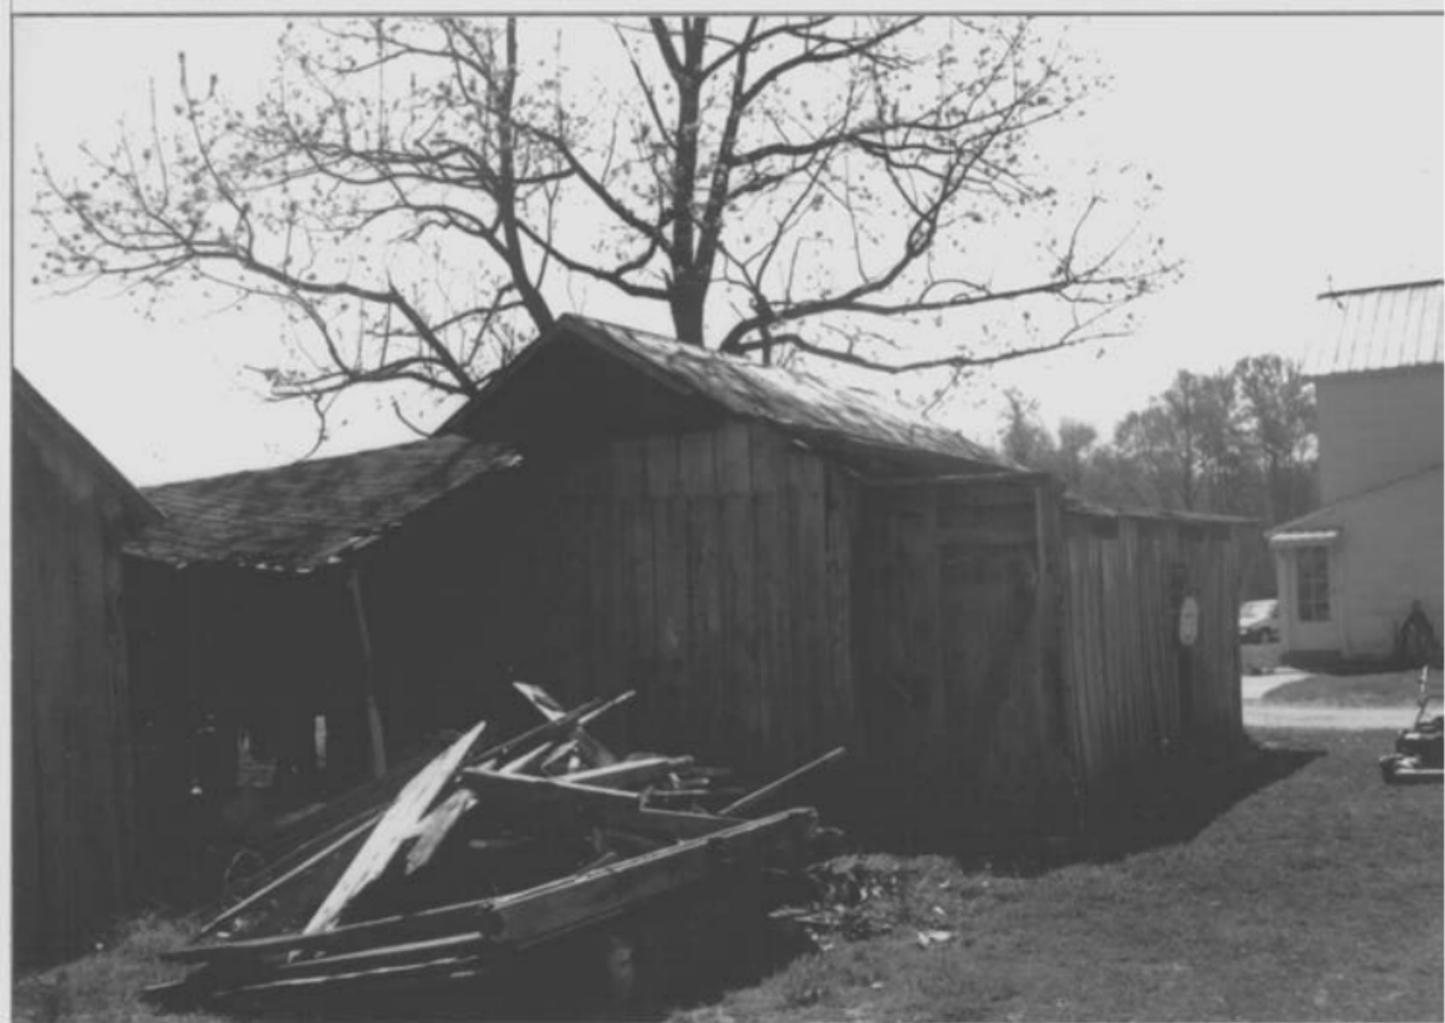
- 1 CH-4418
- 2 Sakah, and Stouten Canter Property
- 3 Charles County, MD
- 4 Eric F Griffiths
- 5 April 1997
- 6 MD SHPO
- 7 Garage, view South east
- 8 13 of 13
