D-149
The Trading Post
East New Market
private

Maryland Historical Trust State Historic Sites Inventory Form

Survey No. D-149

and/or common "THE TRADING POST"

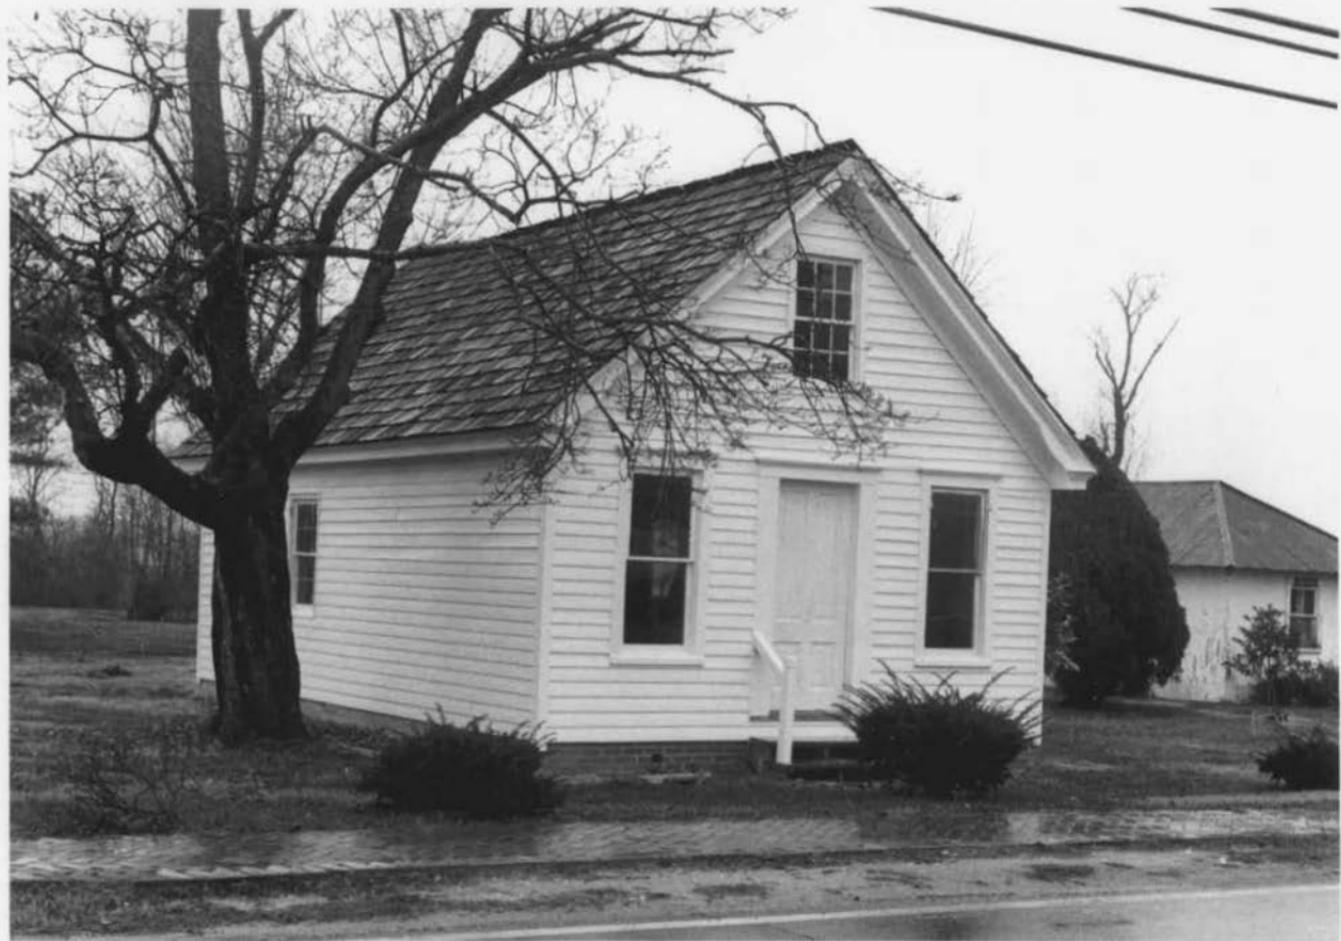
D-149

Northeast elevation

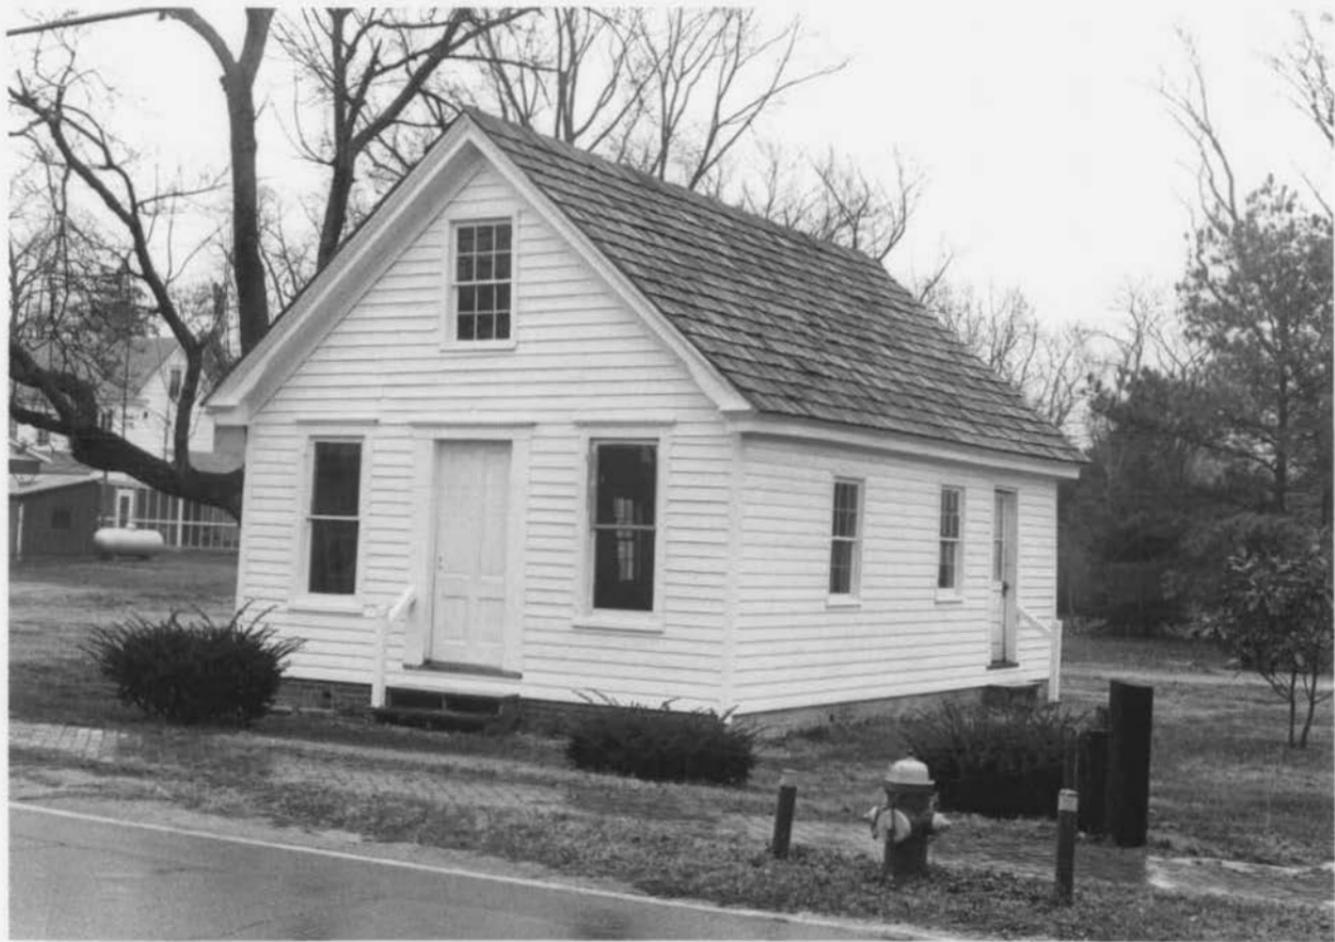
D-149

North elevation

The north (main) facade is a three-bay elevation with a center four-panel door and flanking single-pane sash windows. Each of the openings have a slightly molded lintel. A six-over-six sash window pierces the upper gable.
