D-173

1893

Maryland Historical Trust State Historic Sites Inventory Form

historic ST. STEPHENS EPISCOPAL CHURCH

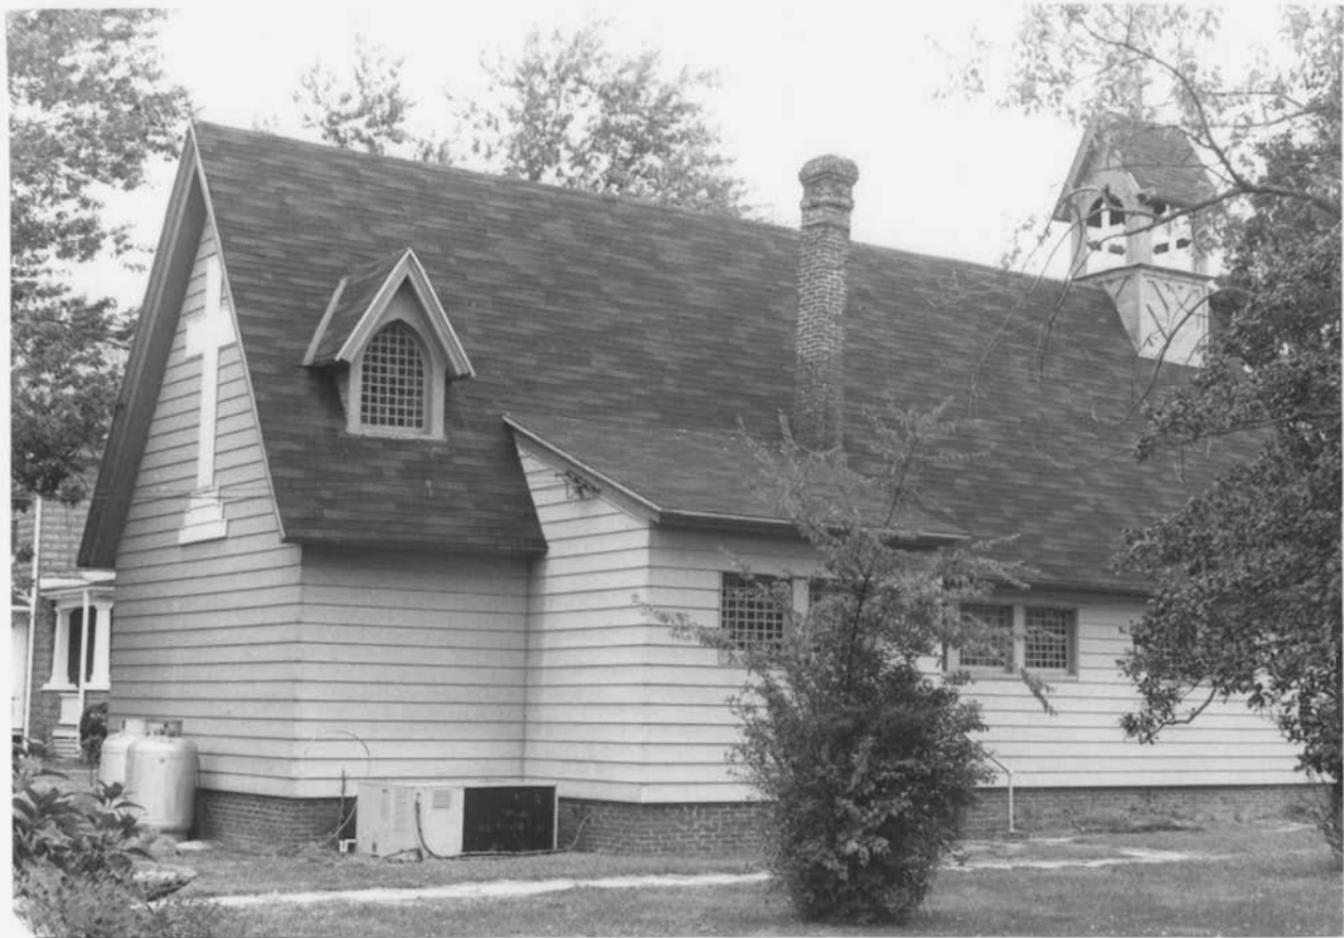
ST. STEPHENS P. E. CHURCH D-173
East New Market, Dorchester Co., MD
South elevation
10/87 Paul Touart photographer
Negative/MD Historical Trust

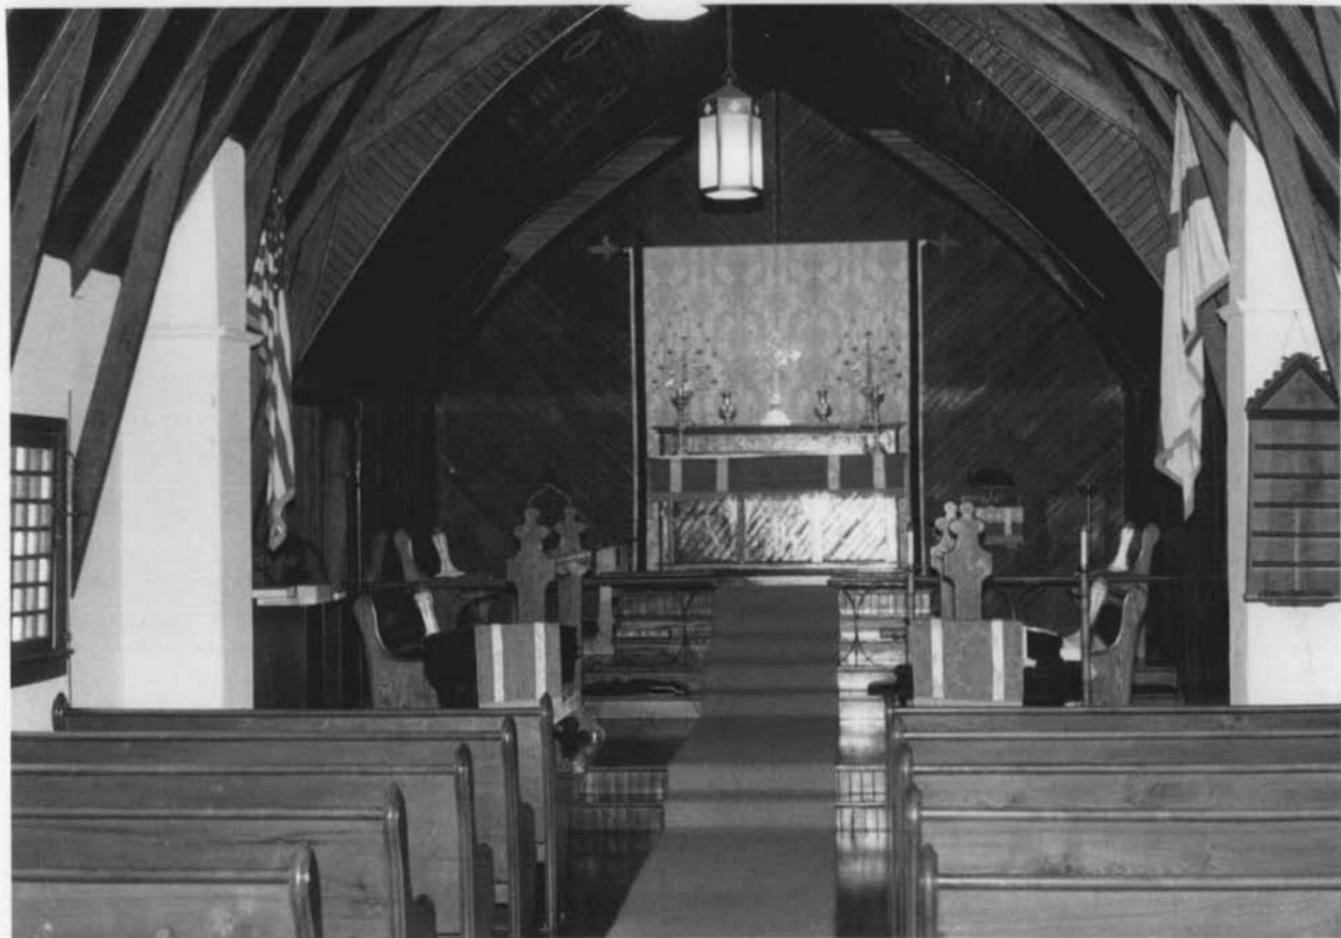
The church interior has not been significantly changed since construction in 1893. The sanctuary walls are covered by a combination of beaded board wainscoting and plaster, while the ceiling is entirely covered by a diagonal matched board sheathing. The scissors roof truss is exposed. The altar area, by contrast, is entirely covered by diagonal patterned beaded board, and the roof structure is concealed. Distinguishing the raised altar is Victorian furniture. Opening through the south wall is a shallow paneled door that provides access to the sacristy, the interior of which is also covered with narrow beaded boards. Fixed on the west wall are double-door vestiment closets.

ST. STEPHENS P. E. CHURCH D-173
East New Market, Dorchester Co., MD
Interior
10/87 Paul Touart photographer
Negative/MD Historical Trust

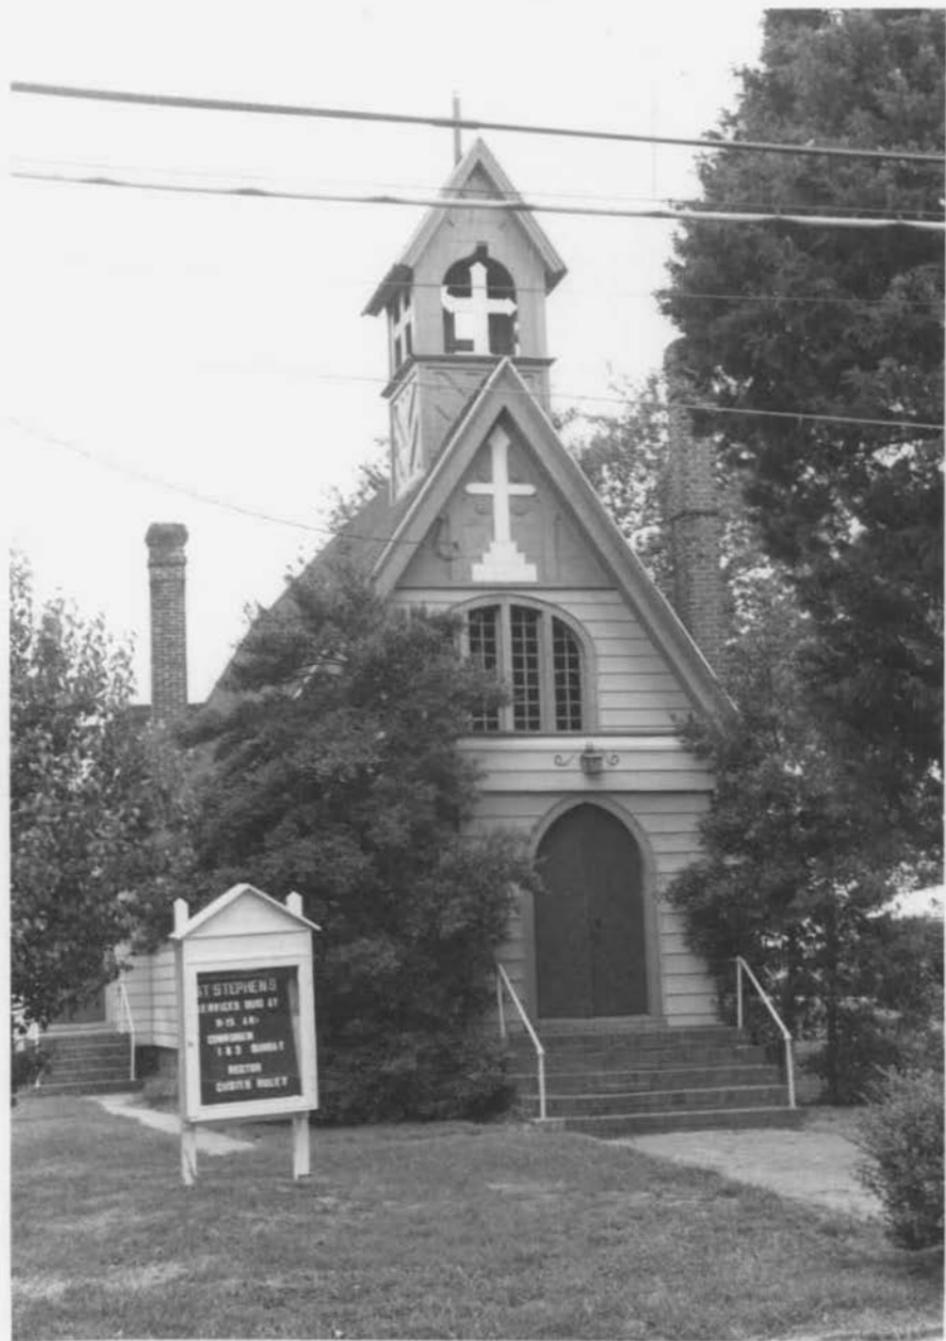
The east (main) facade of the main block is partially covered by a single-story, one-bay frame entry that is marked by a Gothic arched double-door entrance. Piercing the upper gable of the main block is a four-part colored glass window. The uppermost portion of the gable is distinguished by a cross, now covered by aluminum, which is part of a patterned wood surface design. The eaves to the roof are slightly extended. Fixed in the northeast corner of the foundation is the 1893 datestone. Also located in the northeast corner is an interior brick stove stack which rises above the level of the roof. The small gabled belfry has four arched openings, one on each side, with a white cross fixed on each elevation. The base of the belfry is finished with a decorative board pattern, and the gabled roof repeats the slope of the church roof. A small cross rises from the top of the belfry.

ST. STEPHENS P. E. CHURCH D-173
East New Market, Dorchester Co., MD
East elevation
10/87 Paul Touart photographer
Negative/MD Historical Trust

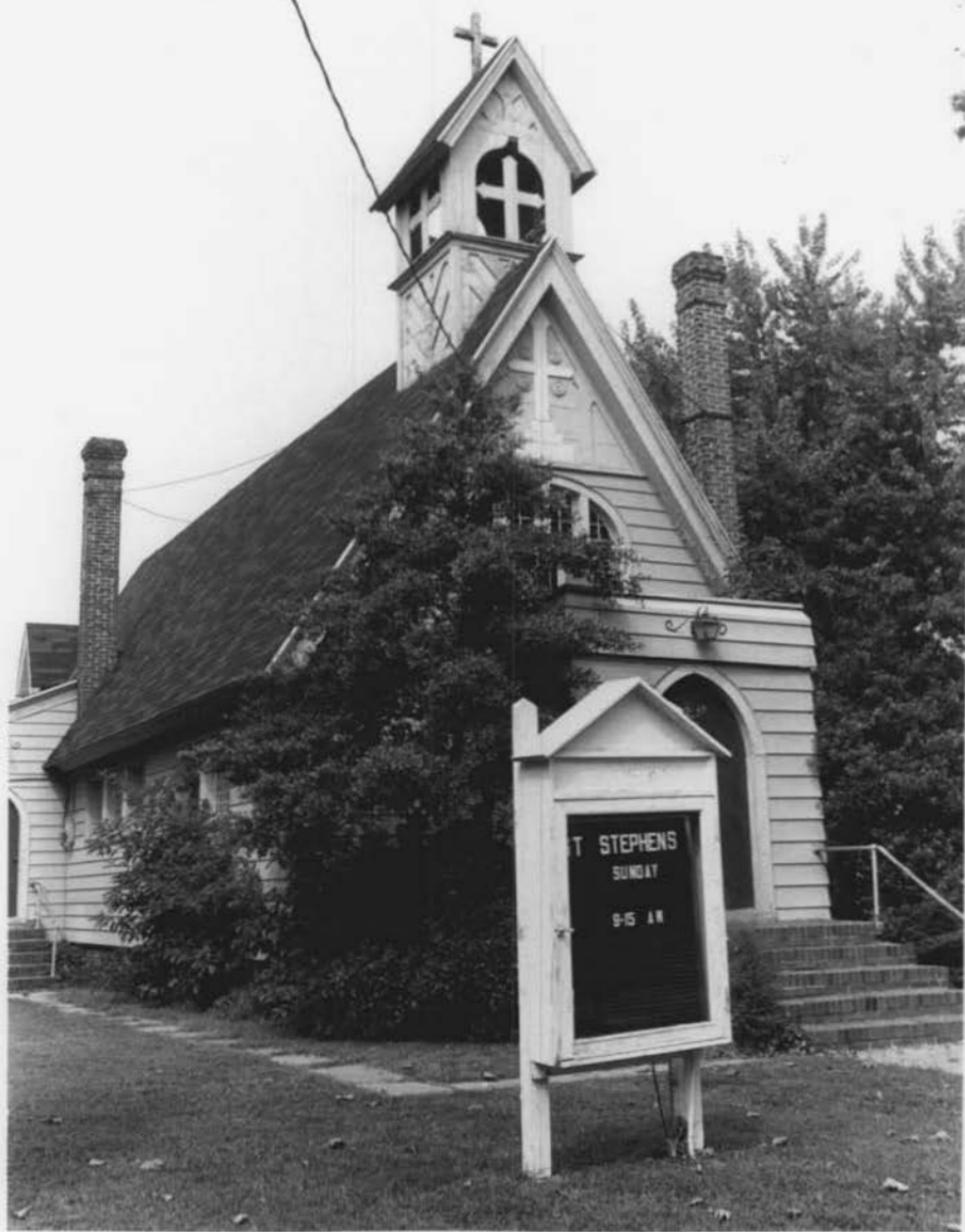
Built in 1893, the single-story Gothic Revival frame church is supported by a continuous common bond brick foundation and sheathed with a uniform layer of aluminum siding. The steeply pitched gable roof is covered with asphalt shingles. Rising from the east gable end is a small gabled belfry.

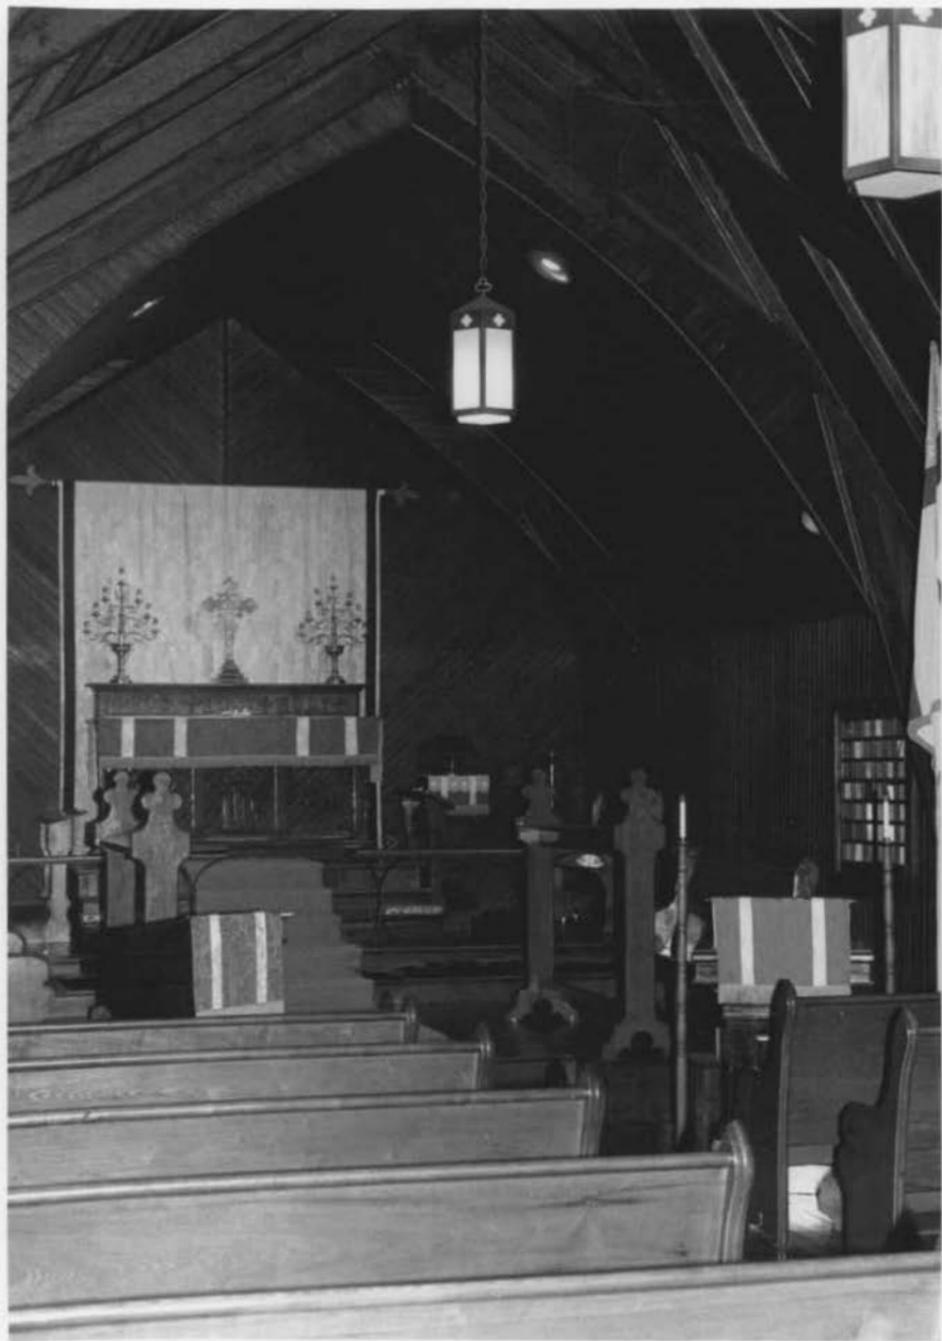
ST. STEPHENS P. E. CHURCH D-173
East New Market, Dorchester Co., Md
Interior
10/87 Paul Touart photographer
Negative/MD Historical Trust

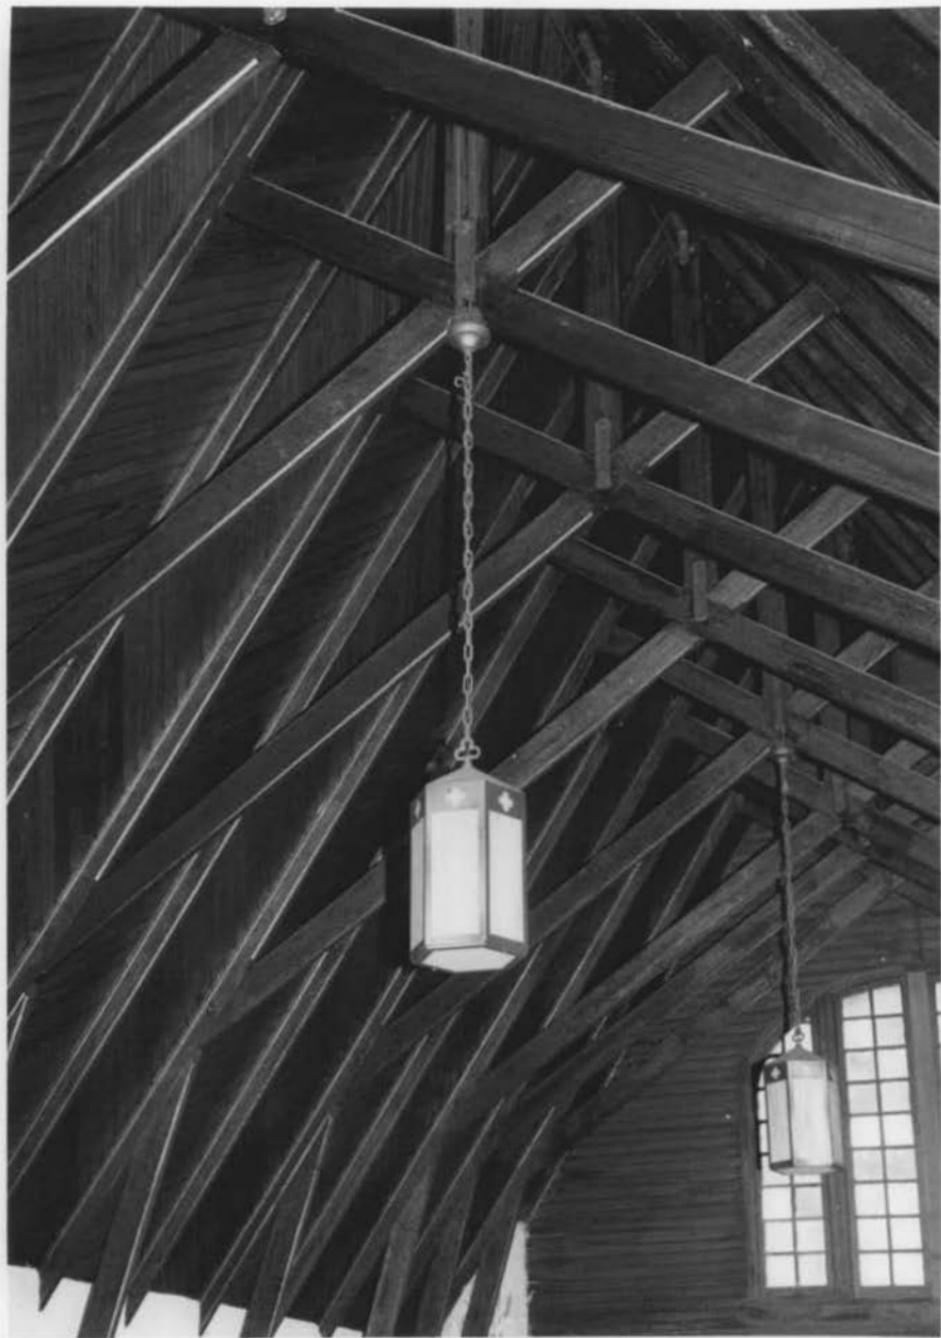
ST. STEPHENS P. E. CHURCH D-173
East New Market, Dorchester Co., MD
Scissors truss roof system
10/87 Paul Touart photographer
Negative/MD Historical Trust
