# National Register of Historic Places Registration Form

historic name Rock M. E. Church

other names Christ Rock United Methodist Church (preferred); D-585

Christ Rock United Methodist Church, D-585

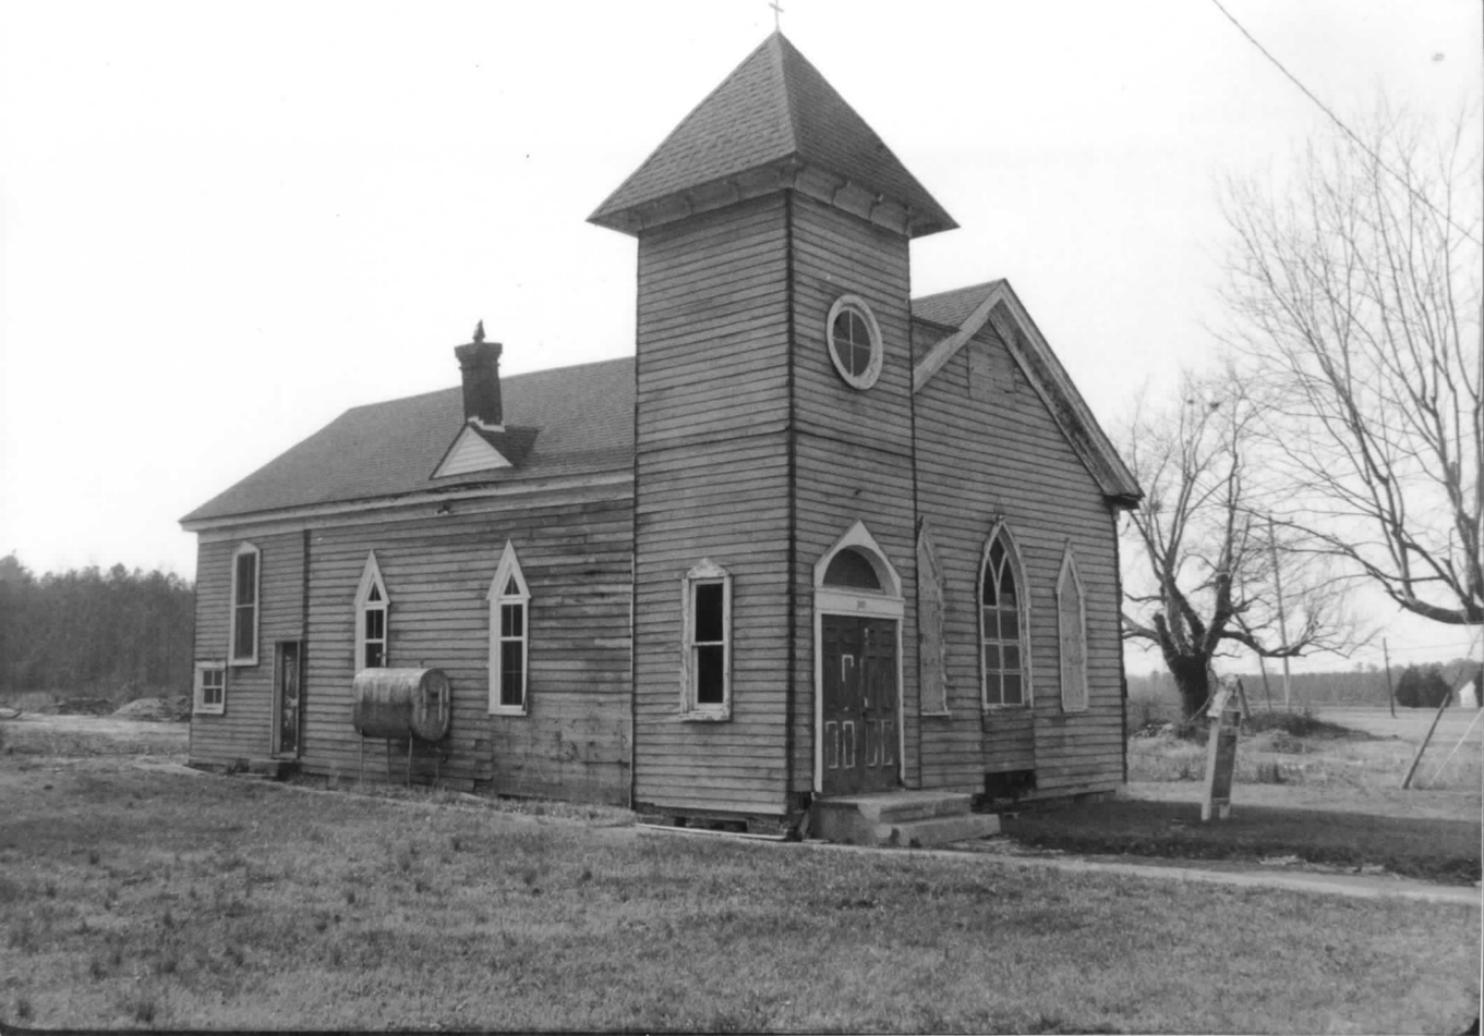
1 OF 10

NORTHEAST ELEVATION

The north (main) elevation is an asymmetrical façade with an entrance and bell tower on the northeast corner. On the first floor of the tower, replacement metal raised-panel double

doors are fitted within a pointed arch door opening. Fixed above the double doors is a round arched transom. The wall surface above the entrance is marked by a round window with quartered panes of colored glass. Capping the tower is a medium pitched pyramidal roof of asphalt shingles. Trimming the base of the tower is a modest Victorian bracketed cornice. Fixed between the tower and the gable roof of the sanctuary is a shed roofed cricket that diverts water away from collecting in the valley between the tower and main gable roof. The north elevation of the main block is defined by three pointed arch windows filled with colored glass. The larger center window, formerly the location of the main entrance in the 1875 church, is wider and slightly taller than the flanking lancet style windows. The top of the gable-front wall is finished with an extended eave, enclosed soffits, and returns at the lower corners.

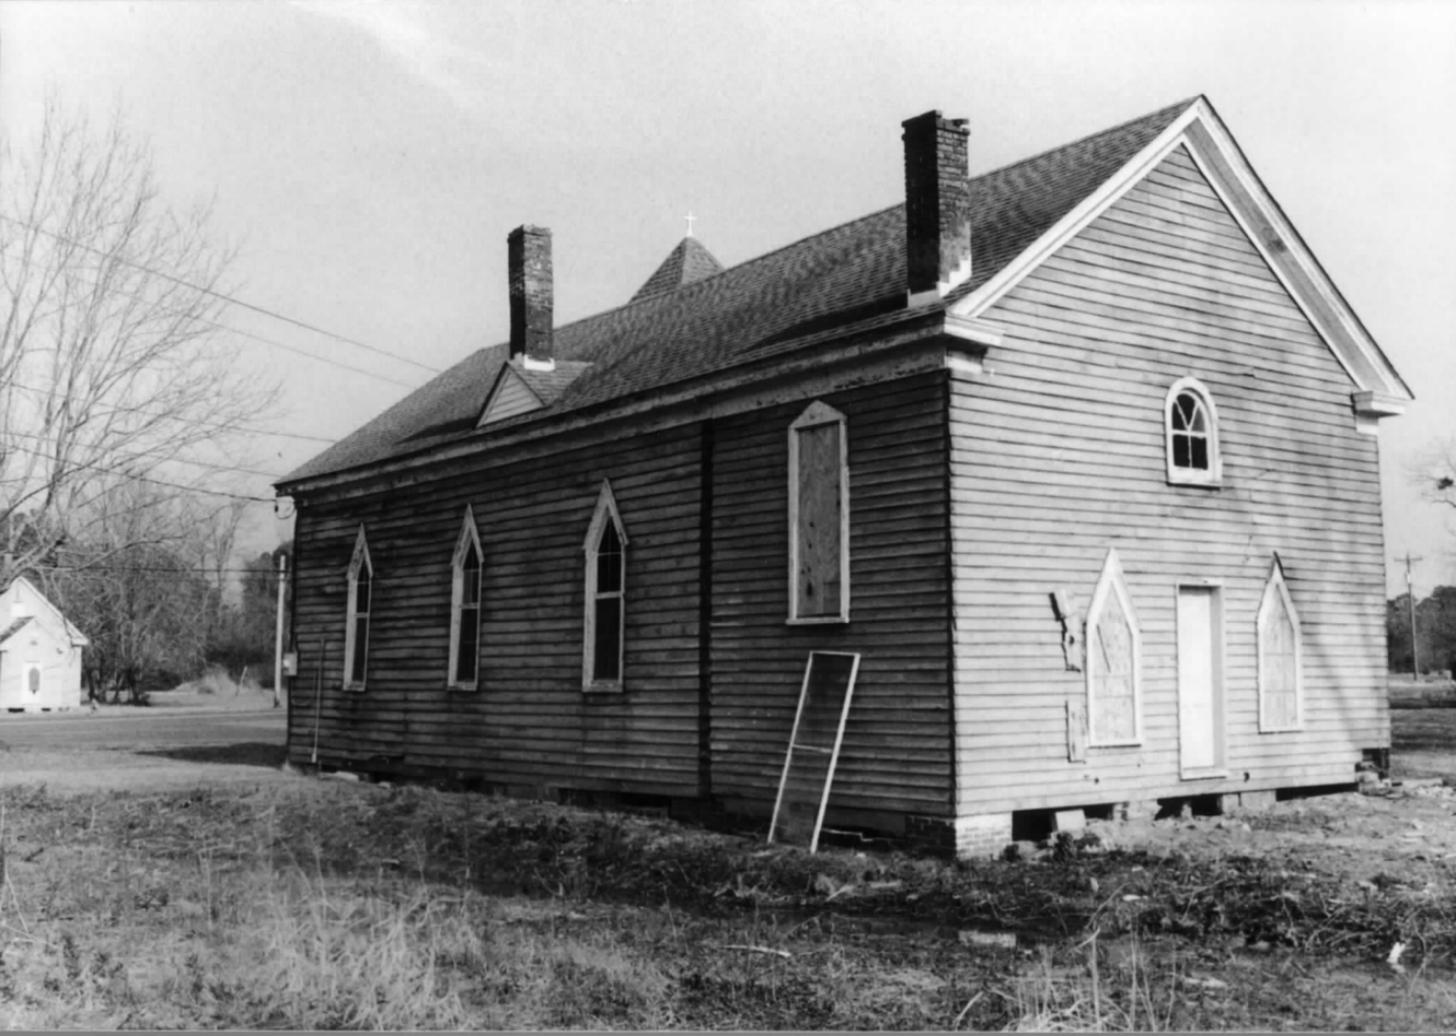
5 OF 10

SOUTHWEST ELEVATION

The side elevations are defined by pointed arch lancet windows. The windows on the west side elevation are original to the late nineteenth century structure, while the windows on the east side are late twentieth century replacements. A seam in the cornice on each side indicates where the 1889 structure ends and the single-bay 1910-11 addition begins. Single flue brick stove stacks pierce the side walls and rise through small cross gables. On the east side there is a four-panel door as a side entrance that provides access to the Sunday School room, and a two-over-two sash window partially lights the choir loft above. A small square window lights one of the two bathrooms on the first floor.

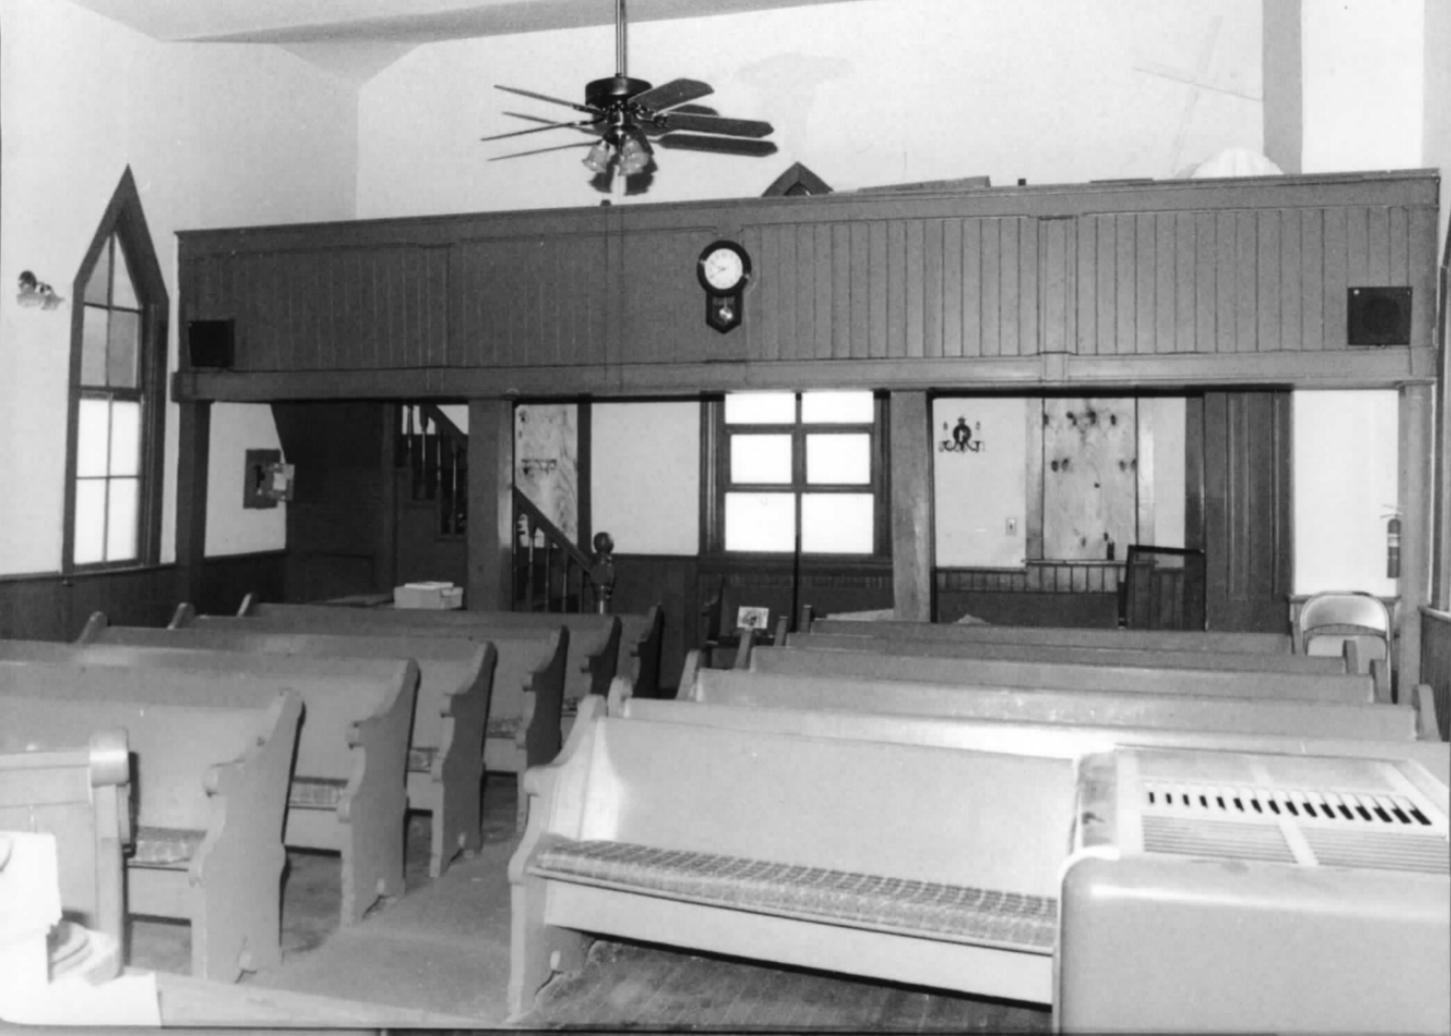
7 OF 10

SANCTUARY - INCLUDING BALCONY  
2/2012, PAUL TOURANT, PITUITV.

The sanctuary has a balcony at its north end. Two blocks of Victorian pews are divided by a center aisle. Trimming the perimeter of the sanctuary is vertical beaded board tongue-and-groove wainscoting with a plaster wall finish above. Fixed on each side wall is an interior brick stove stack serving Monogram oil-fired space heaters. The north end balcony is supported by

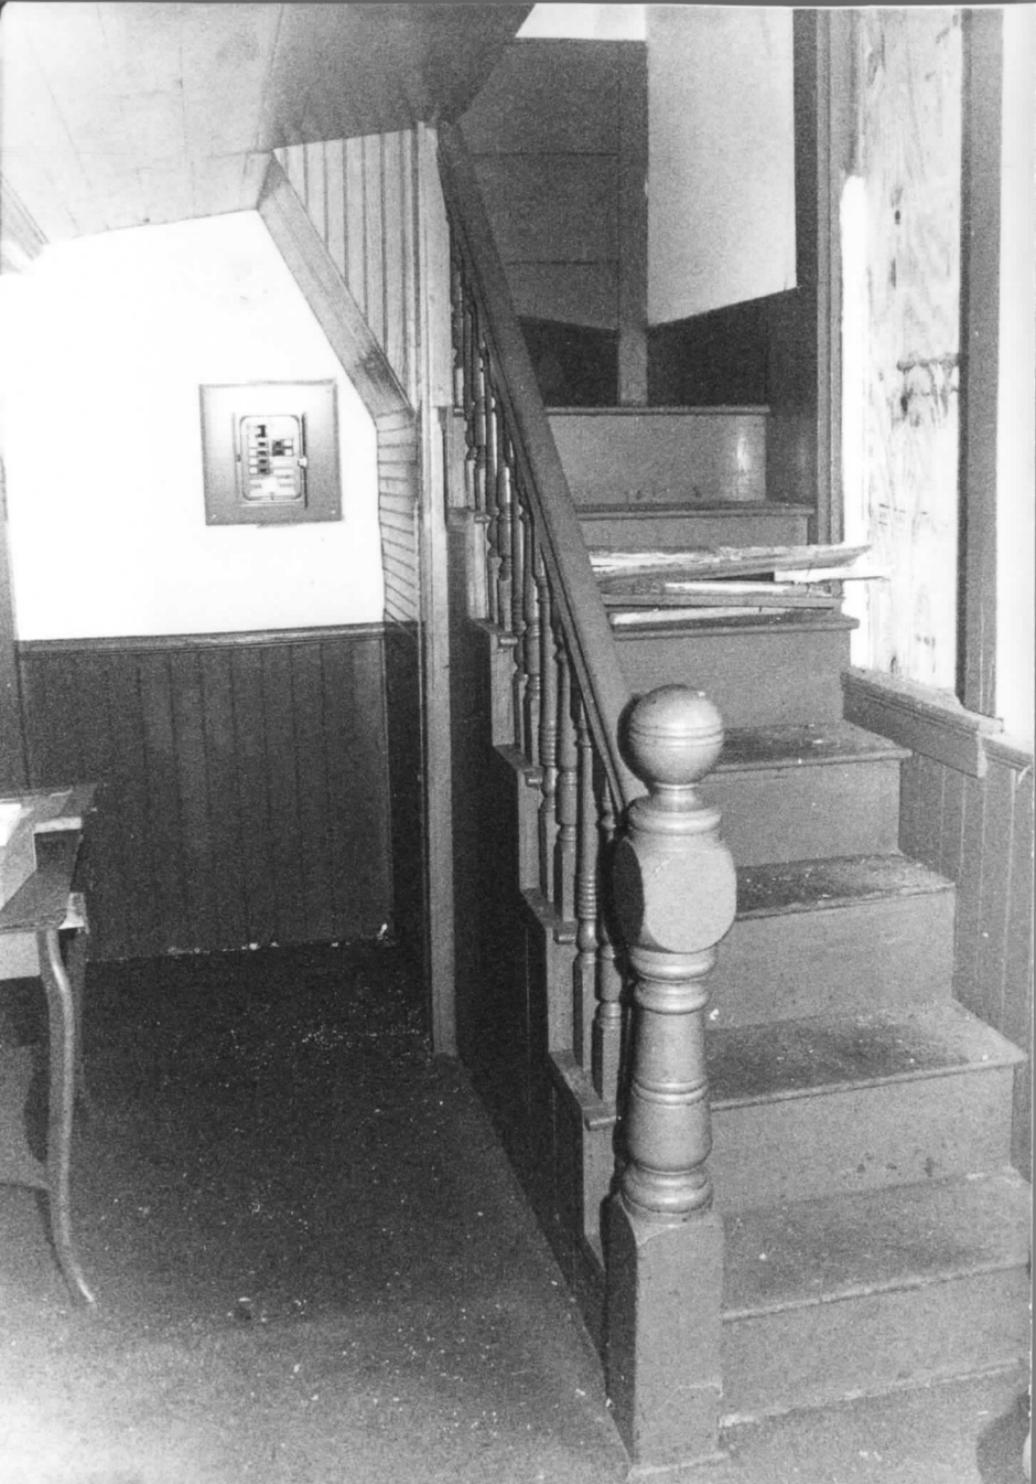
9 OF 10

BALCONY - STAIRCASE

square posts, and a turned baluster staircase rises to the upper level seating. A small tongue-and-groove beaded board door provides access to the storage space underneath the first landing. The altar end of the sanctuary is defined by a semi-circular platform accented by a low, turned baluster railing. There are two tiers to the platform, and the original Victorian pulpit is backed by a decorative set of four beaded tongue-and-groove panels. The upper two panels have diagonally set tongue-and-groove boards. To each side of the pulpit platform are shallow four-panel doors leading to the Sunday School room. Fixed in the southwest corner of the Sunday School room is a narrow staircase leading to the choir loft. The choir loft has an open front marked by decorated posts and a low, turned baluster railing. The Sunday School room on the first floor is a low ceiling room with two mid twentieth century bathrooms located on its east side. Defining the south wall of the Sunday School room are the two pointed arch colored glass windows flanking a center door.

In its original configuration, a board partition enclosed the balcony staircase, which was modified with the installation of a turned newel post, turned balusters, and a molded handrail during the 1910-11 period of construction. Similar turned work is found in the choir loft, also dating to the same time. The rear addition required the removal of the apse, and the colored glass windows were reused in the south wall of the extended structure. The altar area was reworked with diagonal matched, tongue-and-groove beaded boards that infilled the section formerly occupied by the apse. The altar was raised at that time in a two tiered form. According to the church history, the 1910-11 addition was executed by contractor, R. B. Dixon of Easton.

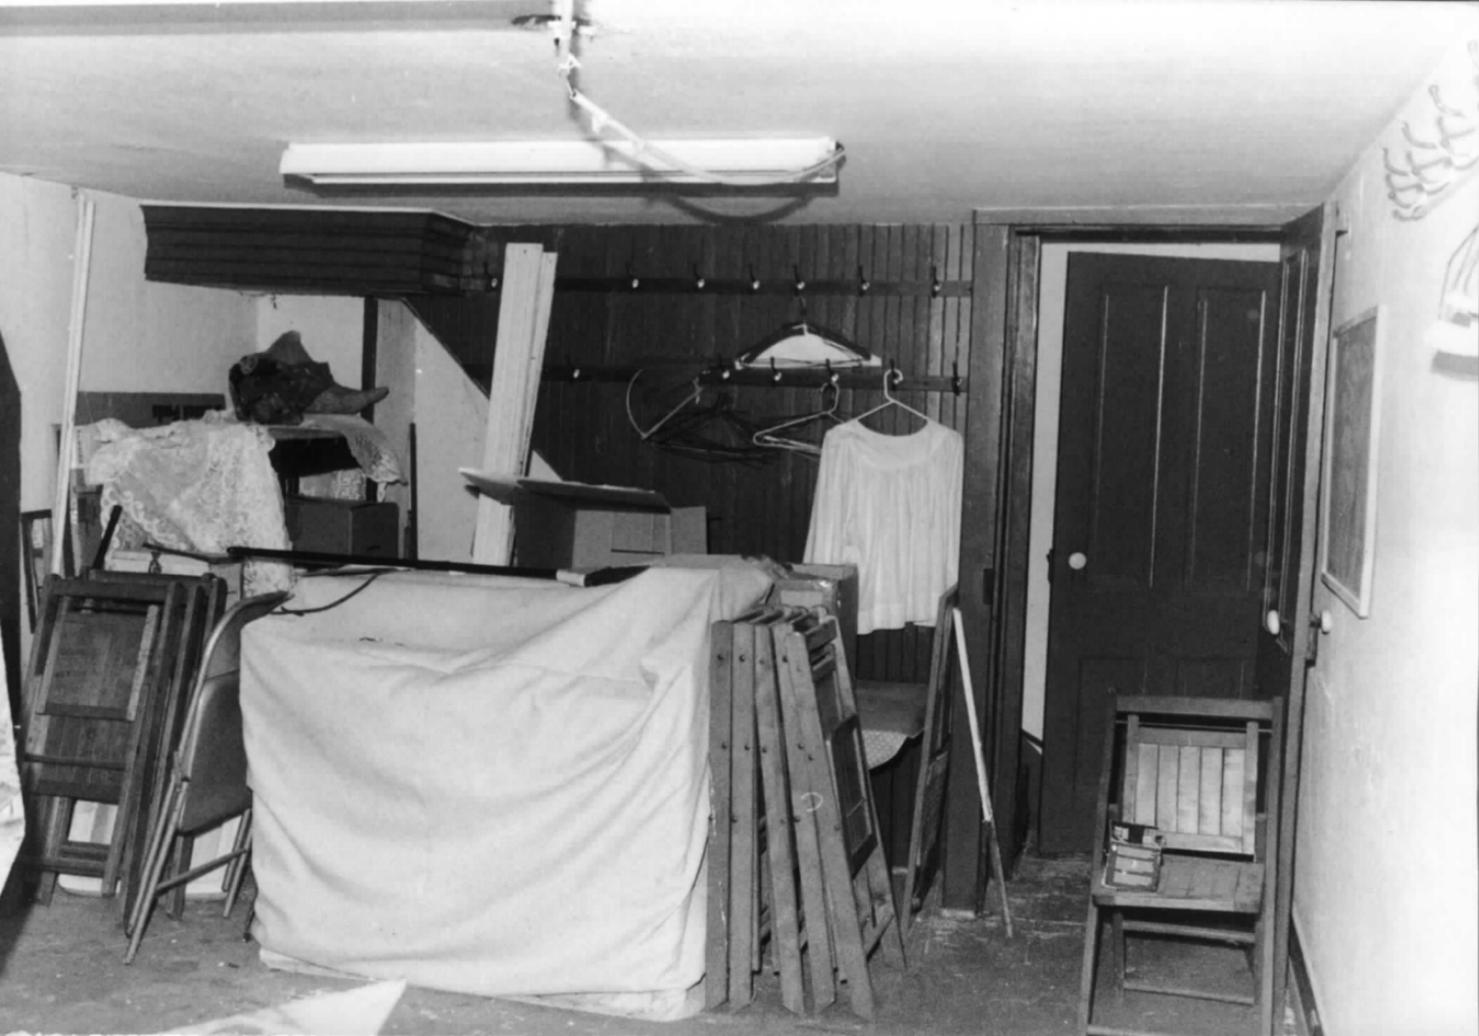
10 OF 10

Sunday School room with  
STAIR TO CITRUS CHURCH IN  
BACKGROUND

In 1910-11, the church was enlarged a second time with a Sunday School room and choir loft addition, which necessitated eliminating the three-sided apse that defined the south end. In an effort to repeat popular Gothic architectural traditions embraced by the national Methodist Episcopal Church, a two-story entrance tower was erected on the northeast corner. The construction of the entrance tower made the old center, gable-end entrance obsolete, and it was closed up and converted into a Gothic arched window. The seams in the exterior weatherboards and the shift inside of the type of wainscoting indicate the position of the former entrance.
