D-622  
Baker House  
East New Market  
private

# Maryland Historical Trust State Historic Sites Inventory Form

Survey No. D-622

and/or common BAKER HOUSE

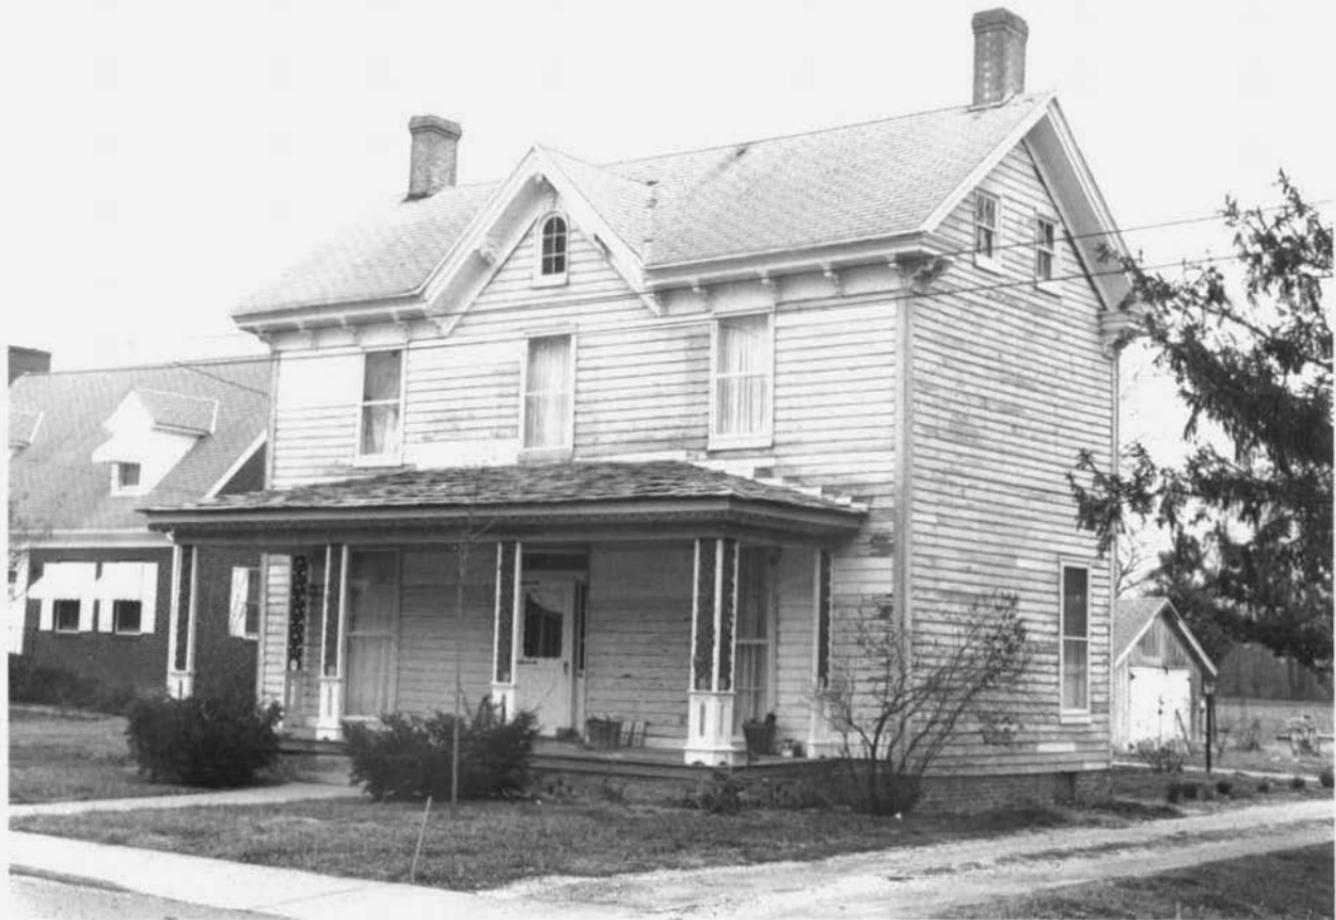
D-622

The west (main) facade is a symmetrical three-bay elevation with a center entrance and flanking six-over-six sash windows. The mid nineteenth-century four-panel door is framed by three-pane sidelights and a four-pane transom. Louvered shutters flank the adjacent windows. Stretching across the entire front of the first floor is a hip roof porch distinguished by elaborate sawn support posts with exuberant sawn corner brackets and fascia trim. The second floor is lighted by three evenly spaced six-over-six sash windows and the center cross-gable is pierced by a round arched two-over-two light. Embellishing the perimeter of the roof are decorative brackets.

Southwest elevation
