F-1-149  
Charles A. Walter House  
Doubs vicinity  
Private

F-1-149  
Charles A. Walter Farmstead  
Doubs vicinity  
Frederick County

# Maryland Historical Trust State Historic Sites Inventory Form

Survey No. F-1-149

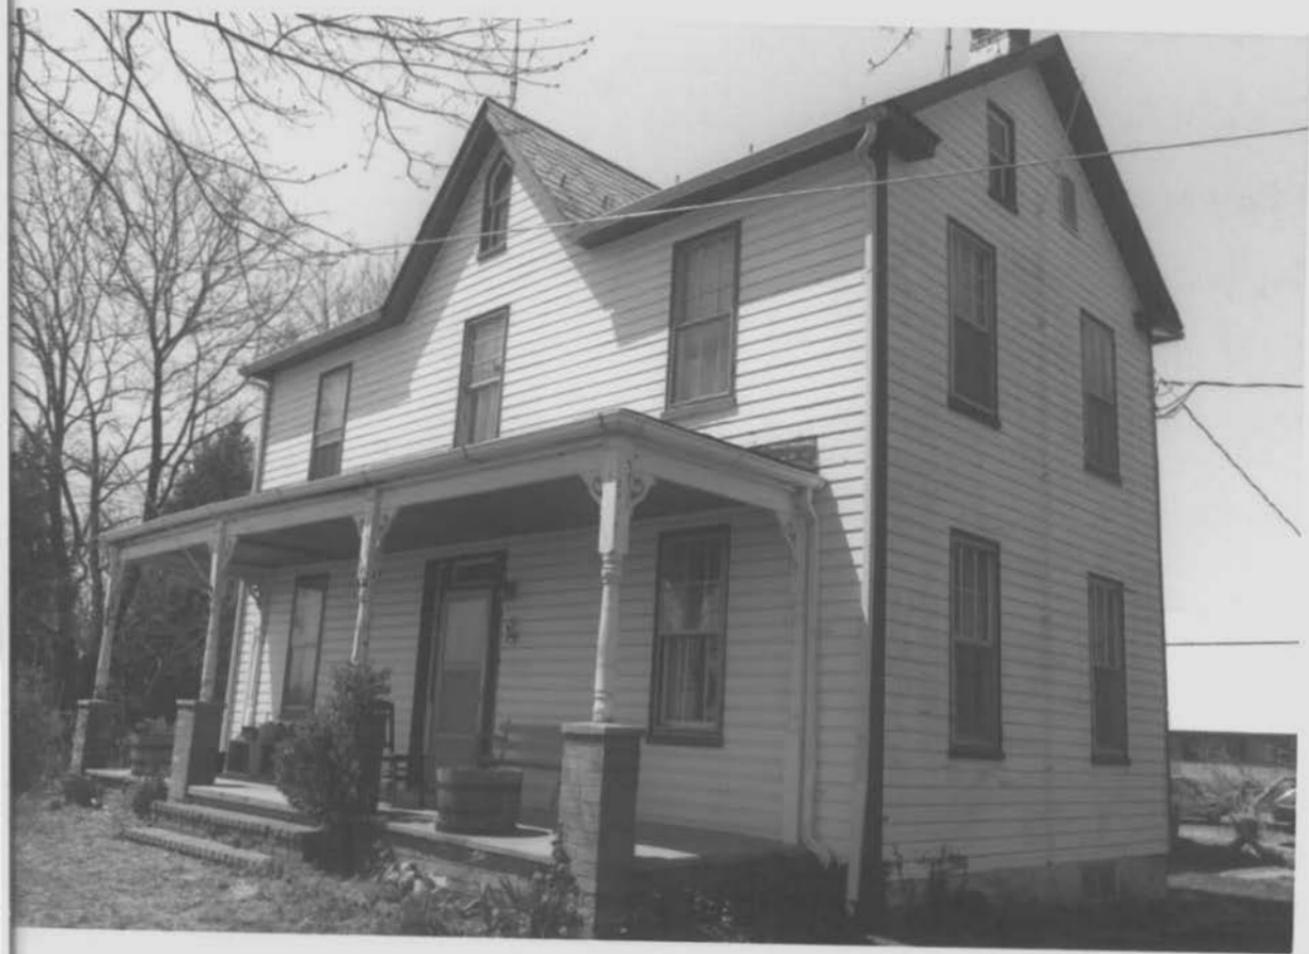
1/5

Southeast elevation

The dwelling has a three-bay southeast elevation with a center cross gable and a one-story porch. A two-story rear wing extends from the southwest corner. The exterior is covered with german siding and the roof is patterned slate. Interior chimneys are located at the gable ends and in the center of the rear wing. The windows have an unusual sash with 6/3 on the first story and 9/3 on the second story. The gable in the center of the southeast elevation has a small pointed arched window. The doorway has a plain rectangular transom and narrow sidelights. The door has four panels. The porch has a concrete block base and concrete deck, with turned columns on brick bases, an apparent alteration of the mid-20th century. The columns have scroll-sawn brackets. The rear wing originally had a two-story integral porch which is enclosed on the second story and is partially enclosed on the first story. This section has 1/1 modern sash. The interior of the house has a basically four-room plan with oak floors and plaster walls. The rear wing has two rooms. Trim and finish in the house is plain with corner blocks and the mantelpieces have been removed or replaced.

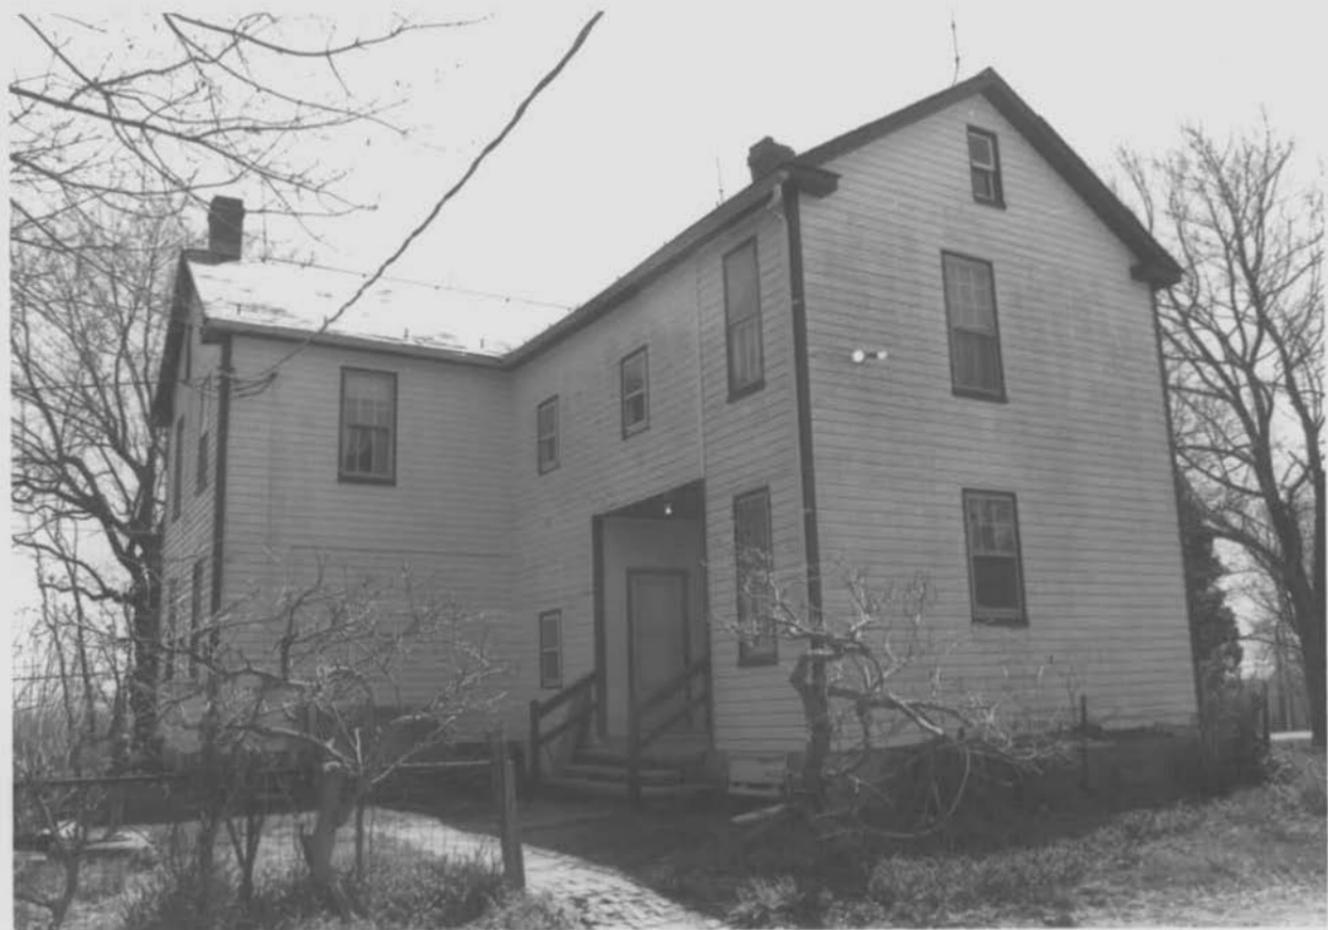
2/5

Northwest corner view

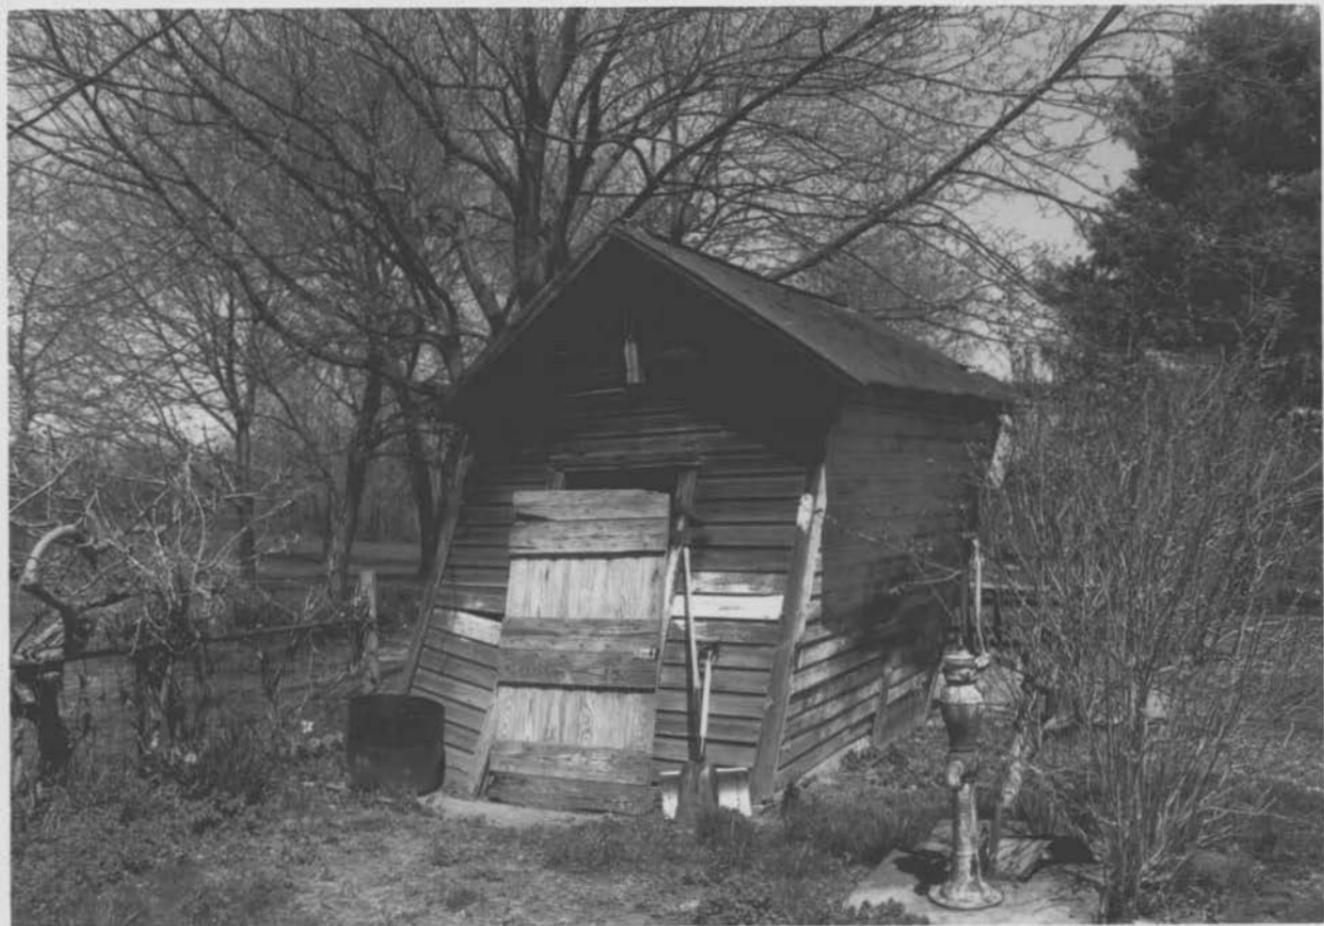
3/5

Meathouse, south elevation

**Meathouse:** The frame meathouse is deteriorated and leaning severely to one side. It has german siding and a corrugated metal roof over wood shingles. The doorway in the southwest gable elevation is boarded. On the rear gable end of the meathouse are the initials "C.W.", which according to the present owner, Mary E. Walter, are those of Charles Walter. She also said that family tradition held that the materials for the meathouse came from a demolished schoolhouse that stood on Ballenger Creek Pike south of the Walter property and that the meathouse was built prior to 1927.

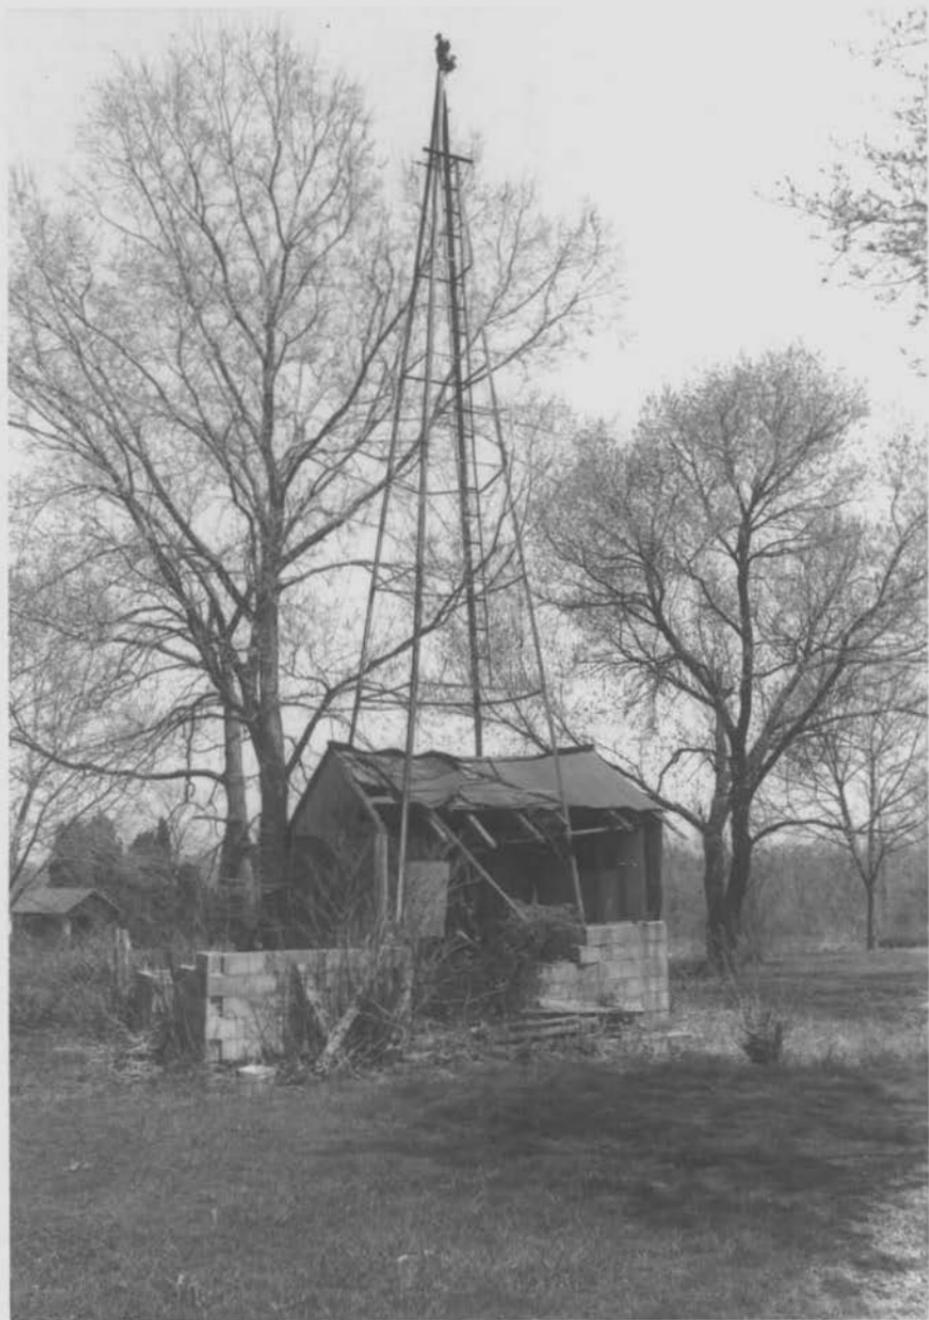
4/5

windmill tower and pump house/dairy, view from  
south

**Pump house and windmill tower:** The circa 1920 frame pump house is also much deteriorated and has a missing wall on the southwest side. A concrete block base and extension wall was built on the southwest side, probably in the 1930's. The remaining walls are vertical boards and the roof, which is partially missing, is corrugated metal. Above the roof of the building and straddling it is the steel framework of a windmill base. The vanes are also missing.

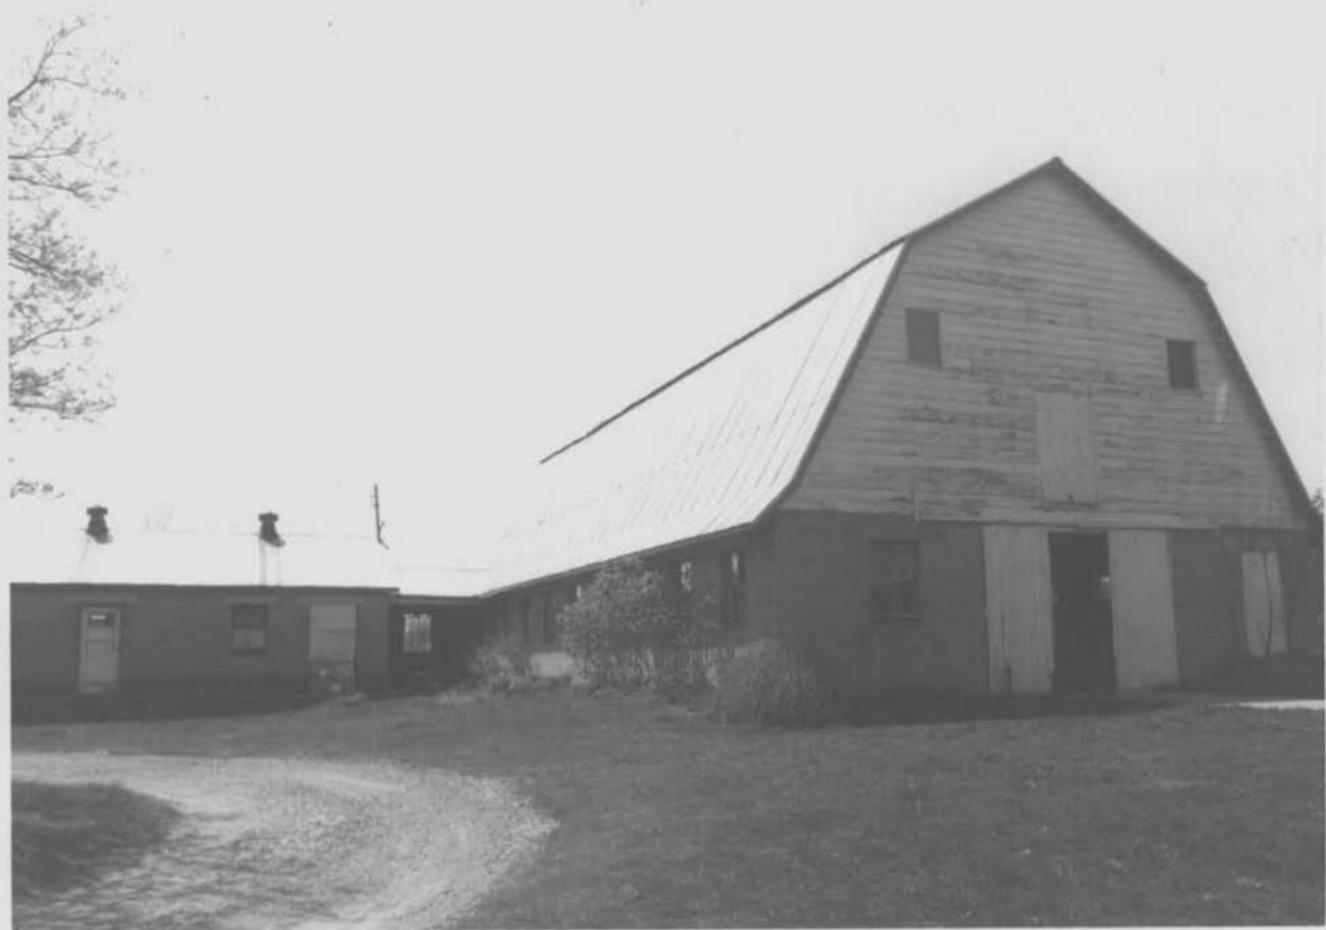
5/5

Dairy barn and milk house, view from north

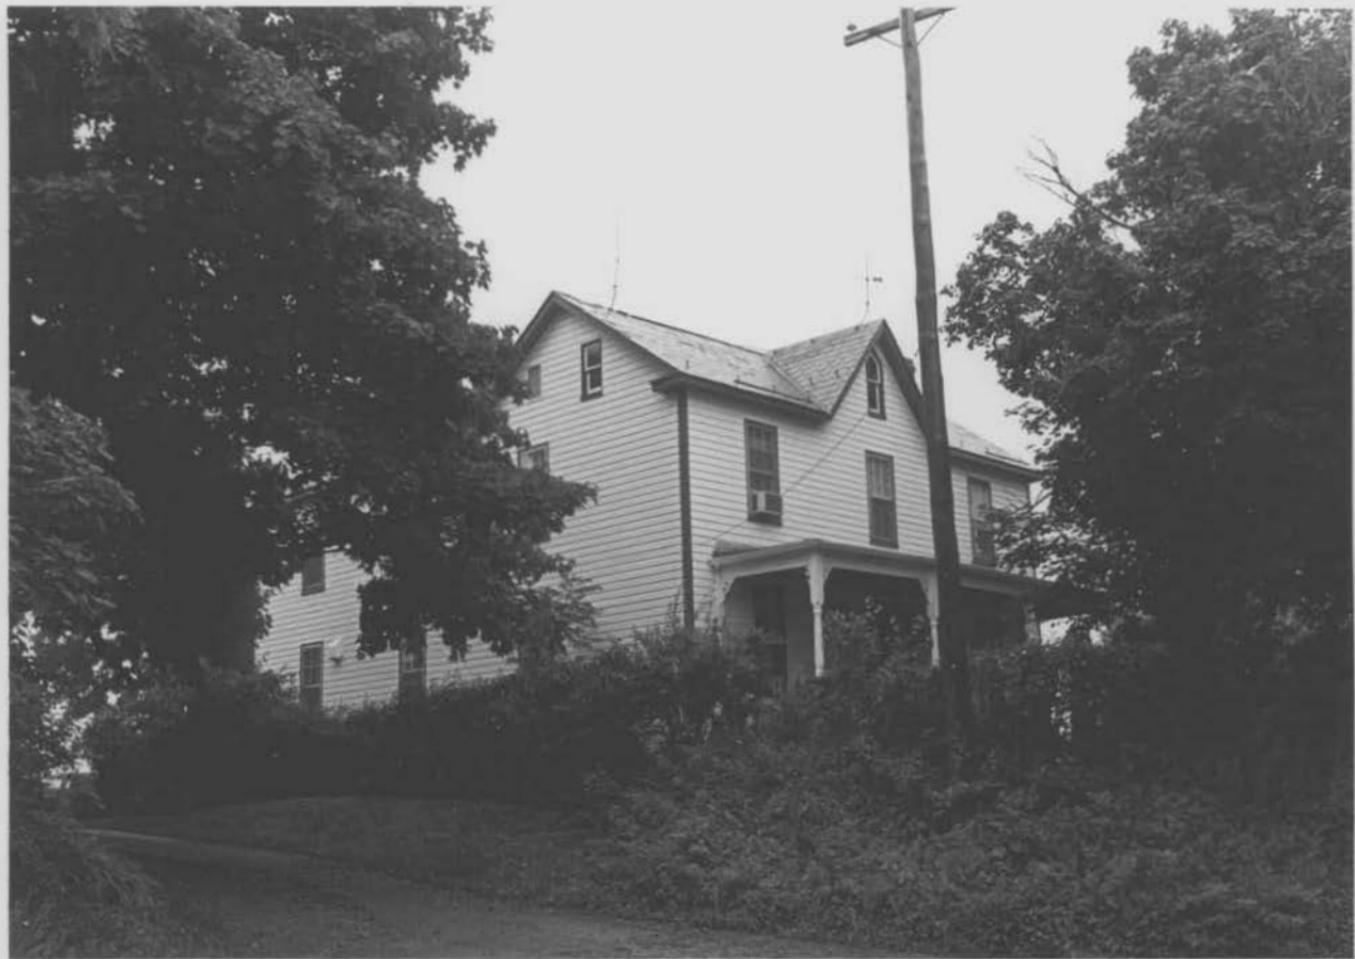
F-1-149

Southeast elevation

This house is located on the northwest corner of the intersection of Point of Rocks Road and Basford Road, west of the town of Doubs in southern Frederick County. The house is set close to Point of Rocks Road, and faces east. It is a two and a half story, gable roofed house composed of a main block and rear ell which form an L-shape plan. The main block which is three bays wide by two deep, has a center gable on its east facade and a one-story wooden porch with ornamental woodwork. The house is probably of frame construction and is now sheathed with white asbestos shingles; this siding appears to be the major exterior alteration.
