**MARYLAND HISTORICAL TRUST
NR-ELIGIBILITY REVIEW FORM**

Property Name: Charles M. Fry ^{Bungalow} Bungalow Inventory Number: F-1-153

Maryland Historical Trust Maryland Inventory of Historic Properties Form

**Maryland Historical Trust
State Historic Sites Inventory Form**

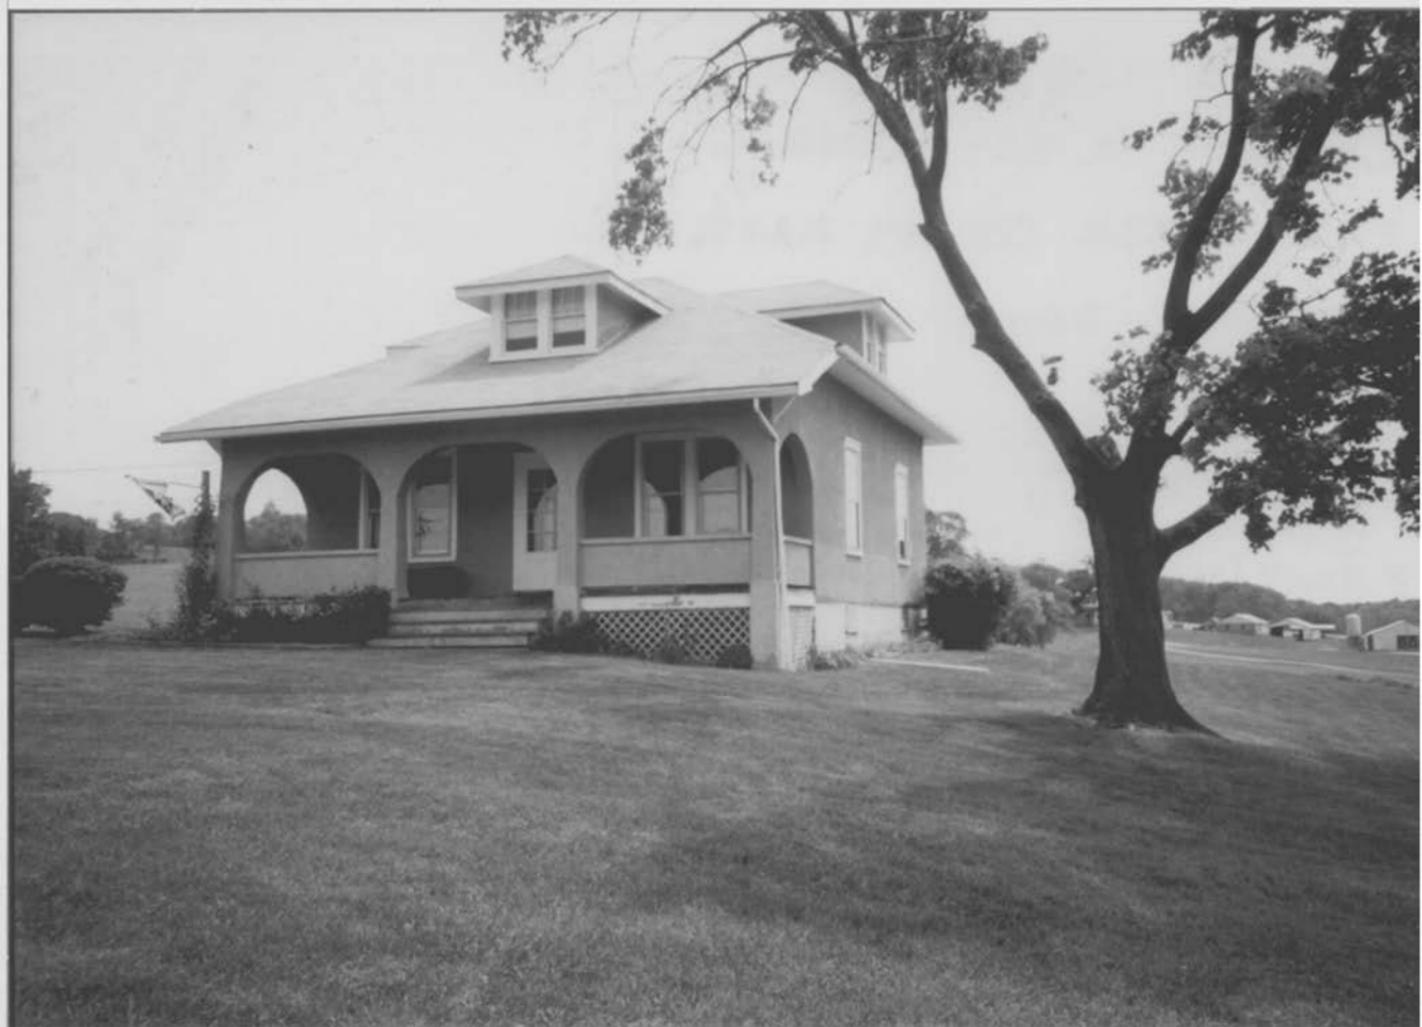
1/2

FRONT (N) AND W FACADES, VIEW SE

The principal (north) elevation features a full width, three-bay porch. Its shed roof is integrated with the hipped roof of the main block. The porch features stuccoed columns with battered sides that gracefully merge into elliptical arches. The handrails are constructed of solid concrete. The porch shelters a central entrance with a nine-light wood door.

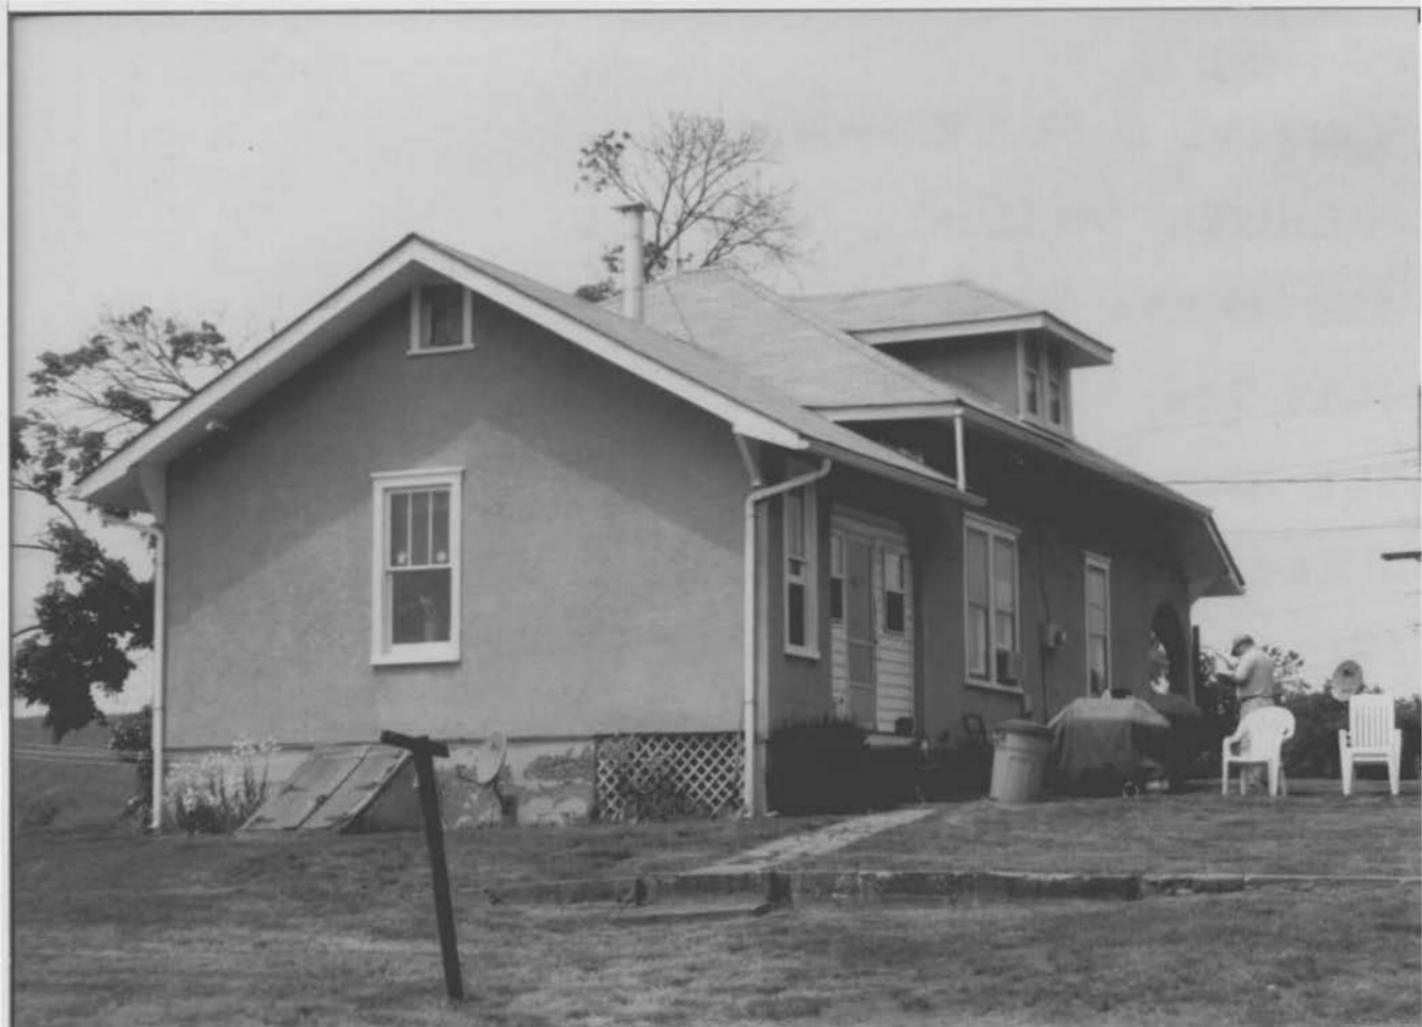
2/2

REAR (S) AND E FACADES, VIEW NW

The east elevation of the rear ell features an integral porch with an elliptical arch opening. The porch rests on concrete piers. The entry arch has been infilled with a wood-frame wall clad with vinyl siding.

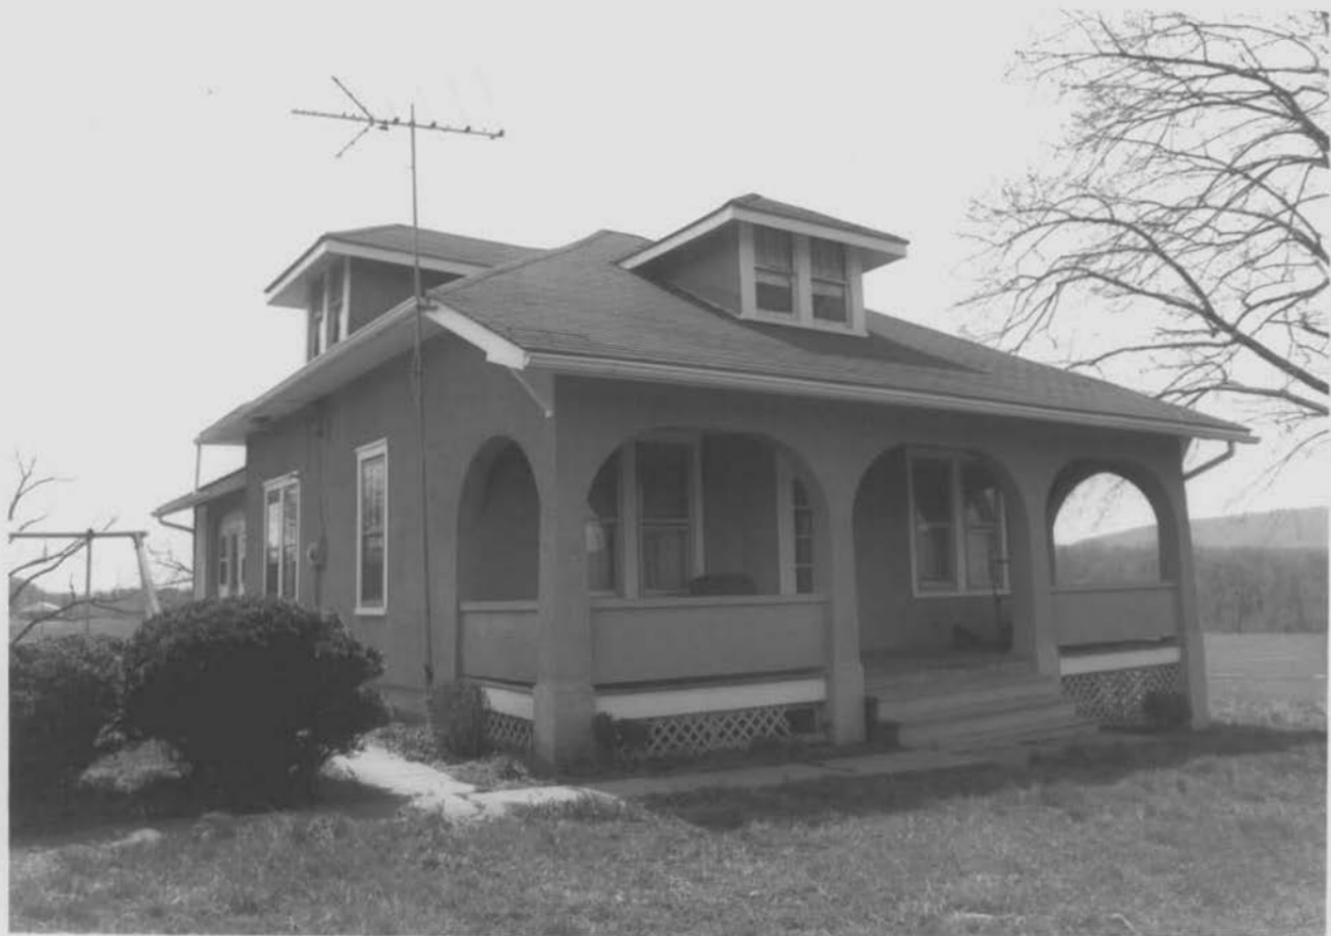
1/3

North elevation

The house has the typical low roofline and horizontality of the bungalow, with three bays on the north elevation. The entrance is in the center bay and the flanking windows are paired 3/1 sash. The door is a multiple-paned glazed type. The integral porch has shaped arches which curve from the tapered porch piers to the arches of the roof cornice. The hipped roof is covered with composition shingles, probably replacing original wood shingles. The extended eaves are covered with vinyl. The stucco exterior appears to be a recent application, but the original exterior could have been the same material. The hipped roof dormers are located in the north, east, and west sides of the roof and have paired 3/1 windows. On the west elevation, two bays each have 3/1 windows and the east elevation has a more functional window arrangement, as well as an enclosed integral rear porch near the southeast corner. A one-story wing extends from the south elevation. The interior was inaccessible for this survey.

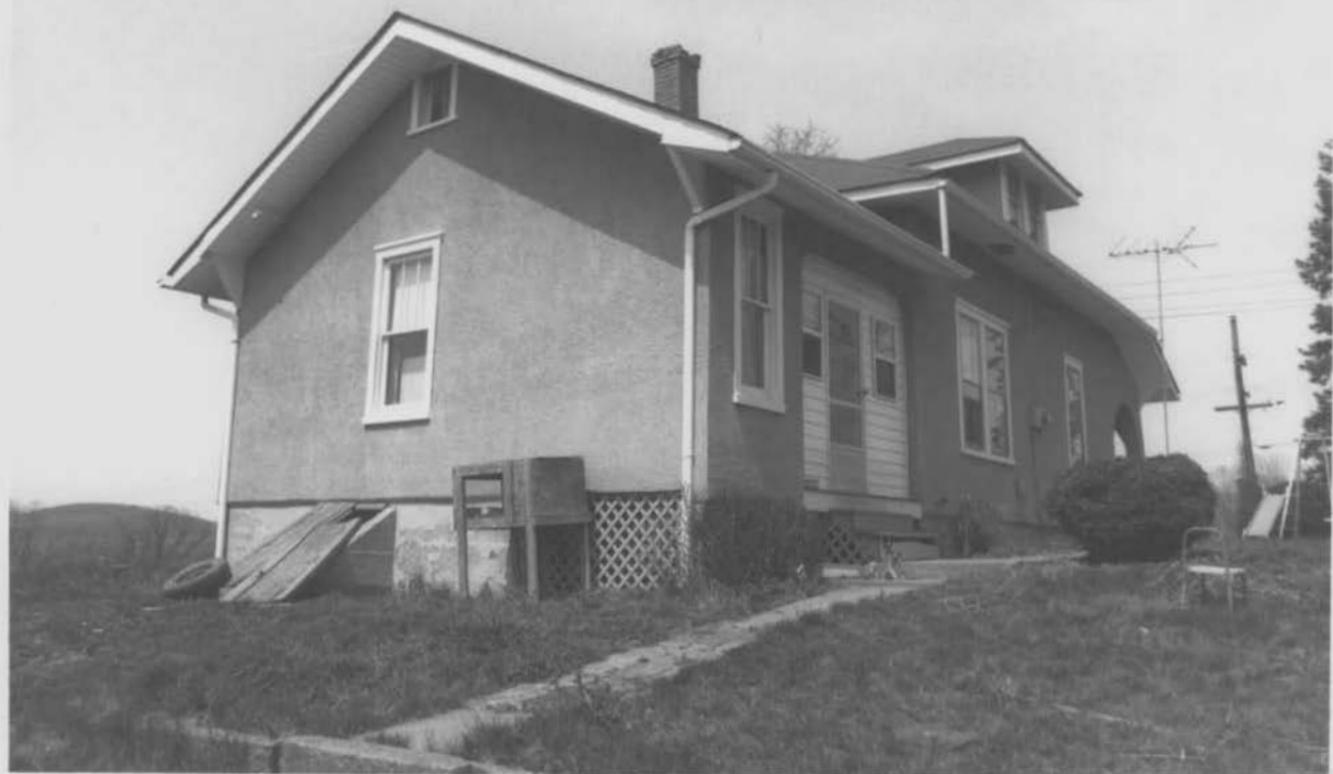
2/3

South east corner view

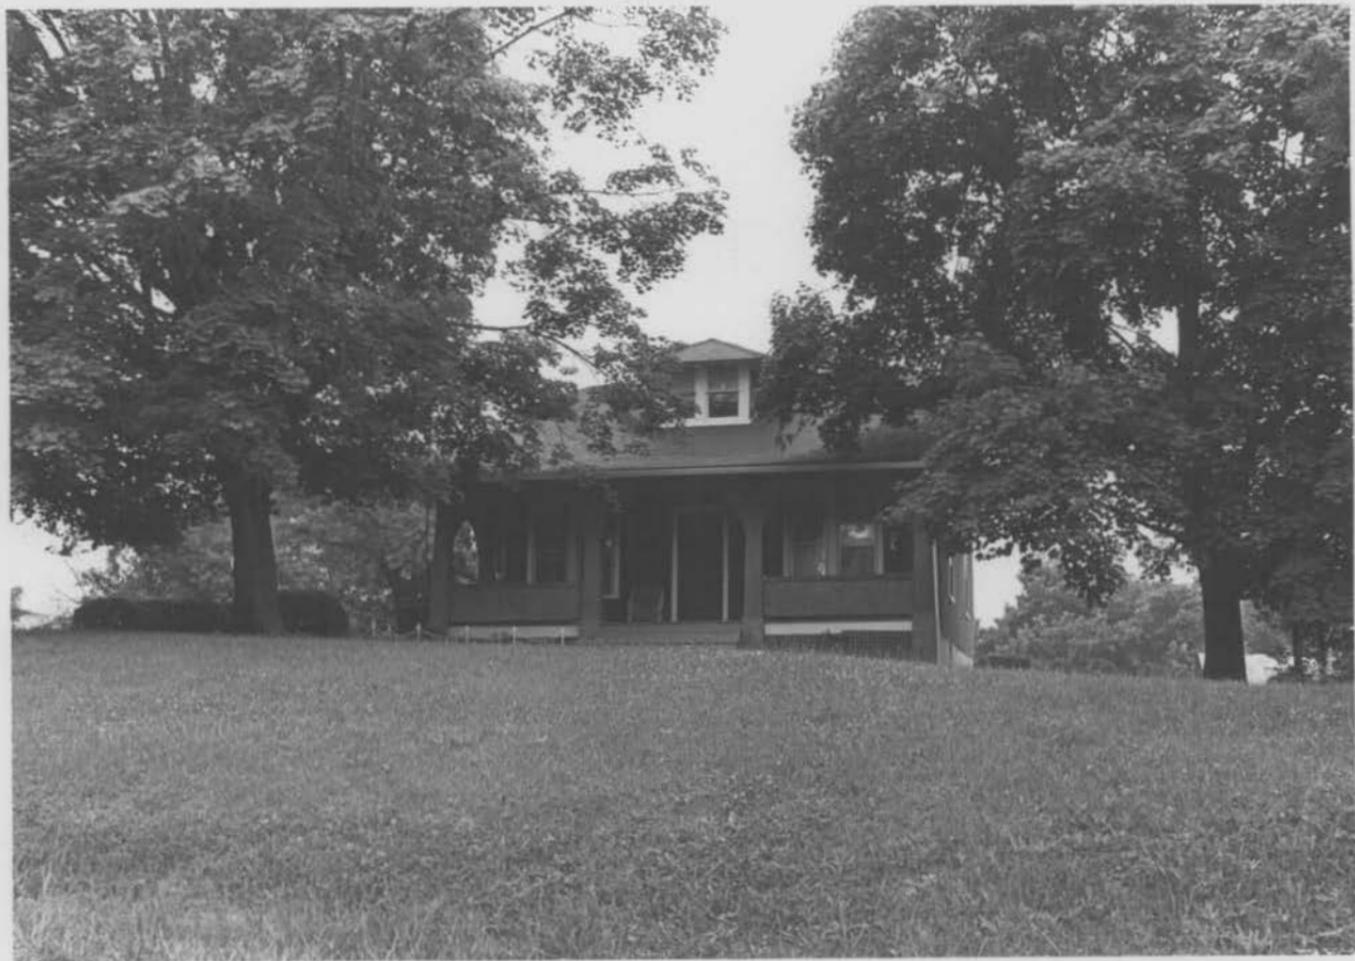
North elevation

The house is three bays wide by two deep; the principal facade has a central doorway flanked on each side by paired double-hung sash windows. This facade also has a one story porch, also stuccoed, which is sheltered by the main roof of the house. The porch has three wide arched openings, supported by tapered square piers. There is a solid stuccoed low porch wall within the two end arched openings. The east and west ends of the porch also have the same type of arched openings.
