John B. Thomas Farmstead; Bloomington
Tuscarora vicinity
Private

Ca. 1900-1905

F-1-161
John B. Thomas Farmstead
Tuscarora vicinity
Frederick County

State Historic Sites Inventory Form

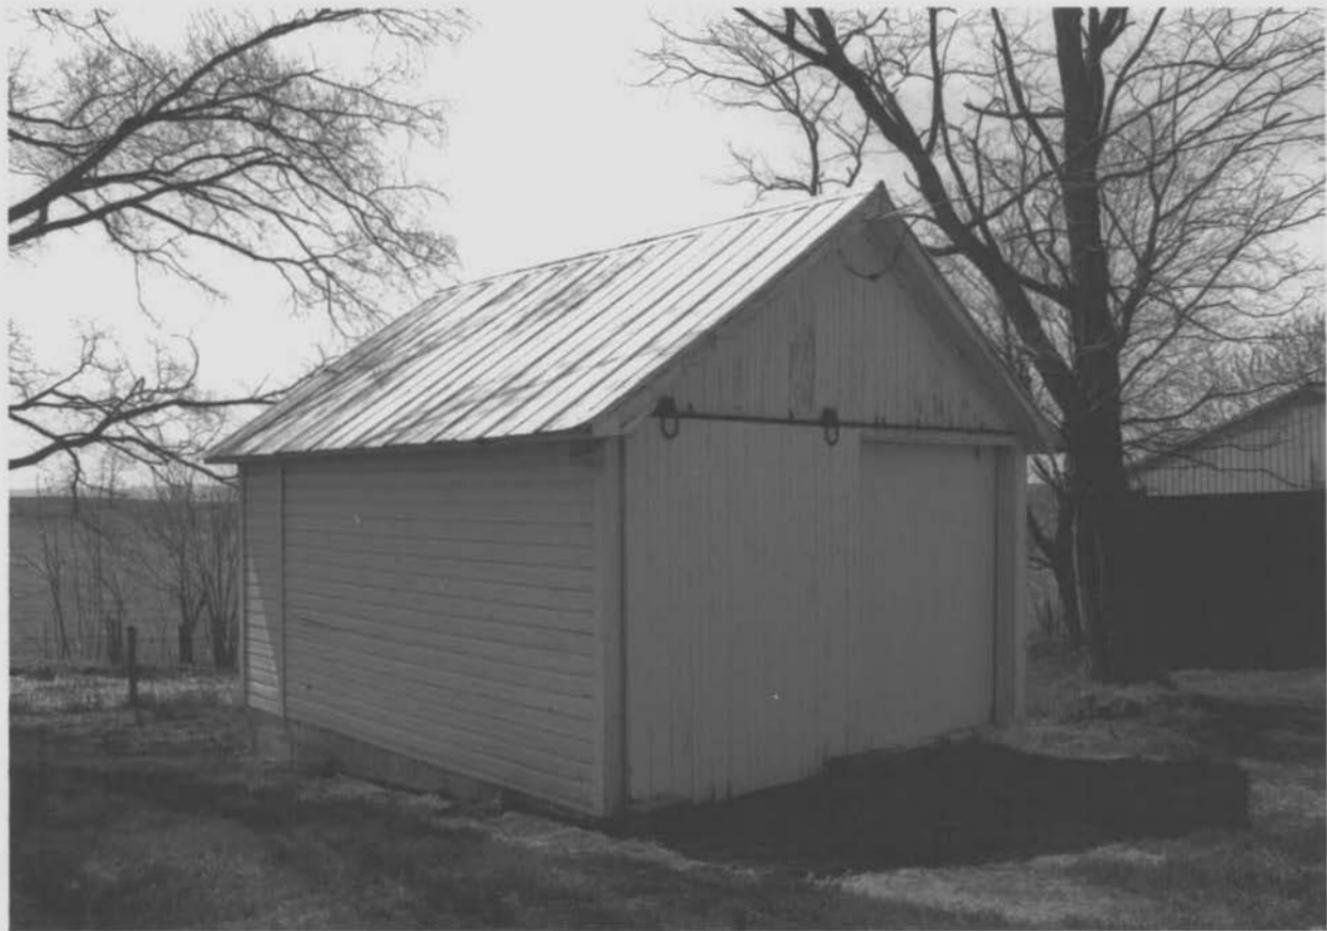
3/6

Garage: A small frame garage with tongue-and-groove and german siding is located southwest of the house on the south edge of the driveway which runs around the southern edge of the farmstead toward the agricultural group west of the house. The garage has sliding tongue-and-groove doors on the north elevation and a standing seam metal gable roof. Its construction materials indicate a date probably contemporary with the house.

Garage, 1775, 1775, 1775

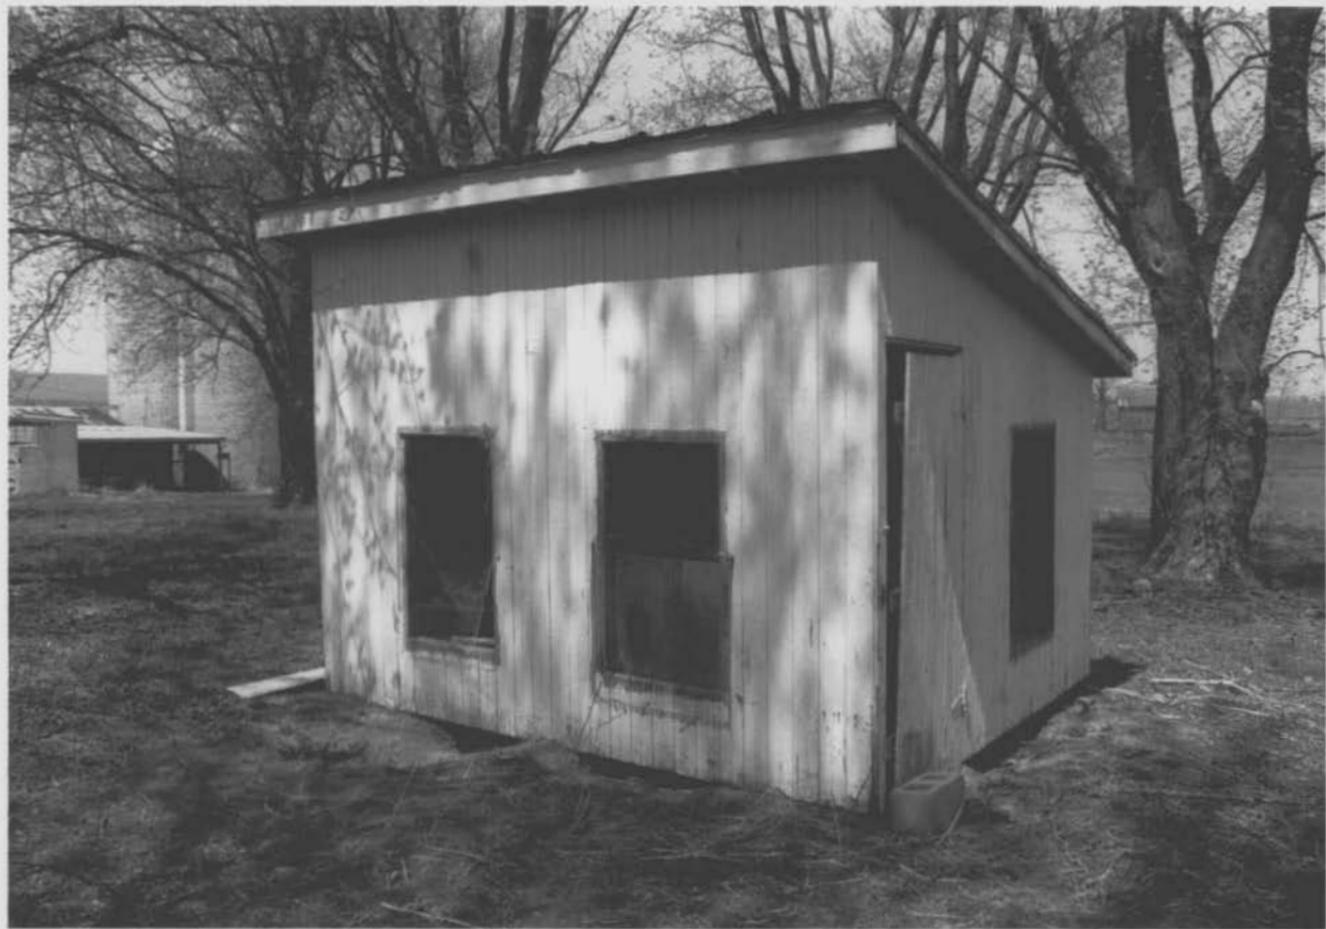
Chicken house: The frame chicken house is located north of the dwelling and has a shed standing seam metal roof with vertical siding. The south elevation has a band of windows and a vertical board door is located near the southeast corner. It was probably built about 1920.

Neg. 50-11-11-11-11, Crown Point Md
Chicken house, southeast corner view
4/3

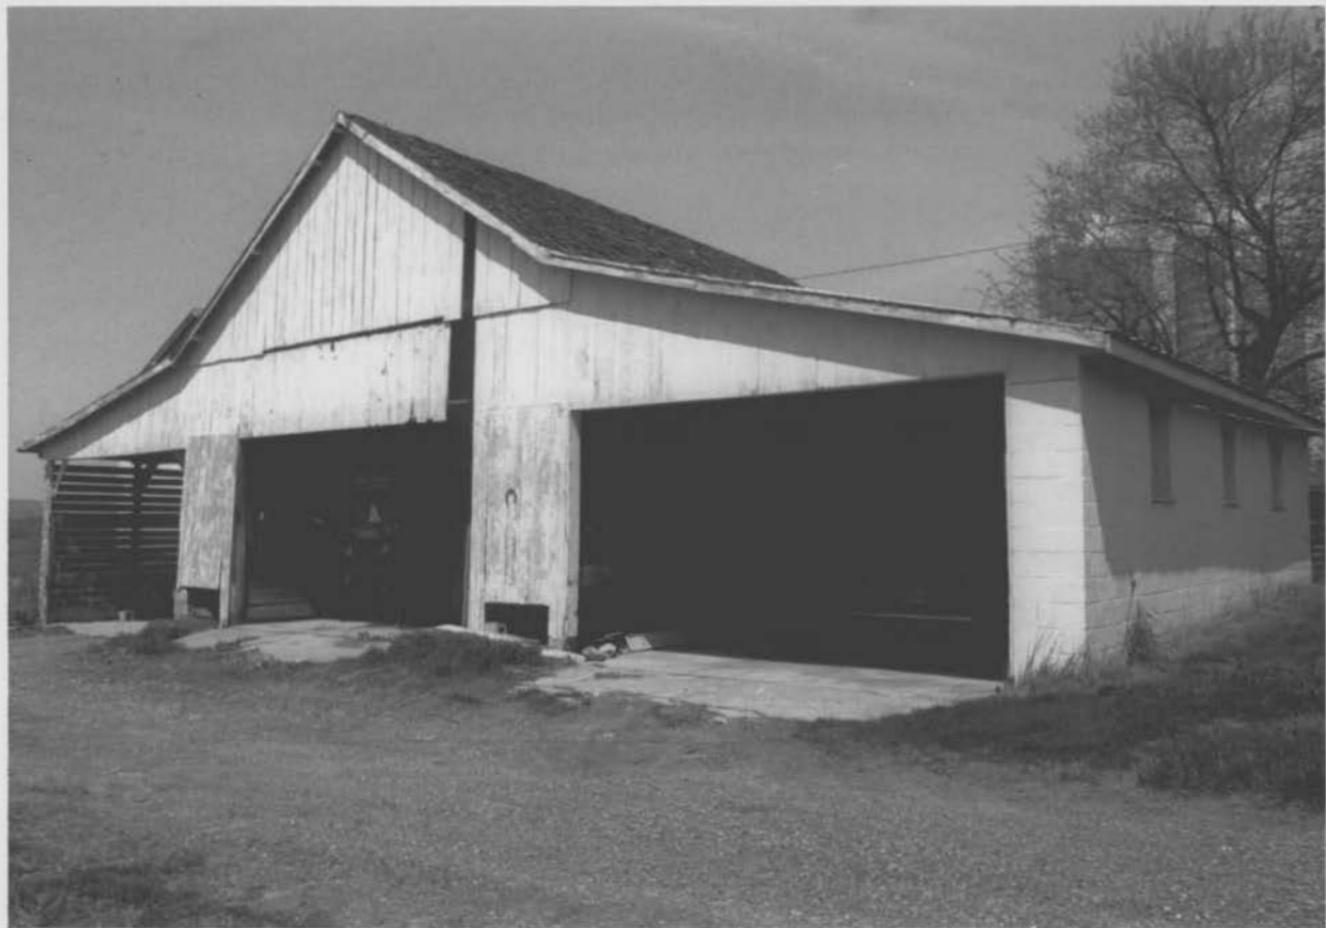
2/6

Wagon shed/corn crib: The frame wagon shed is located near the western edge of the farmstead and is flanked by non-contributing concrete block buildings. It has extensions on its east and west elevations for additional equipment storage. The exterior is covered with vertical board siding and the gable roof has both standing seam metal and original wood shingles. The building probably dates from about 1900.

Wagon door 20th elevation
