MARYLAND HISTORICAL TRUST
NR-ELIBILITY REVIEW FORM

F-1-186

**LIME KILN SURVEY DISTRICT
 FREDERICK COUNTY, MARYLAND**

and/or common Lime Kiln Survey District

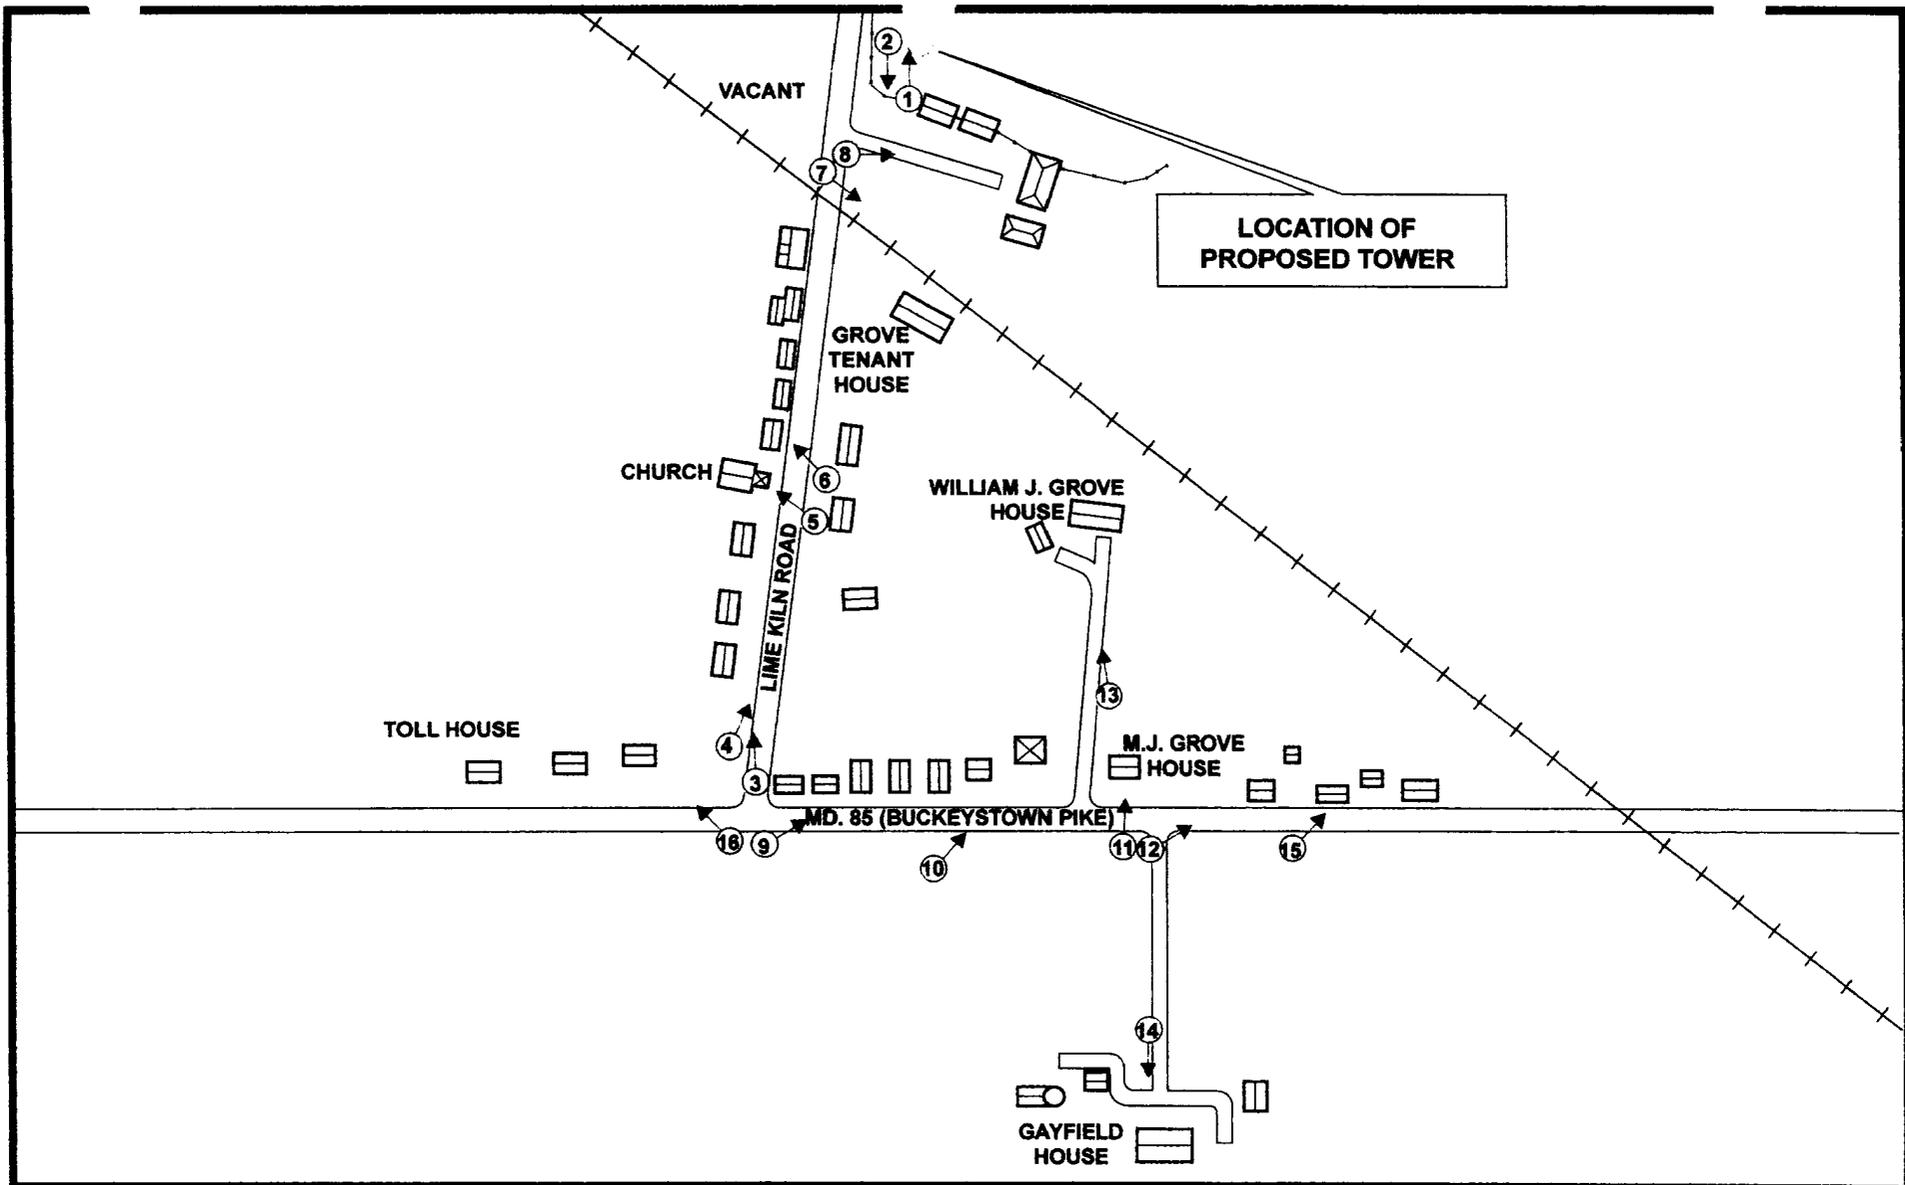
FIGURE 1

SITE PLAN

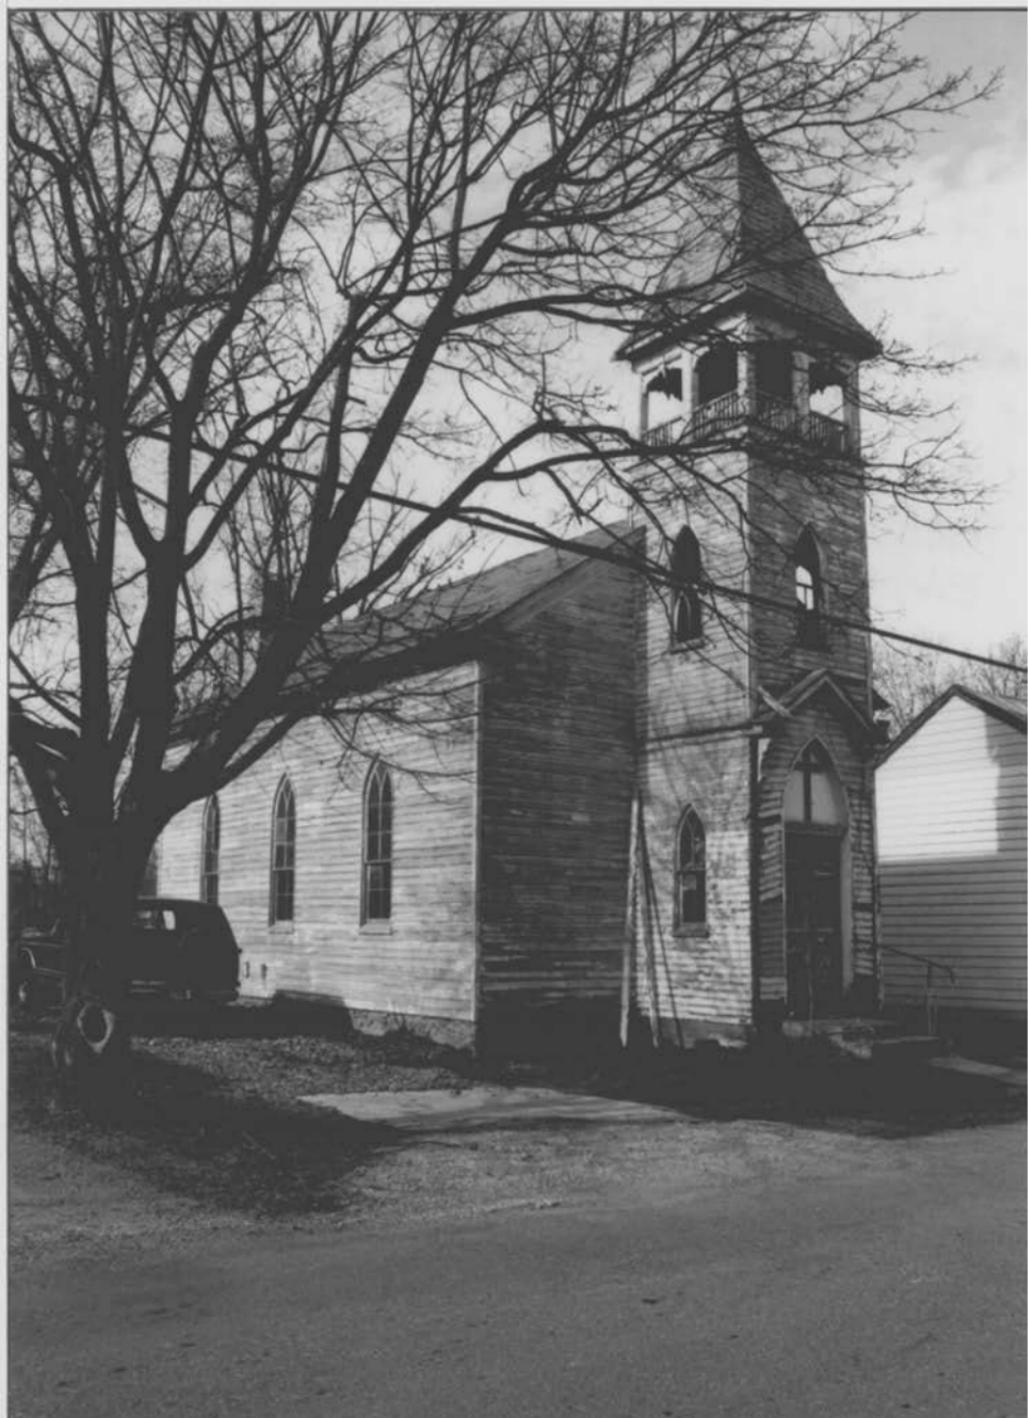
• 5/16

- F-1-196
- Methodist
Protestant Church,
- Frederick County, MARYLAND
- GUNNEY LUNCH
- FEBRUARY 26, 2002
- MD SHPO
- Methodist
Protestant Church, LIME KILN ROAD,
EAST FACADE

Methodist Protestant Church, Lime Kiln Road (F-1-98): The one-story frame church was built in 1888, according to the stone in the northwest corner of the stone foundation. It has german siding and a patterned slate roof. The north elevation has a projecting square bell tower with the main entrance on the north side. The doorway has double paneled doors and a Gothic arched transom with a centered wood cross. Above the doorway is a pediment cornice with console brackets at the corners. The upper part of the tower has Gothic arched windows with tracery muntins. The open belfry has a plain balustrade and pendant and bracket decoration. The tower roof of patterned slate rises to a simple finial. The east and west elevations of the church have three bays each with Gothic arched windows. The church is not currently in use and is in somewhat deteriorated condition. Photos from the original 1978 survey show that the building was in fair condition at that time and it has since then lost the glass in the tower windows. The exterior siding is deteriorated or missing in places and the paint is severely weathered. Foliage overgrowth is kept at bay by a neighboring property owner.

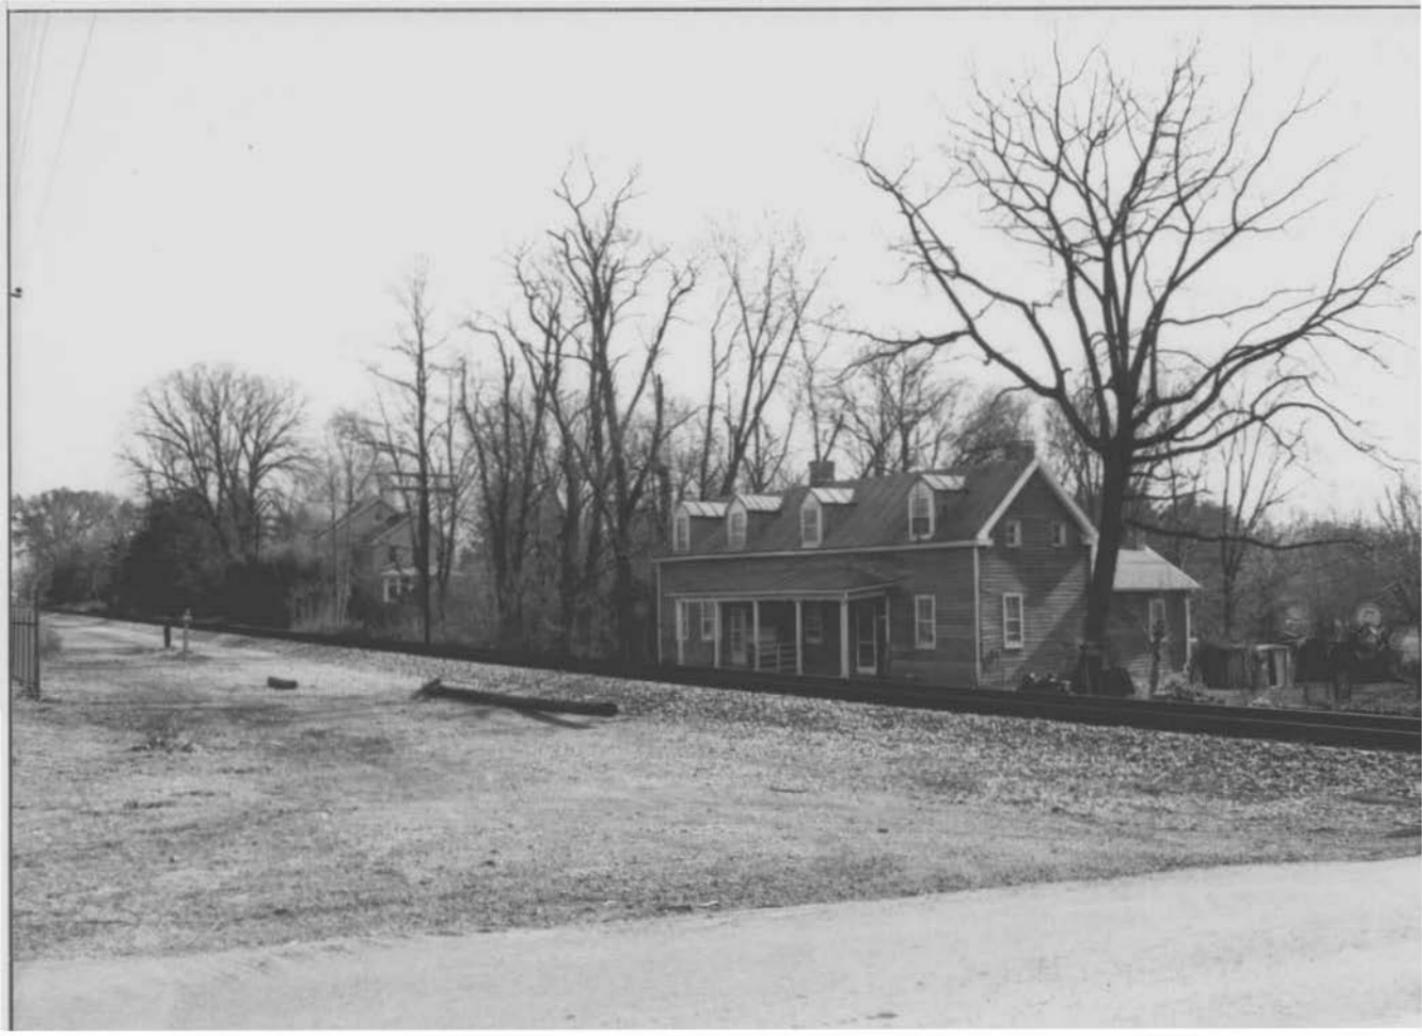
• 7/16

- F-1166
- M.J. GROVE TENANT HOUSE
- FREDERICK COUNTY, MARYLAND
- COURTNEY LYNCH
- FEBRUARY 26, 2002
- MD SHPO
- M.J. GROVE TENANT HOUSE, 4219 LIME KILN RD.,
WEST FACADE

M. J. Grove Tenant House, 4219 Lime Kiln Road (F-1-79): The frame 1-1/2 story tenant house is a double residence located on the east side of the railroad tracks. The principal elevation faces west, supporting the connection of the house with the lime kiln site on the west side of the tracks. The building was erected about 1860 with the establishment of the M. J. Grove & Son Lime Company

in 1858, undoubtedly to house laborers at the works. The long rectangular building has a one-story porch over the two entrances to the separate dwellings. Four dormers are 6/6 sash are located in the standing seam metal roof. Chimneys are on the south end of each dwelling unit; therefore, the same original floor plan was probably in both sides. Each has a one-story rear wing projecting toward the each. The raised stone foundations are visible on this elevation. The exterior is covered with german siding and the windows are 2/2 in the main section and 6/6 in the rear wings.

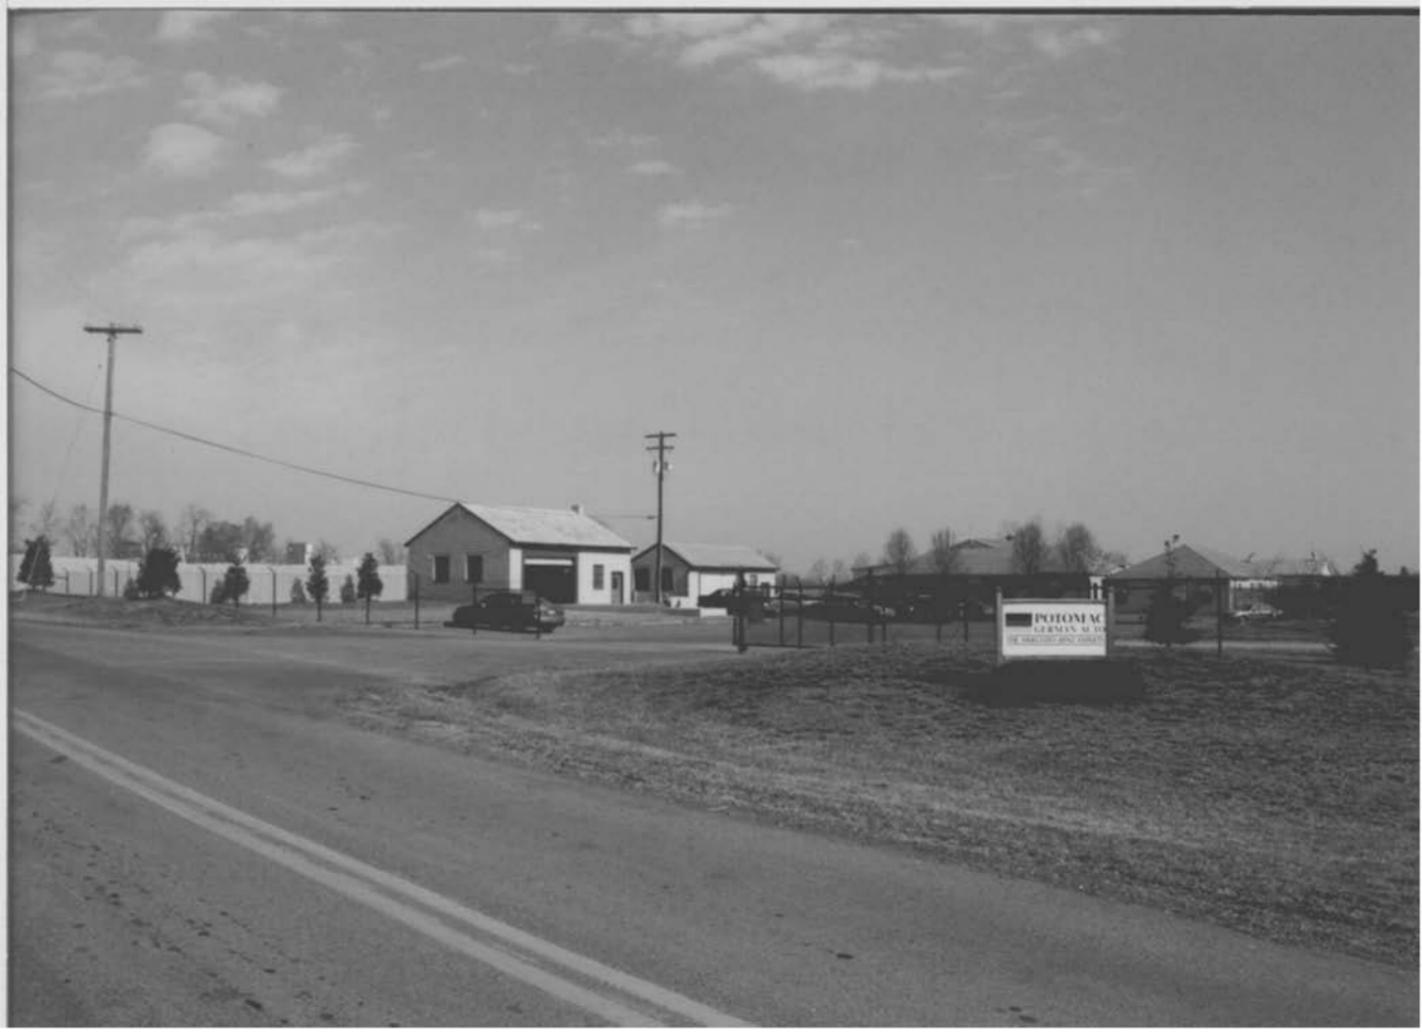
- F-1-186
- 4305 LIME KILN ROAD, LIME KILN SURVEY DISTRICT
- FREDERICK COUNTY, MARYLAND
- COURTNEY LYNCH
- FEBRUARY 26, 2002
- MD SHPO
- 4305 LIME KILN ROAD, SITE OF DEMOLISHED LIME KILNS,
LOOKING NORTH
- 8/10

M. J. Grove Lime Company, 4305 Lime Kiln Road: The site of the Grove lime works is marked by the stone ruins of one of the large kilns on the north side of Lime Kiln Road just west of the railroad tracks. At least 8 other buildings associated with the works are arranged in a rough semi-circle from the railroad crossing northward and westward, terminating at the stone ruins. Nearest the railroad tracks are a series of two-story and one-story concrete block and frame buildings in which the offices, company store, and post office were located up to the mid-20th century, when the company had undergone several mergers and redirections in production which caused the closure of the Lime Kiln works. One of the two-story buildings is rusticated concrete block with a hipped slate roof, a bracketed cornice, and three bays on the east side. The openings are boarded and an exterior iron staircase leads down from the second story. North of this building and linked by a one-story section is a second, plain concrete block two-story building. Its openings are also boarded, with a small entry porch at the northeast corner. The roof is hipped with composition shingles. A free-standing residential building with a standing seam gable roof and three bays on the east, vinyl siding and boarded openings was moved to the site as a storage building. Its original location and date are unknown. A rectangular vinyl-covered former shop is now the main office of the auto restoration company which leases the site; its extensive alterations have made the building non-contributing. A small frame barn with tongue-and-groove siding and a standing seam metal roof was also moved to the site for storage. Two one-story rusticated concrete block shops dating from about 1940 each have sliding doors and metal sash windows. They are currently used by the restoration company. All of the buildings appear to date from the early 20th century except the ruins of the kiln, which is probably one of the stacks built by Grove in 1858 when he began the business.

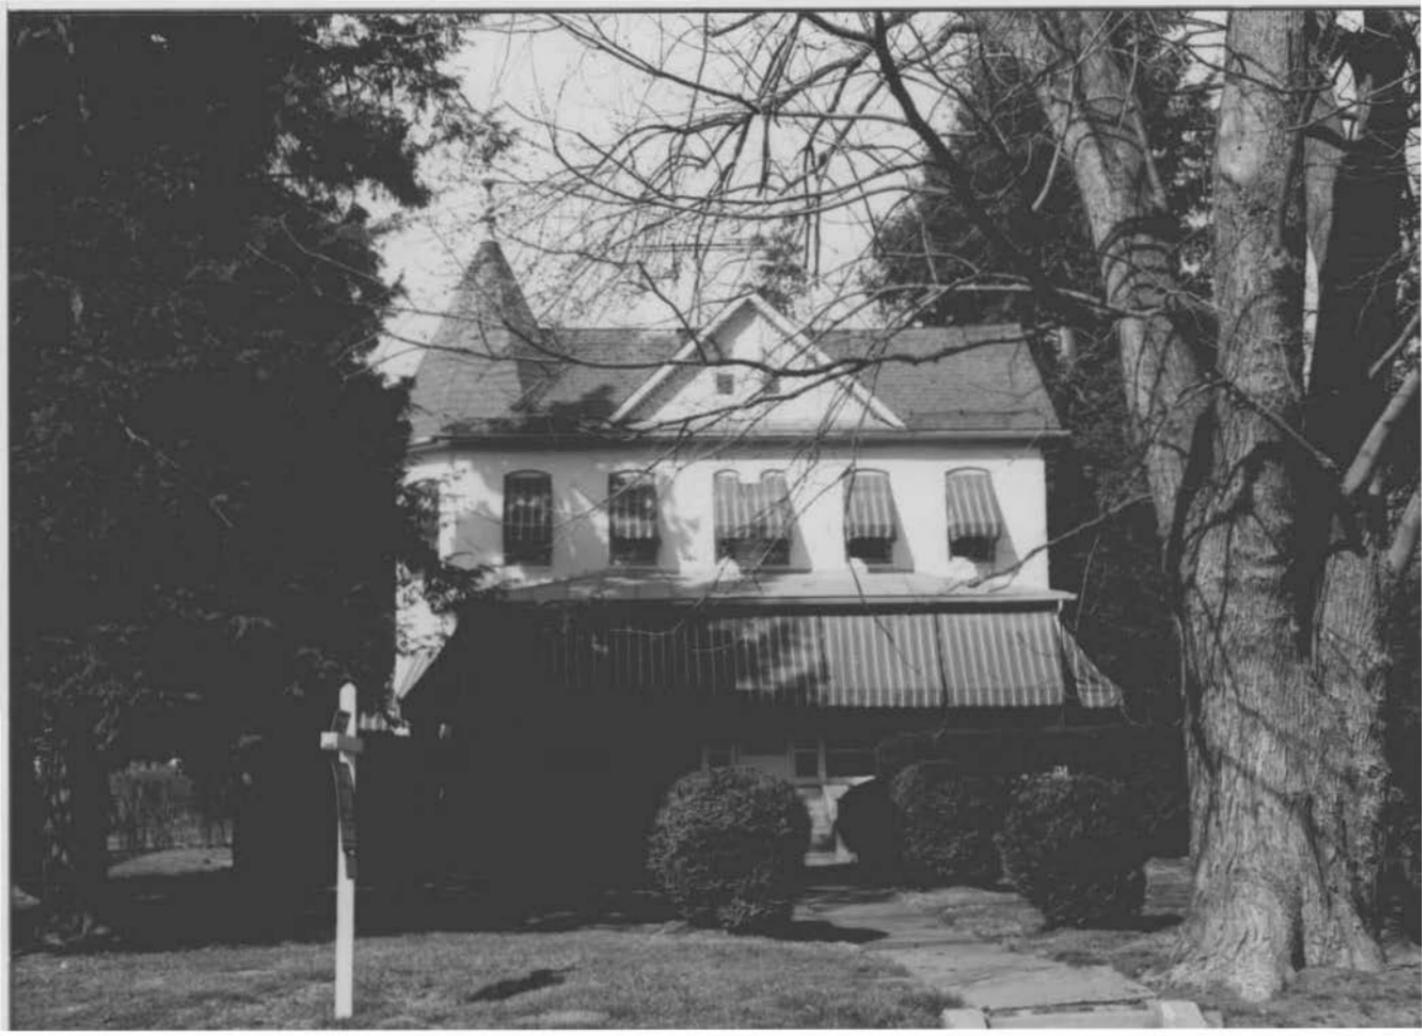
- 11/16

- F-1-186
- M.J. GROVE HOUSE, LIME KIN SURVEY DISTRICT
- FREDERICK COUNTY, MARYLAND
- CONRNEY LYNCH
- FEBRUARY 26, 2002
- MD SHPO
- M.J. GROVE HOUSE, 4314 BUCKEYSTOWN PIKE,
NE FACADE

Manassas J. Grove House, 4314 Buckeystown Pike (F-1-78): This house was originally surveyed in 1978 and named the M. J. Grove House. Further examination of the land records and biographical sketches of the Grove family strongly suggests that the proper historical name is more likely the Eugene A. Grove House and its date is about 1902. Eugene A. Grove was one of the five sons of Manassas J. Grove and secretary of the M. J. Grove Lime Company. The house is a two-story brick building painted white with a polygonal bay with a turret roof at the southeast corner. A central cross gable with a dentil cornice molding and two small windows is in the east elevation of the slate roof. The east elevation of the house has five bays with segmental arched openings largely obscured by canvas awnings. The center bay on the second story has two narrow lancet windows. A one-story porch extends across the east elevation and is also shielded from view by awnings. A two-story rear wing has been extensively altered in the 20th century.

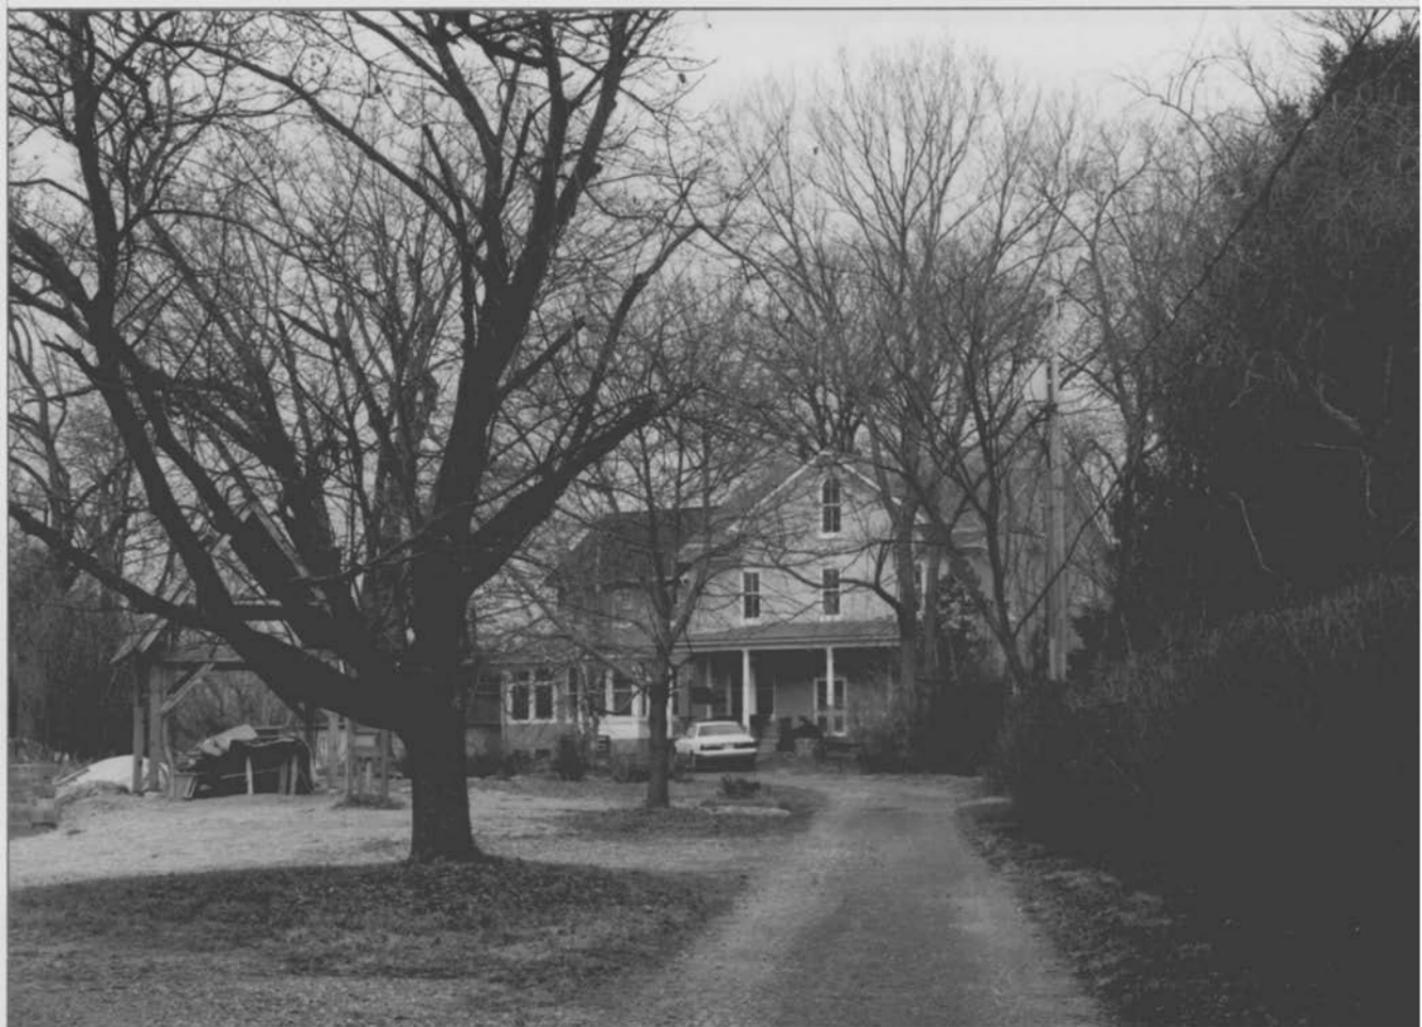
- F-1180
- WILLIAM J. GROVE HOUSES, LIME KILN SURVEY DISTRICT
- FREDERICK COUNTY, MARYLAND
- COURTNEY LYNCH
- FEBRUARY 26, 2002
- MD SHPO
- WILLIAM J. GROVE HOUSE, 4310 BUCKEYSTOWN PIKE,
NE FACADE
- 13/16

William J. Grove House, 4310 Buckeystown Pike (F-1-99): When originally inventoried in 1978, the house was dated at about 1880 and named the William Grove House. Further examination of the land records and the architectural details of the house identify the house as the home of Manassas J. Grove (1824-1907), the founder of the M. J. Grove Lime Company in 1858. Williams & McKinsey's History of Frederick County (1910) states that Grove moved to Lime Kiln in 1860. The two-story, white-painted brick house has simple decorative details in the Italianate style which clearly place its date as about 1860. The east elevation is dominated by a large cross gable with a round-arched 2/2 window and a molded cornice. The other windows have segmental arches and 2/2 sash on the second story. The first story windows are paired 1/1 windows. A one-story porch with Tuscan columns extends across the east elevation. A two-story side wing adjoins the house on the south. This section has 1/1 sash on both stories and a projecting square bay on the first story. Photos from 1978 appear to indicate that the wing originally had a two-story open porch in the traditional style of mid-19th century dwellings. It has been altered at least twice in the 20th century. The north elevation has a one-story polygonal bay with dentil molding and segmental arched windows. The west elevation of the house has the same general plan as the east elevation, with the cross gable and one-story porch. The windows on the first story were 2/2 single openings in 1978; these were not observed in the current survey to describe their current style. The house has several small outbuildings, the most prominent being a small frame barn with louvred cupolas on the corrugated metal roof. The exterior is vertical tongue-and-groove siding with arched louvred vents.

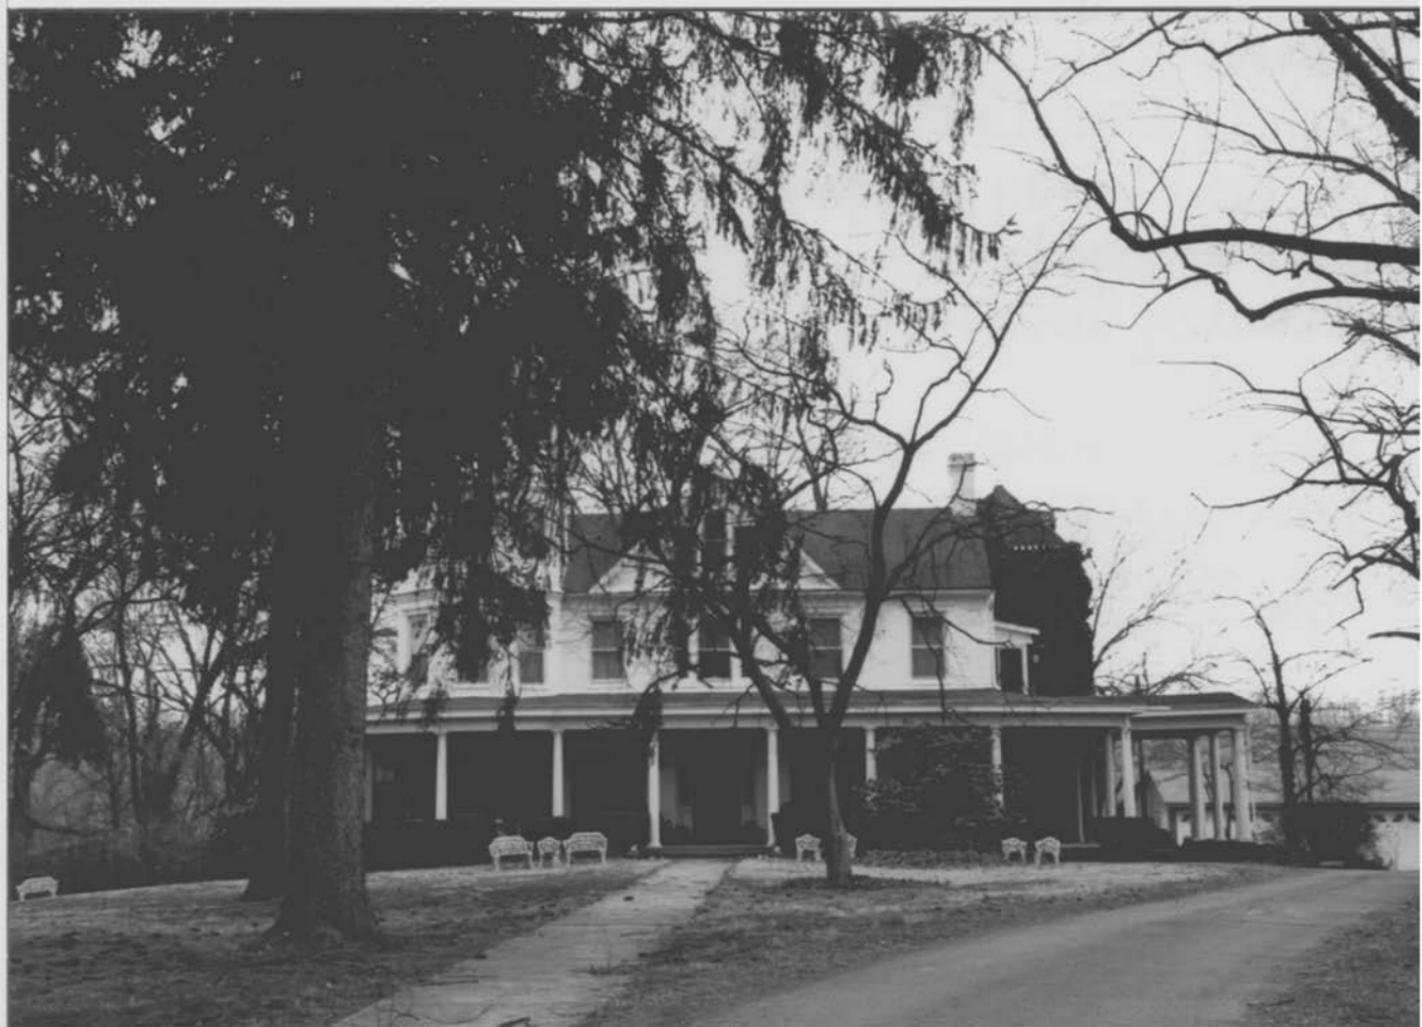
- F-1-186
- GAYFIELD HOUSE, LIME KILN SURVEY DISTRICT
- FREDERICK COUNTY, MARYLAND
- COURTNEY LYNCH
- FEBRUARY 20, 2002
- MD SHPO
- GAYFIELD HOUSE, 4317 BUCKLEUP TOWN PIKE,
SW FACADE
- 14/16

Gayfield, 4317 Buckeystown Pike: The original two-story brick house was built by Thomas R. Jarboe between about 1855 and 1865 and was apparently a five-bay building with a three-part window in the center of the second floor west elevation. In about 1900, the house was altered by Charles Rohrback, whose wife Margaret was Thomas Jarboe's sister. The alterations included a polygonal three-story bay added to the northwest corner of the house with an open observatory as a fourth level. A cross gable was added on the west elevation and a wide veranda extending on three elevations was also built. The brick exterior is painted white and its bond pattern is obscured, but is probably 6:1 or 5:1. The original window openings have moldec

lintels in an interlaced design which is also found at Moreland (F-1-164), a mansion of about the same date. This feature is typical of Italianate style decorative details. The doorway has a plain transom and replacement sidelights. The sash is 1/1. The cross gable above the second story has a shingled face and a three-part window with a round-arched center section. It is notable that two variations on the Palladian window are present, one above the other, representing two different time periods in the building's history. The third story of the tower also has a shingled exterior. The observatory level has a turned balustrade and scroll-sawn brackets between the main piers. The roof of the tower is patterned slate. The main roof of the house is covered with composition shingles, replacing the original slate. Interior end chimneys rise at the north and south gable ends. On the northeast corner of the main section, the original two-story rear wing extends eastward, with dormers in the roof. The east end of the wing has been considerably altered in the 20th century, with a modern porch and shed addition on the north side. The south side of the house has a porte cochere integral with the veranda extension. The south side of the rear wing has also been much altered, with a modern glass-enclosed porch. This incorporates the original two-story open porch on the wing. Near the southeast corner of the house is a stone water tower, a rectangular structure with a dated 1898 stone in its base. The tower is about 40 feet high with a hipped composition roof. A serpentine bargeboard edges the eaves. The tower has a brick tank in its upper section, held in place by iron bars anchored in the walls. The lower level has an interior stair lit by three small windows on the south side. The tower is almost completely covered by ivy during the growing seasons. A much-altered smokehouse is located directly east of the house; it is now a rental residence. The agricultural buildings are located primarily southeast of the house and include a bank barn, a dairy barn, and a brick silo which was remodeled for use as an apartment building in the 1980's.

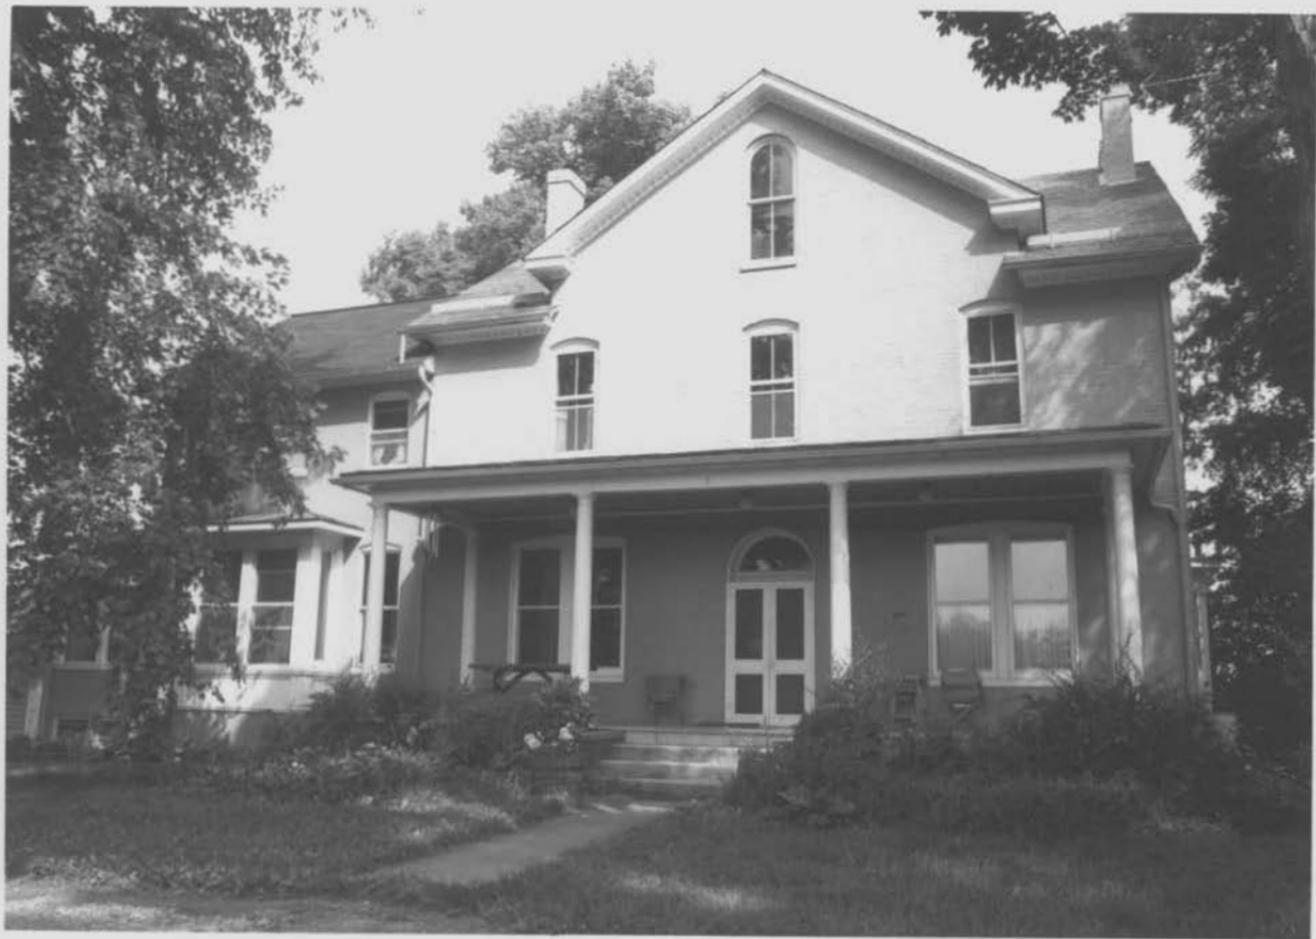
4/26

M.J. Grove House (F-1-78), east elevation

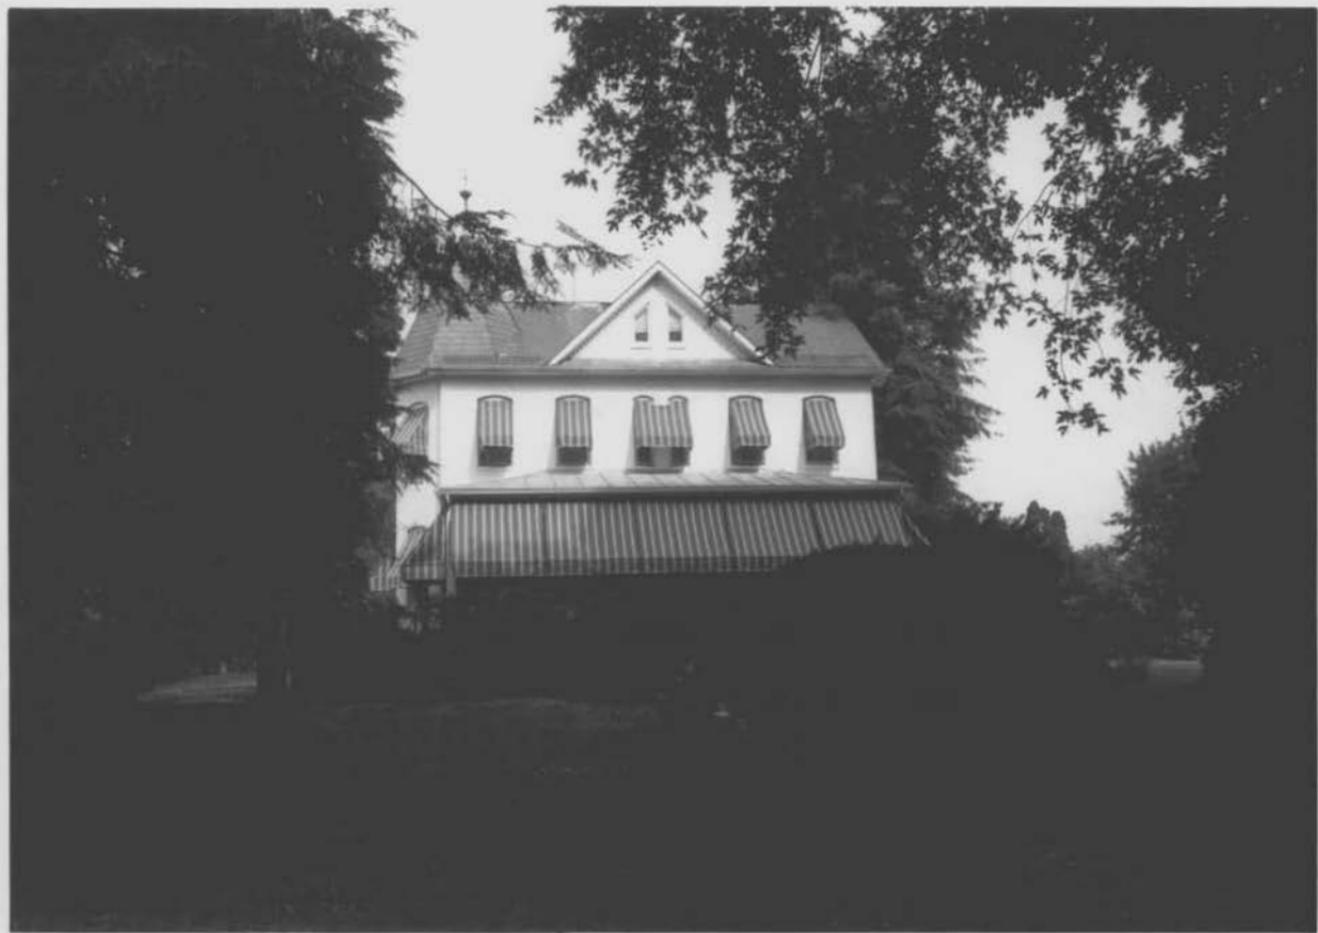
6/26

William J. Grove House (F-1-99), east
elevation

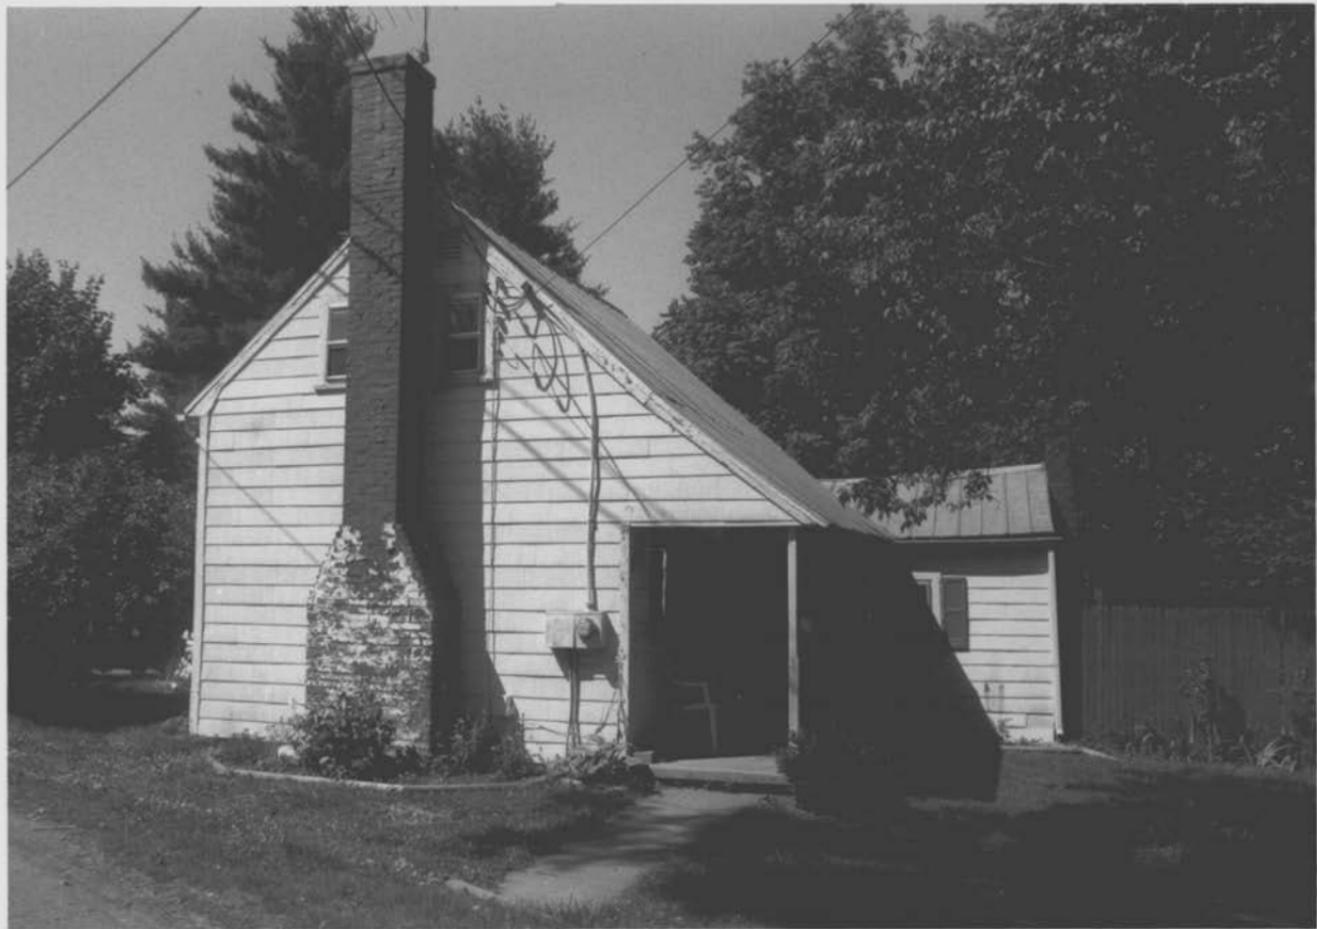
12/26

4205 Lime Kiln Rd., south elevation

4205 Lime Kiln Road: This is a 1-1/2 story log house with asbestos shingle siding and an exterior brick chimney on the south gable end. A one-story shed porch is located on the east side and a one-story extension with a second exterior chimney adjoins the house at a right angle on the north elevation. The roof is corrugated metal. The sash is 6/6 with replacement shutters. The building has the size and configuration of a domestic outbuilding or summer kitchen, but, according to Mr. Cecil, a long-time resident of the village living across the street, no other building is known to have been associated with it since the early 20th century.

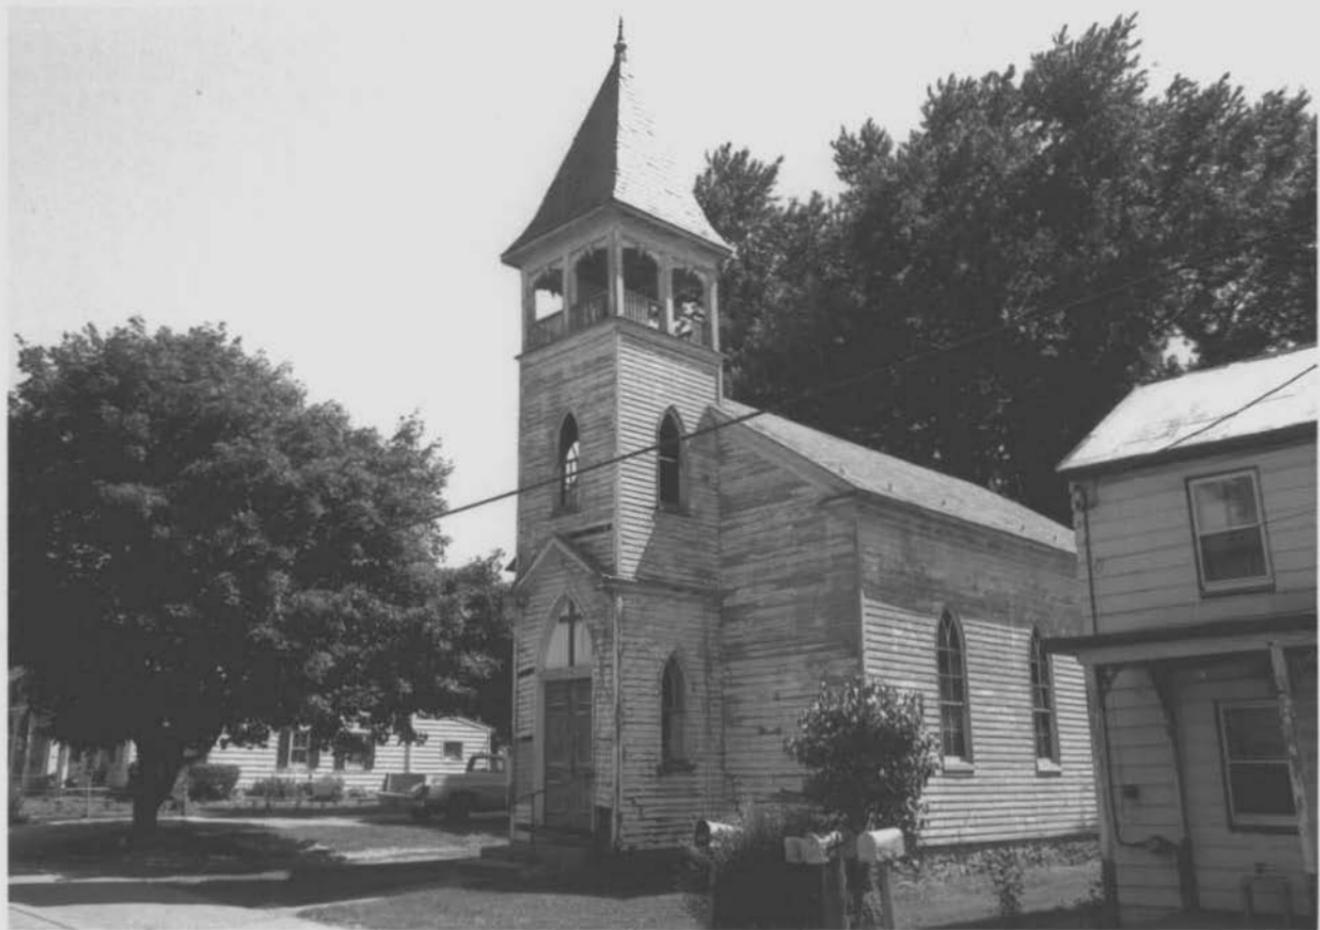
14/26

Methodist Prot. Church (F-1-98), northwest
corner view

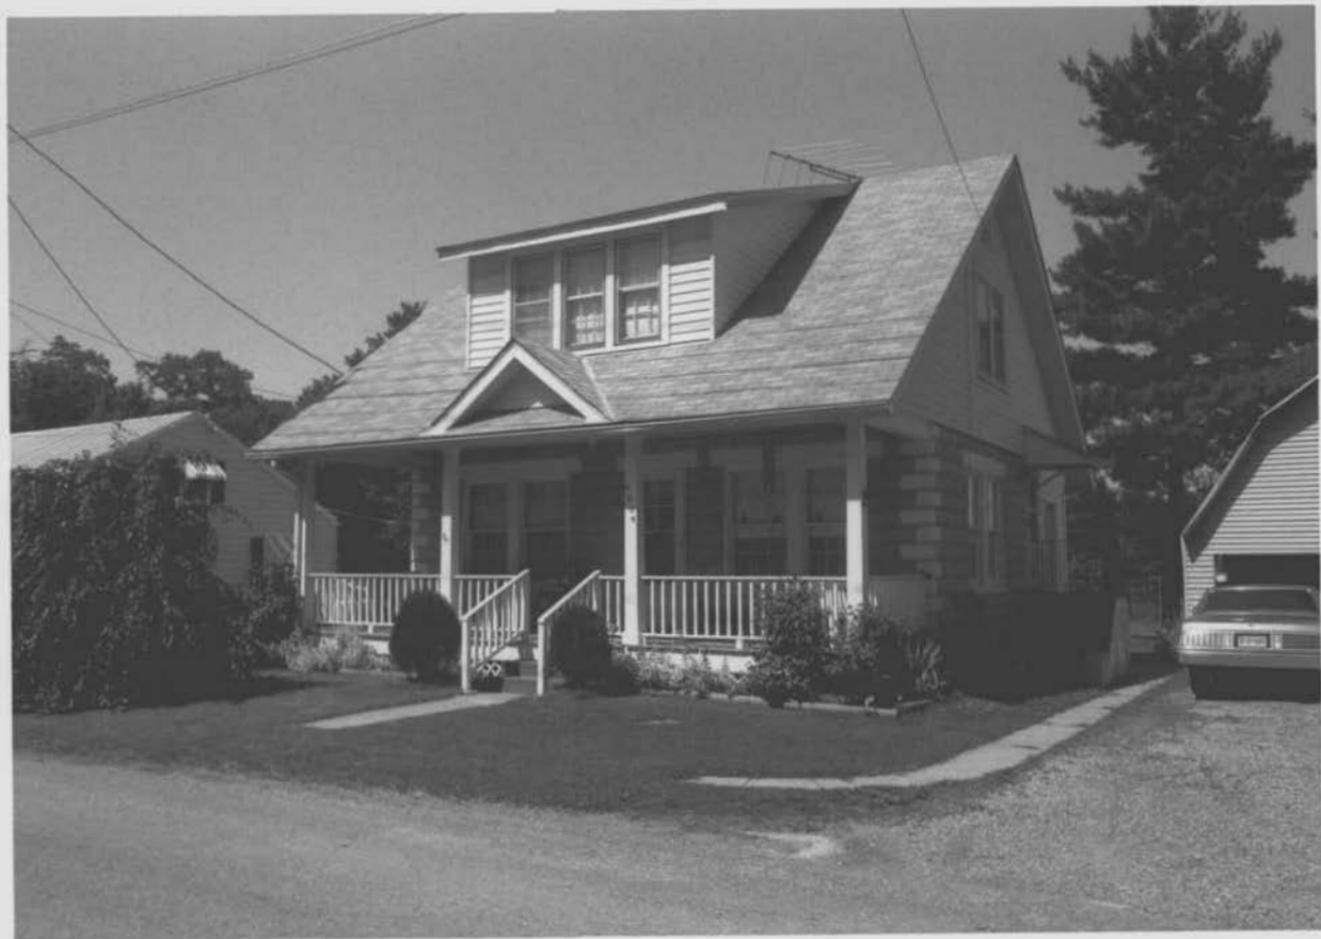
15/26

4209 Lime Kiln Rd., south elevation

Bungalow, 4209 Lime Kiln Road: This is one of two bungalows in the survey district, both of apparently the same design. This house is rusticated concrete block, while the second bungalow, 4302 Buckeystown Pike, has an artificial stone veneer. The Lime Kiln Road house has corner quoins in lighter concrete and plain window lintels. The three-bay facade has paired 6/6 windows flanking the center entry with a glazed panel door. The integral roof forms the one-story porch with a plain balustrade. The roof is covered with composition material and has a gable peak above the entrance to the porch and a shed dormer with three 6/6 windows. The east and west gables and the dormer are covered with modern siding. The bungalow was probably built in the 1930's.

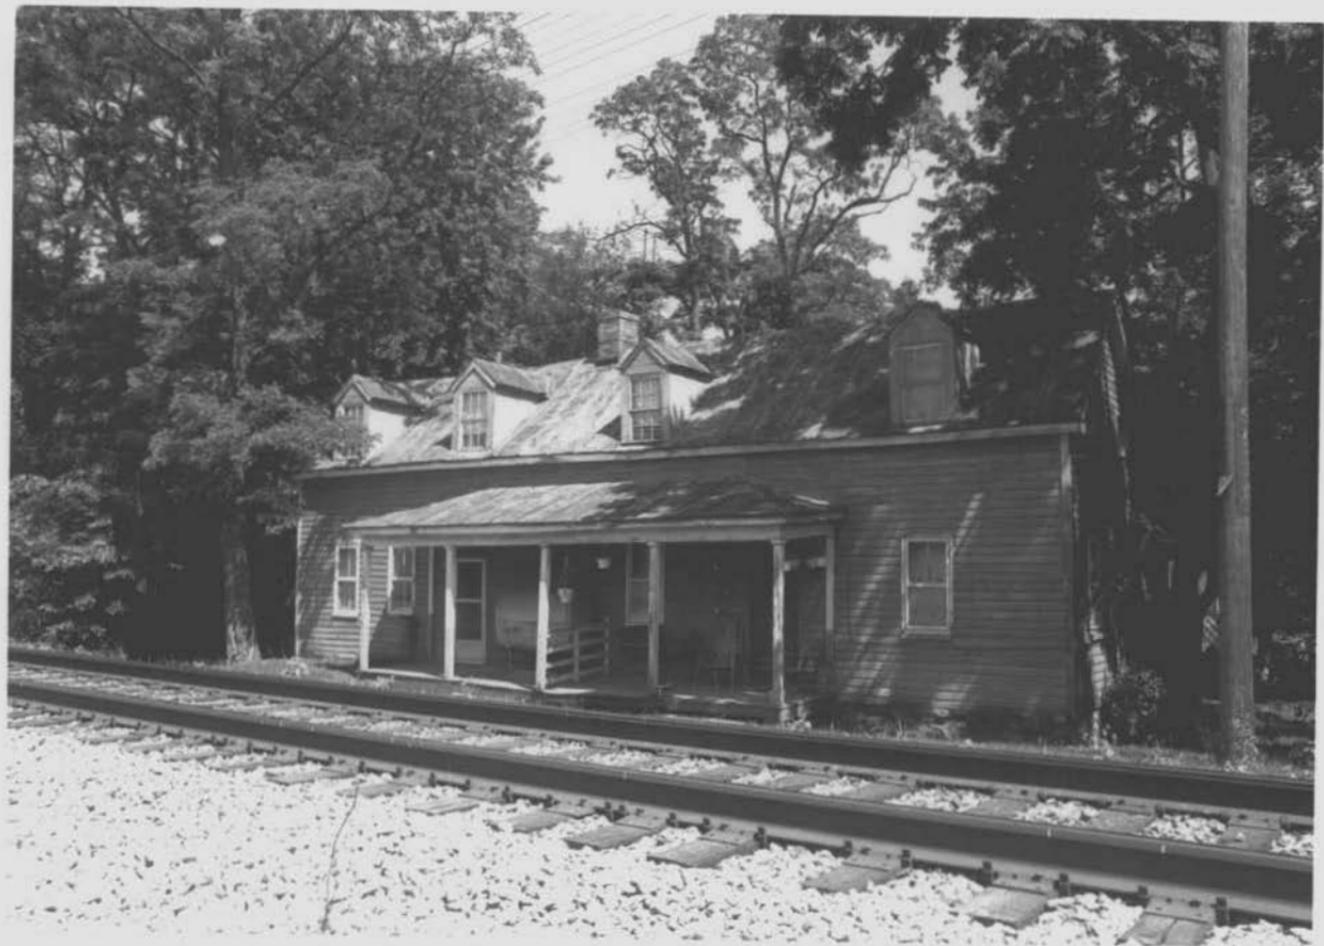
17/26

M. J. Grove Tenant House (F-1-79), west
elevation
