MARYLAND HISTORICAL TRUST
NR-ELIBILITY REVIEW FORM

F-1-186

**LIME KILN SURVEY DISTRICT
 FREDERICK COUNTY, MARYLAND**

and/or common Lime Kiln Survey District

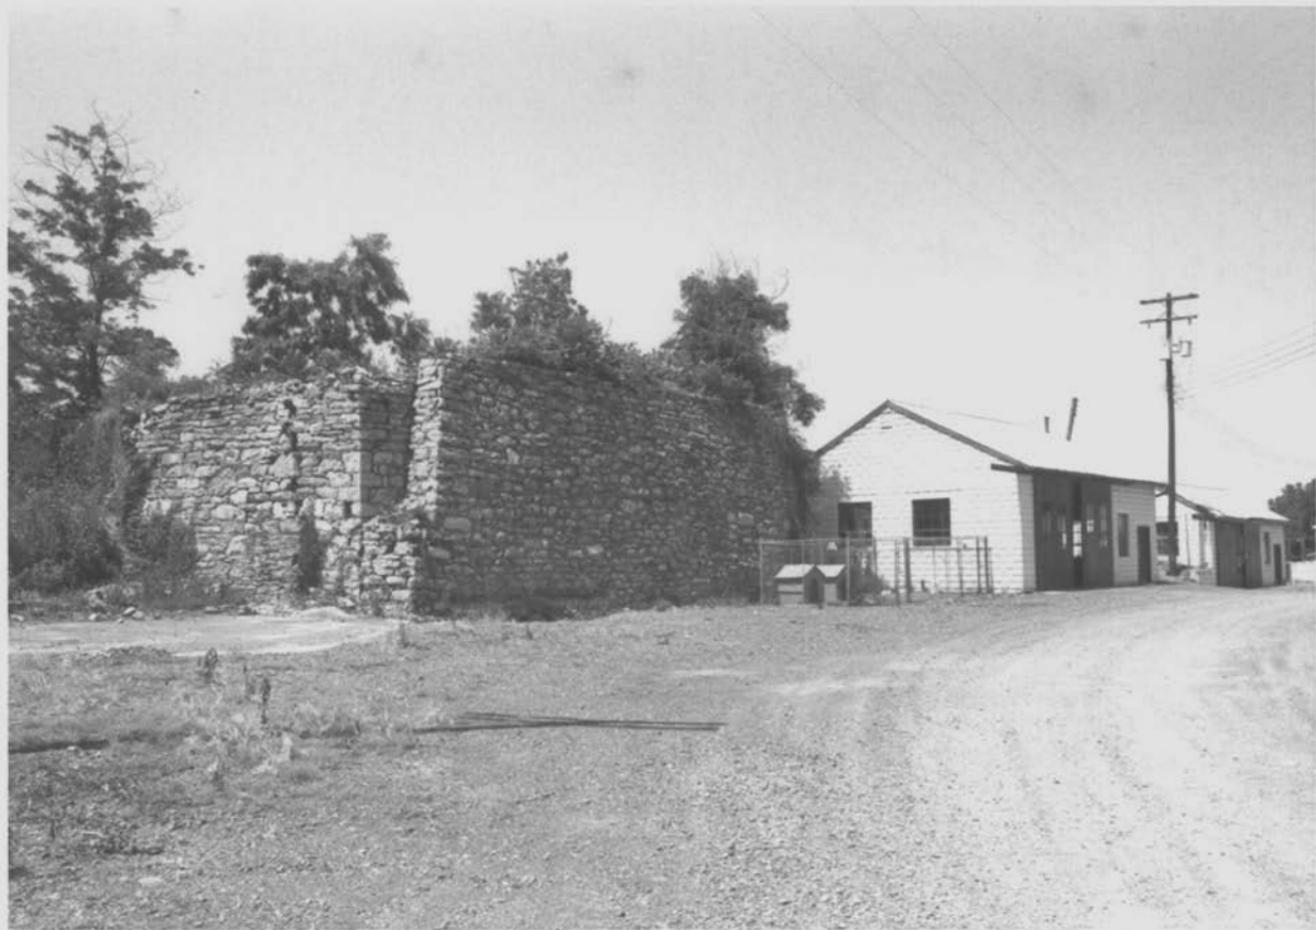
18/26

M. J. Grove Lime Co., Kiln and sheds

View from South

M. J. Grove Lime Company, 4305 Lime Kiln Road: The site of the Grove lime works is marked by the stone ruins of one of the large kilns on the north side of Lime Kiln Road just west of the railroad tracks. At least 8 other buildings associated with the works are arranged in a rough semi-circle from the railroad crossing northward and westward, terminating at the stone ruins. Nearest the railroad tracks are a series of two-story and one-story concrete block and frame buildings in which the offices, company store, and post office were located up to the mid-20th century, when the company had undergone several mergers and redirections in production which caused the closure of the Lime Kiln works. One of the two-story buildings is rusticated concrete block with a hipped slate roof, a bracketed cornice, and three bays on the east side. The openings are boarded and an exterior iron staircase leads down from the second story. North of this building and linked by a one-story section is a second, plain concrete block two-story building. Its openings are also boarded, with a small entry porch at the northeast corner. The roof is hipped with composition shingles. A free-standing residential building with a standing seam gable roof and three bays on the east, vinyl siding and boarded openings was moved to the site as a storage building. Its original location and date are unknown. A rectangular vinyl-covered former shop is now the main office of the auto restoration company which leases the site; its extensive alterations have made the building non-contributing. A small frame barn with tongue-and-groove siding and a standing seam metal roof was also moved to the site for storage. Two one-story rusticated concrete block shops dating from about 1940 each have sliding doors and metal sash windows. They are currently used by the restoration company. All of the buildings appear to date from the early 20th century except the ruins of the kiln, which is probably one of the stacks built by Grove in 1858 when he began the business.

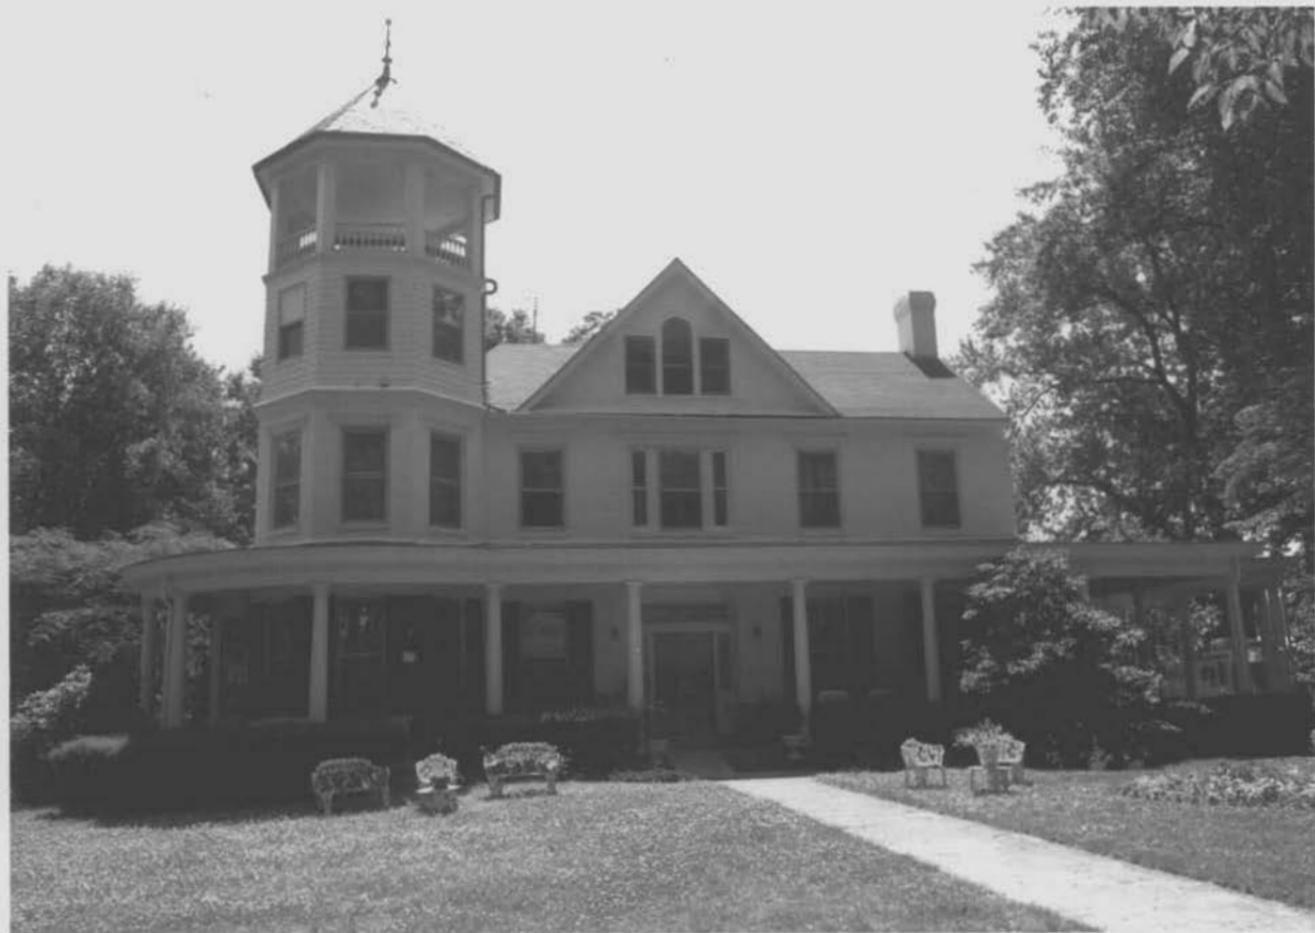
20/26

Gayfields, west elevation

Gayfield, 4317 Buckeystown Pike: The original two-story brick house was built by Thomas R. Jarboe between about 1855 and 1865 and was apparently a five-bay building with a three-part window in the center of the second floor west elevation. In about 1900, the house was altered by Charles Rohrback, whose wife Margaret was Thomas Jarboe's sister. The alterations included a polygonal three-story bay added to the northwest corner of the house with an open observatory as a fourth level. A cross gable was added on the west elevation and a wide veranda extending on three elevations was also built. The brick exterior is painted white and its bond pattern is obscured, but is probably 6:1 or 5:1. The original window openings have moldec

lintels in an interlaced design which is also found at Moreland (F-1-164), a mansion of about the same date. This feature is typical of Italianate style decorative details. The doorway has a plain transom and replacement sidelights. The sash is 1/1. The cross gable above the second story has a shingled face and a three-part window with a round-arched center section. It is notable that two variations on the Palladian window are present, one above the other, representing two different time periods in the building's history. The third story of the tower also has a shingled exterior. The observatory level has a turned balustrade and scroll-sawn brackets between the main piers. The roof of the tower is patterned slate. The main roof of the house is covered with composition shingles, replacing the original slate. Interior end chimneys rise at the north and south gable ends. On the northeast corner of the main section, the original two-story rear wing extends eastward, with dormers in the roof. The east end of the wing has been considerably altered in the 20th century, with a modern porch and shed addition on the north side. The south side of the house has a porte cochere integral with the veranda extension. The south side of the rear wing has also been much altered, with a modern glass-enclosed porch. This incorporates the original two-story open porch on the wing. Near the southeast corner of the house is a stone water tower, a rectangular structure with a dated 1898 stone in its base. The tower is about 40 feet high with a hipped composition roof. A serpentine bargeboard edges the eaves. The tower has a brick tank in its upper section, held in place by iron bars anchored in the walls. The lower level has an interior stair lit by three small windows on the south side. The tower is almost completely covered by ivy during the growing seasons. A much-altered smokehouse is located directly east of the house; it is now a rental residence. The agricultural buildings are located primarily southeast of the house and include a bank barn, a dairy barn, and a brick silo which was remodeled for use as an apartment building in the 1980's.

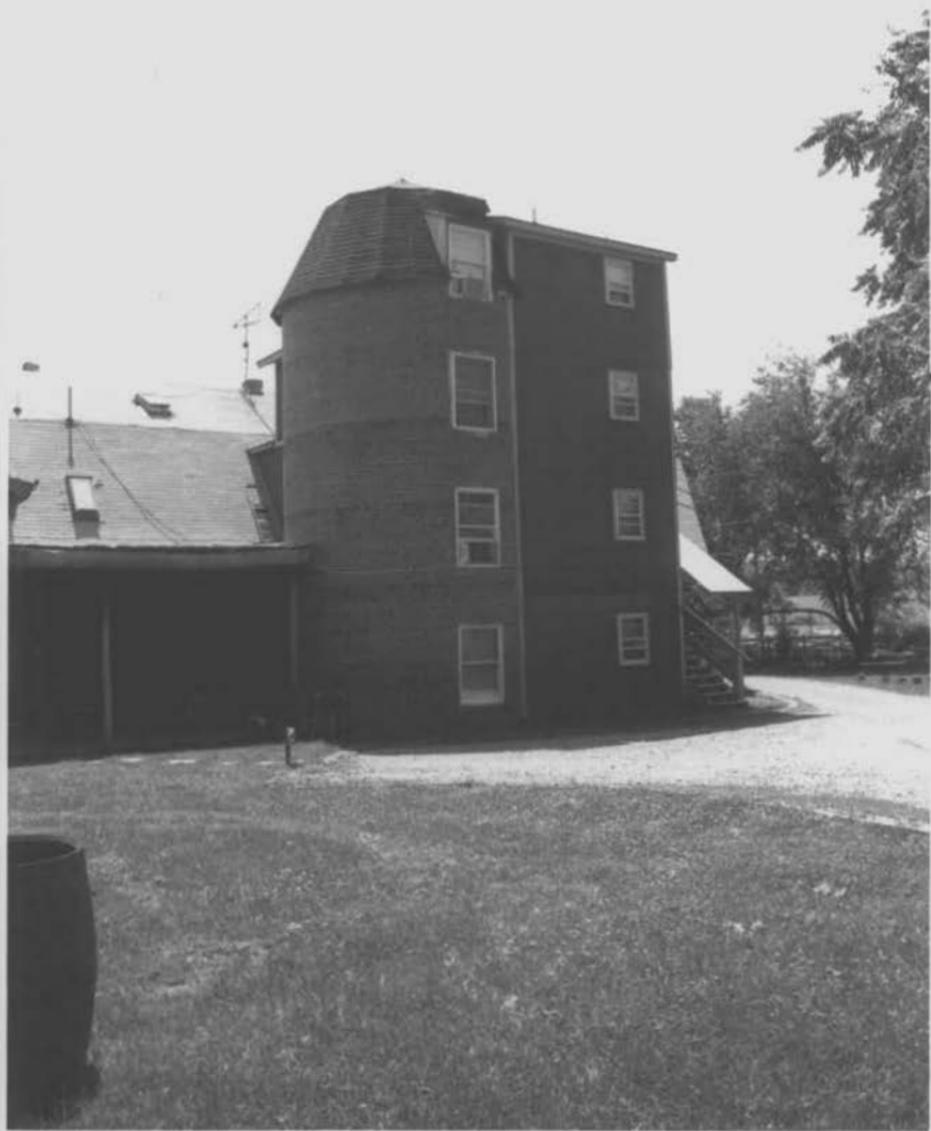
23/26

Gayfields, silo/apartment bldg., view
from west
