Joseph N. Chiswell Farmstead; "Ellerslie"
Buckeystown vicinity
Private

Ca. 1852-1930

Joseph N. Chiswell Farmstead
Buckeystown
Frederick County

**Maryland Historical Trust
State Historic Sites Inventory Form****1. Name** (indicate preferred name)

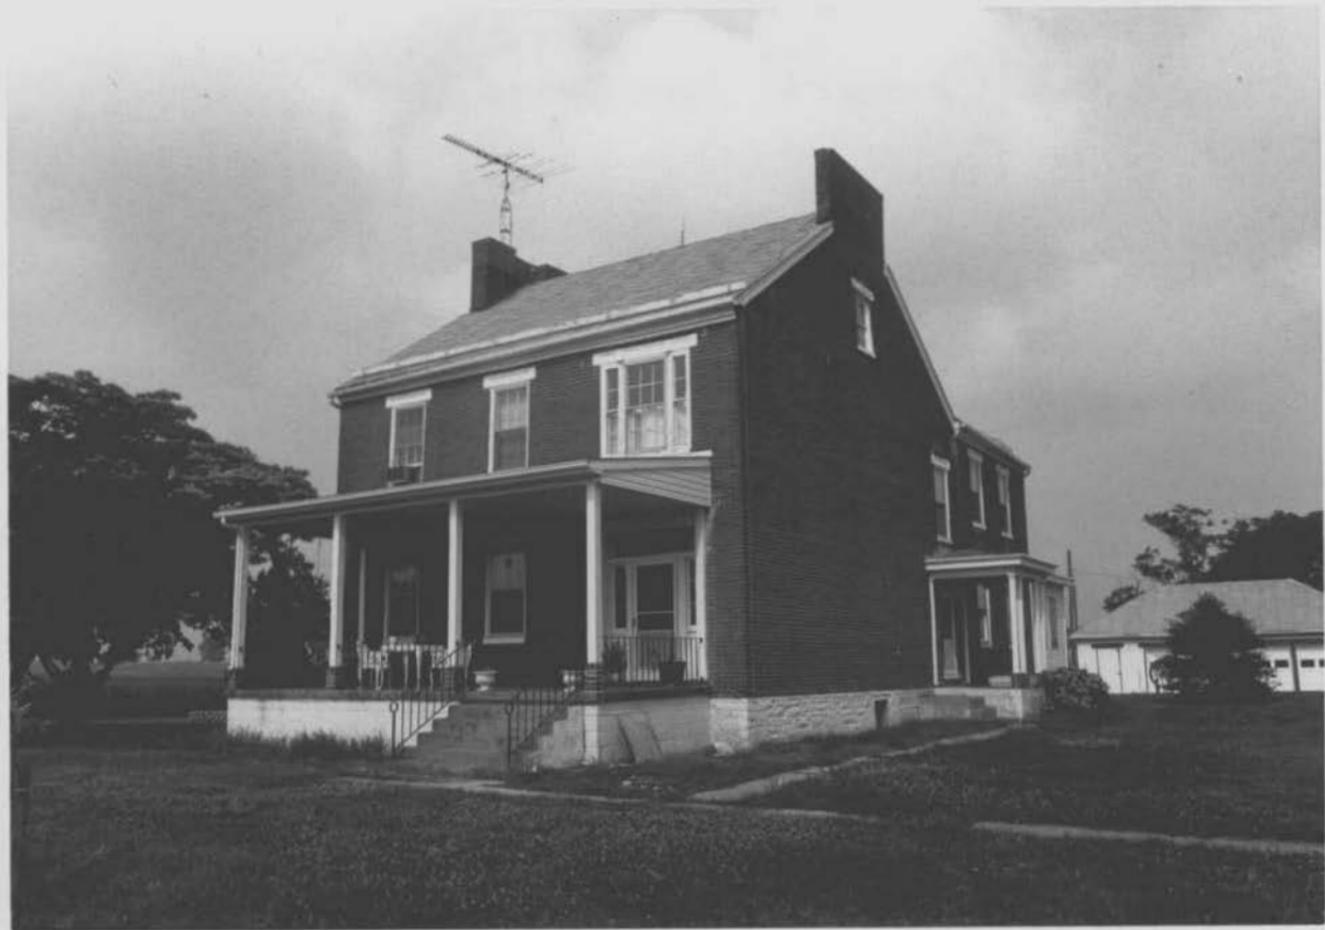
1/5

The dwelling has a three-bay east elevation with 5:1 American bond walls. The entrance is in the north bay and a one-story porch extends across the facade. The north bay second story has a three-part window with a dominant central sash and narrow sidelights. Outlines on the brick wall surface around the door show the outline of a bracketed porch which the present porch replaced in the mid-20th century. It has a concrete block base, plain posts, and a shed roof. The windows have 6/6 sash with plain wood lintels and corner blocks. The doorway has a 7-light transom with sidelights. The cornice is corbeled brick and the roof is covered with modern composition material. The four interior end chimneys have parapet walls at the gable ends. The north elevation of the house has only a single central 6/6 window at the attic level; the south elevation has the attic window and a single bay near the southwest corner. Each story has a 6/6 window. A two-story rear wing with an interior end chimney extends from the northwest corner of the house. A one-story porch is located on the north side of the wing and a two-level porch with the first story enclosed in brick and extended in size is on the south elevation. A frame extension with german siding on the first story is at the southwest corner. The second story of the porch has a somewhat deteriorated scroll-sawn balustrade and an ornamental bargeboard trim. The interior of the house was inaccessible for this survey.

Northeast corner view

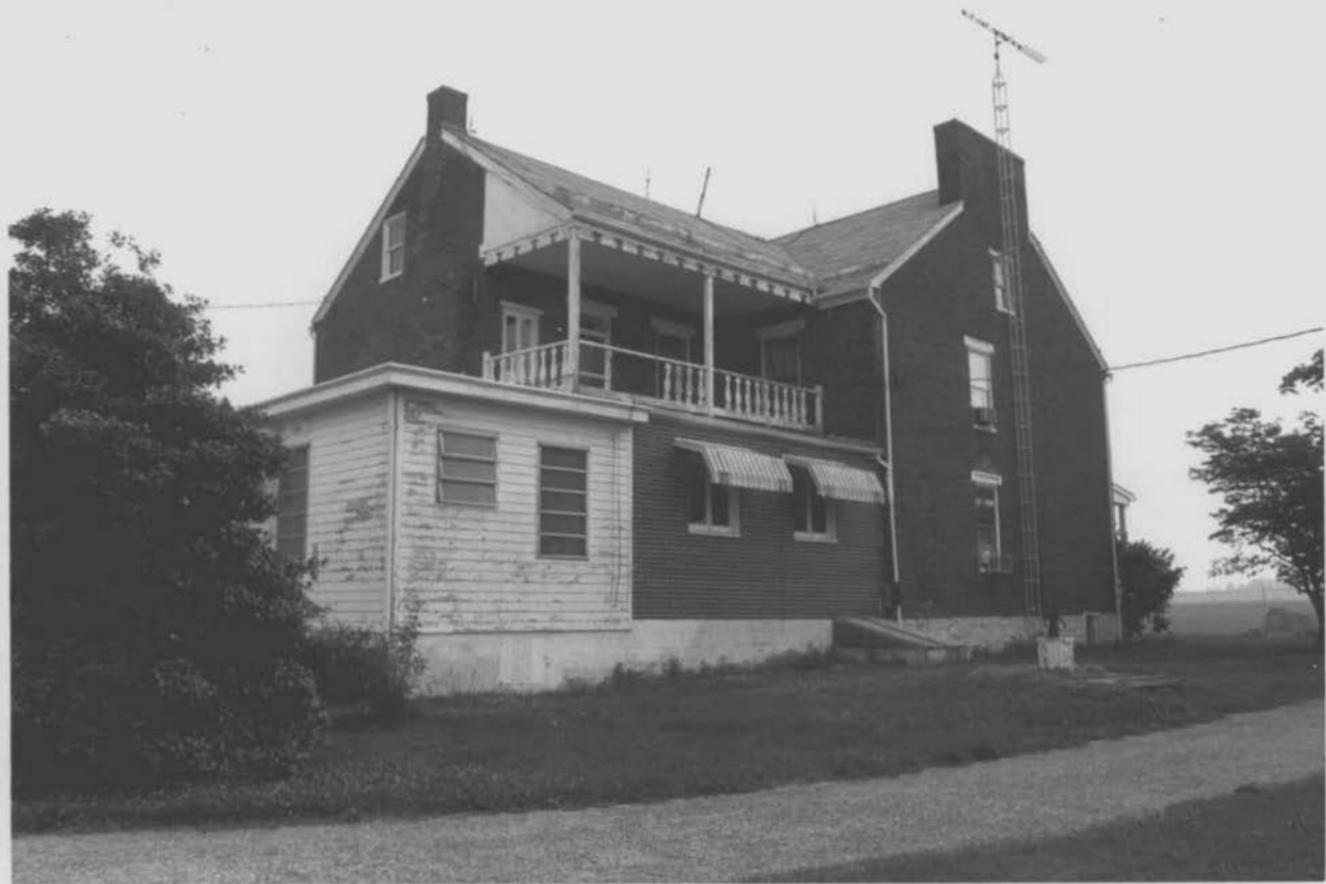
2/5

Neg. loc.: Md. SHPO, Crownsville Md.
Southwest corner view

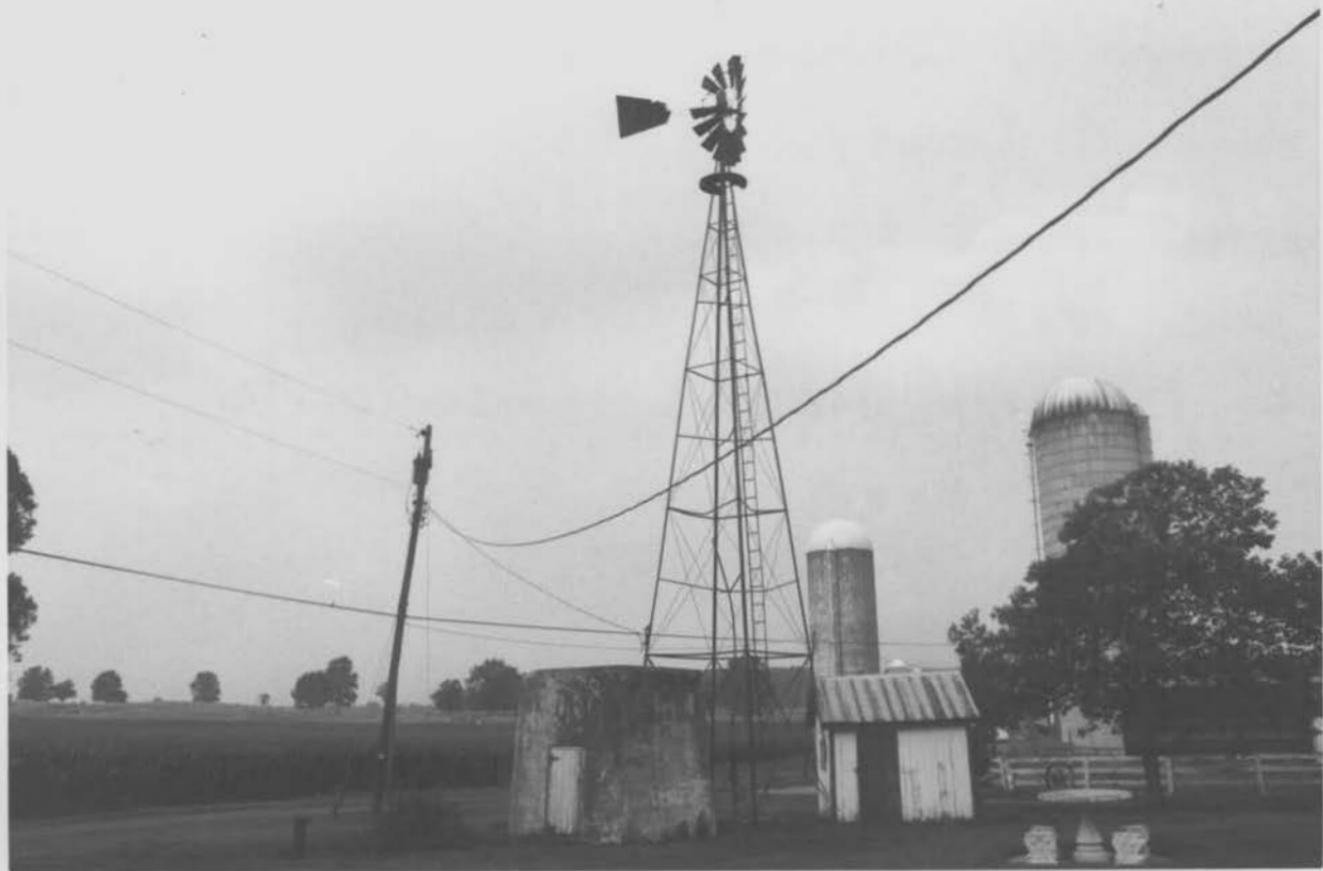
3/5

Windmill and pump house and possible meathouse: The deteriorated frame of a windmill is located southwest of the house, with two square structures, at least one of which is probably a pump house, located on the east and west sides of its base. The windmill has a few of its vanes and the rudder intact. The eastern structure is a flat topped, square concrete building with a slightly battered wall plane. Logs protrude from the walls near the top. Although the interior of the structure was inaccessible, its form also suggests that it was built as a meathouse. A single board door is on the east elevation. The probable pump house is a frame structure sited at an angle to the windmill, facing northeast, with tongue-and-groove siding and a corrugated gable roof. A single tongue-and-groove door is located on the northeast side. The windmill and pump house appear to have been built about 190. The date of the possible meathouse is undetermined, but may be of the same period.

Windmill + pump house + smokehouse,
view from northeast

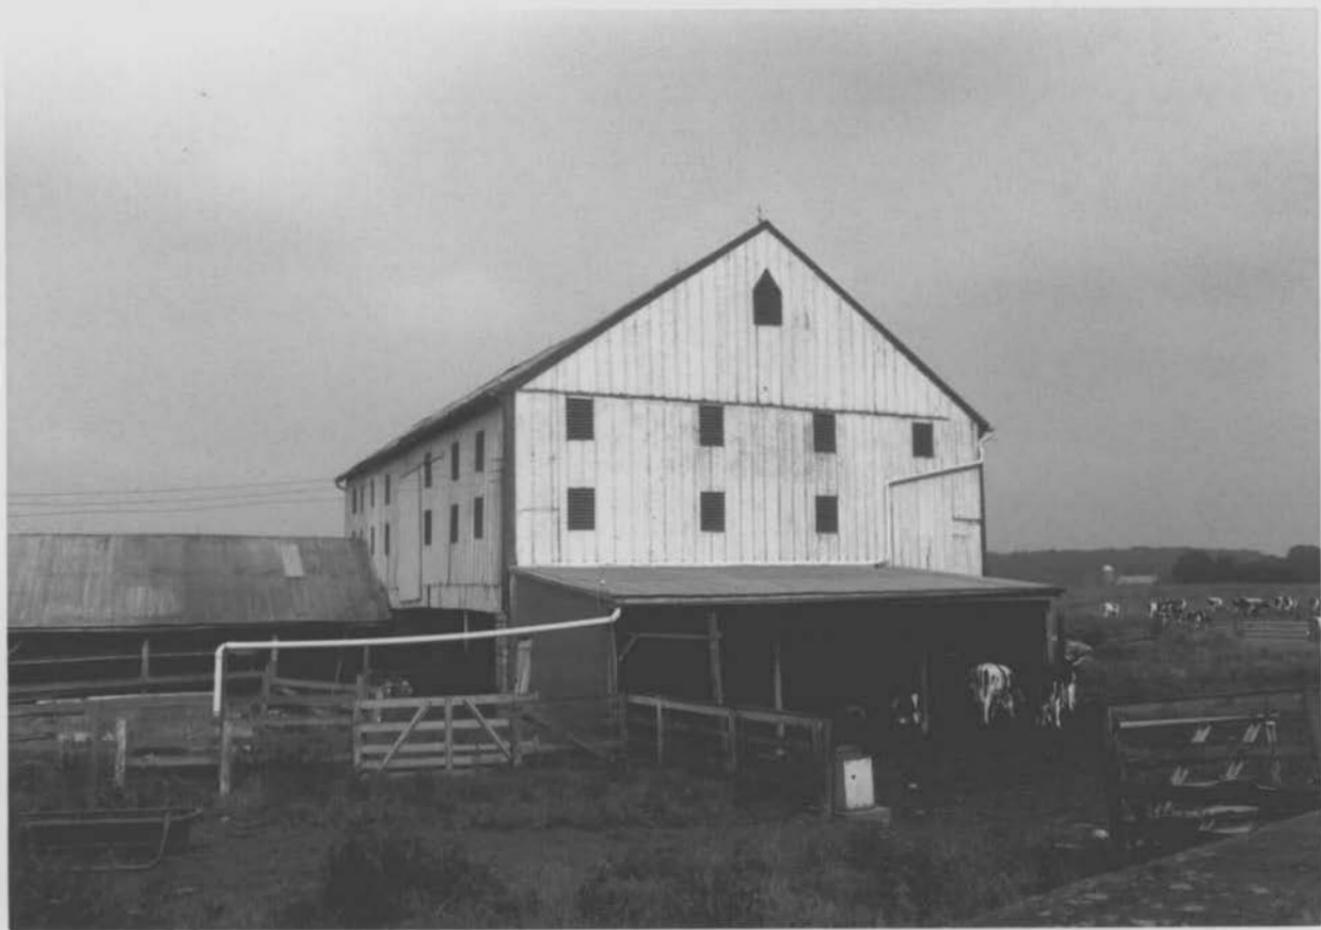
4/5

Bank barn: The bank barn is surrounded by several non-contributing loafing and other sheds which appear to have been built from about 1945 to the 1980's. The barn has board and batten siding with rectangular louvred vents. A single vent located in the gable end on the east has a Gothic arched outline. The barn, although its interior was not observed, appears to date from about 1900.

Bank barn, east elevation

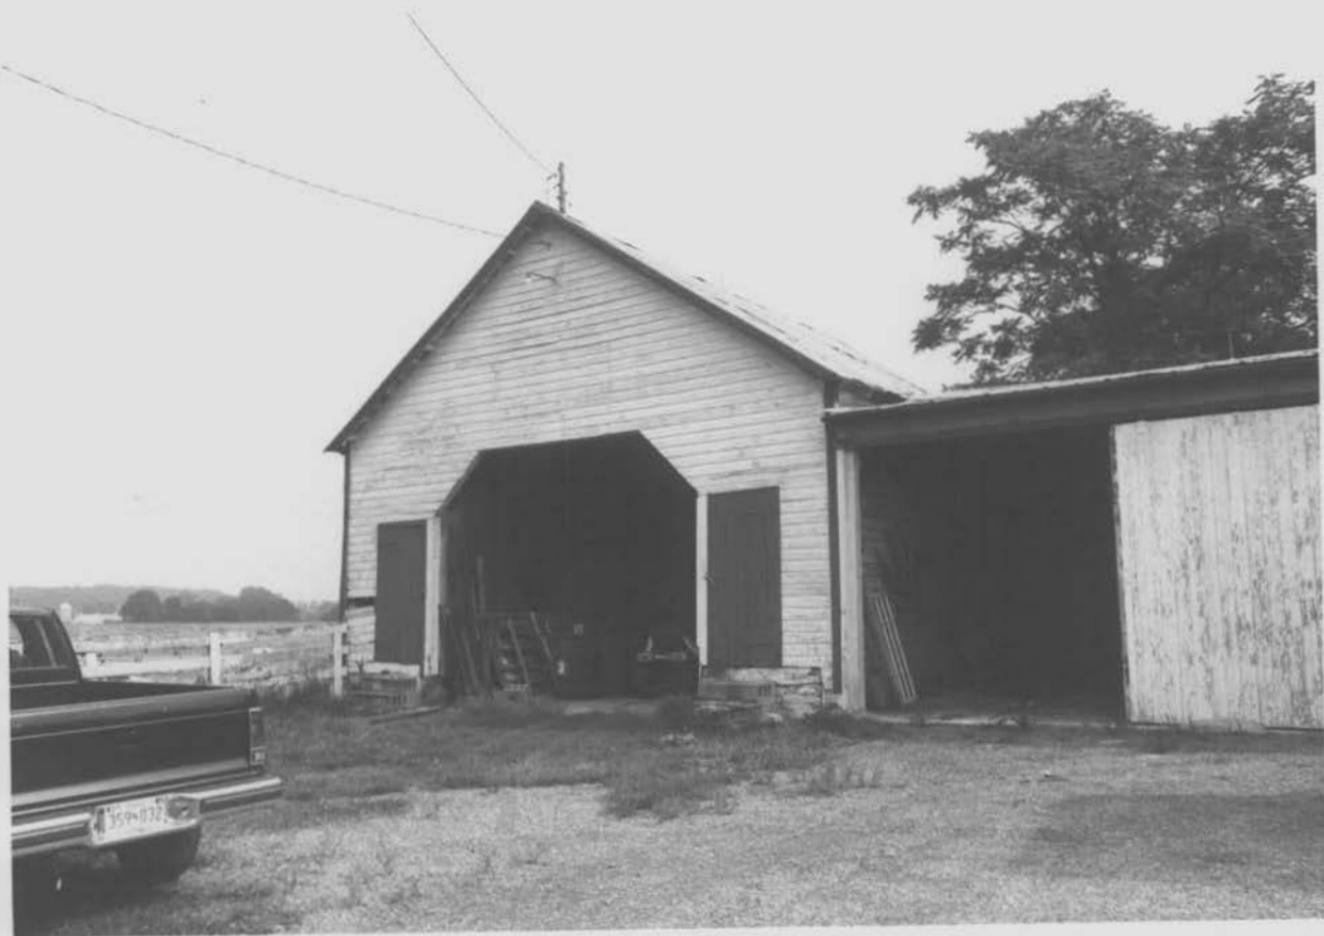
Wagon shed/corn crib: The frame wagon shed/corn crib was built about 1890-1900 and has german siding and a corrugated metal roof. An attached concrete block shed with sliding doors is located on the east side of the shed, an alteration dating about 1920-1930.

Neg. loc.: Md. SHPO, Crownsville, Md.
Wagon shed/corn crib, south elevation
5/5
