F-1-202  
Hebb-Kline Farmstead  
Adamstown vicinity  
Private

F-1-202  
Hebb-Kline Farmstead  
Adamstown  
Frederick County

DOE  yes  noMaryland Historical Trust  
State Historic Sites Inventory Form**1. Name** (indicate preferred name)

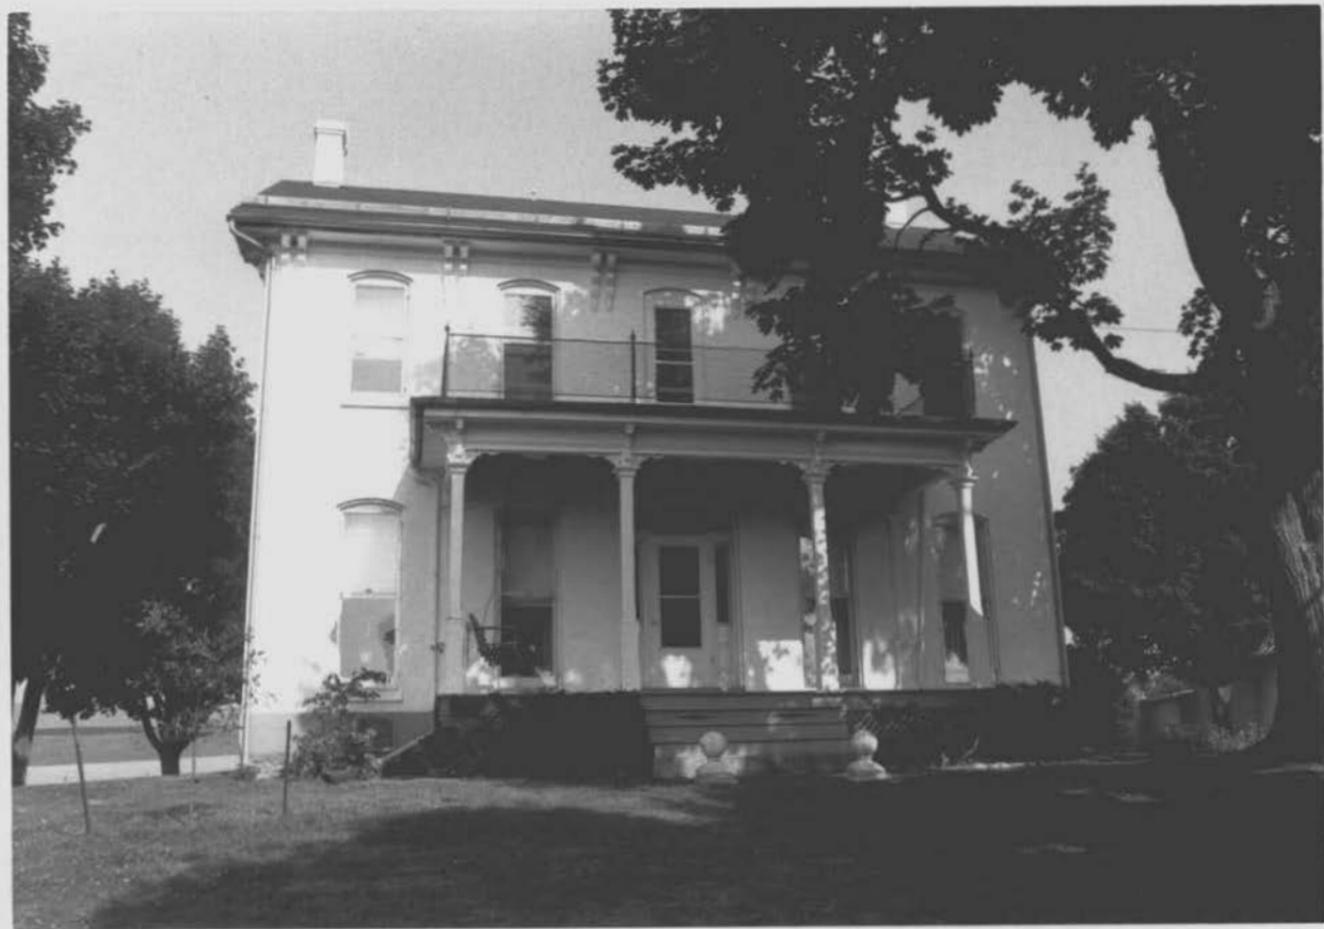
1/4

Southeast elevation

The white-painted dwelling has a five-bay south elevation on the main section and a two-story rear wing extending from the middle of the north elevation with one-story porches on both the east and west sides. The south elevation has a one-story porch over the central three bays. The window and door openings have segmental arches and 1/1 sash. The first story windows are tall and narrow, reaching almost to the floor of the porch. The doorway has a two-light transom and sidelights. The porch has scrolled brackets and chamfered square posts with a wood deck. The flat roof of the porch has an iron mesh fencing along the top and the center second story bay is a small door opening on the porch roof. The main cornice of the house has extended eaves and paired brackets which extend on all elevations of the front section. The wing has single brackets in its cornice. The north and south elevations have two bays each with small attic windows. The composition roof was probably wood shingles or slate in its original form. The interior end chimneys are still intact. The rear wing has a single interior chimney near the center of the section. The east and west side porches have scroll-sawn brackets and balustrades. The porch on the south side has a concrete block base below the deck. The north side has an enclosed section at the west end of the porch, with a 2/2 window. This was probably the original sash configuration of the entire house. The interior was not accessible for this survey.

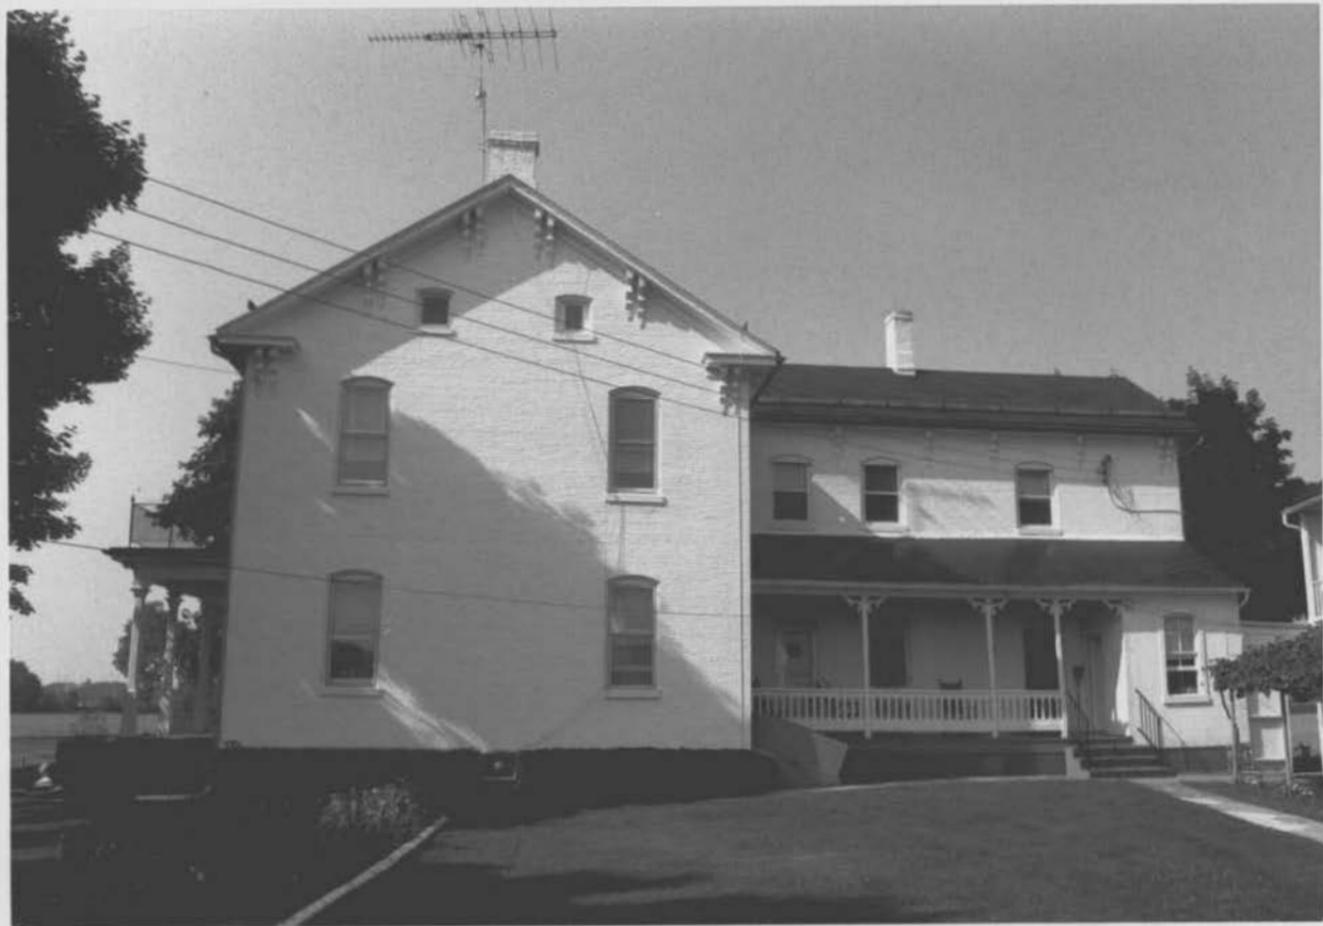
2/4

North elevation

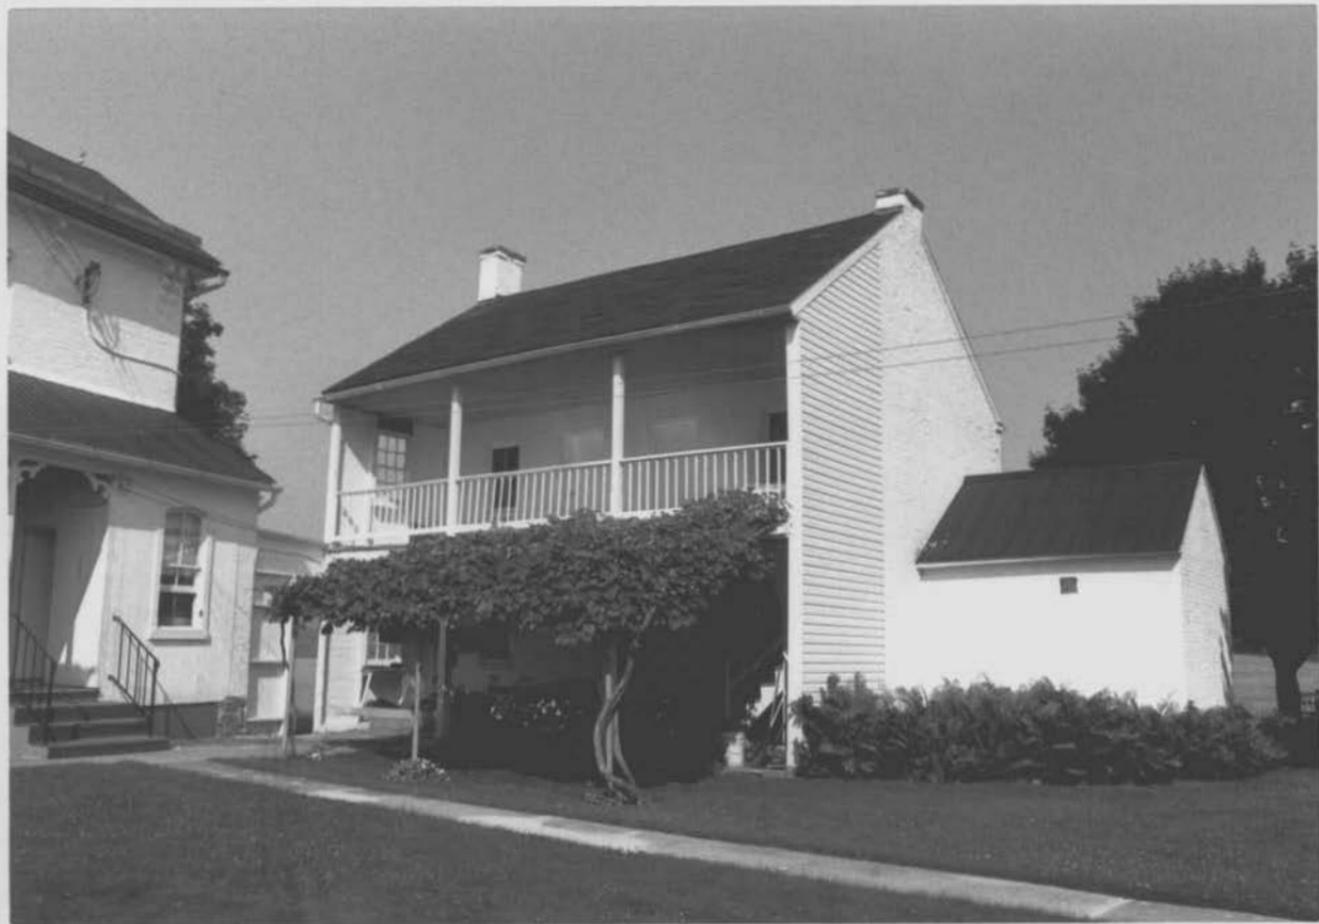
3/4

Tenant house / smokehouse, east elevation

Summer kitchen/smokehouse: The term summer kitchen may be an understatement of the original intent of the structure. This outbuilding resembles a free-standing rear wing as found on mid-19th century houses. It is only slightly lower in height than the rear wing of the dwelling. Its brick structure has an integral two-story porch on the south side and interior end chimneys. There are three bays on the first story and four on the second. The upper porch has a plain balustrade and square posts. The roof of the building is composition. The sash is 2/2. On the north elevation are three bays on the first story and two on the second. The cornice is corbeled. Attached to the summer kitchen on the east gable end is the one-story brick smokehouse. It has a standing seam roof and a single vertical board door on the north. At the east gable end is a pierced brick vent in the wheat sheaf pattern often seen in brick barns. The interior of the summer kitchen was not accessible. but observation of its interior features may reveal more about its purpose a

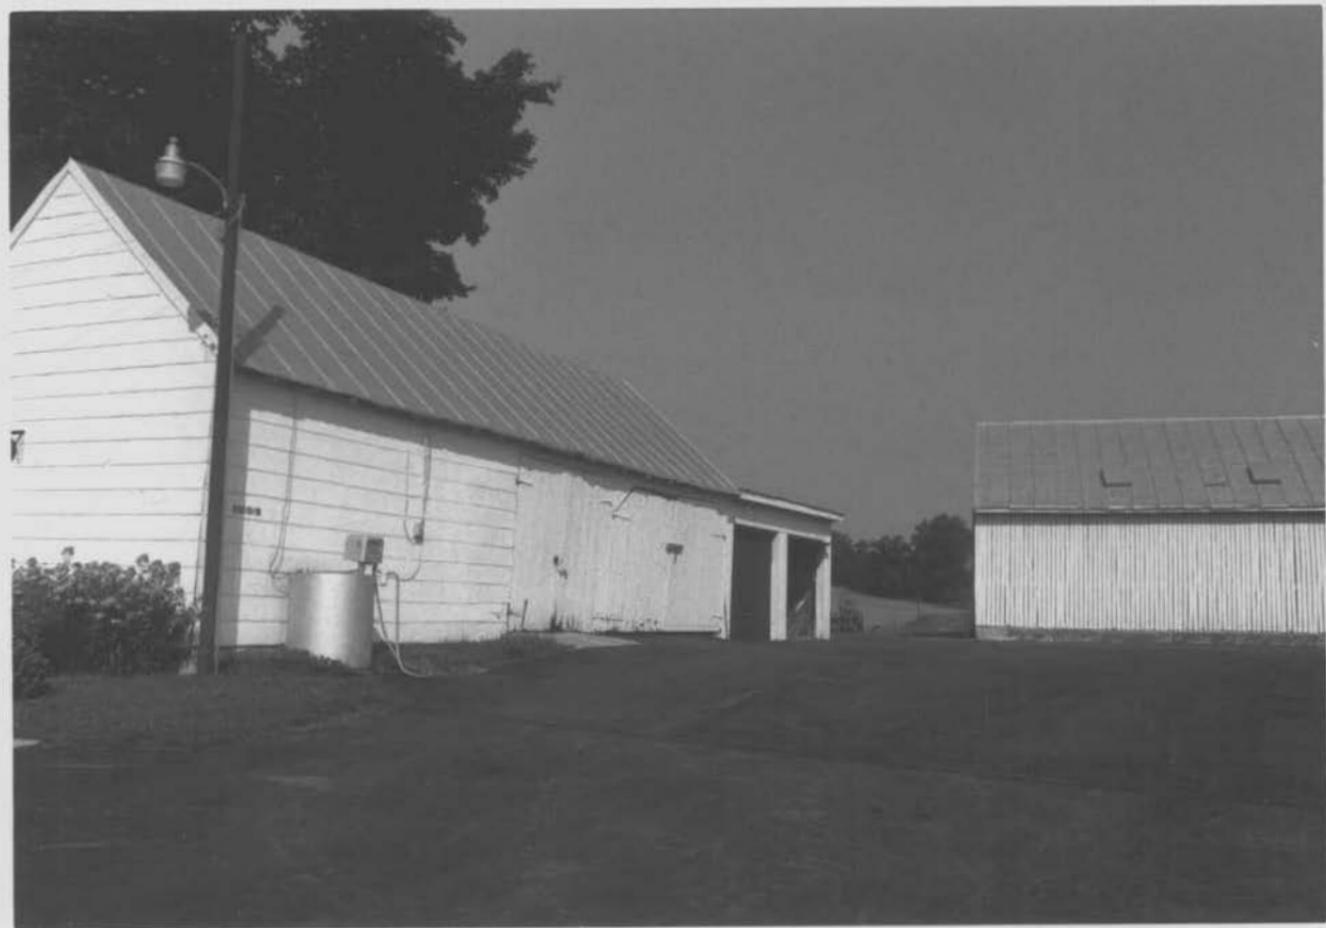
4/4

Garage and wagon shed/corn crib, view from  
east

Wagon shed/corn crib: The frame wagon shed is at the north side of the paved area. It has corrugated metal siding on the west elevation and vertical siding on the east, with sliding doors to close off the drive-through. The north and south sides of the crib have vertical lath strips. The roof is standing seam metal. The wagon shed may date from about 1890.
