St. Luke's Evangelical Lutheran Church
Point of Rocks
Private

1889

Maryland Historical Trust State Historic Sites Inventory Form

Survey No. F-1-7

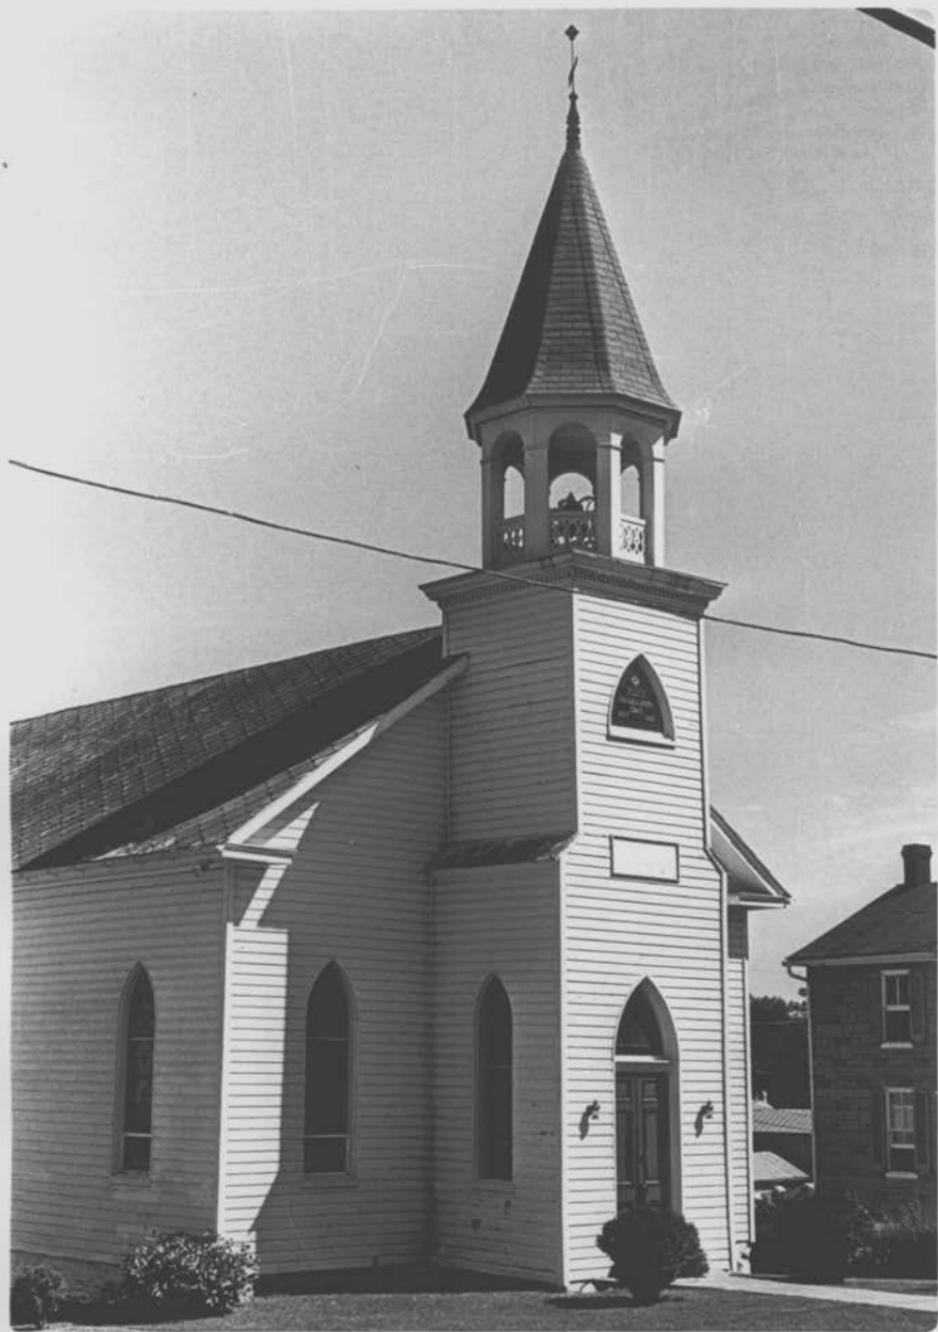
WEST ELEVATION

A two story frame belfry extends forward of the main block of the building and accommodates Gothic twin paneled doors with triangular stained glass transom and dentiled molding which states "St. Lukes Evangelical Church, Built 1889." Segmented Gothic stained glass windows are located on the north and south sides of the belfry and occupy each bay of the main block of the residence. The frame belfry tower with original fishscale wood roof, finial, weather vane and bell, has a dentiled frieze at the base of the belfry.

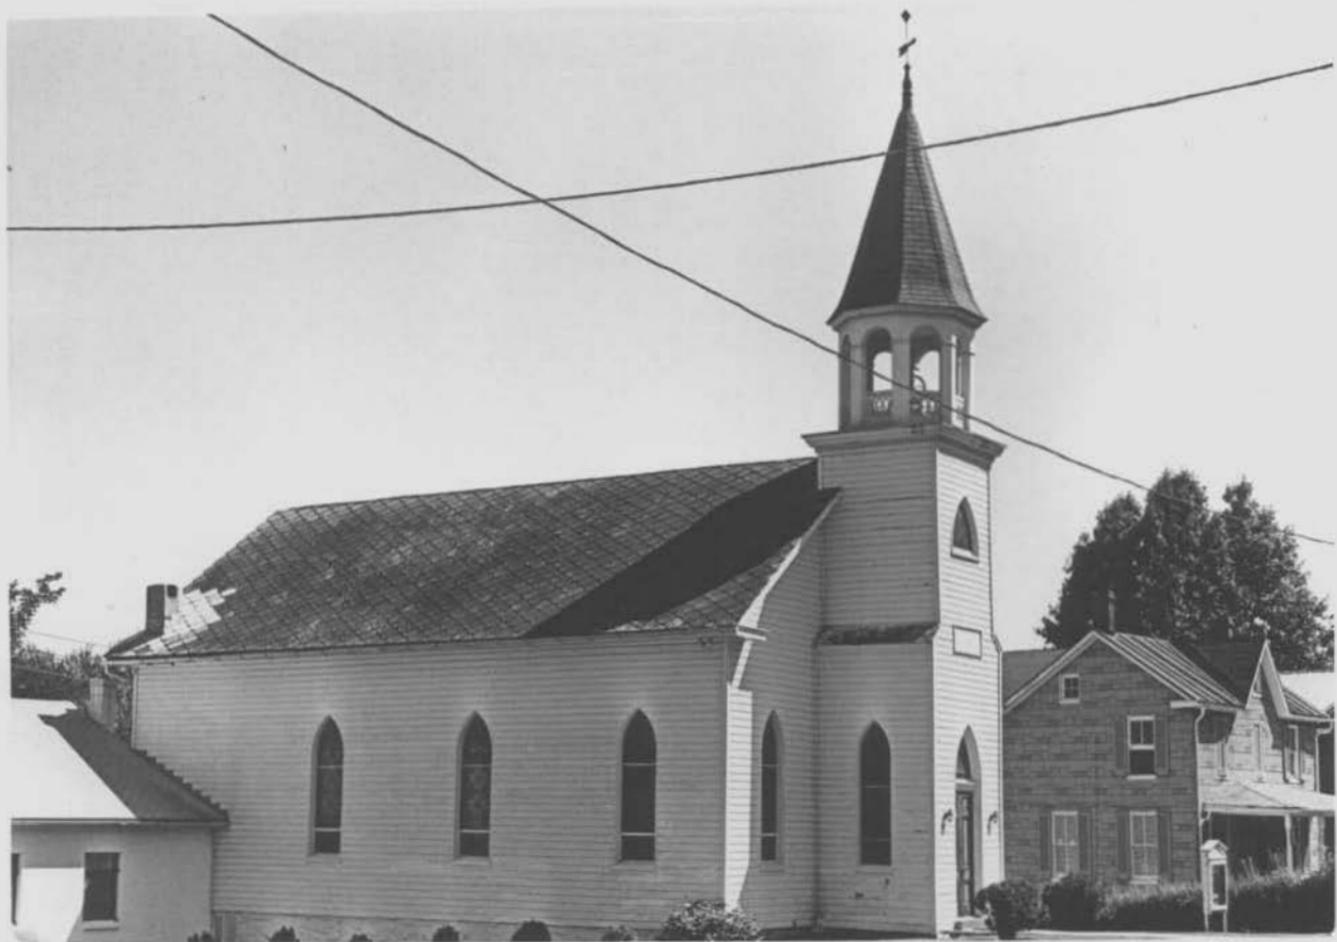
NORTH ELEVATION

A modern one story cinder block addition has been made on the north side of the main chapel.

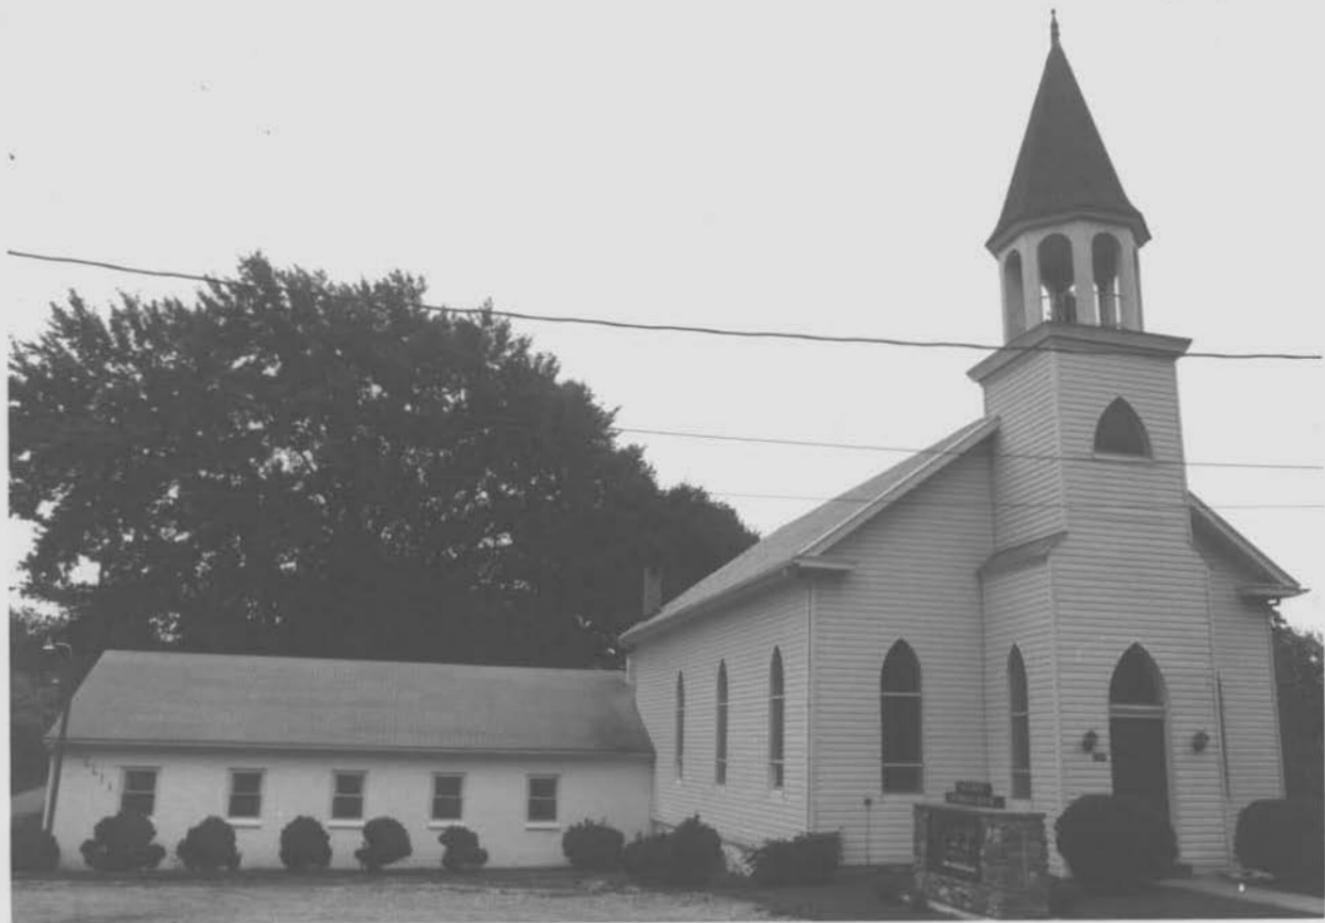
West elevation

The principal section of the church is a rectangular hall with an attached, projecting bell tower on the center of the west gable end with the main entrance in the west side. The windows and door opening have Gothic arches. The exterior is covered with aluminum siding, covering German siding pictured in the original 1978 survey photos. The roof is covered with composition material. The bell tower has an open belfry with a turret roof topped with a weather vane and finial. In the 1978 photos, a scroll-sawn balustrade and dentil molding at the cornice are visible. In 1987, the church was remodeled, according to a stone in the north side of the foundation. At that time, the balustrade, the molding, an arched stained glass window and a rectangular sign panel in the upper west face of the tower were removed or covered over by the aluminum siding. The stained glass panel was relocated to the transom over the double 3-panel doors. The north and south elevations have three bays each, with stained glass windows. On the east gable end, the stone foundation is revealed by the sloping ground level, with a vertical board door into the basement of the church. A projecting section behind the pulpit with arched windows in the north and south sides is centered in the gable end. The interior of the church was inaccessible for this survey.
