Lewis Mill  
Jefferson  
Private

**National Register of Historic Places  
Inventory—Nomination Form**

historic Lewis Mill Complex

Lewis Mill Complex  
Continuation sheet Frederick County, Maryland Item number

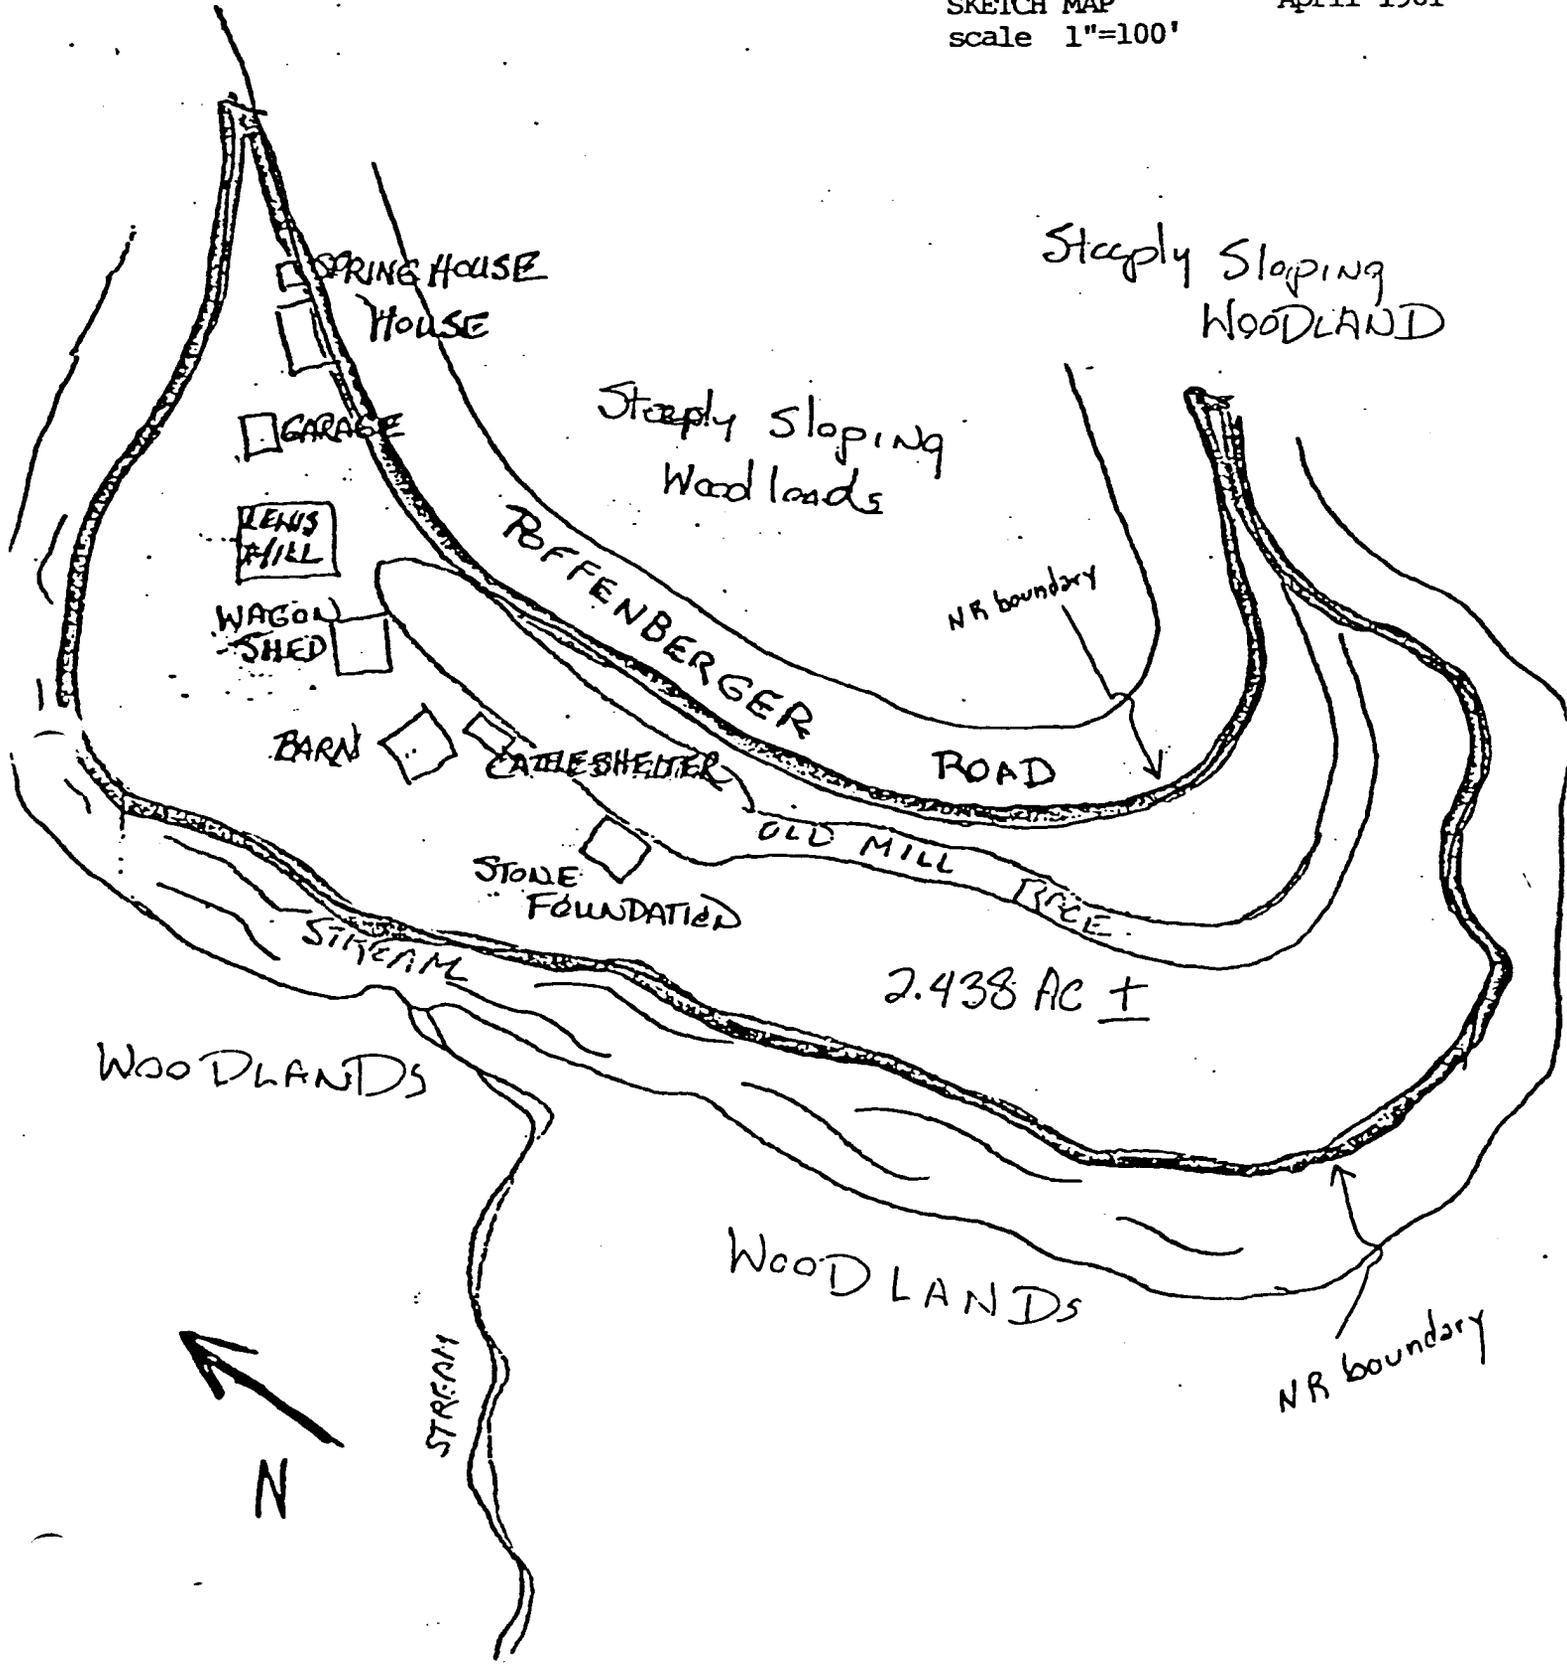
SKETCH MAP  
scale 1"=100'

Lewis Mill Complex  
Frederick County  
Maryland

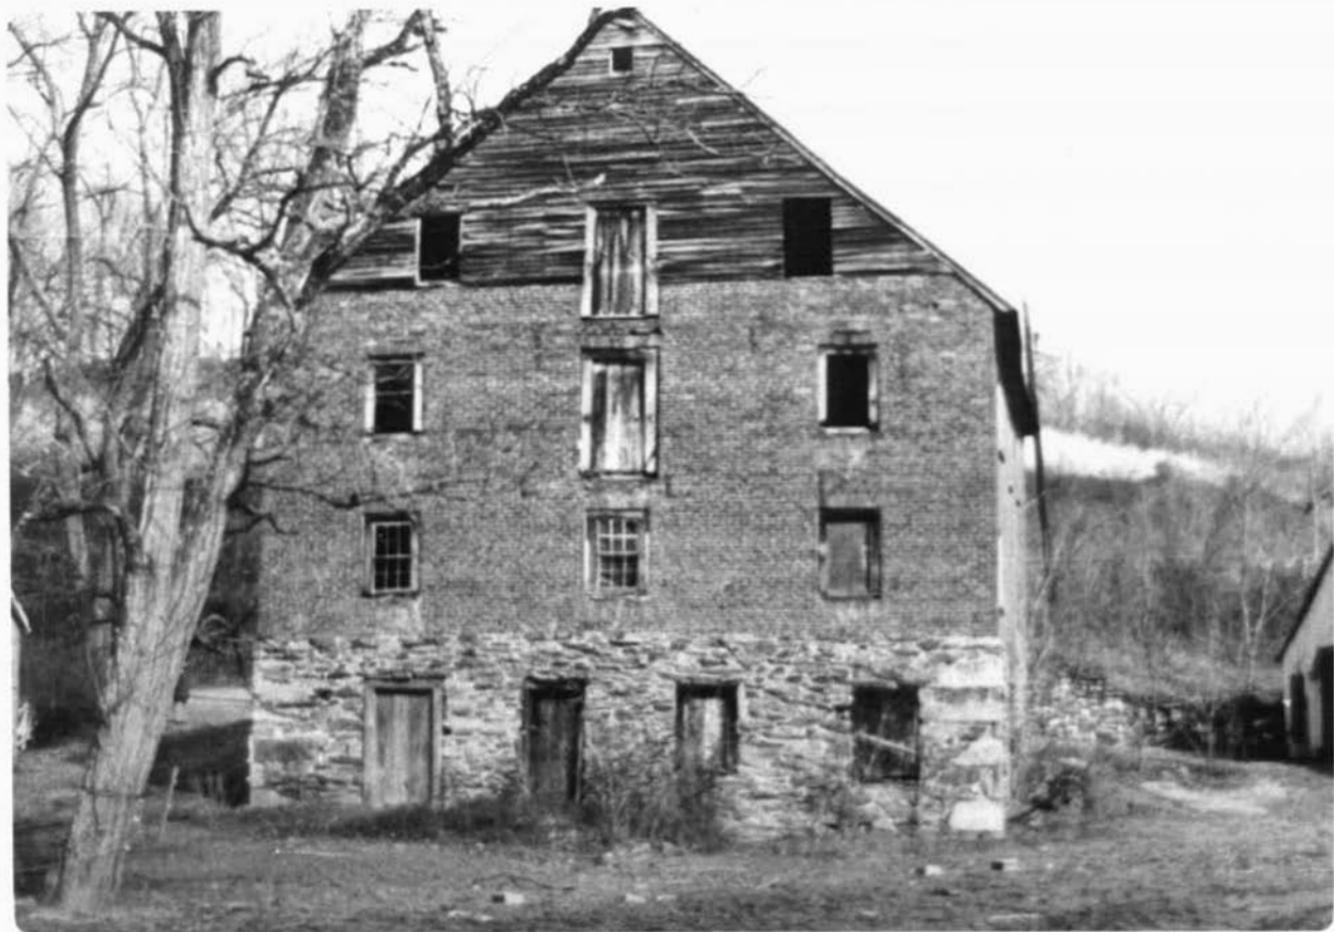
The west side is the principal facade. It is four bays wide on the stone first floor and three bays wide on the three upper levels. A replaced board and batten door set into a panel entrance is located in the northern most bay on the ground level. Two additional doors were located in the central bay of the third and fourth levels and have been replaced with plate glass. Replaced and repaired double hung 6/6 windows occupy the remaining bays on the west gable end. Flat brick arches are laid in the brickwork above each opening in the second and third floors.

Lewis Mill, Frederick County  
west side of Poffenberger Road  
West Elevation  
Photographer, Cherilyn Widell  
Summer, 1978

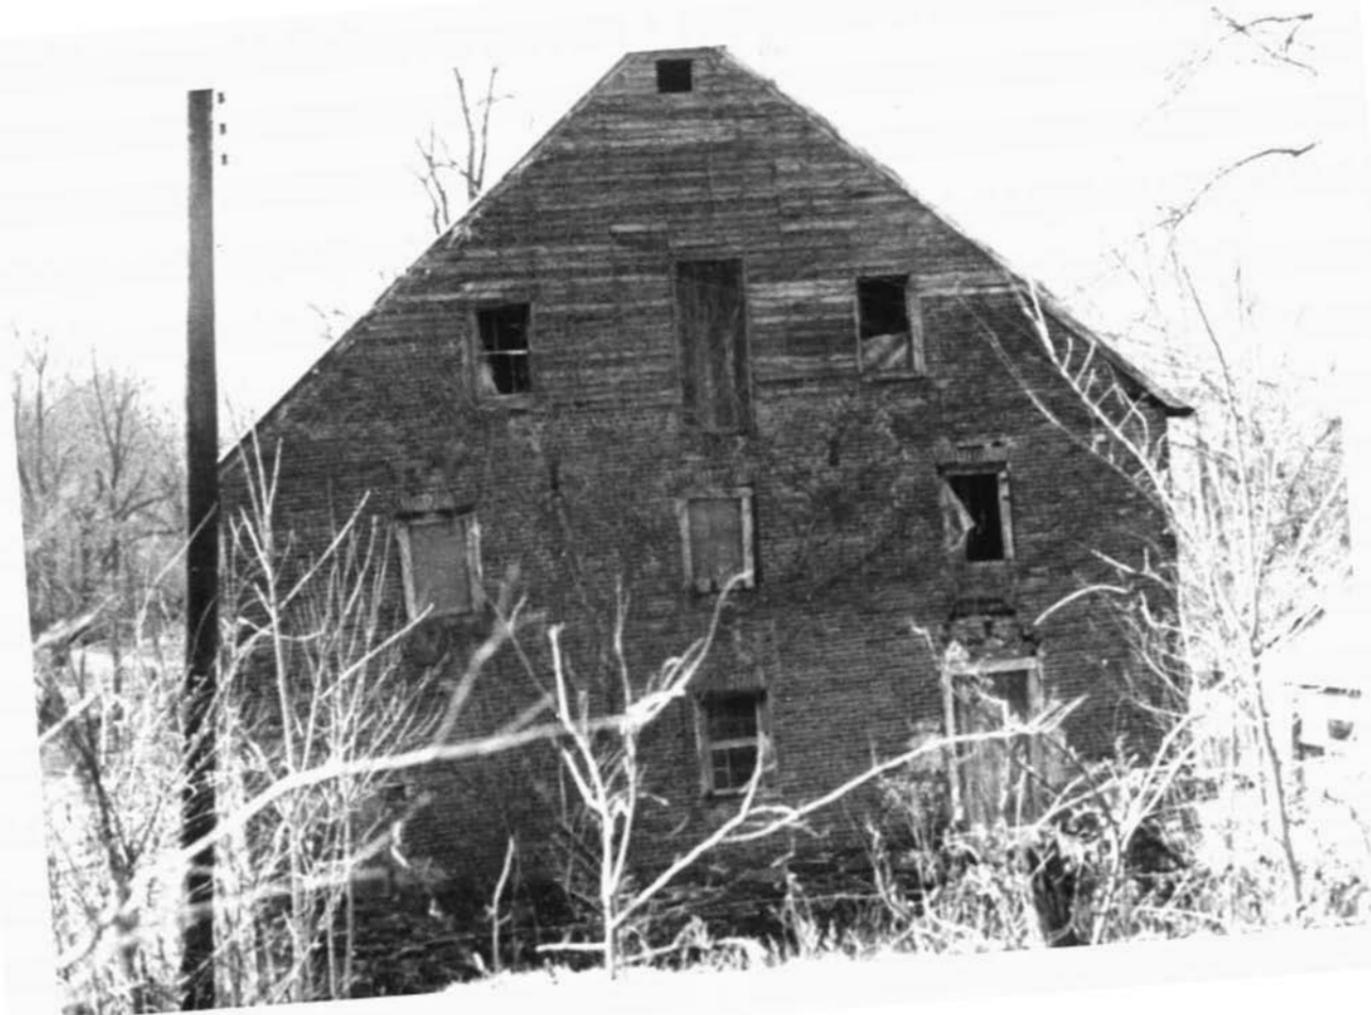
The east gable is three bays wide, with a central door in the fourth floor level with windows flanking it, three windows on the third, and a window in the center bay and a board and batten door into an office in the north bay of the second. This facade also has flat arches above the window openings. The brick wall on this side is built to the sill of the fourth level windows in the center and almost to the head of these windows on each side.

The east side of the building is very similar to the west side, but is only three levels high. An office entrance is located in the northeast corner on the first level. Much of the brickwork above the door frame is missing.

Lewis Mill, Frederick County  
West side of Poffenberger Road  
East Elevation  
Photographer, Cherilyn Widell  
Summer, 1978

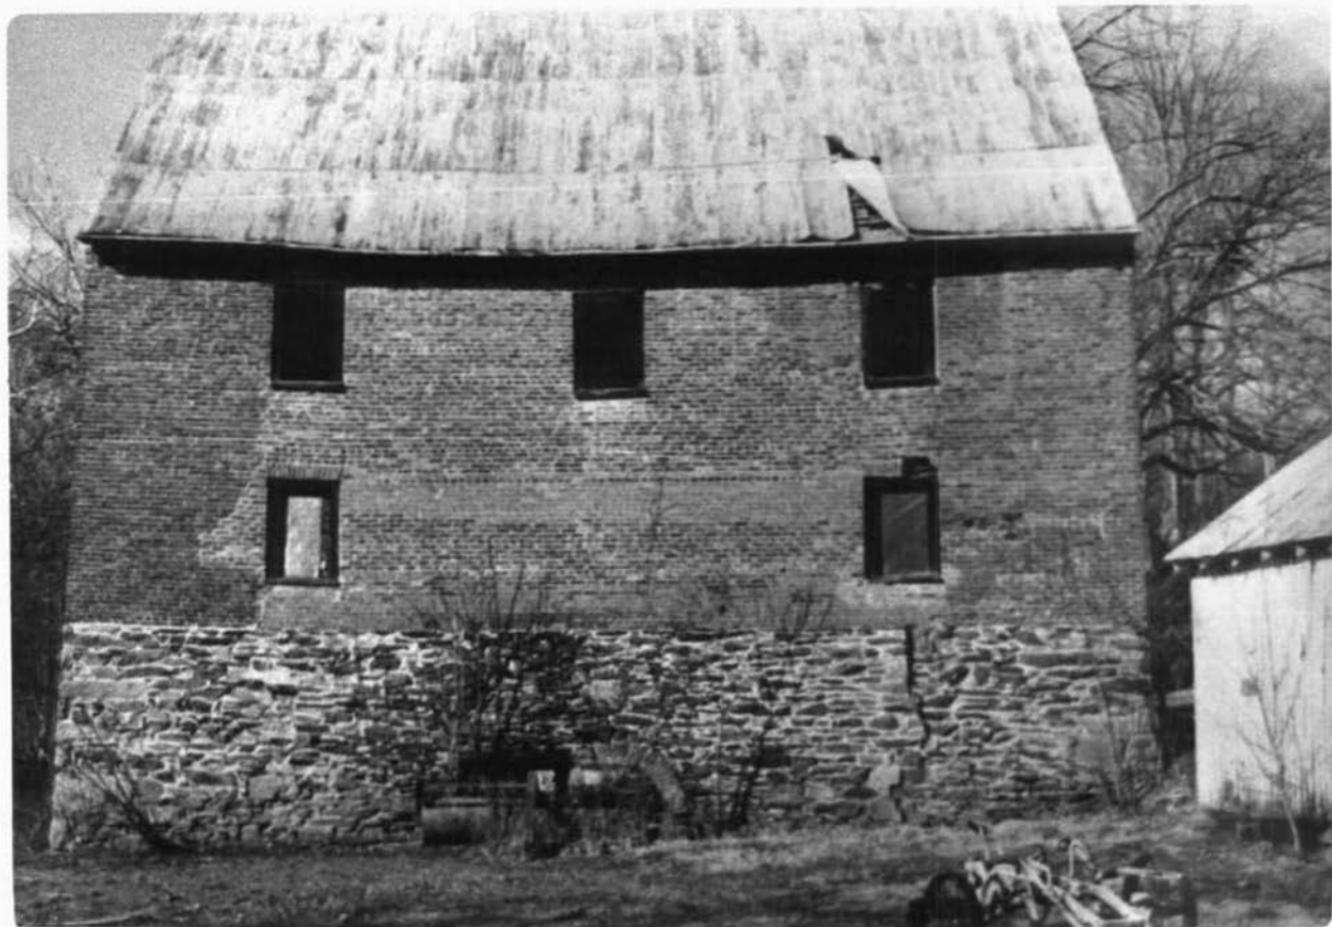
The north and south elevations each contain three rather wide bays. On the south, there is a window in each bay of the third floor and a window in each end bay on the second floor. All have flat brick arches and replaced double hung 6/6 sash. The brickwork in the center of this wall was rebuilt at an early time.

The north and south sides of the building are three bays wide and accommodate only two levels. The brickwork in the center of the south side appears to have been replaced at an early date.

W Lewis Mill, Frederick County F-2-1  
west side of Poffenberger Road  
F South Elevation  
Photographer, Cherilyn Widell  
S Summer, 1978
