George Willard House  
Jefferson vicinity  
Private

F-2-51  
George Willard House  
Jefferson  
Frederick County

# National Register of Historic Places Registration Form

historic name WILLARD, GEORGE, HOUSE  
other names/site number New Freedom Spring F-2-51

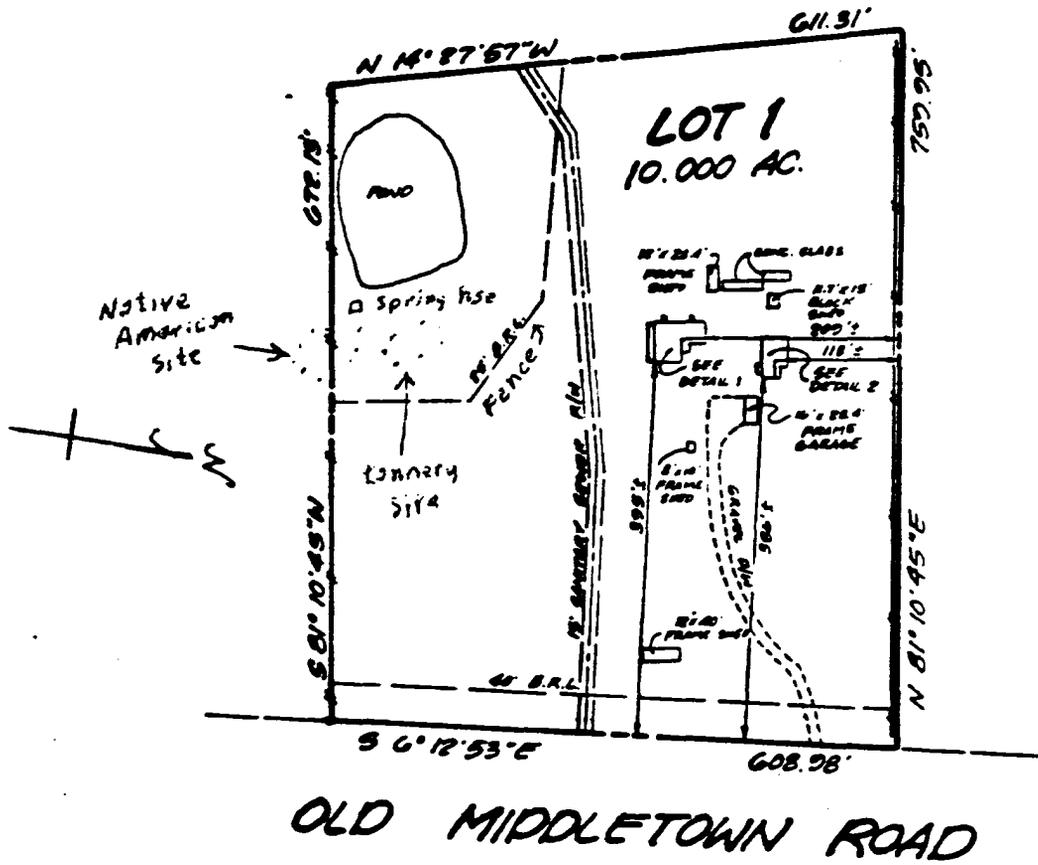
BOUNDARY AND RESOURCE SKETCH MAP, 1993

Also on the property, are several non-contributing resources which appear to post-date the construction of the George Willard house. The resources include a frame, one-story tenant house, c.1900; a modern frame garage; two undated concrete slabs; and four frame sheds probably built about the close of the nineteenth century. Three archaeological sites on the property, part of in case of one, have been found and partially investigated. One of these sites reflects domestic life. It is below the back wing of the house. Another relates to the tannery which once was operated by Willard. The third, a native American site, straddles the present property line to the south. None of the archaeological sites have been adequately addressed for purpose of National Register listing.

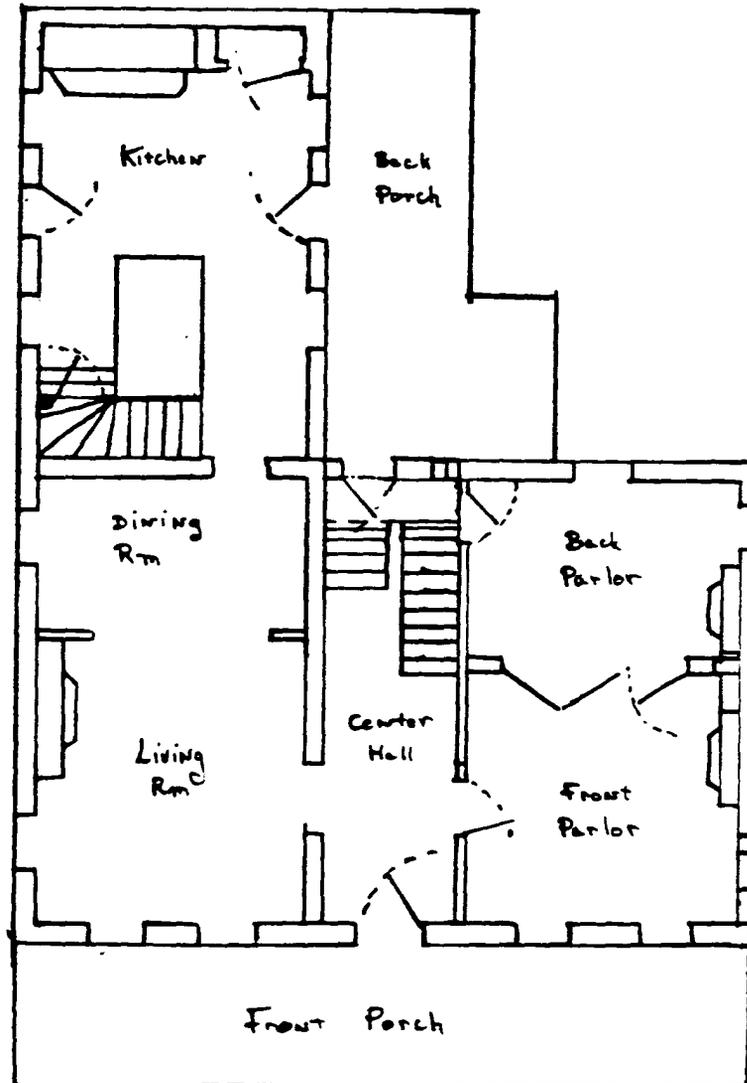
FIRST FLOOR PLAN

The interior of the house is laid out in a center passage, double pile plan that has its roots in the formality of the Georgian style. The front entrance opens into a central passage, with doors leading to rooms on either side. The staircase, set toward the back of the passage, is typical of the 1818 period. It has a small, delicate newel post with a curved profile, a rounded handrail, and long, round balusters set two per step. The ends of the risers are decorated with curvilinear cut trim. Doors in the passage have six low relief panels which had a grain-painted finish. The current finish replicates the original graining on the doors, including lining along the perimeter of each panel. The passage is trimmed with chair rail and baseboard.

To the east of the passage is a double parlor divided by three leaves of doors. One pair of leaves is hinged together while the third is hinged to a partition wall. These doors each have six horizontally placed panels. Both leaves have wrought iron slide bolts attached to the top and bottom of the stiles which can lock the doors into a closed position. These doors were probably added

West of the central hallway is a large room, partially divided just north of its fireplace. Originally this division was complete. It now functions as a dining room and living room and may originally have had a similar function, principally as a dining room that could be reduced or expanded in size.

The back wing on the first floor is the kitchen. This space consists of one large room with opposing east and west doors, a large service fireplace in the north end wall and a separate set of stairs to the second floor and attic, located in the southwest corner of the room. The large cooking fireplace is located in the northwest corner of the room and has an adjacent cupboard. The fireplace retains an early crane and is able to function in its original manner. The crane is attached to the original bracket. Evidence remains of an attached bake oven as well. Along the walls is narrow tongue and groove wainscotting which was probably added about 1900.

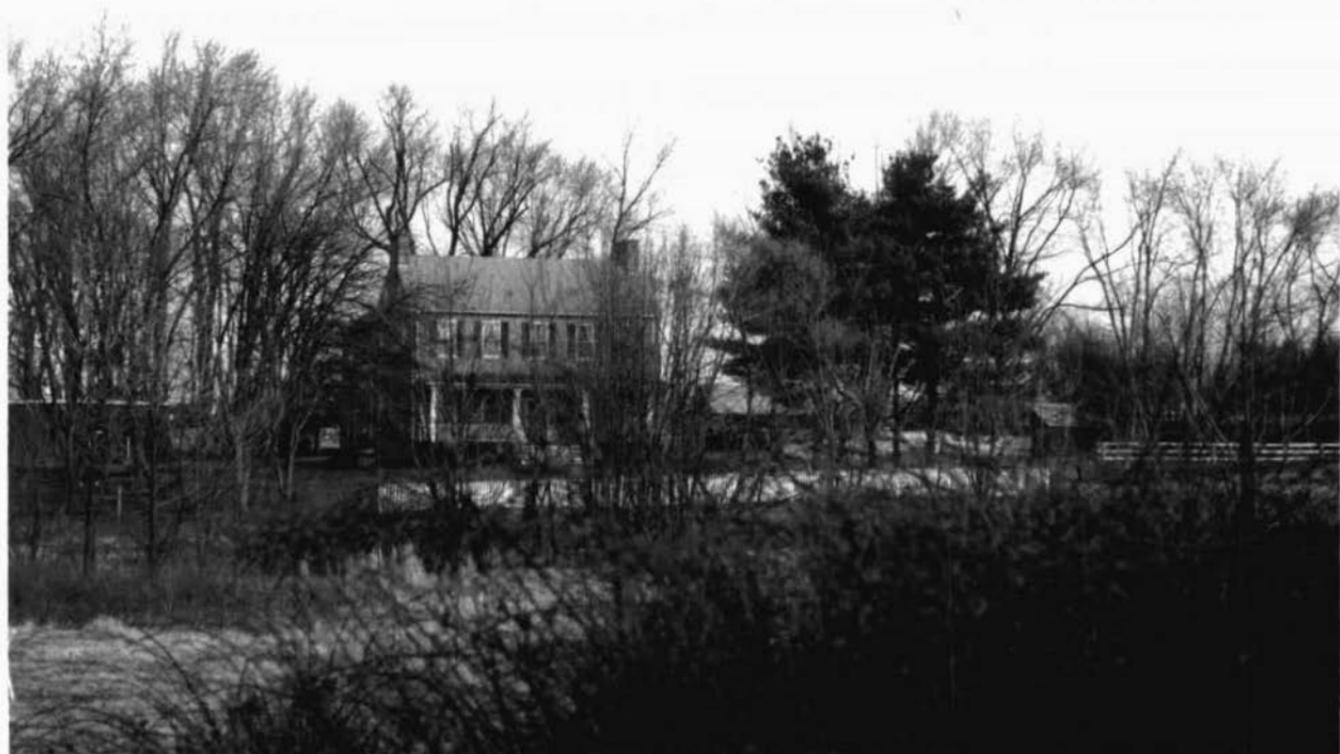
#1

1. General view: Northeast, showing house, sheds, spring and tannery site
2. General view: Front (south elevation), north view
3. General view: Northeast view
4. General view: South and west elevations, northeast view
5. General view: North and west elevations, southeast view
6. General view: North and east elevations, southwest view
7. General view: South and east elevations, northwest view
8. General view: Detail, date tablet, east gable
9. General view: Interior, stair-entrance hall, first floor north view
10. General view: Interior, front parlor, southeast room, northeast view
11. General view: Detail, front parlor mantle, east view
12. General view: Kitchen fireplace, north view
13. General view: Second floor stair hall, northeast view
14. General view: Second floor, southeast room, fireplace, northeast view

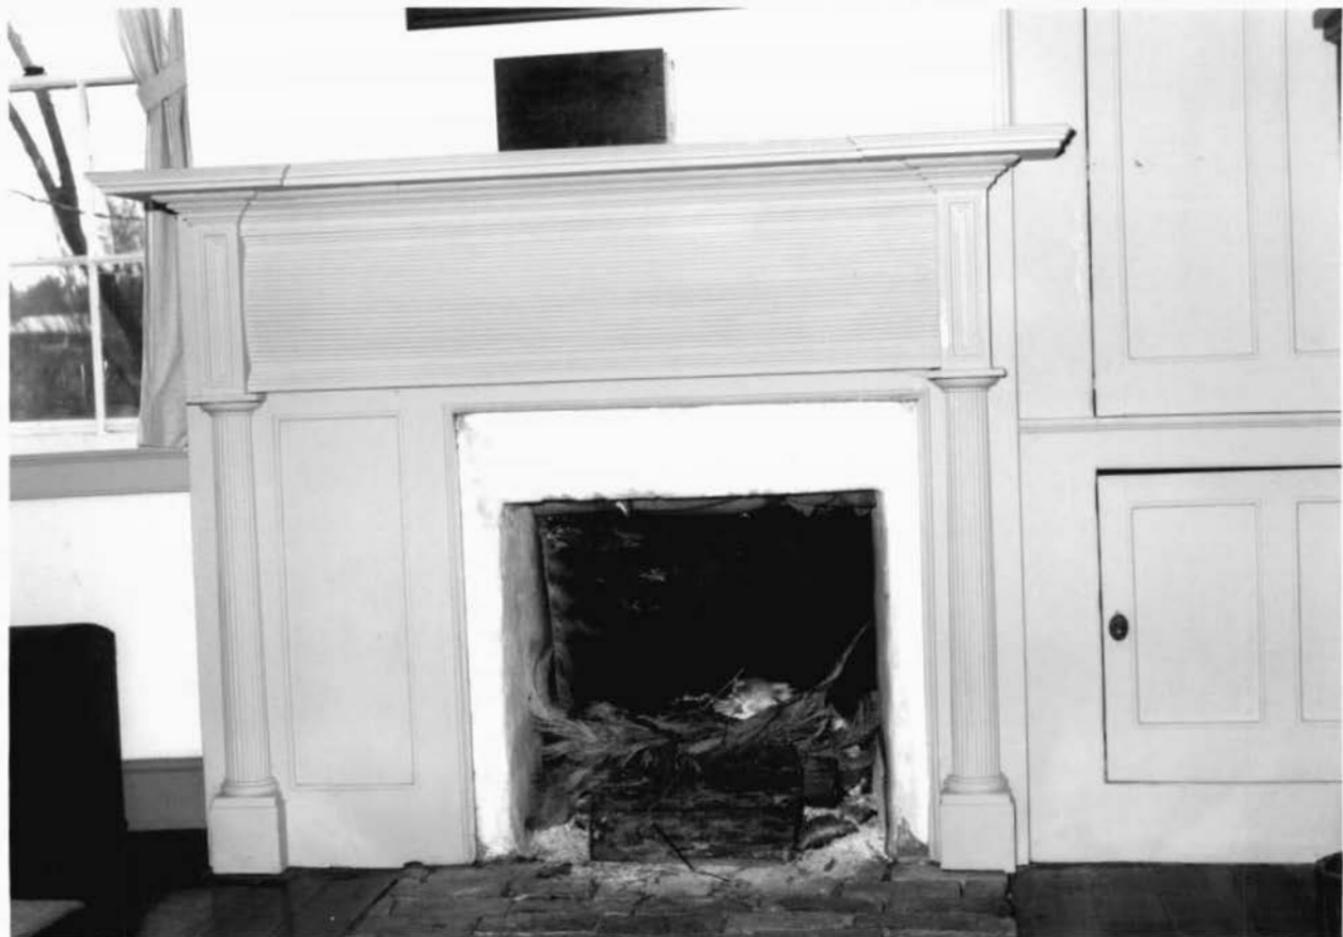
#15

- 
15. General view: Second floor, northeast room, fireplace, east view
  16. General view: Detail, mantelpiece, northeast room, second floor
  17. General view: Second floor, west room, fireplace, west view
  18. General view: Detail, mantelpiece, west room, second floor

The mantle in the front bedroom, the smaller of the two, has a mantle shelf supported by symmetrically molded pilasters. Above these pilasters the mantle shelf projects slightly. In the back bedroom which is larger, the mantle piece is embellished with horizontal reeding across the frieze and reeded oval colonnettes.
