G. C. Huffer Farmstead  
Burkittsville vicinity  
Private

G.C. Huffer Farmstead  
Burkittsville  
Frederick County

# Maryland Historical Trust State Historic Sites Inventory Form

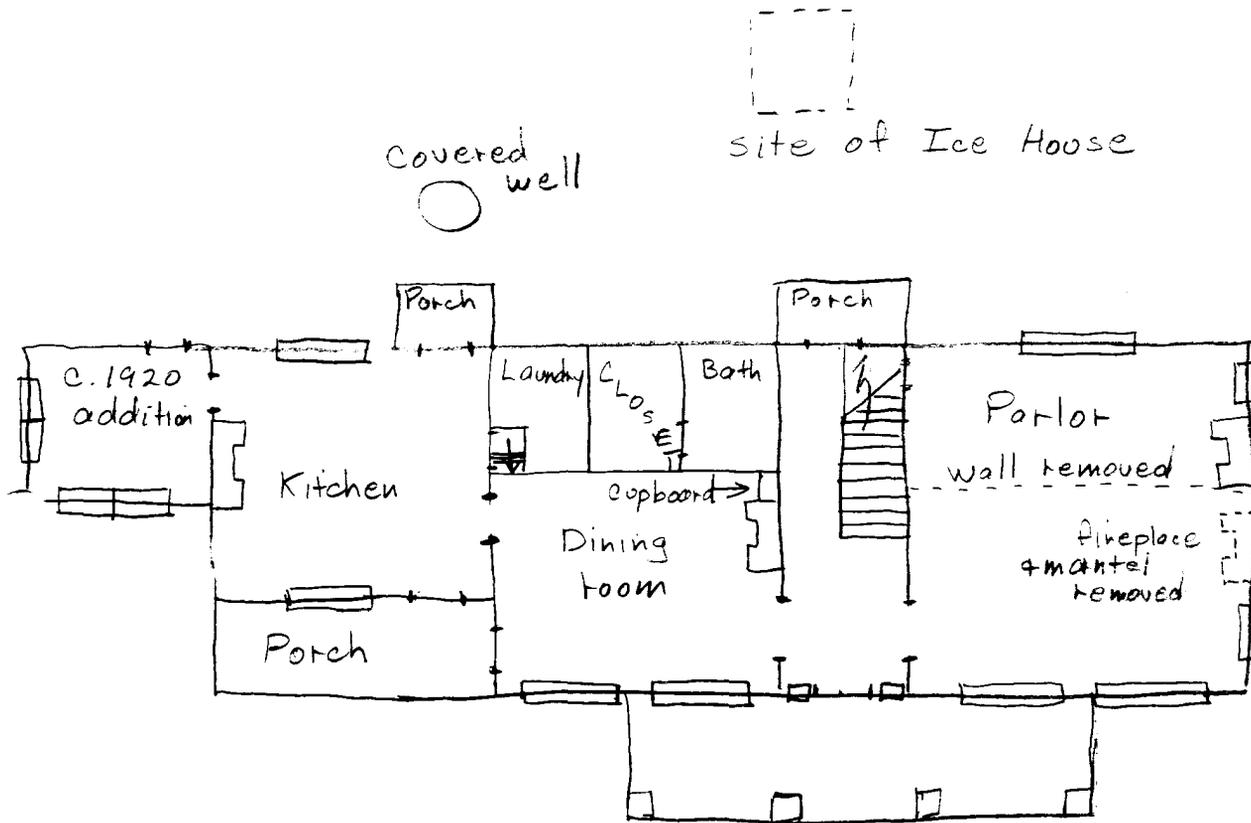
None of the domestic outbuildings survive, although the foundations of a smokehouse and an icehouse, and a covered well are located near the south wing of the house. A tenant house formerly stood southeast of the main dwelling house, as shown in an aerial photo of the 1950's in the owners' possession.

Covered well  
○

site of Ice House  
□
