William V. Wolfe House and Barn  
Frederick vicinity  
Private

William V. Wolfe House and Barn

# Maryland Historical Trust State Historic Sites Inventory Form

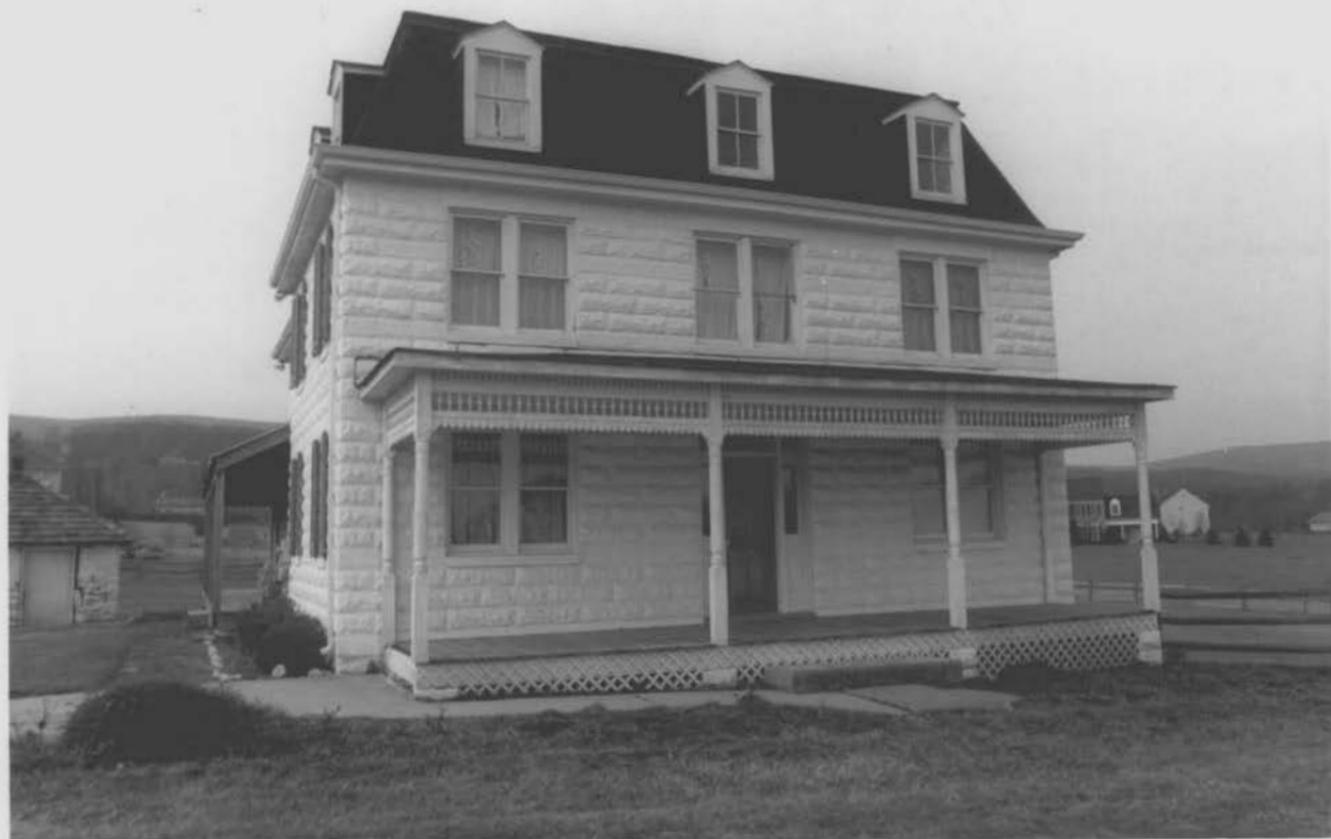
1/6

East elevation

The house has three stories, including the mansard level, which is covered with composition material. The molded concrete block is painted white and a one-story porch is located on the principal elevation on the east. The east elevation has three bays with a center entrance containing a natural finish 6-panel door with a plain transom and sidelights. The sash is 1/1 in pairs on both lower stories, the dormers in the mansard having 2/2 sash, which was probably the original sash on all elevations. The north and south elevations have 2/2 sash and, on the north side louvered shutters flank the openings. These were probably removed on the other elevations. A three-story rear wing, also with a mansard third story, extends to the west from the main section. Modern one-story porches are located on the north and south sides of the wing. The modern two-story addition on the west end of the wing appears to fill in the area of an original two-story porch on the south side, in the traditional location of vernacular houses of the 19th and early 20th centuries. At the base of the brick addition on the south elevation is the marble stone giving the date 1987 and the name of the current owner, Priolo.

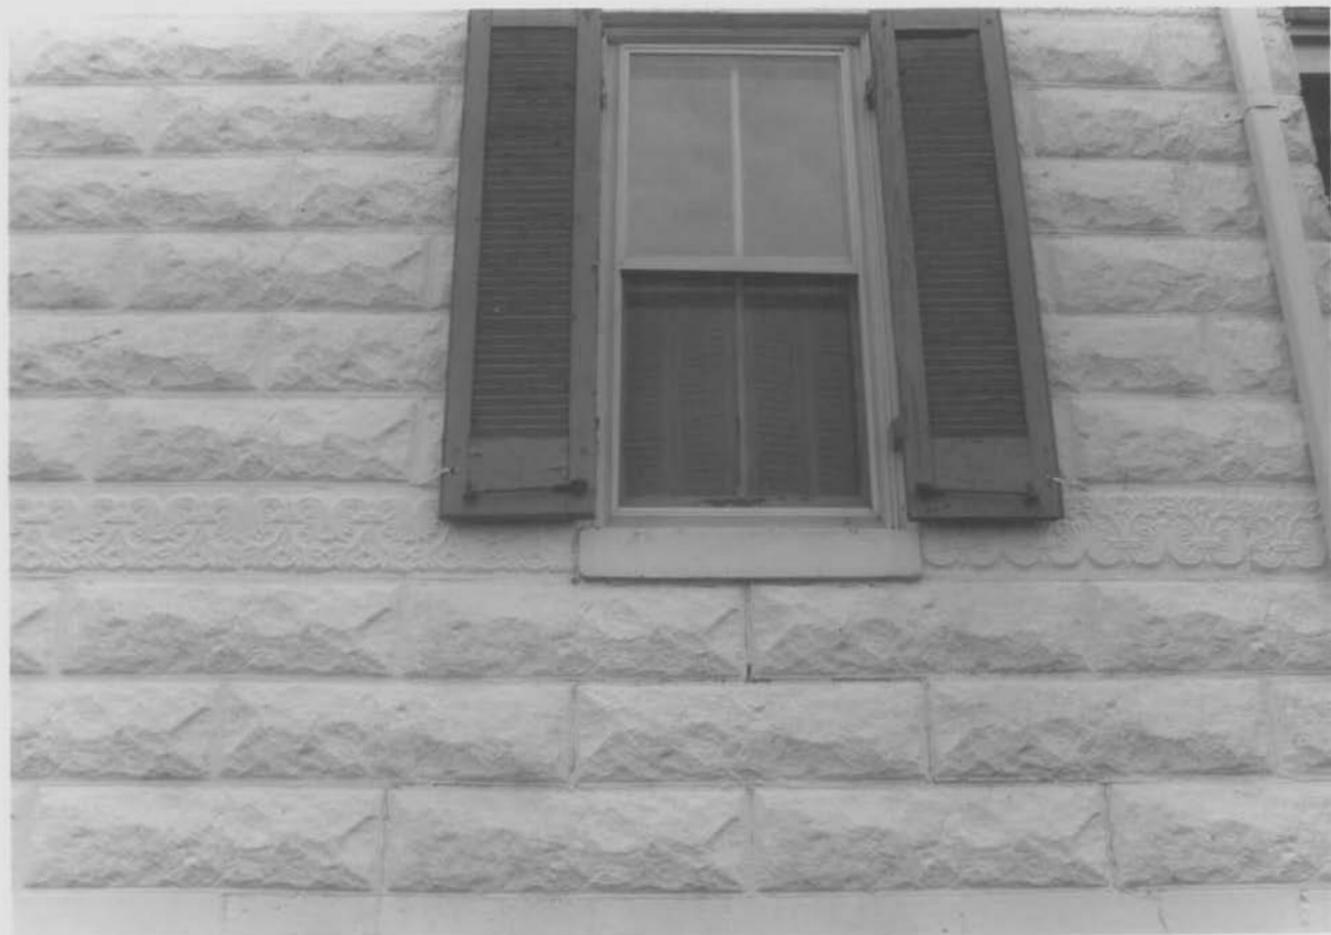
2/6

Neg. loc.: Md. SHPO, Crownsville, Md.  
Concrete block detail, north elevation

The pattern of the concrete blocks in the exterior of the house is indicative of the early period of use of the material in Frederick County. The majority of blocks are quarry finish, with four courses of running floral blocks at the sill and lintel levels of the window openings and near the base and cornice lines. The floral blocks are not entirely laid in the same manner, since the design is sometimes reversed, especially on opposite sides of some of the windows. The occurrence seems to have been random, indicating a possible ignorance of aesthetics in the use of the new material. This is particularly evident on the west elevation of the wing, above the roofline of the modern addition, where several courses are in the floral block pattern. This may have been a thrifty use of extra floral blocks molded but not used in the other elevations.

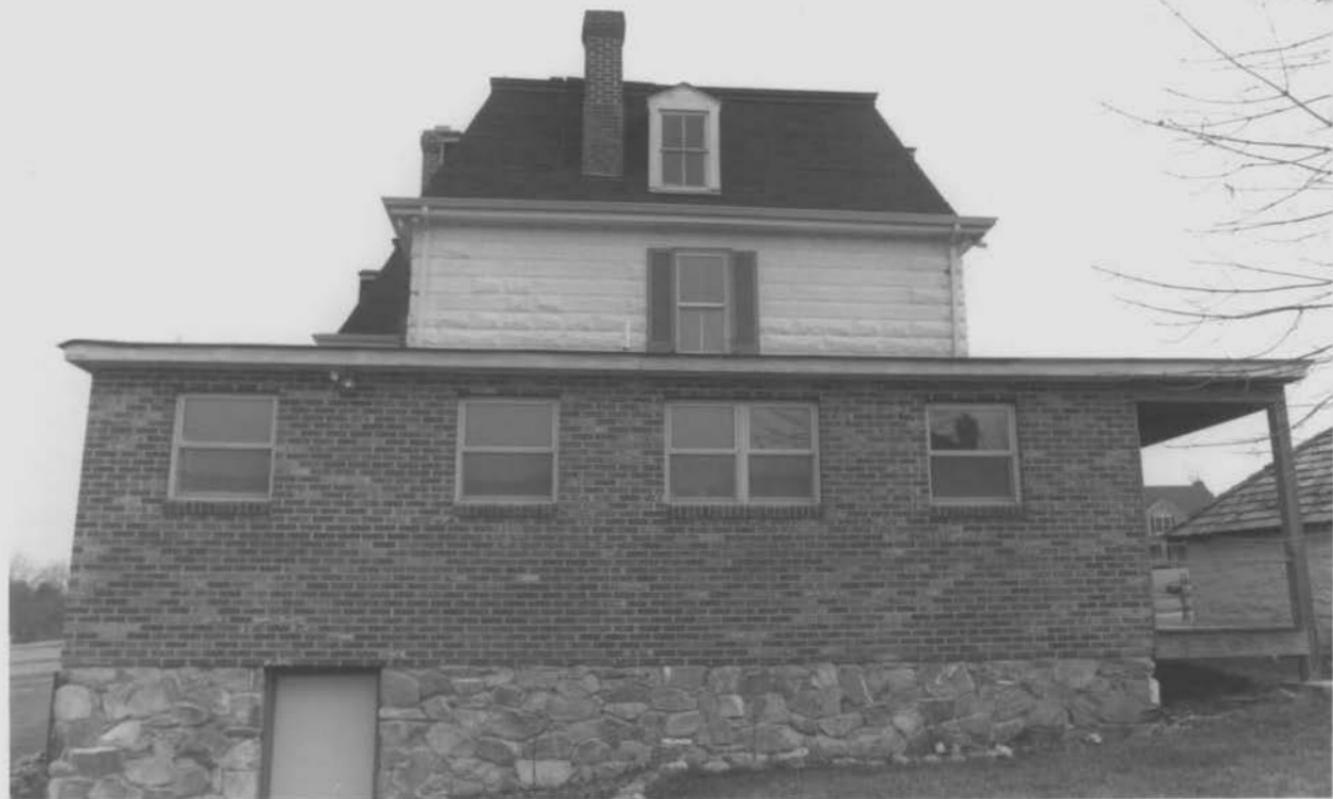
3/6

West elevation

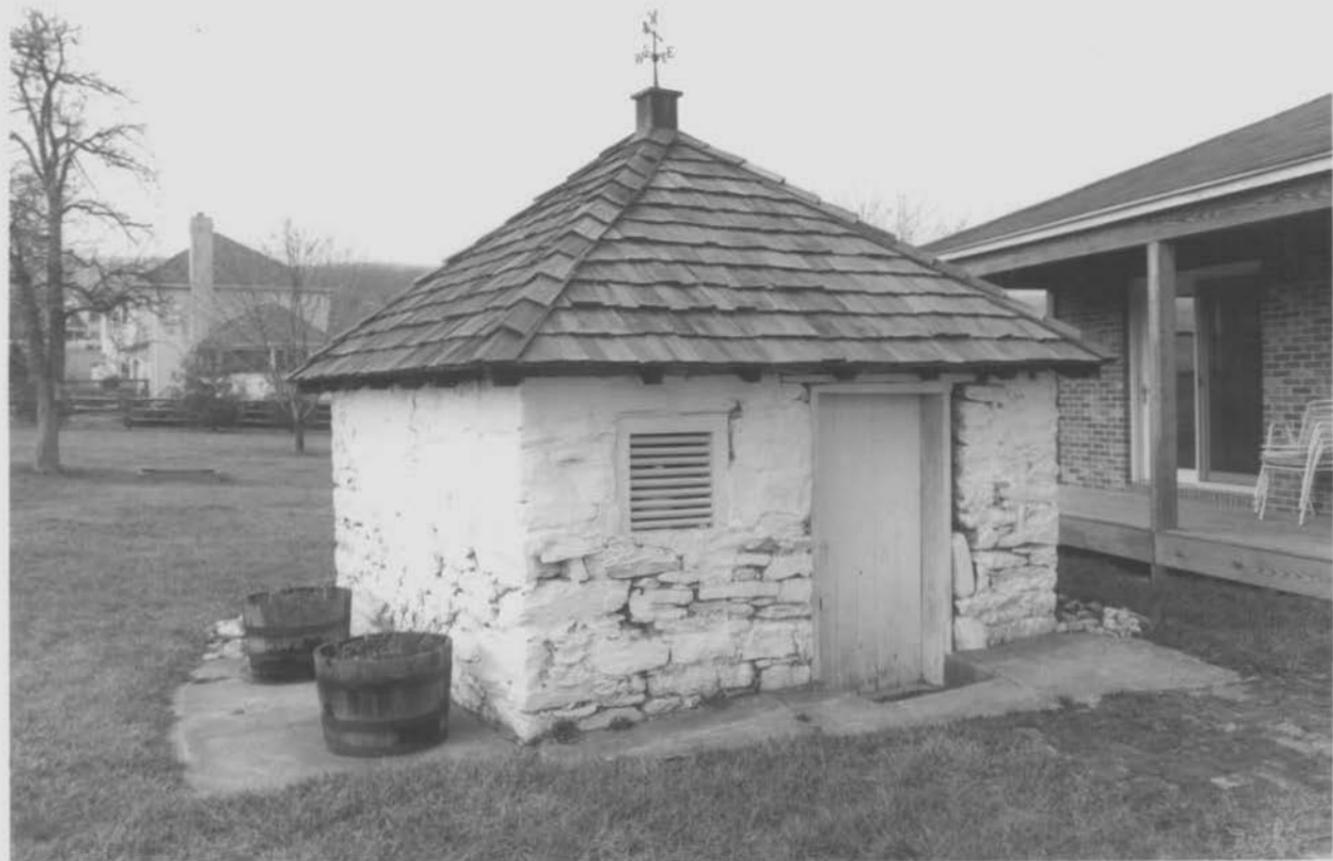
4/6

Neg. loc.: Md. SHPO, Crownsville, Md  
Smokehouse, east elevation

Springhouse: The square plan fieldstone springhouse is located just south of the rear wing and is set at a slight angle to the south side of the house. It has a hipped wood shingle roof and square louvered openings in the east and west elevations. A vertical board door is located in the east elevation. Its design

and materials are identical to springhouses built throughout the 19th century and may in fact have been built during the last quarter of the 19th century to accompany an earlier house on the farmstead.

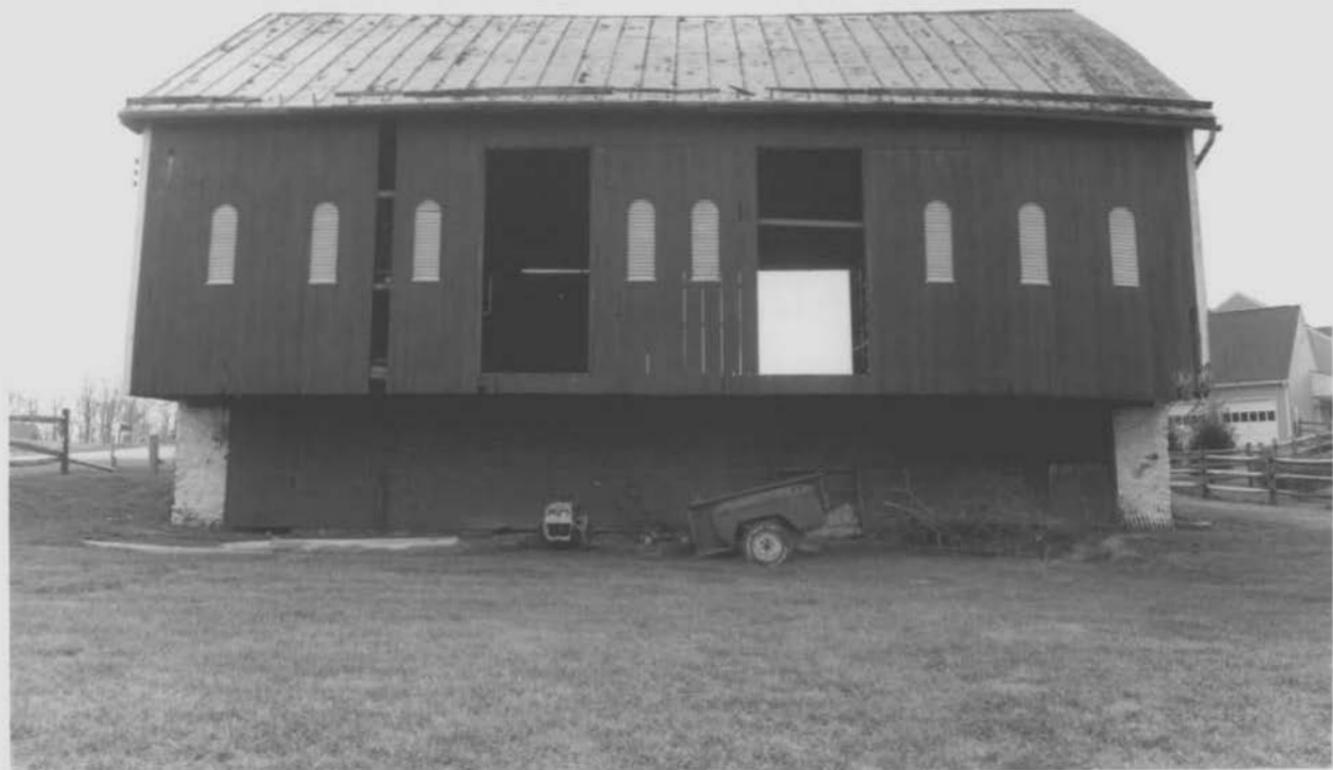
5/6

Neg. loc.: Md. SHPO, Crownsville, Md  
Barn, north elevation

Barn: The large frame bank barn is located south of the house and is in rather deteriorated condition. The ramp to the loft floor is on the south elevation and the stall level on the north side is enclosed with horizontal tongue-and-groove and flush boards. The foundation is fieldstone and the upper structure is covered with vertical siding with louvred arched vents. The sliding doors to the loft on the north side have been removed. The roof is standing seam metal. Inside the barn on the granary wall is the inscription "1898 W. H. Canon, W. V. W." W.V.W was William V. Wolfe, one of the owners of the farm from 1899 to 1916. The other name is assumed to be that of a local builder.

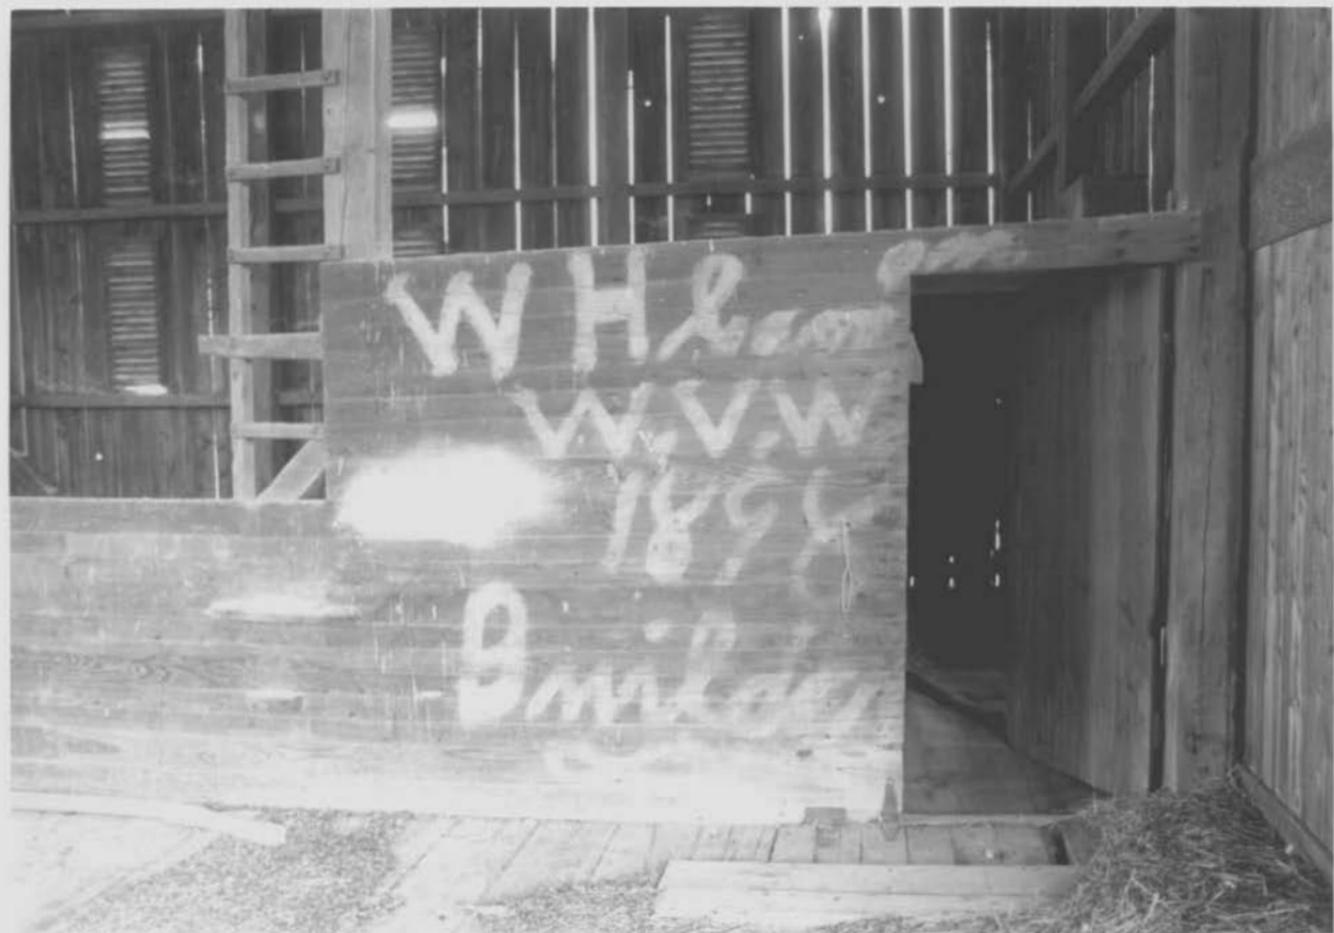
6/6

Born date & builders' names

The William V. Wolfe House and Barn are located on the west side of Rocky Springs Road just south of the intersection of Indian Springs Road near Frederick (City), Frederick County, Maryland. The house was built of rusticated and molded concrete block with a mansard roof in 1910 and the barn is a frame traditional German bank barn built in 1898. A third outbuilding is a stone springhouse built about 1910 near the dwelling. The buildings are the remaining structures of a farm, now built up as the Frederick suburb of Aynsley. In 1987, a two-story brick addition was built on the west elevation of the original 1910 house, as noted by a marble stone in the brick wall of the south elevation. The house was dated by a reference to its construction in Williams & McKinsey's History of Frederick County (1910) and the barn has the names of the builders and the year painted on the granary wall of the interior.
