F-3-22  
Spring Bank Farm  
Harmony Grove  
Private

# National Register of Historic Places Inventory—Nomination Form

historic Spring Bankand or common Spring Bank

street & number 7945 Worman's Mill Road n/a not for publicationcity, town Frederick n/a vicinity of congressional district Sixthstate Maryland code 24 county Frederick code 021

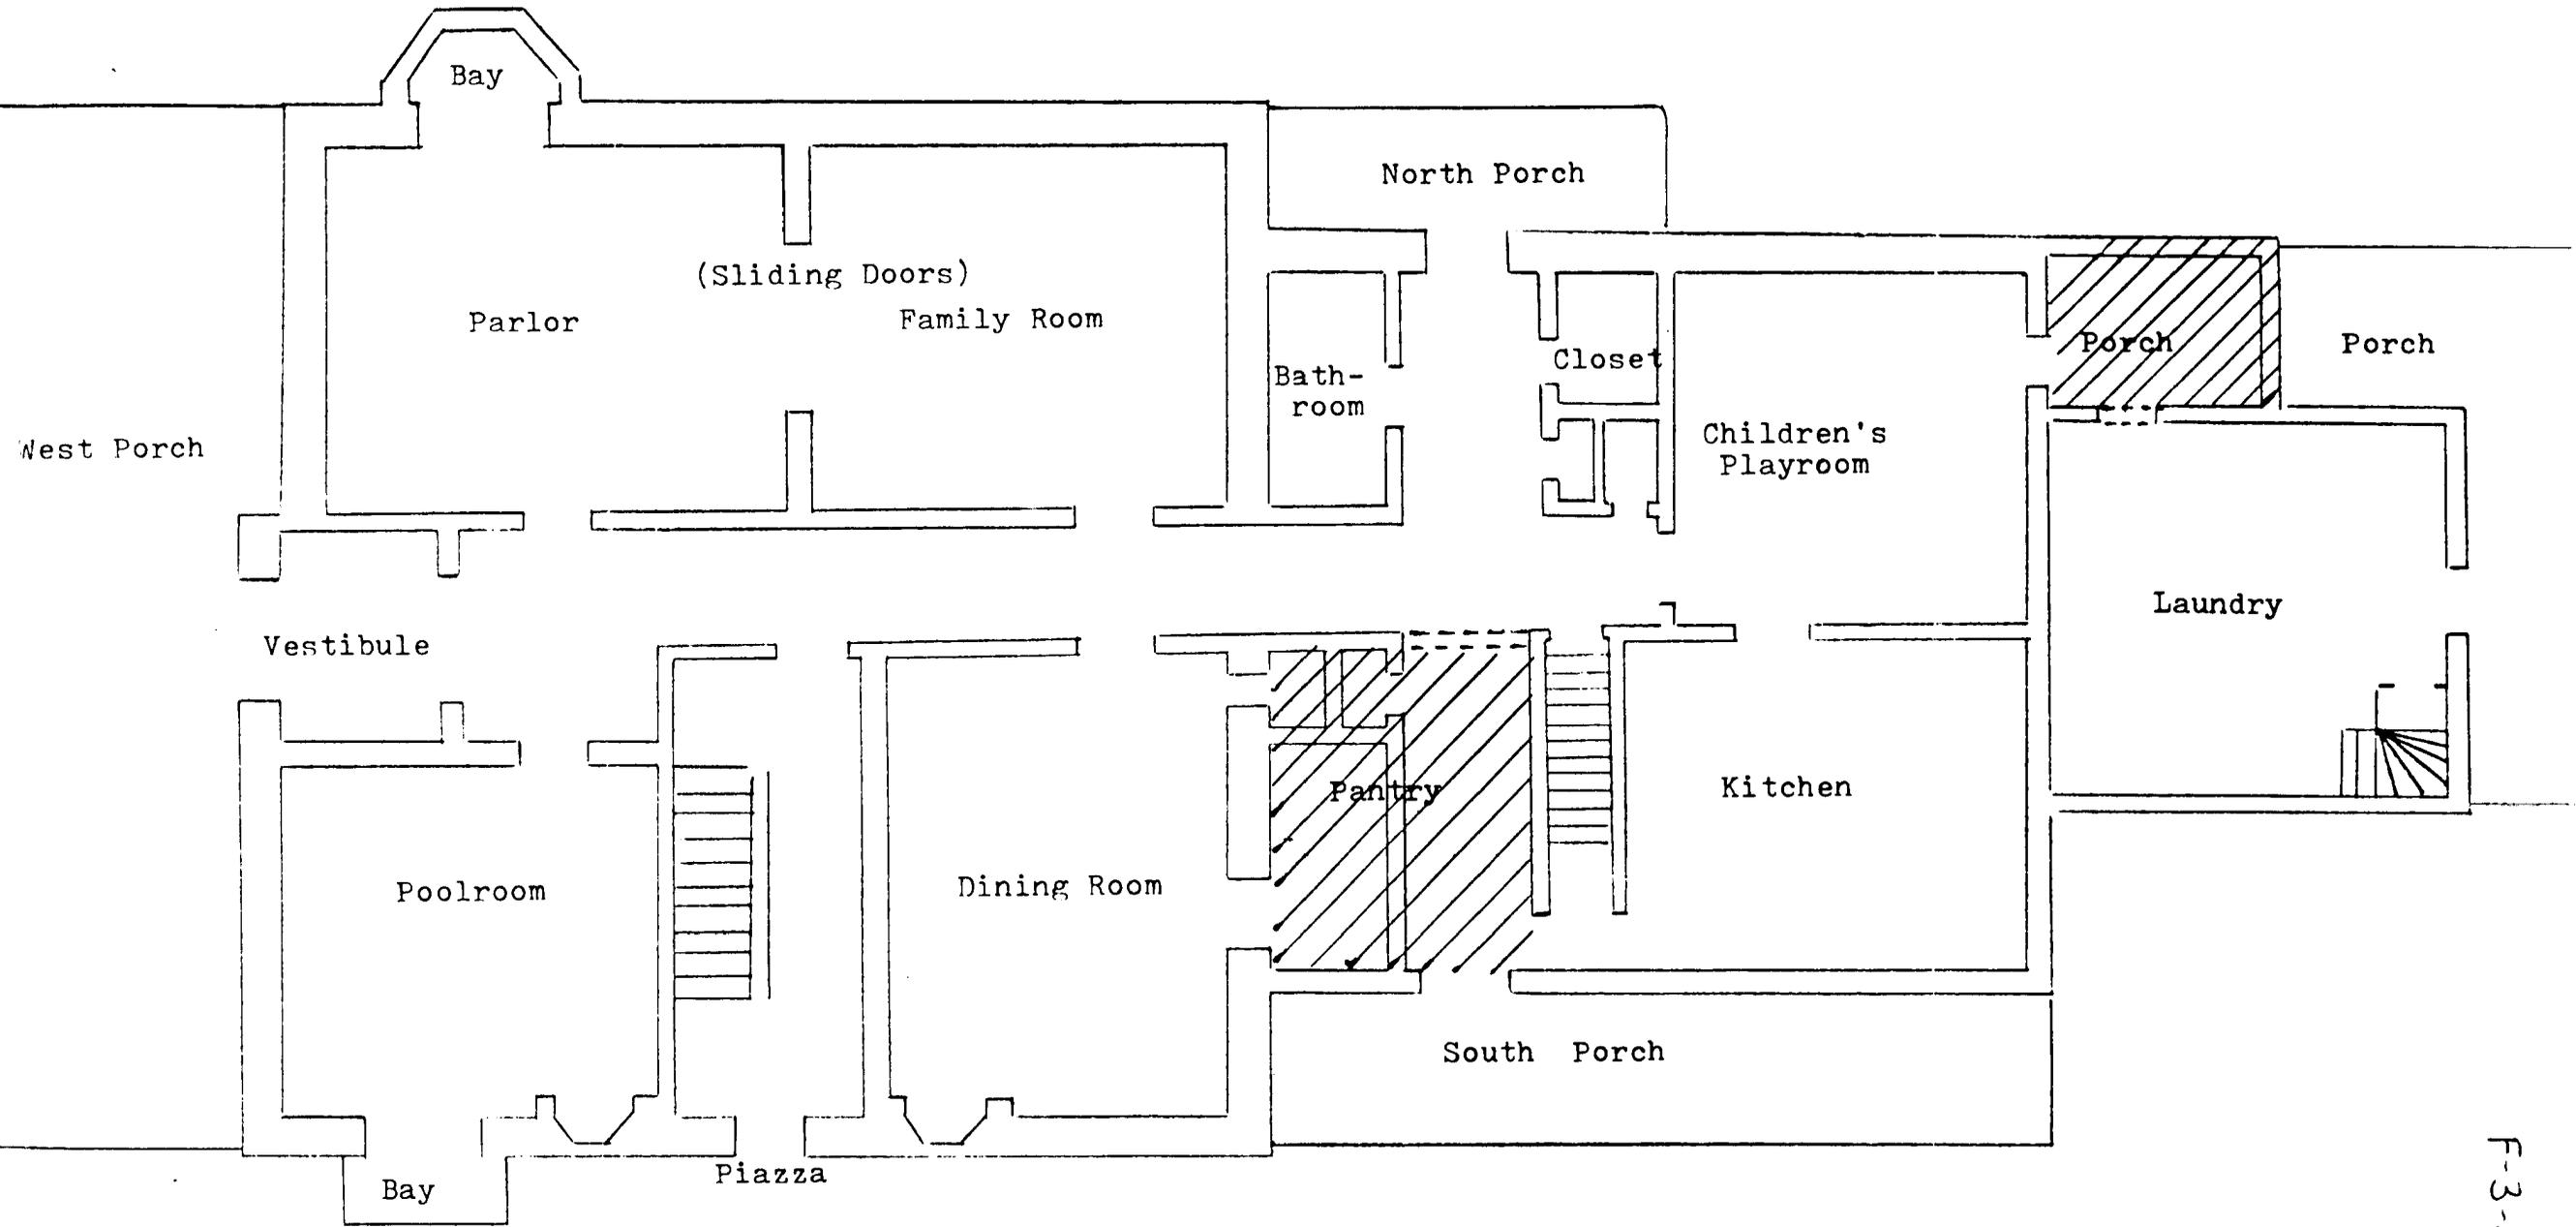
FIRST LEVEL: 1880-1923

Note: Cross hatched areas indicate areas which have been removed.

Between 1924 and 1926, the then-current owners made several renovations, planned by their son, who was studying architecture at the time. These renovations are enumerated below:

1. A new herring-bone pattern brick porch deck replaced a wood frame porch on the west (front) facade.
2. The balustraded second level porch on the west facade was removed and a standing-seam, sloped roof installed.
3. Sills to all original floor-to-ceiling windows across the west (front) first level were raised 22 inches. Interior shutters (lower sections) were removed and facing panels altered to accommodate new sill heights. Upper panels were nailed in place - not to be reopened. (A tobacco tin with a note inside was found inside a shutter casing that was opened in 1980. On the paper was written the date: February 24, 1924 and the name J. D. Ford.)

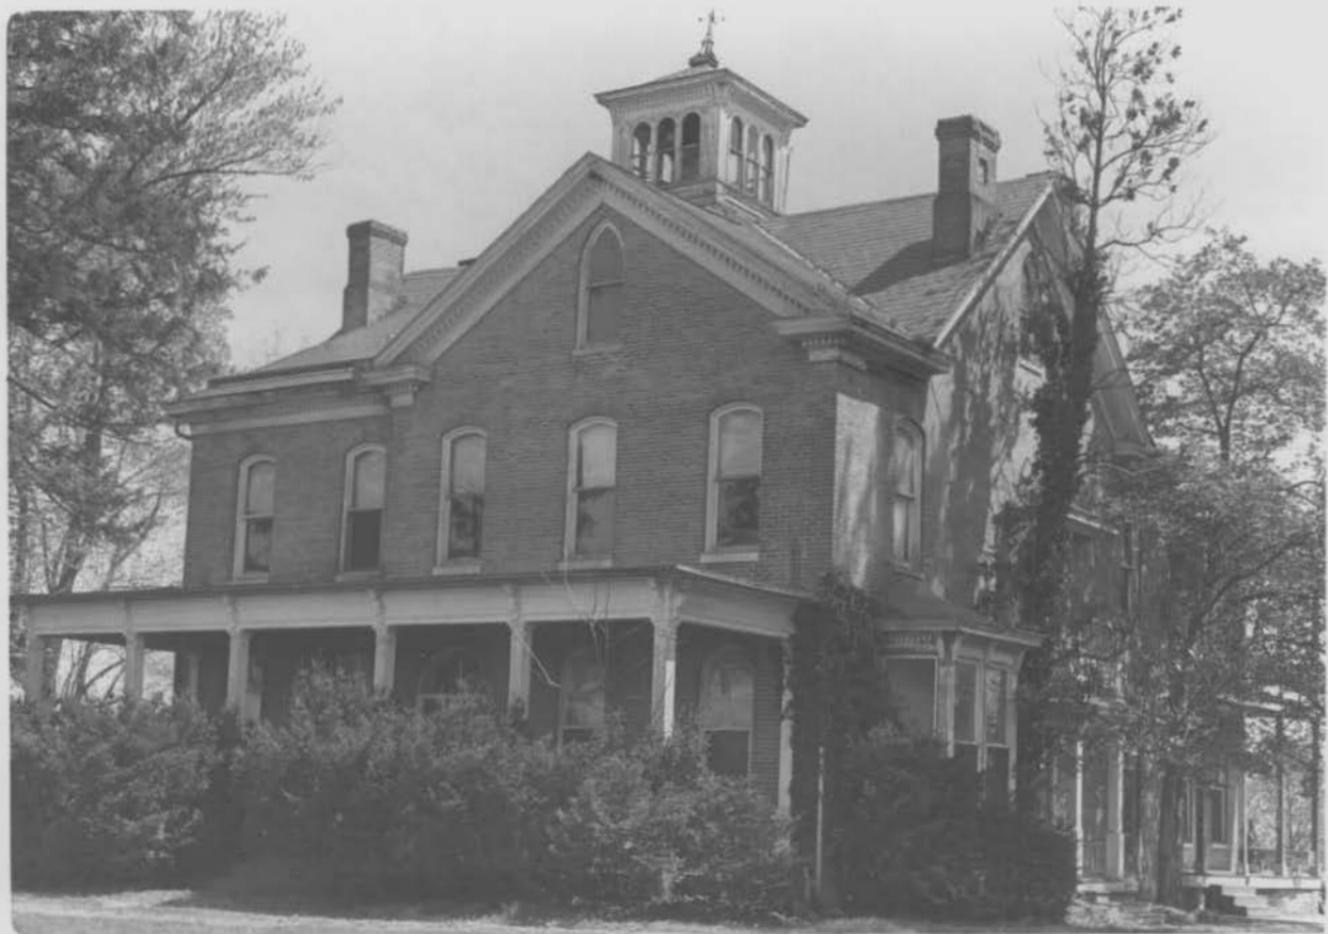
West elevation

Spring Bank is a two and one-half story cross gable vernacular brick residence constructed in 1880 which faces west from the east side of Worman's Mill Road in the small community of Harmony Grove. The principal facade is five bays wide. The southern three bays project slightly forward of the main block of the house. The main entrance, located in an arched paneled opening with radiating stretchers, is twin two panel doors with upper arched panel and plain elliptical transom. The exterior doors open into an entrance foyer with alternating square black and white tile floor. The doors to the interior of the house are twin two panel doors with copper-wheel-etched glass inserts and etched glass elliptical transom in a flower basket design.

Located in the remaining bays on the first level are tall double hung 1/1 semicircular windows with radiating stretcher arches. Located in each bay on the second level are double hung 1/1 segmental windows with radiating stretcher arches. Centered in the front gable of the house is a 1/1 lancet window.

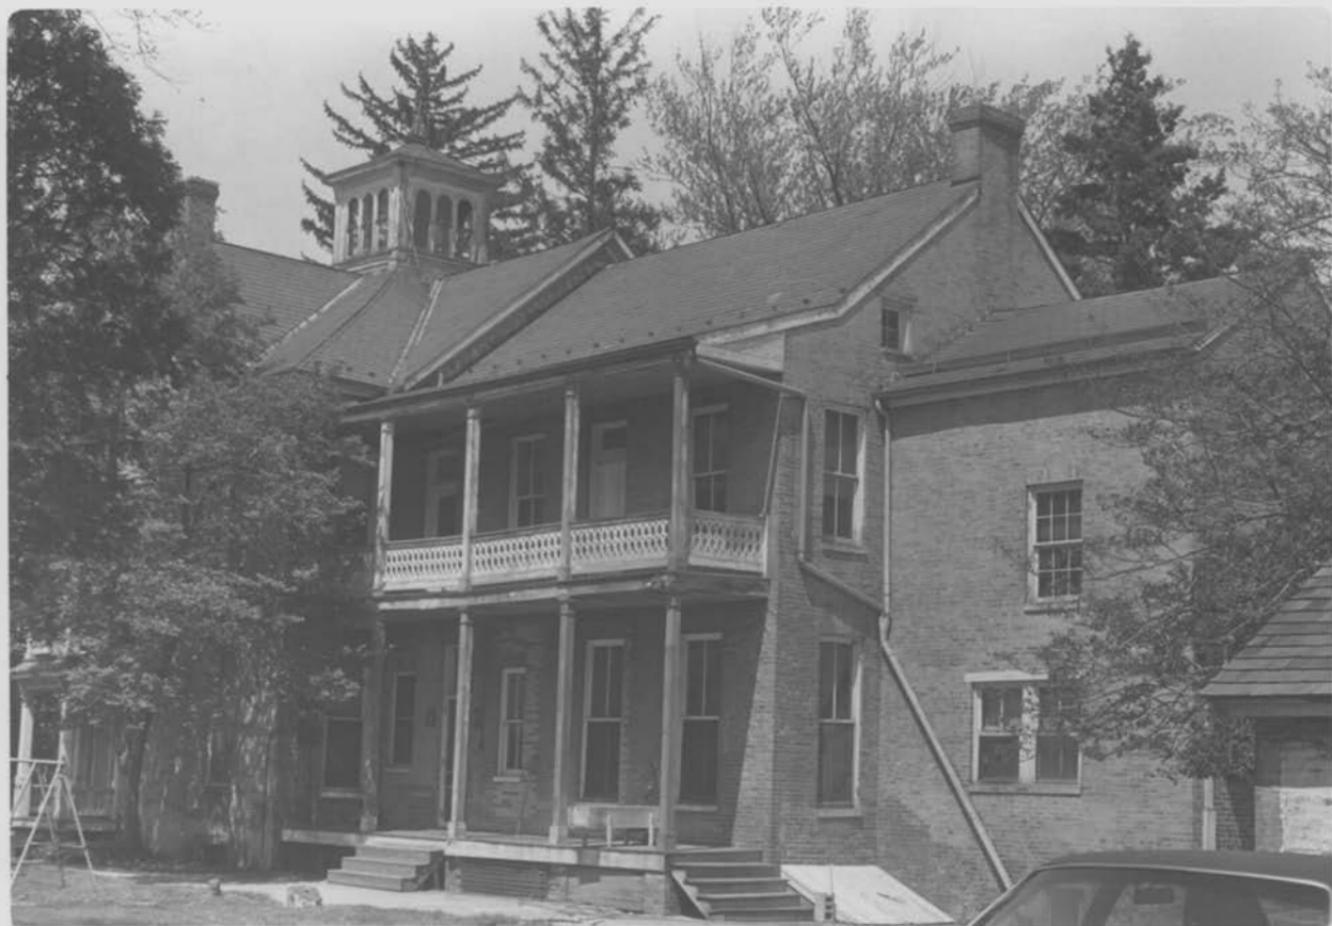
Elevation

The south side of the building is the most ornately decorated side. A frame bay window with four double hung 1/1 windows with paneled aprons supported by brick foundation and covered with a hipped composite roof with boxed cornice, dentiled frieze and small brackets is located in the first bay from the southwest corner. A plain 1/1 semicircular window with radiating stretchers is located immediately over this bay window in the first bay on the second level.

A side entrance and porch are located in the second bay on the first level shaded by a canopy on the second level. The entrance is a five panel door with single light transom. The porch is a small one bay wide frame porch with four wood boxed columns supporting a flat composition roof with boxed wood cornice, dentiled frieze, and small scrolled brackets. A small wood balcony with boxed wood columns topped by turned wood finials and with decorative wood railing is located above the porch. A plain double hung 1/1 window is located over the porch. A triangular composition roof with turned wood finial supported by scrolled brackets and decorated with scalloped edges is located over the porch and window.

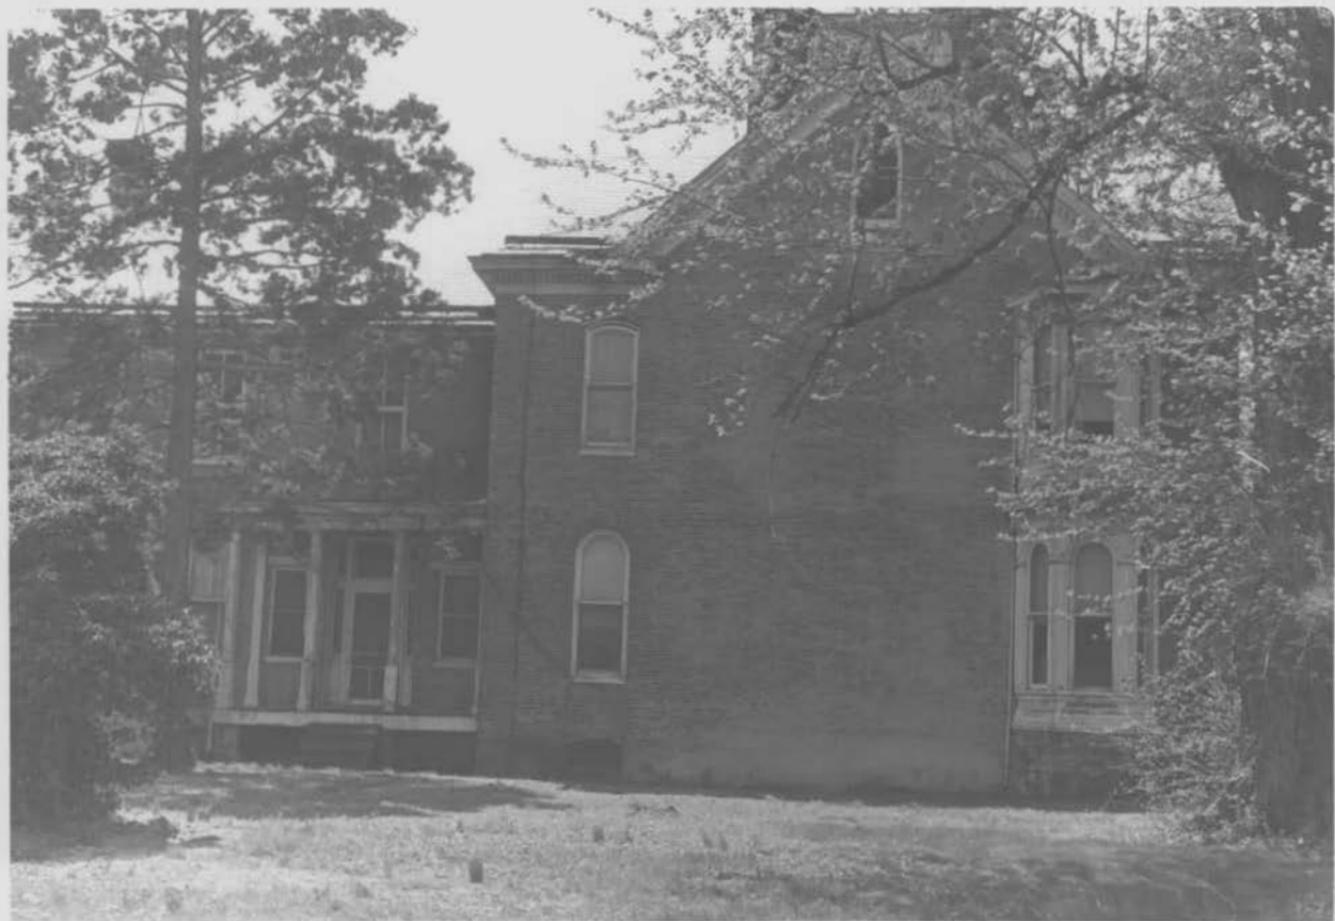
North elevation

The north side of the main block of the building is two bays wide. Located in the first bay from the northwest corner of the building is a two story projecting bay window constructed on a brick foundation with three arched 1/1 windows surrounded by raised and molded panels with dentiled frieze and boxed cornice supported by scrolled brackets.

Located in the second bay on the first level is a double hung 1/1 semi-circular window with radiating voussoirs. A double hung 1/1 segmental window with radiating arch is located in the second level. A 1/1 lancet arch window is centered in the north gable.

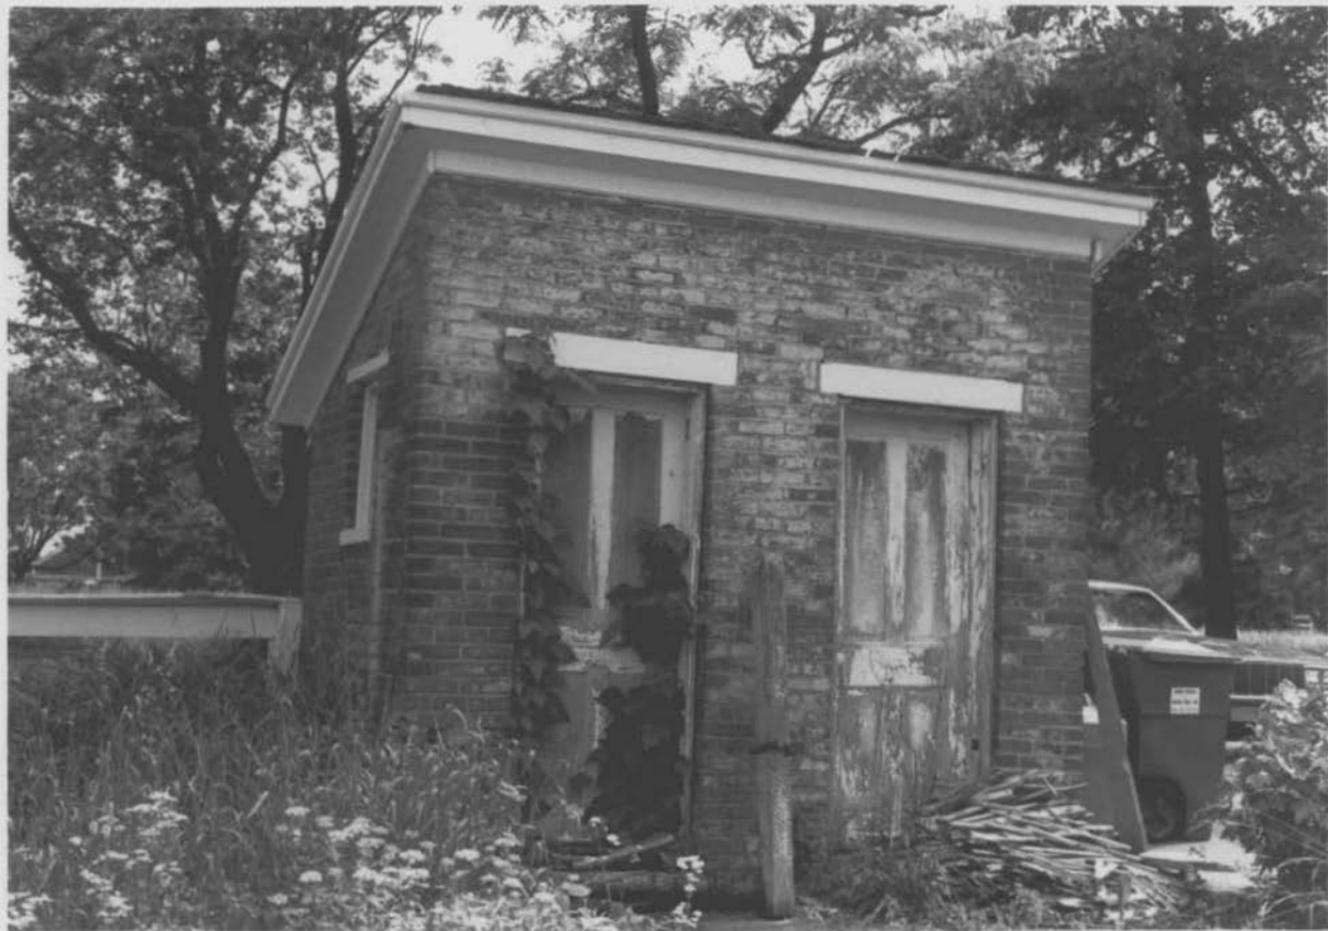
Privy  
9/20

The front yard of the site bordering Worman's Mill Road is delineated by a decorative cast iron fence with granite posts and foundation. The site once part of a two hundred acre farm is now contained in ten and one half acres which also includes a one story brick gas house constructed c. 1900 with a standing seam gable roof, a one and one half story carriage house three large bays wide (originally five) constructed in brick c. 1880 with a slate gable roof, a one story brick smoke house with wood shake gable roof, c. 1880, and a two bay wide privy with interior plaster walls and wood shake shed roof c. 1880.

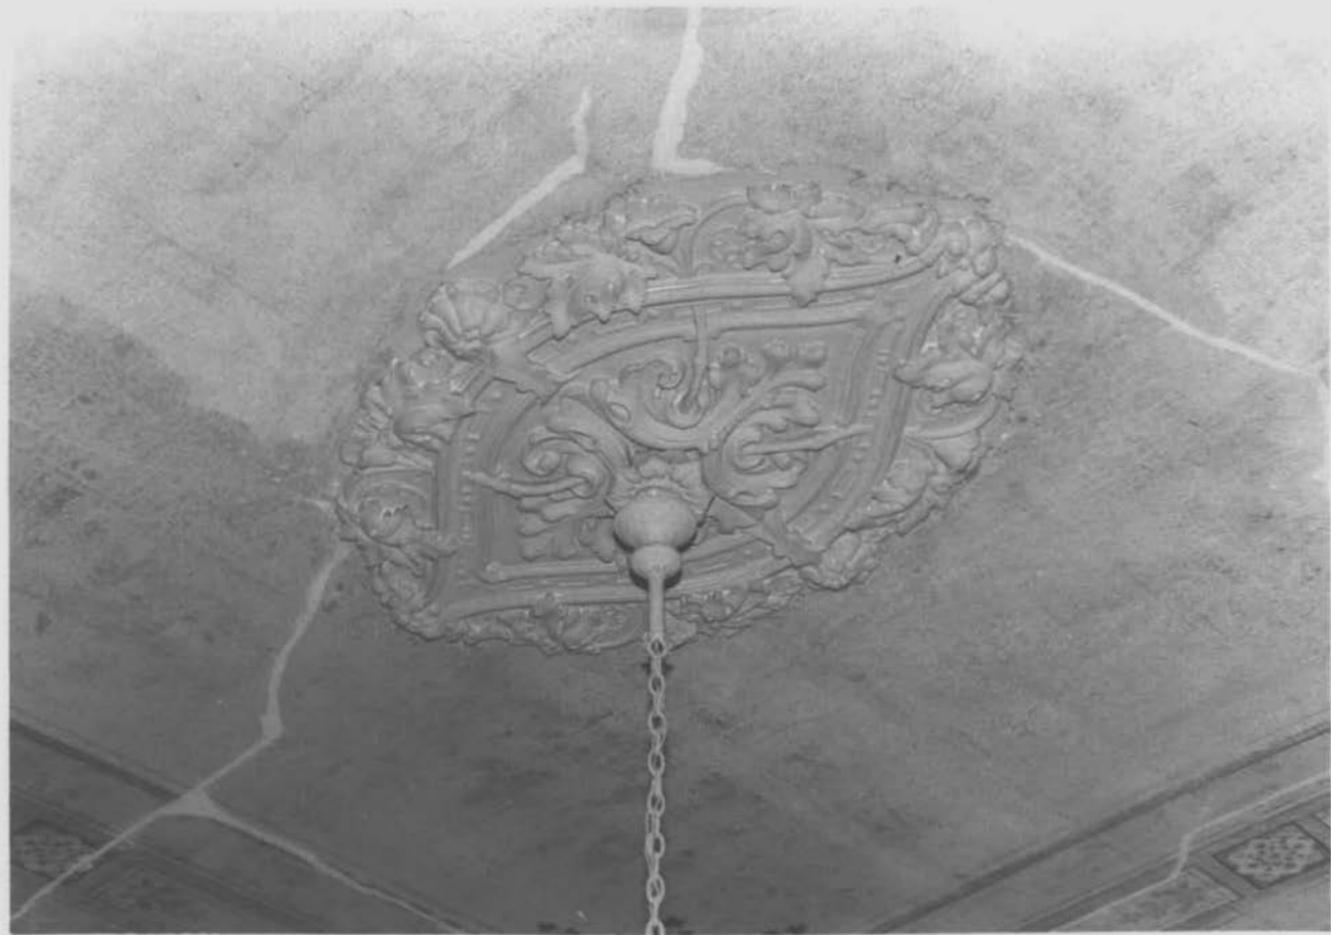
Neg Loc: MHT  
Plaster Medallion  
First level  
15/20

The high style characteristics continue on the interior of the house with floral stencilling on the walls and ceilings, imitation marbled slate fireplaces, wood graining on door panels and baseboards. The interior entrance is particularly significant with a diamond patterned floor of slate and marble, simulated leather wallpaper and twin arched doors with copper wheel etched glass panels and transom in flower basket design. Gas fixtures also survive in some locations.

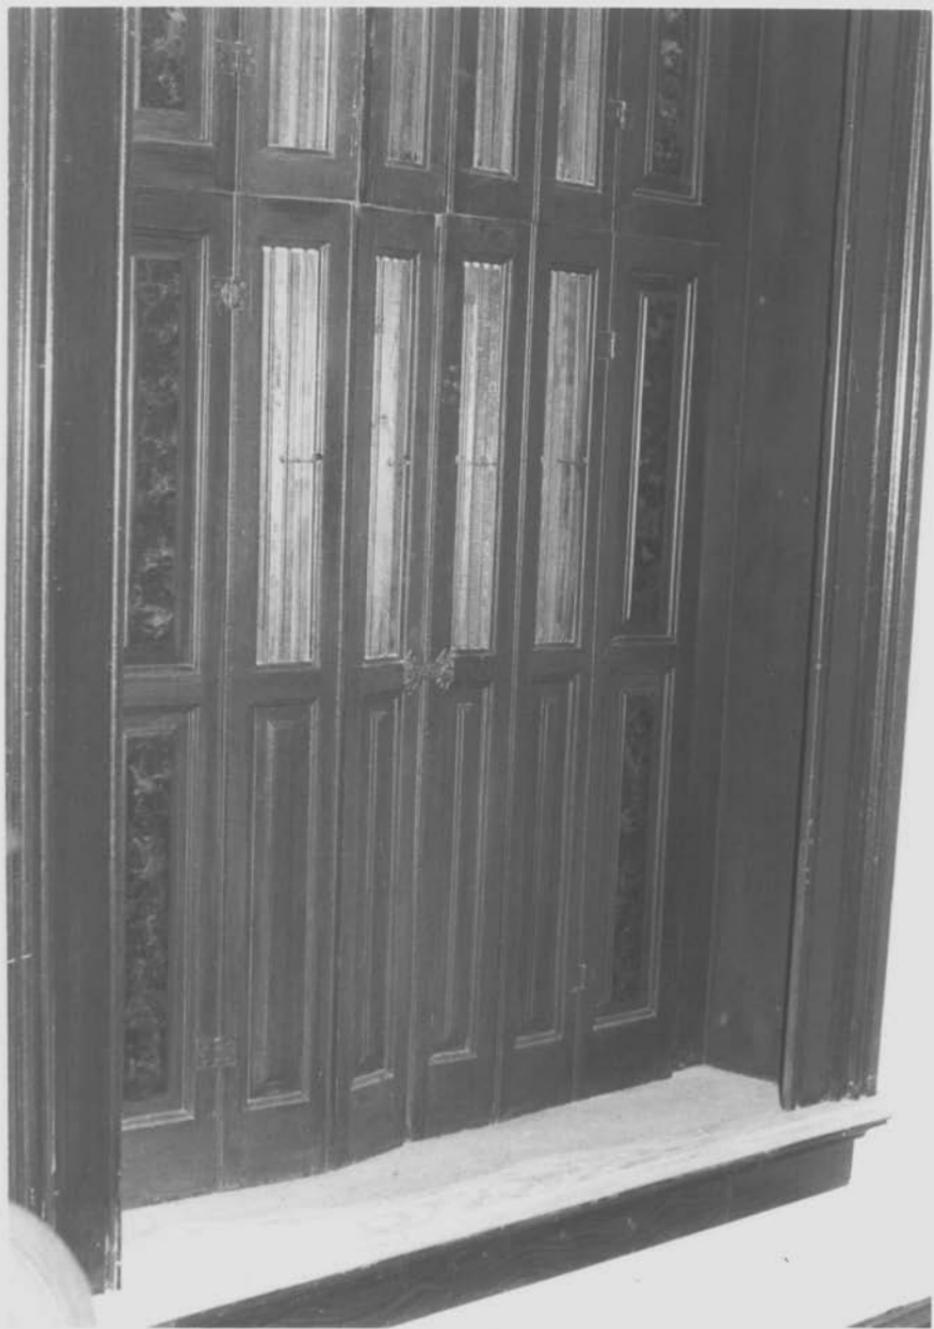
Spring Bank  
WORMAN'S Mill Rd  
Frederick, MD  
Photo: C. Widell  
MAY, 1984  
Neg Loc: MHT  
Detail of Paneled  
Shutters

Spring Bank is primarily significant for its architecture, as a well-preserved example of a type of late 19th century dwelling combining Gothic and Italianate influences which appears in rural contexts in north Central Maryland. This form clothes the traditional 5 bay, double pile, 2½ story farmhouse in high-style ornament, including such Gothic-derived details as lancet-arched windows and projecting bays and an irregular multigabled roof clad in fishscale patterned slate, along with an Italianate belvedere and tall round-arched (originally floor-to-ceiling) windows opening onto a veranda. A number of large brick farmhouses displaying this interplay of conservative form and stylish ornament can be found in Frederick County and adjacent Carroll and Washington Counties; Spring Bank is distinguished among these by its excellent state of preservation. The house retains a wealth of original interior fabric and detail intact; notable features include floral stencil-painted walls and ceilings, plaster cornices and ceiling medallions, marbleized slate mantels and grain-painted doors, interior shutters and baseboards.
