Capsule Summary

Inventory No. F-3-225

Daniel Snook Farm
10200B Old Frederick Road
Frederick County, MD
Ca. 1840; 1831-1941
Access: Public

Maryland Historical Trust Maryland Inventory of Historic Properties Form

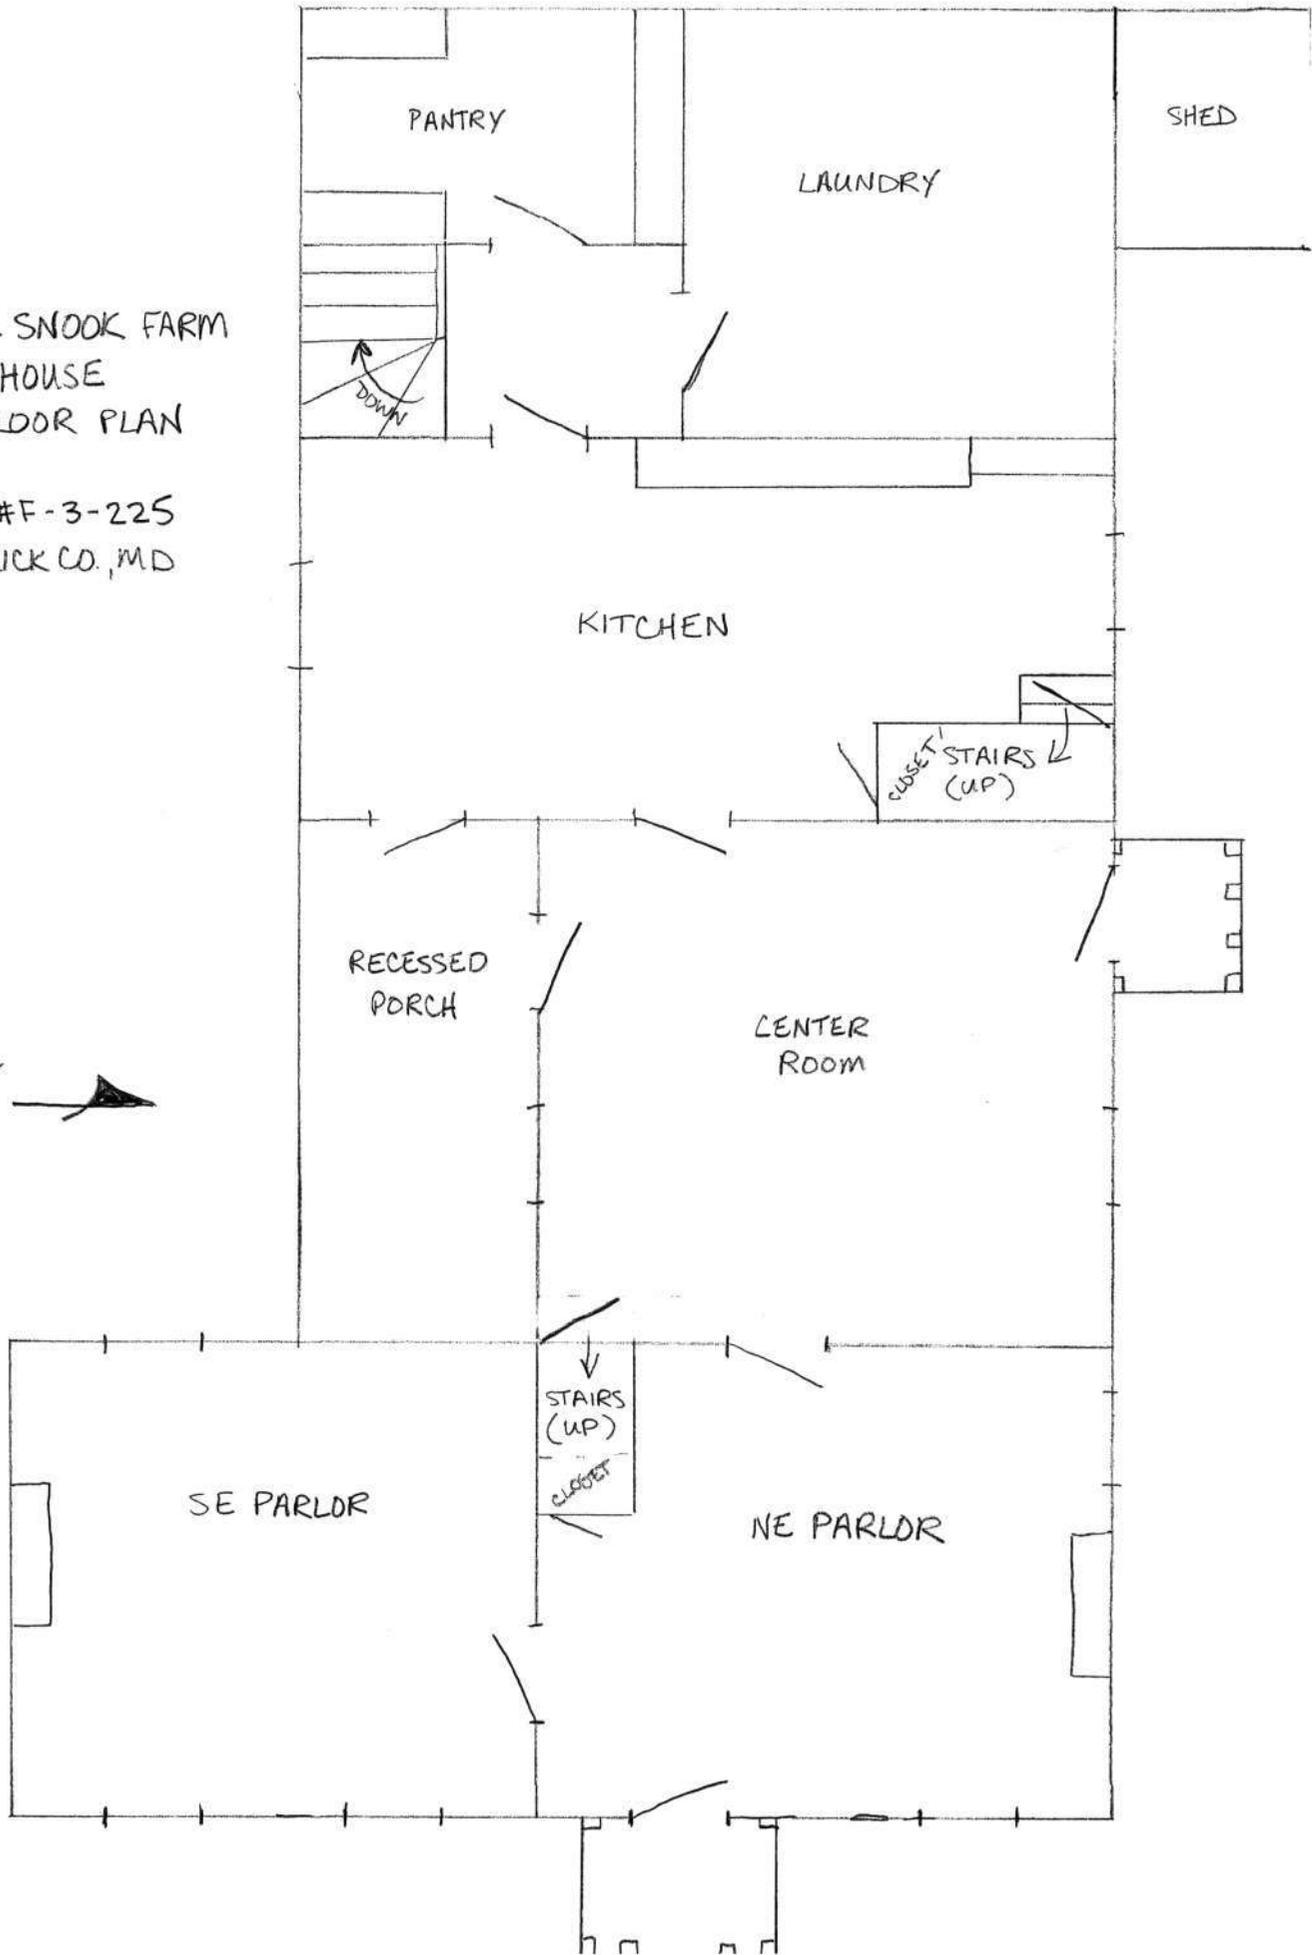
DANIEL SNOOK FARM
MAIN HOUSE
FIRST FLOOR PLAN

Interior: The floor plan of the house (see attached) reveals a German influence. There are two parlors in the front section with two chambers above and two rooms in the ell (back building) with two rooms above. All rooms open one to another without passageways. The ca.

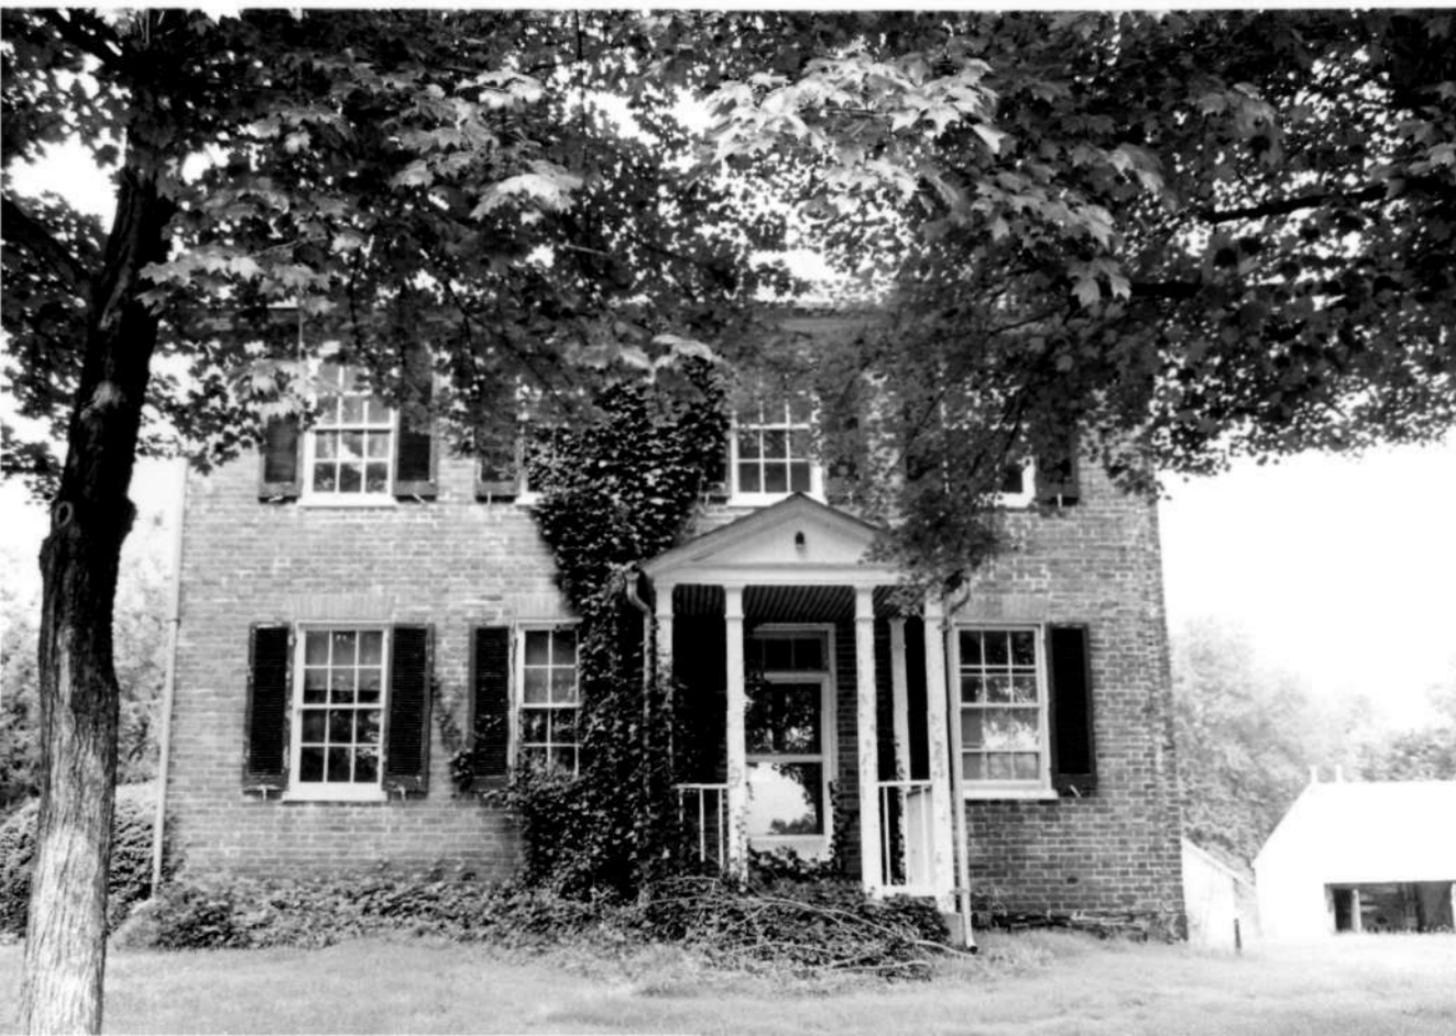
2/47

E elevation, main house

Main House: Constructed ca.1840, the house is a two-story, gable end brick building with Flemish bond on the east (front) elevation and 5:1 common bond on the remaining elevations. It appears that paint has been removed from the brick surface. Evidence of original "staining and striping" remains on some protected bricks. The house stands on a primarily sandstone foundation. It is four bays wide with a window/window/door/window fenestration. Windows over all are six over six light double-hung sash with louvered shutters. Windows have standing brick jack arches above with a slight flare (these rather than wood lintels suggests a mid-1830s date). Most window sash and shutters appear to be original. There is a four light transom over the front door; the entrance jams have molded panels. All doors are six panel; several, including the front door and south door, have the four upper panels replaced with glass. The front (east) and north side entrances have a one-bay porch with pedimented roof supported with four square columns across the front and two pilasters against the wall. Both porches have replacement rails, however the original rounded rail mortise remains visible in the columns.

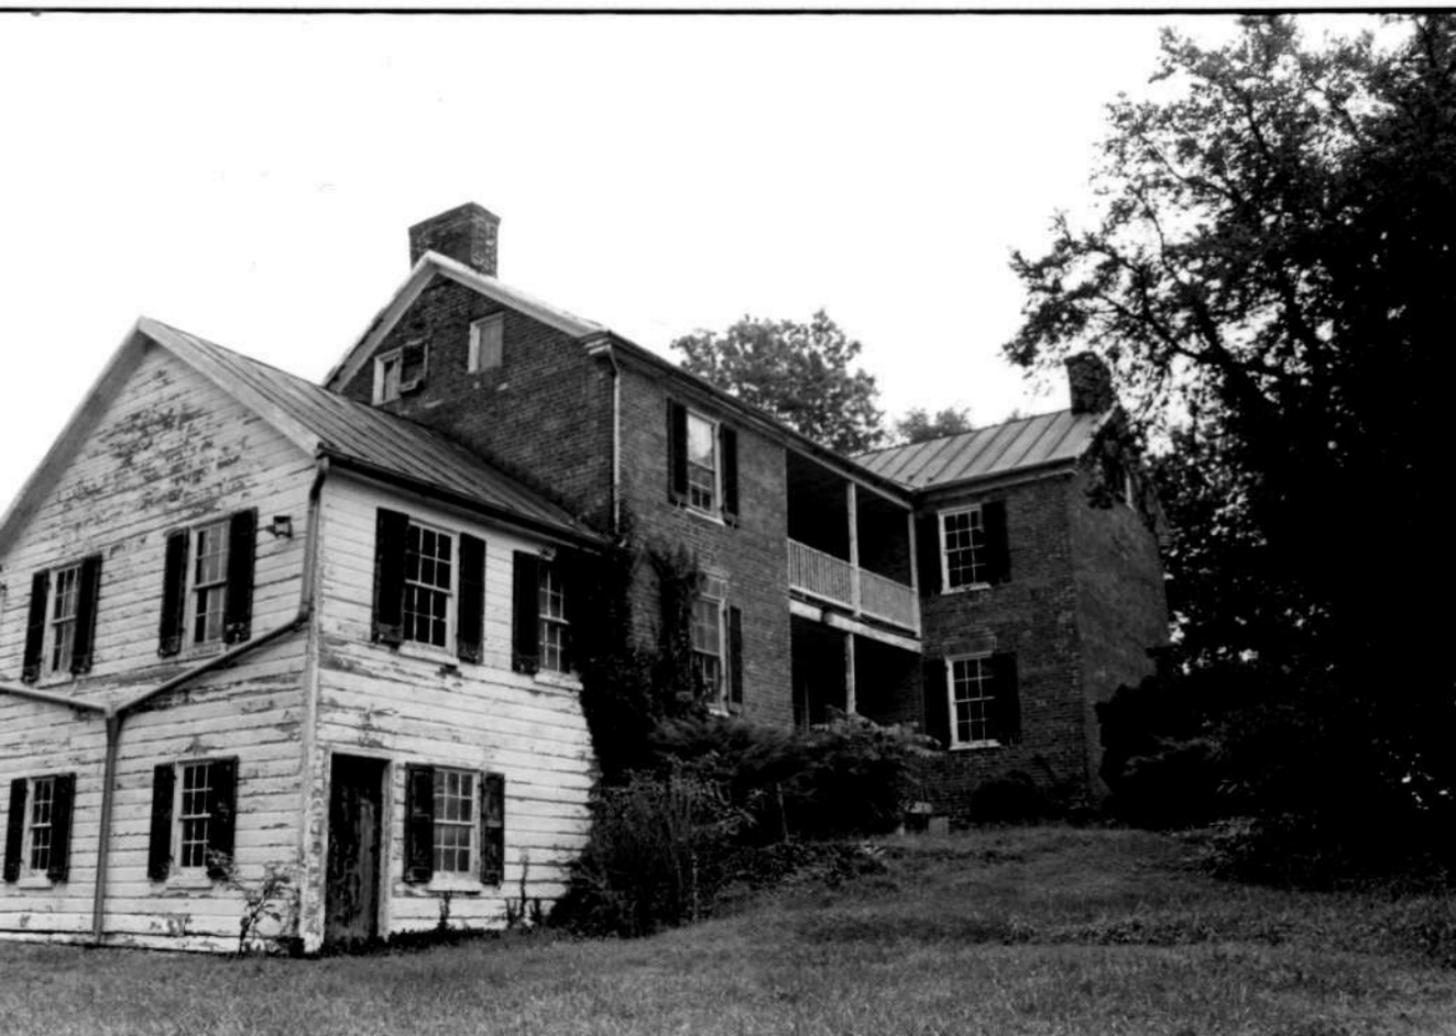
4/4/7

W and S elevations, main house

The house has a brick "ell" back building with a two-story recessed service porch on the south elevation. The lower level of the porch shows evidence of a baseboard, which was later removed. Brick chimneys with stepped corbelling rise from the interior of the north, south, and west gable ends. A one-story frame addition with exposed cellar is located on the west (rear) elevation of the brick ell (documented date of 1873). The addition is covered with original (1873) German board siding. The roof is covered with standing seam metal sheets over all.

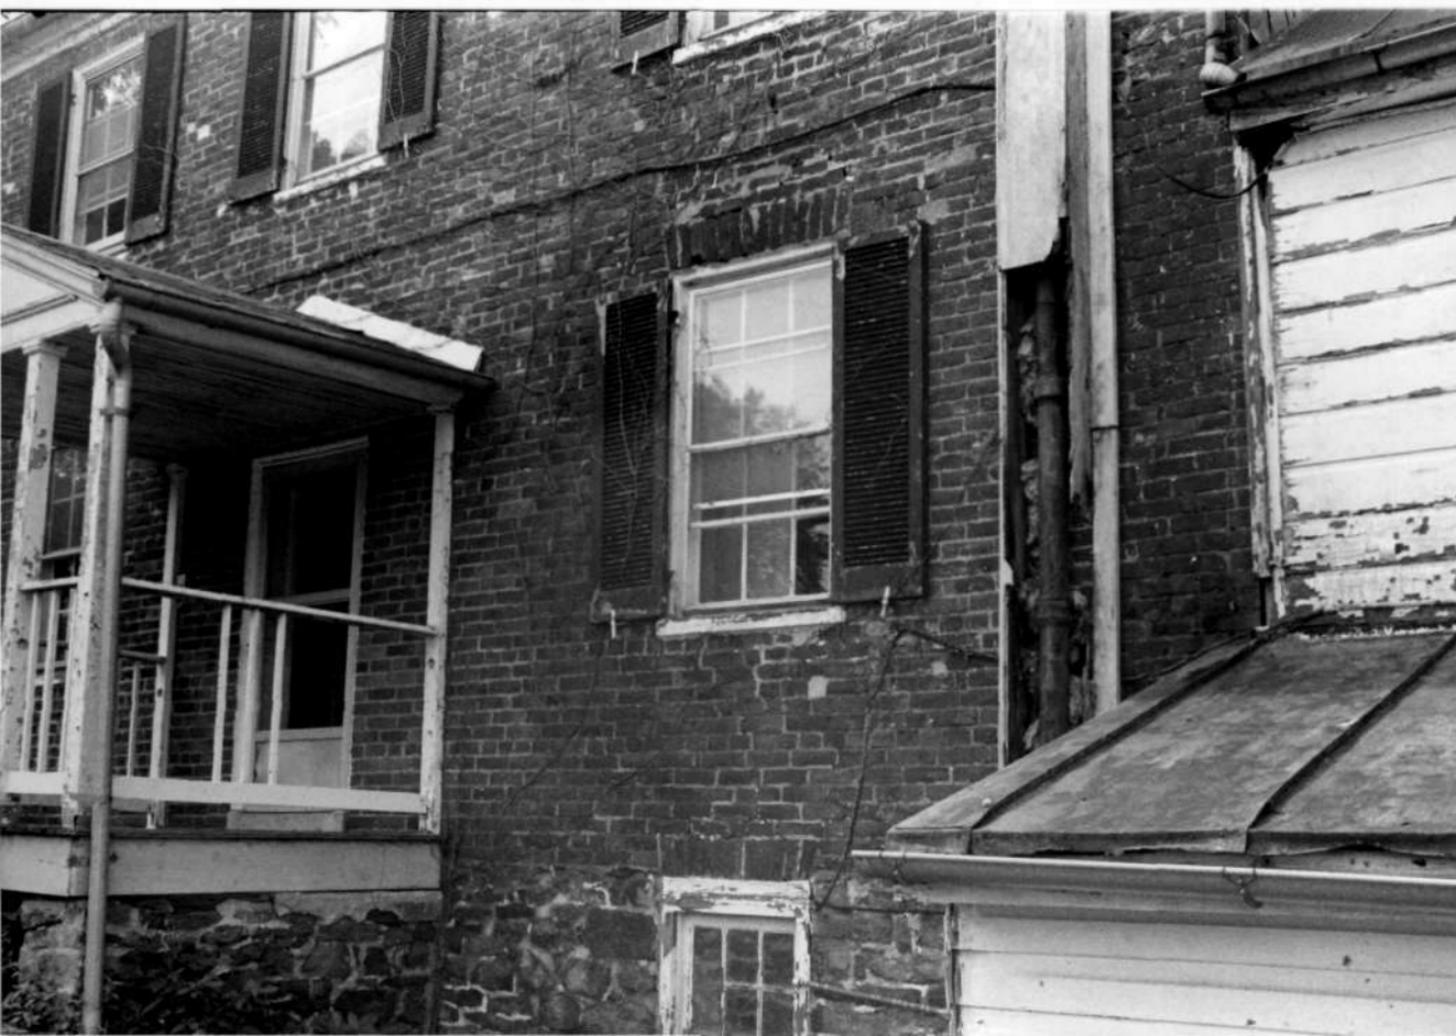
5/47

N elevation, main house

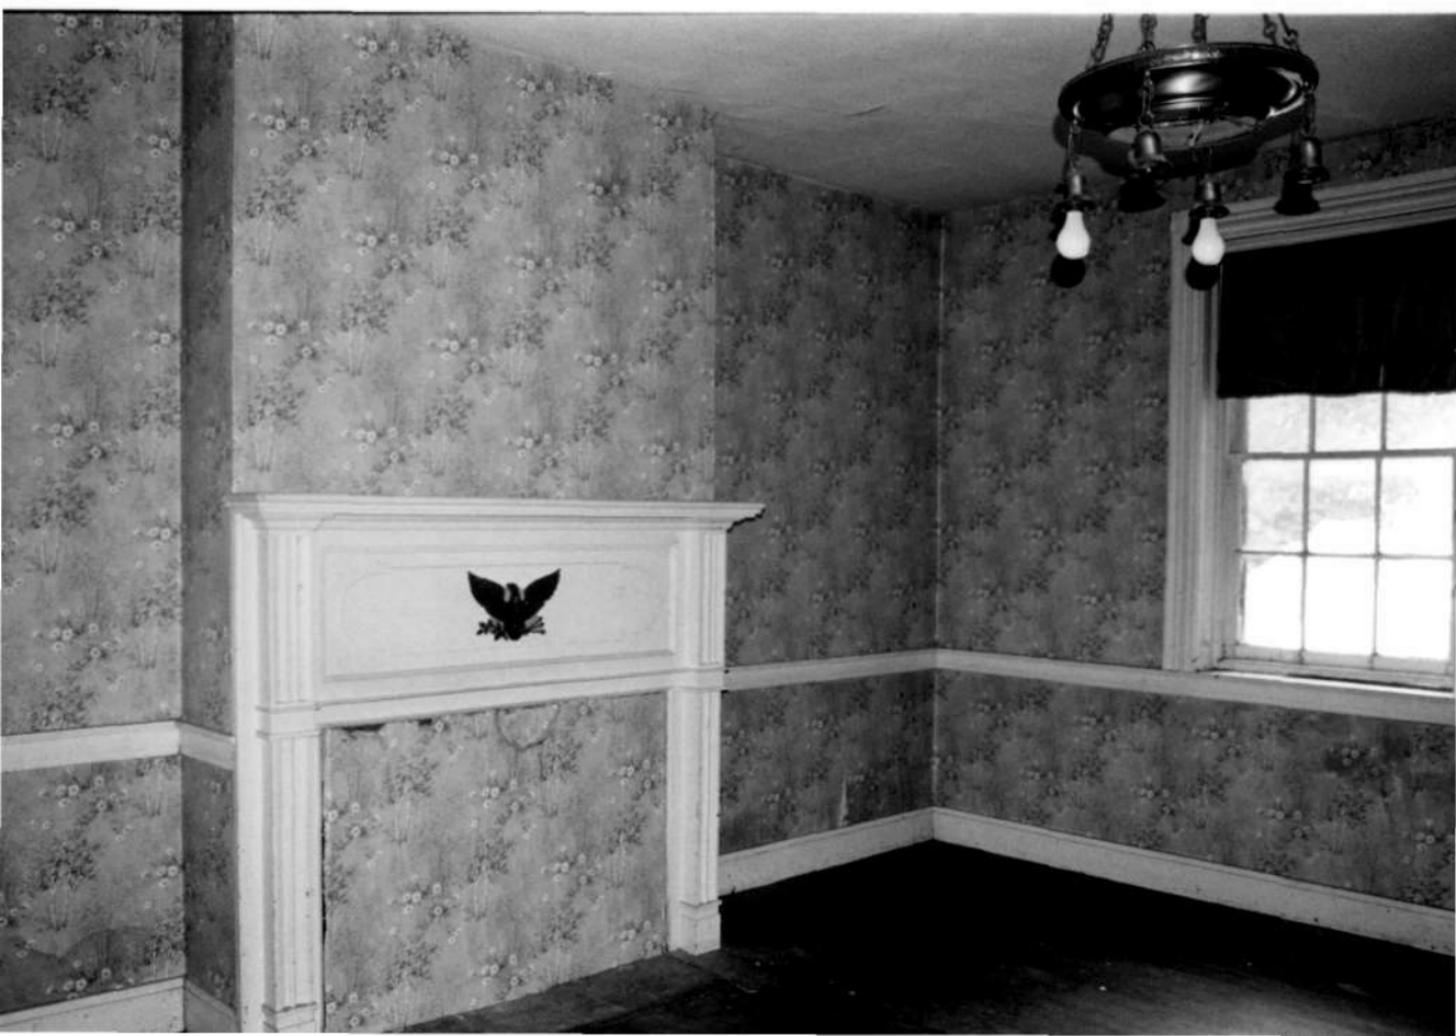
6/47

SE parlor, S and W walls, main house

The southeast parlor has oak flooring, deeply carved symmetrical molded trim with plain corner blocks, chair rail, and the inverted "T" nailer on the east wall. The mantelpiece has a paneled frieze with rounded ends and molded pilasters, a Federal period stylistic carryover. Very significant original porcelain knobs remain on the window architraves for looping ropes for blinds. An early 20th century brass chandelier light fixture hangs from the center of the ceiling.

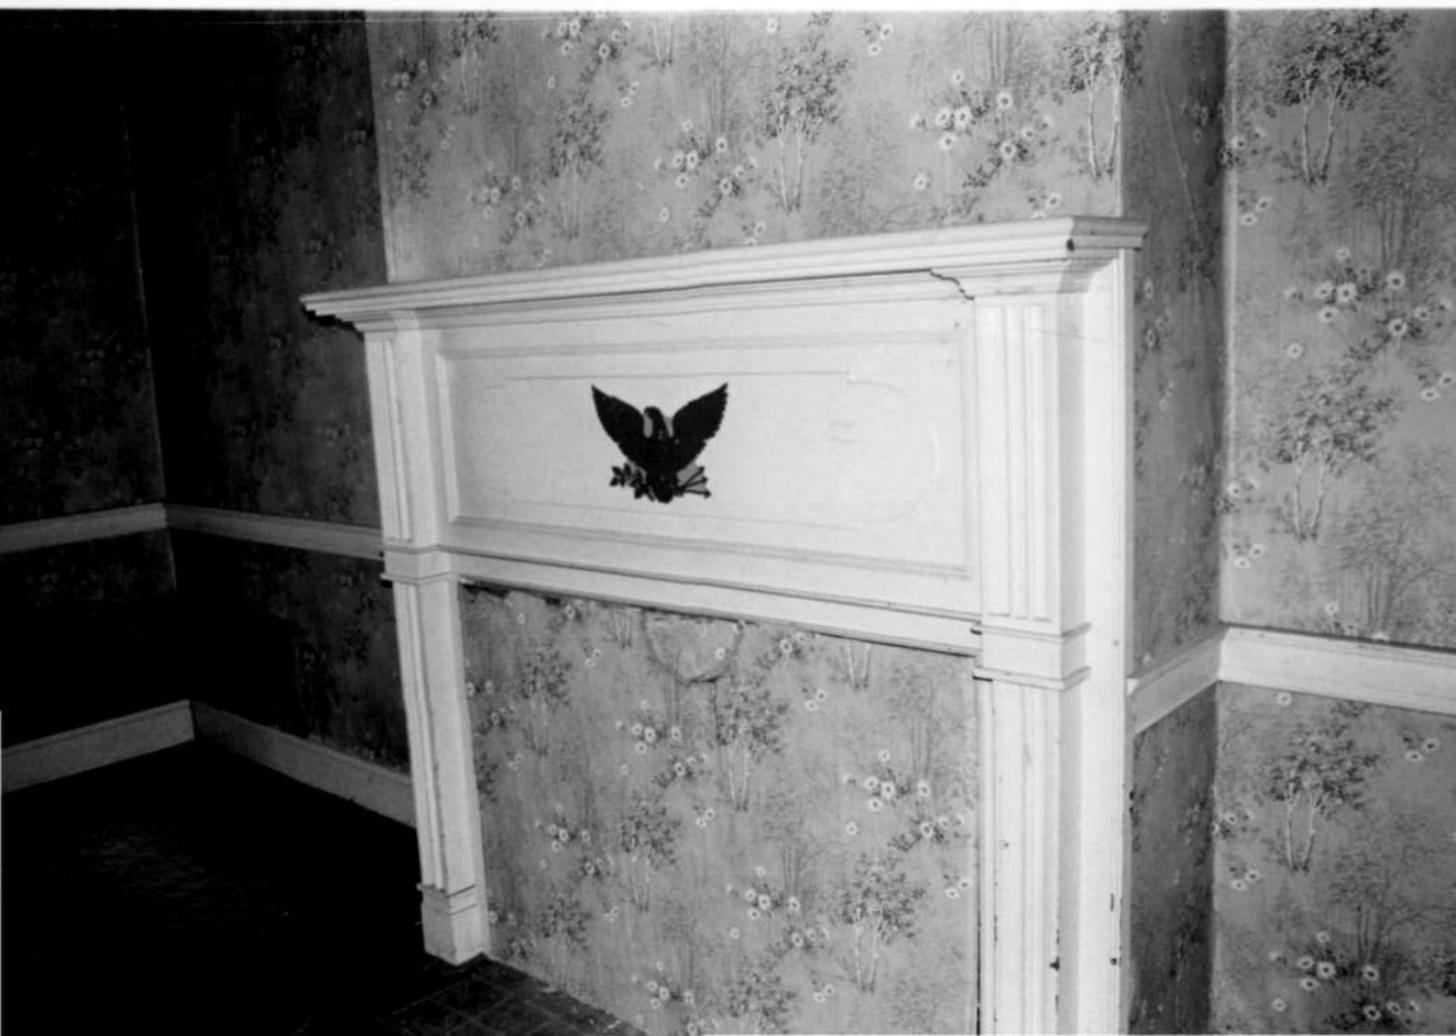
7/47

SE parlor, mantel detail, main house

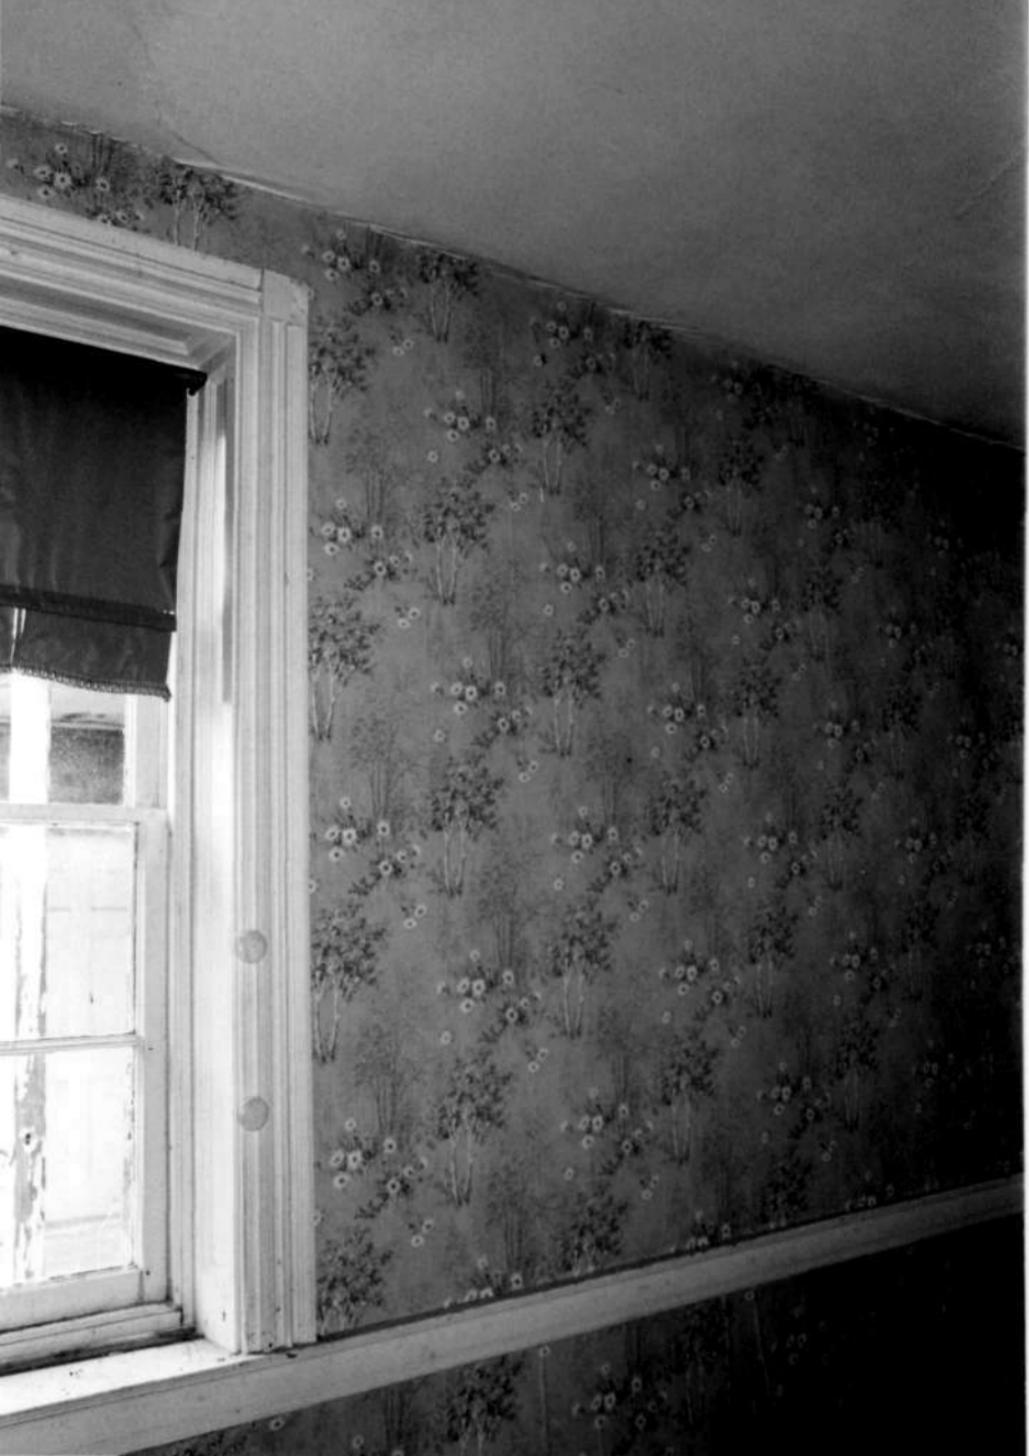
8/47

SE parlor, E wall detail, main house

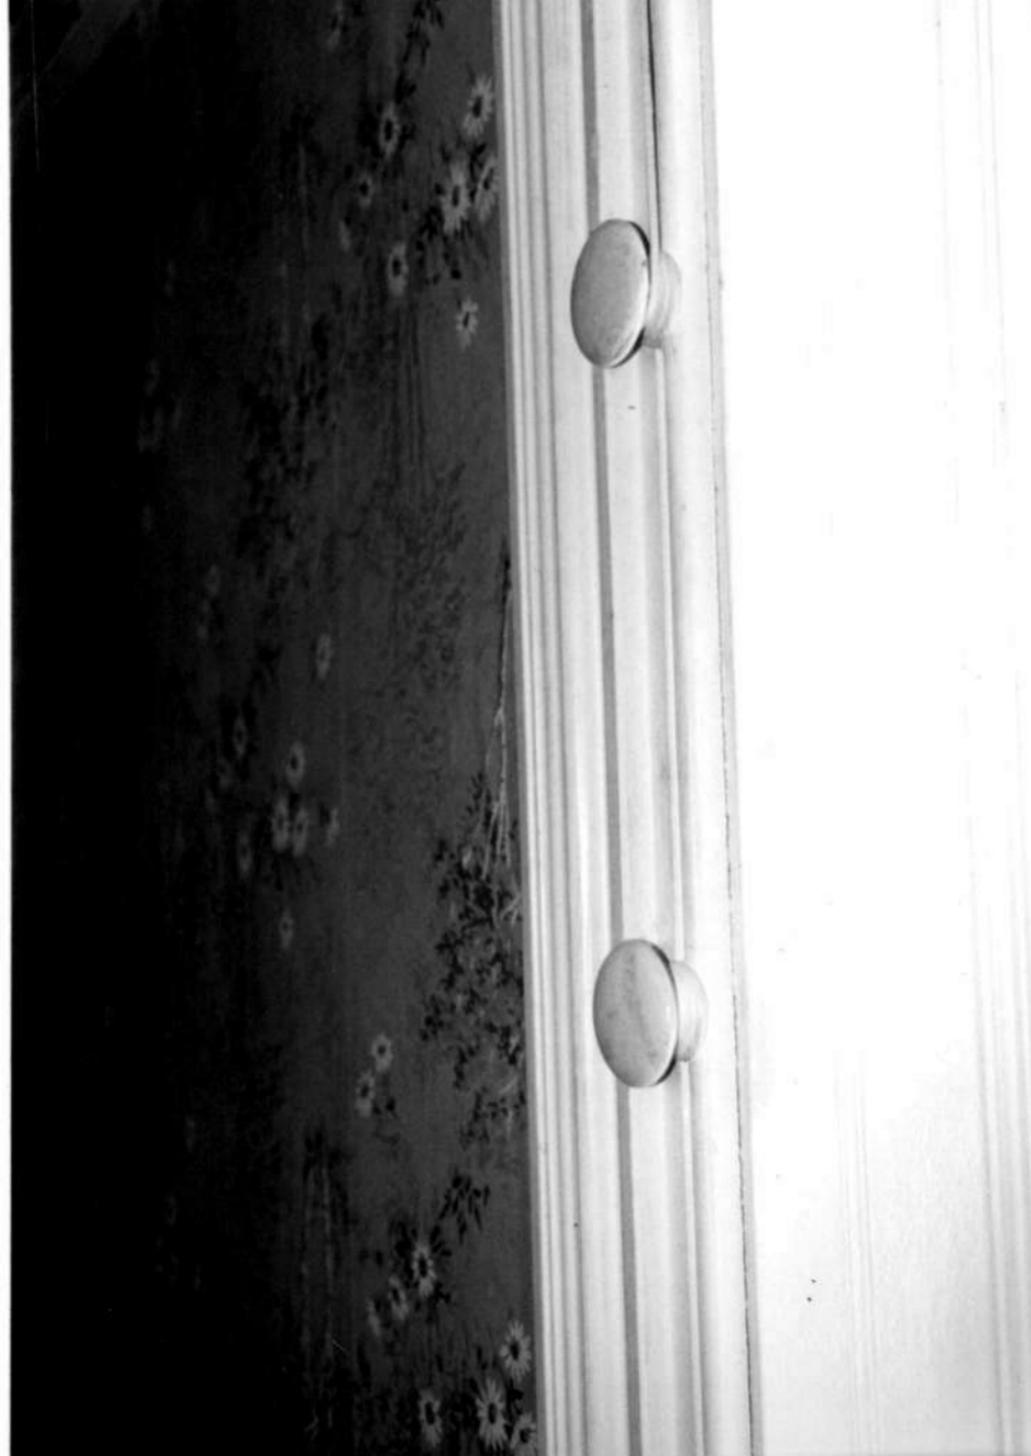
9/47

SE parlor, sash knob detail, main house

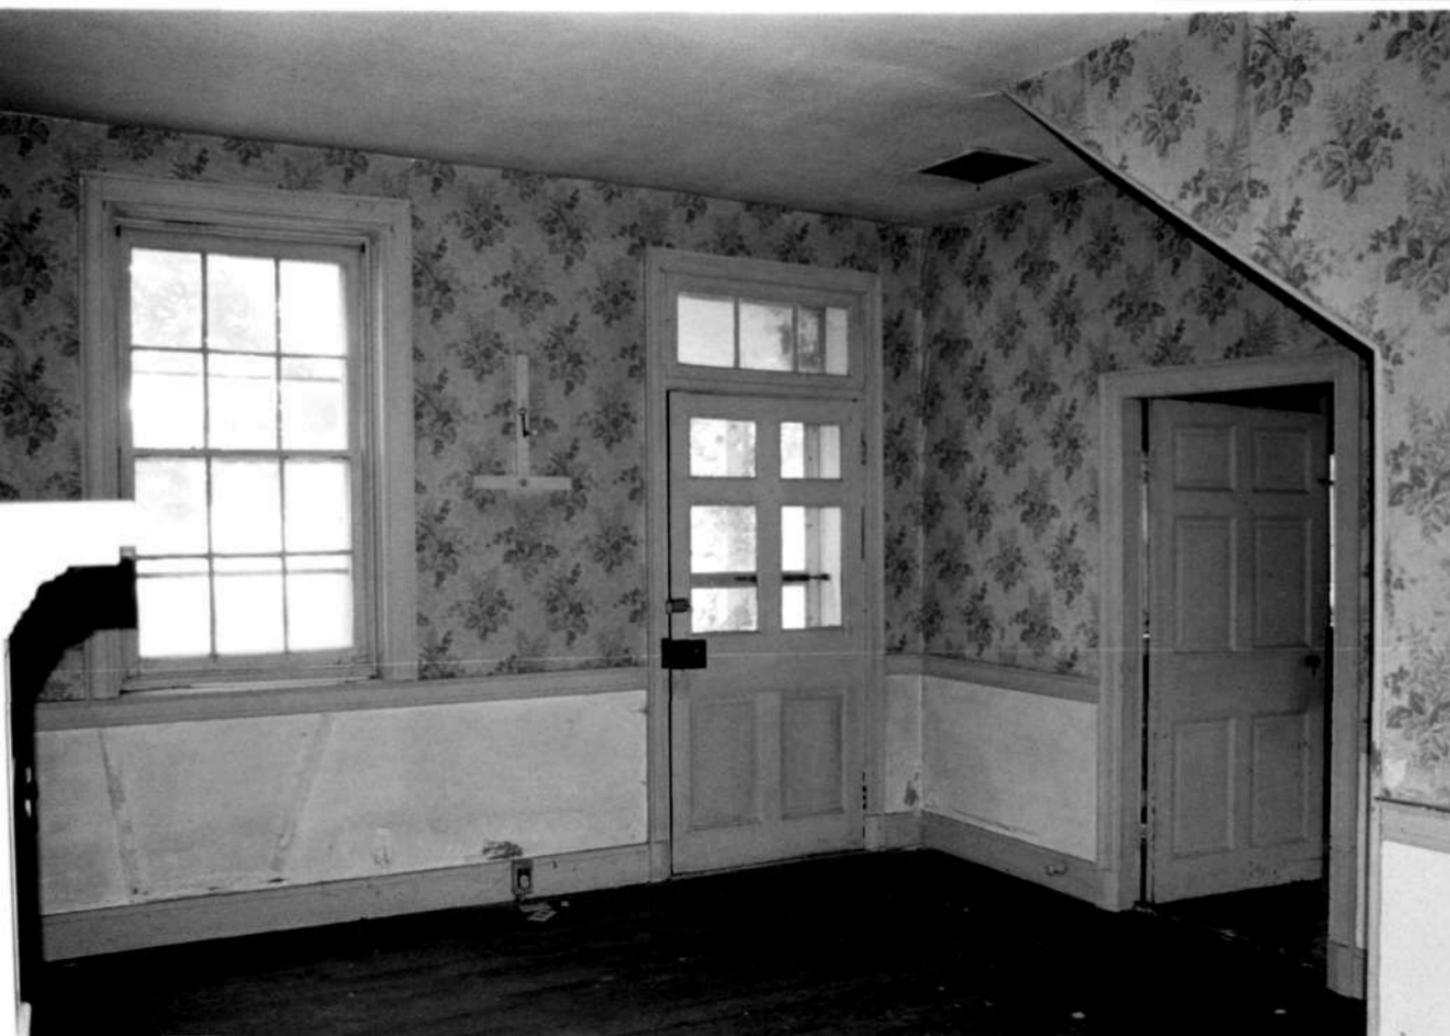
10/47

NE parlor, view toward front (east)
entrance, main house

The east (front) door of the front section of the house opens directly into the northeast parlor. The room has original oak flooring, ogee double-bead molded trim, chair rail, and an inverted "T" wooden nailer on the east wall that appears to have held an oil lamp. The mantelpiece on the north wall has both Federal and Greek Revival style deeply carved, symmetrical molding, including smooth rounded pilasters and ridged frieze. The fully enclosed stair runs up the interior south wall of this room, however access to the stair is through the west (ell) room. An under-stair closet with peg-board faces the front entrance of the house.

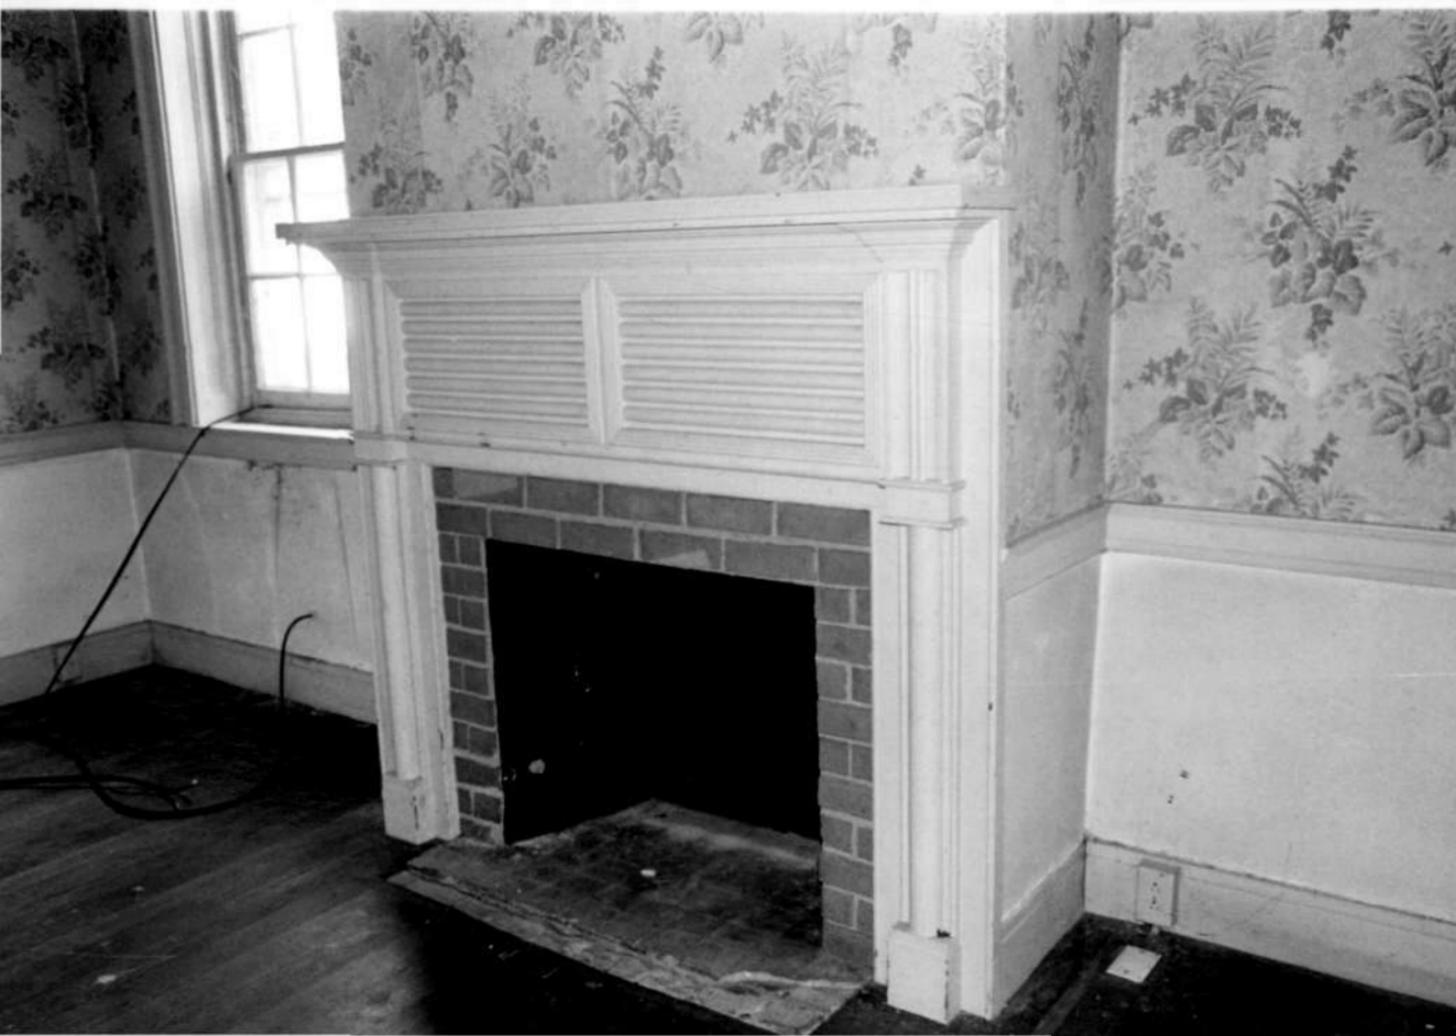
11/47

NE parlor, N wall mantel, main house

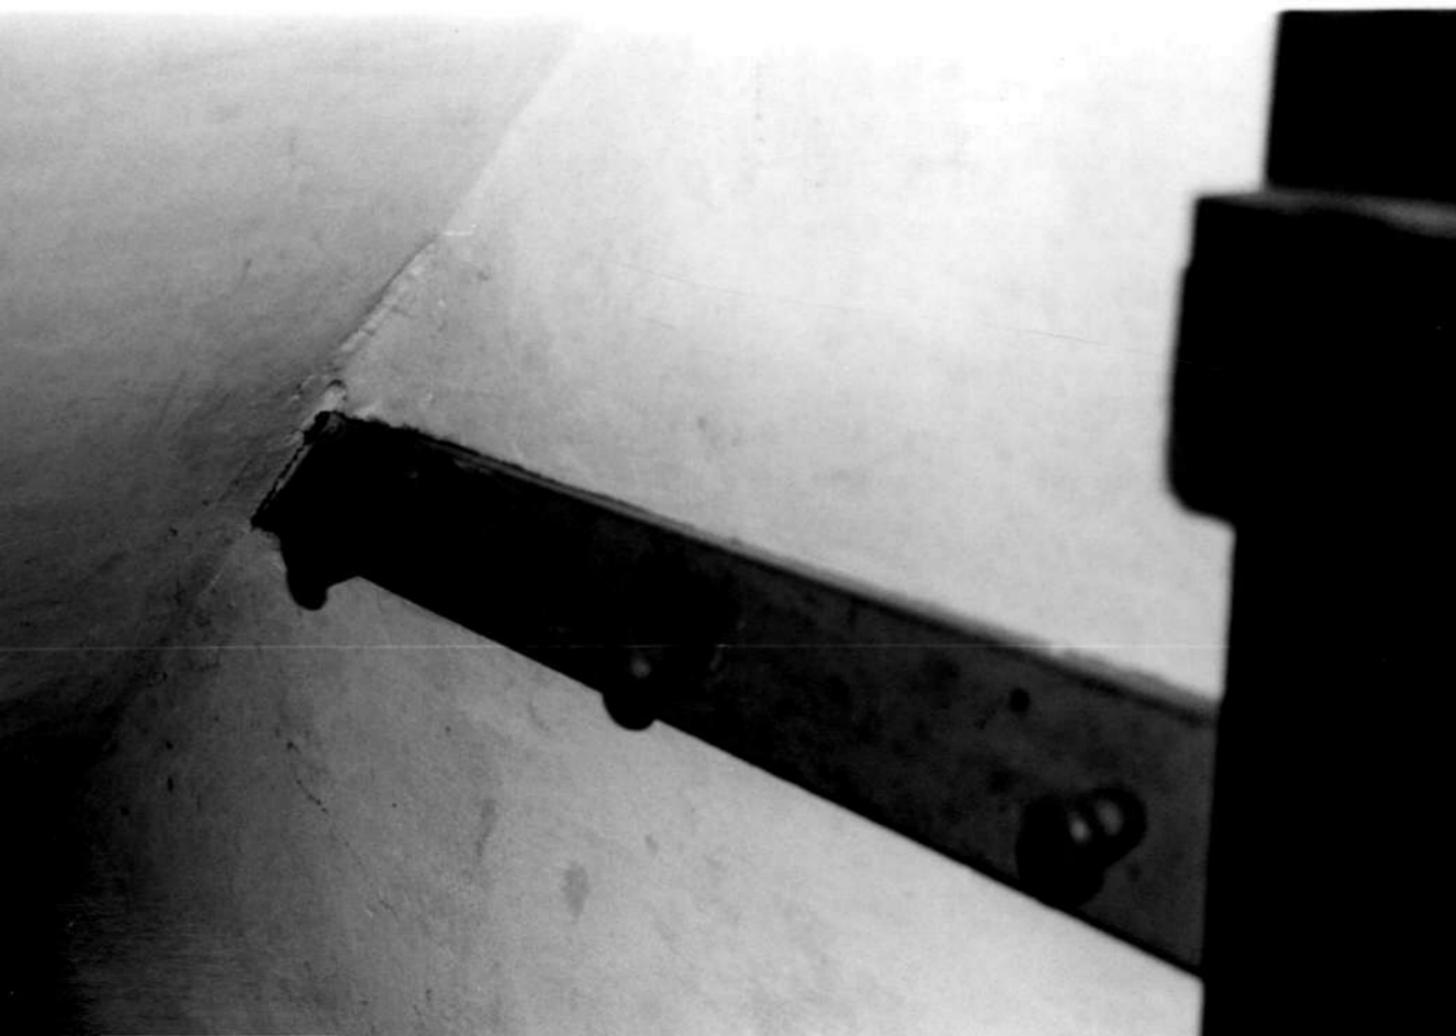
12/47

NE parlor, under stair closet detail,
main house

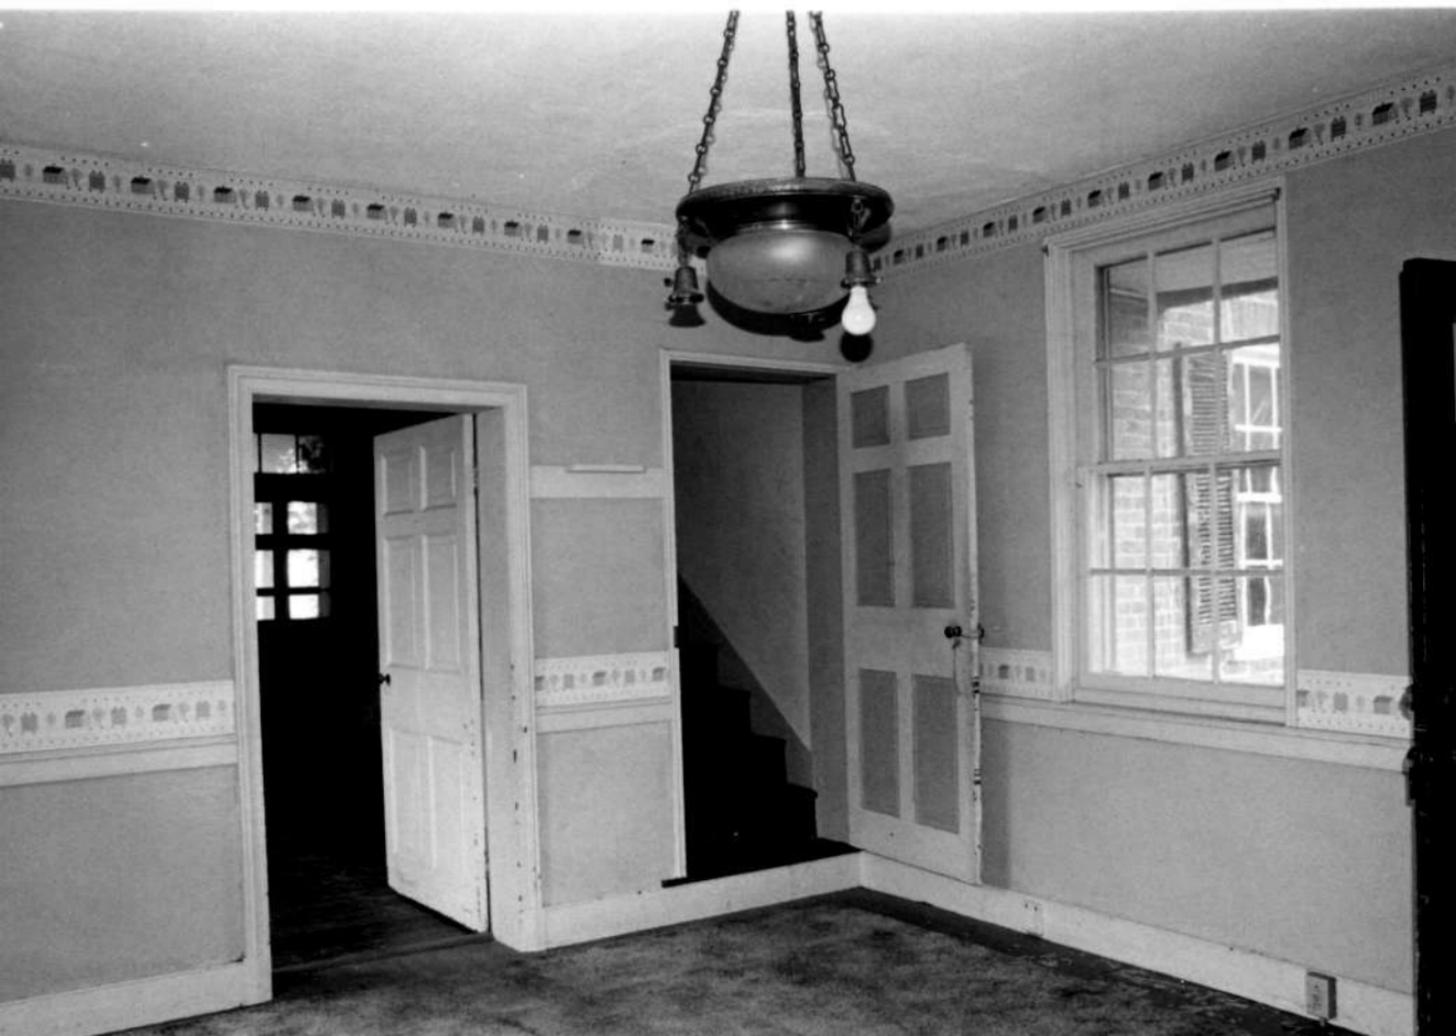
13/47

Center room, view SE toward enclosed stairs,
main house

A door in the west wall of the north parlor opens into the ell. This room has an outside door in both the north and south walls, the south door opening onto the L-extension's service porch. The west wall has a beaded pegboard. A board and batten door in the east wall opens to the stairs to the second story.

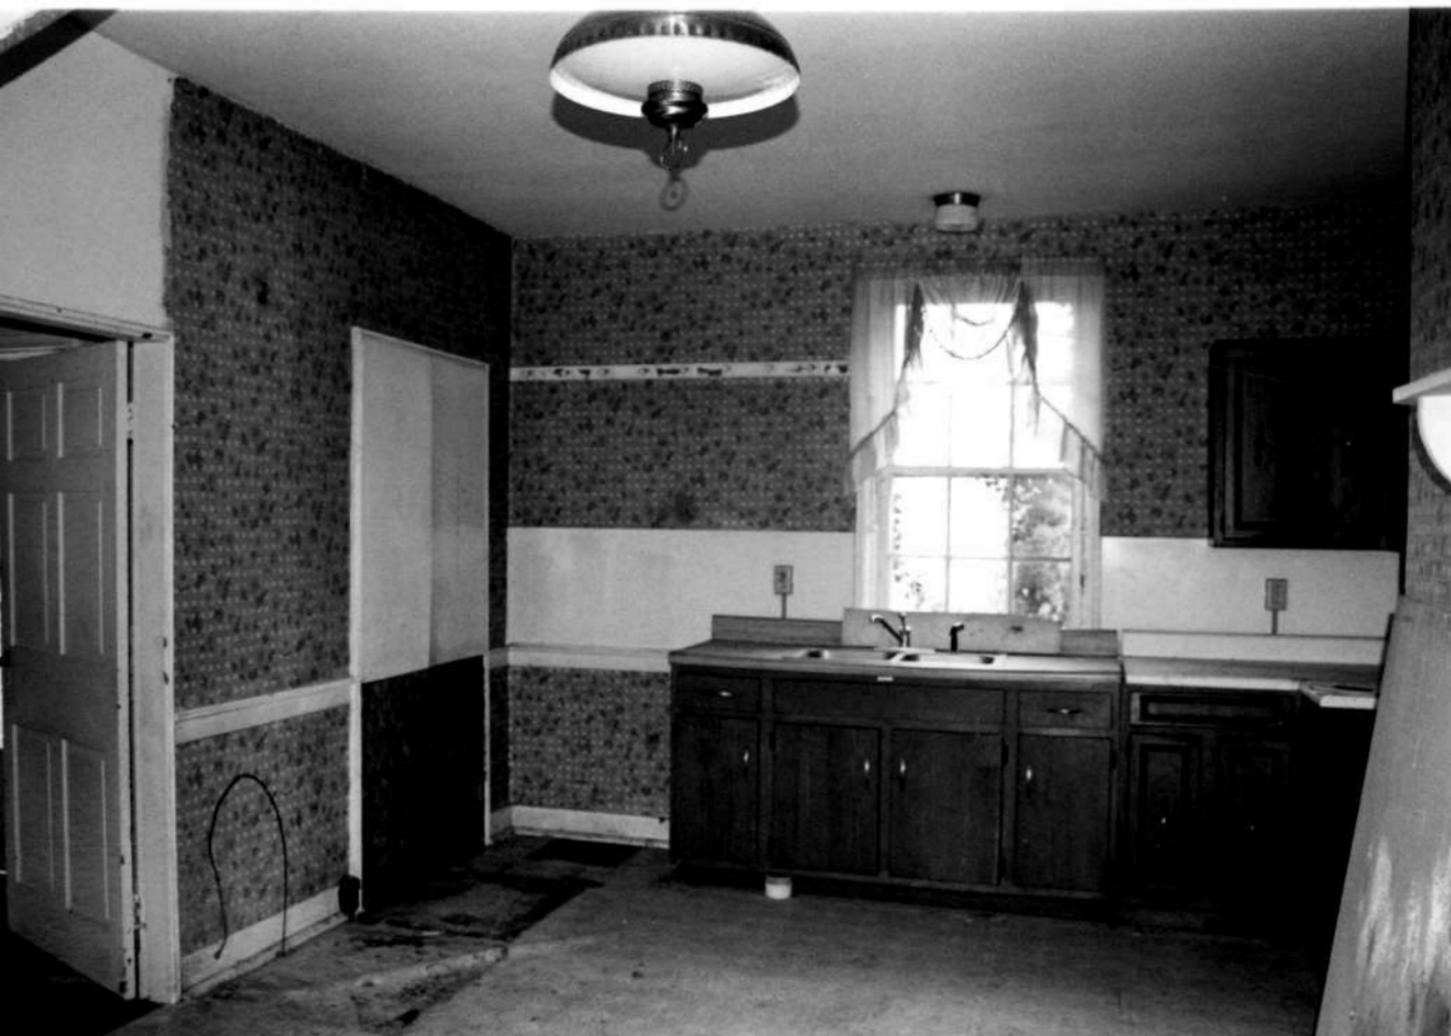
15/47

Kitchen, E and S walls, main house

The kitchen is the western-most room in the ell. It has original flooring under particleboard sheets. The kitchen hearth and fireplace has been completely re-bricked; an original beaded mantelshelf remains above. Original cupboards fill the space between the fireplace and the exterior north wall. Boxed winder stairs to the second story ell are located in the northeast corner of the room. There is a door to the service porch on the east wall. Although modern counters were added to the room, the chair rail remains in place behind them.
