Capsule Summary

Inventory No. F-3-225

Daniel Snook Farm
10200B Old Frederick Road
Frederick County, MD
Ca. 1840; 1831-1941
Access: Public

Maryland Historical Trust Maryland Inventory of Historic Properties Form

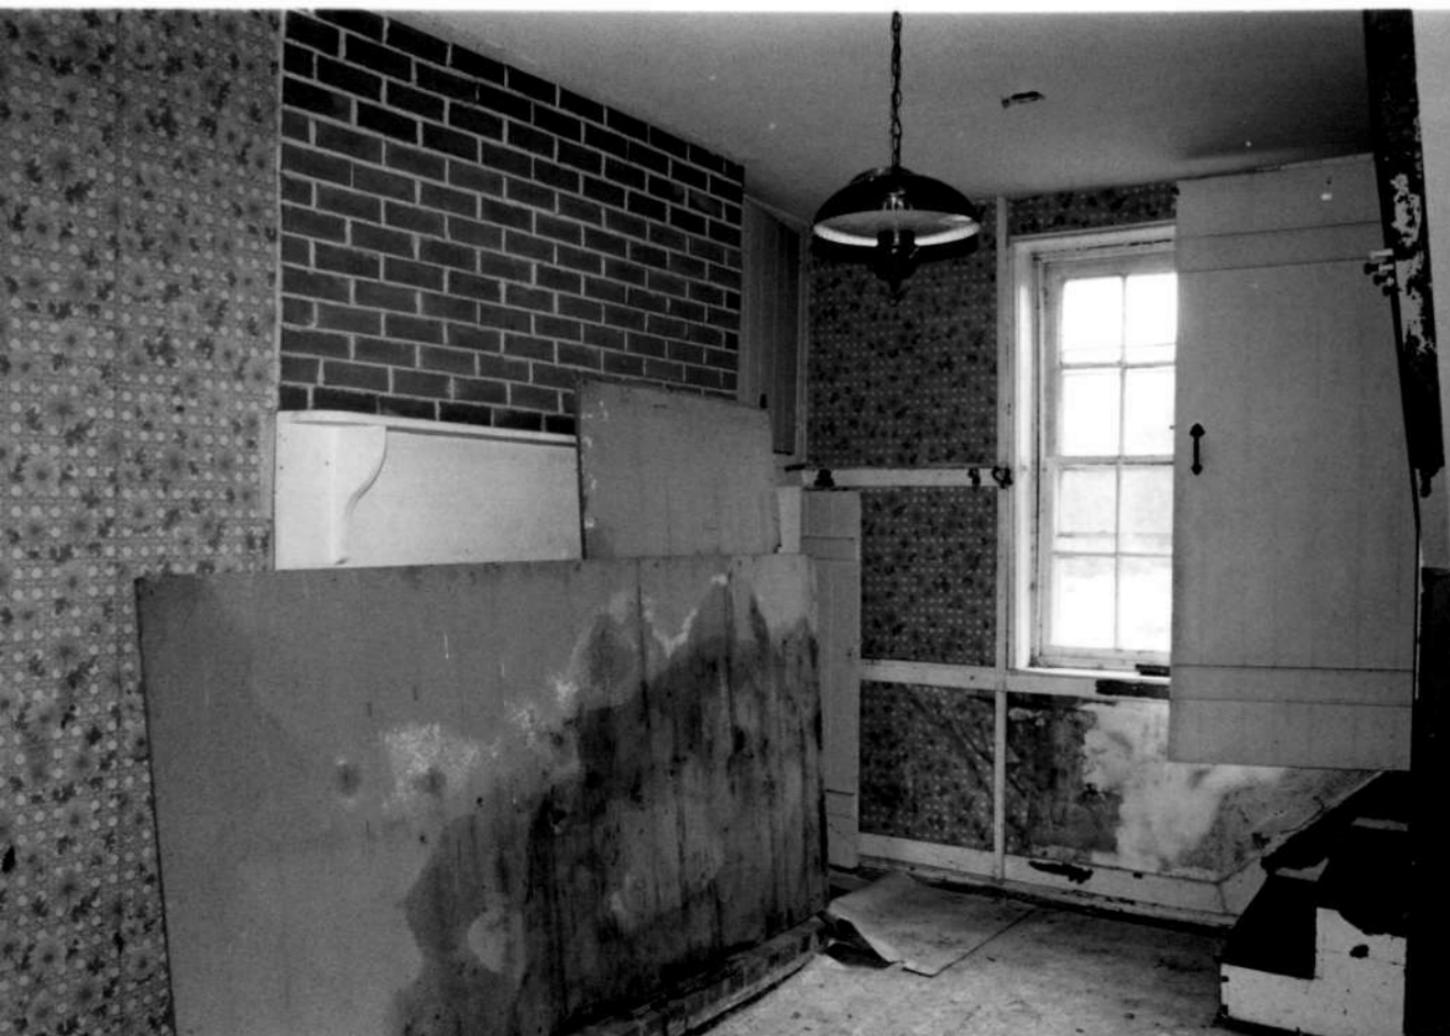
16/47

Kitchen, W and N walls, main house

The kitchen is the western-most room in the ell. It has original flooring under particleboard sheets. The kitchen hearth and fireplace has been completely re-bricked; an original beaded mantelshelf remains above. Original cupboards fill the space between the fireplace and the exterior north wall. Boxed winder stairs to the second story ell are located in the northeast corner of the room. There is a door to the service porch on the east wall. Although modern counters were added to the room, the chair rail remains in place behind them.

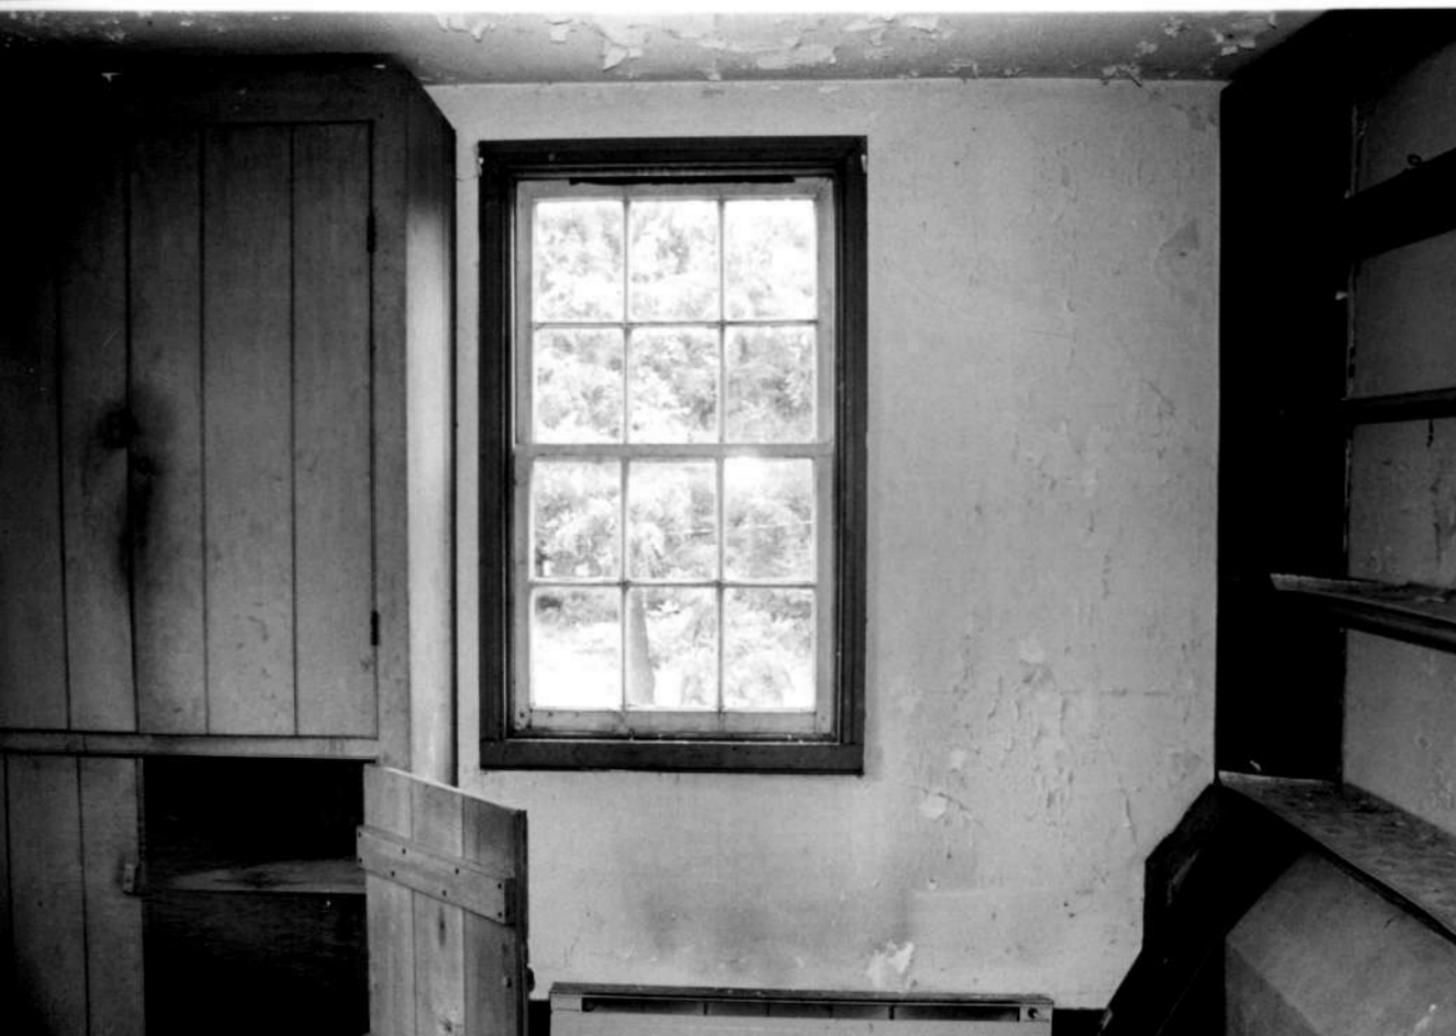
17/47

Pantry, W wall, frame addition, main house,

From the west wall of the kitchen (original brick exterior wall) is a door to a small hall in the frame addition; on the south side are winder stairs down to the cellar. The southwest room of the addition is a small pantry room with built-in shelves and cupboards; the north room is a finished room, probably originally worker housing, but most recently used as a laundry room.

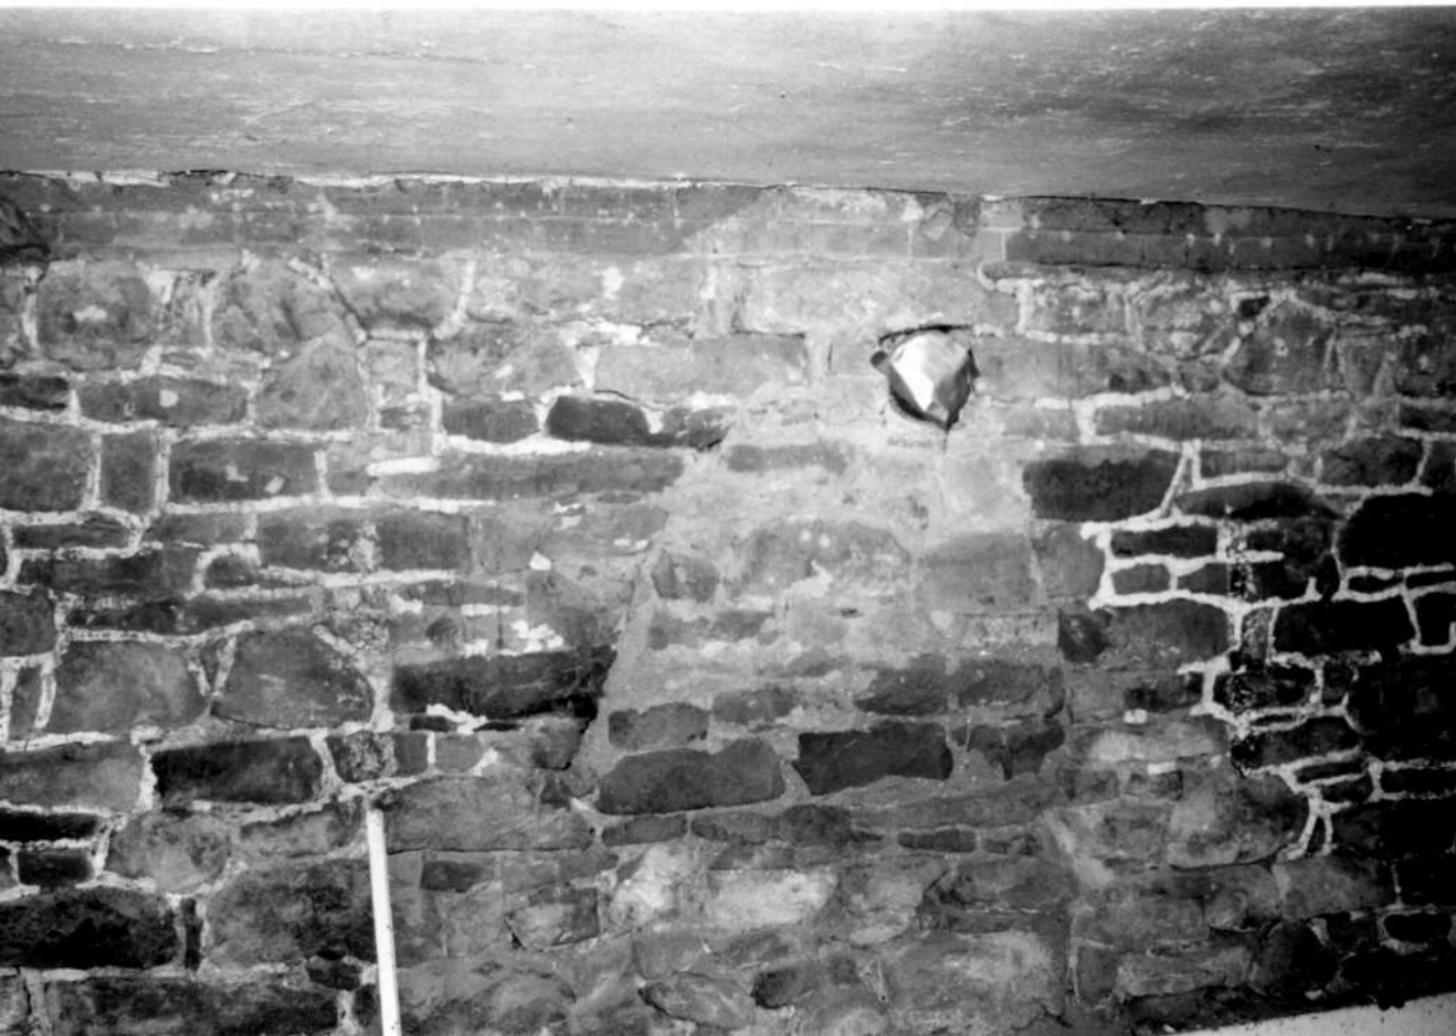
24/47

West finished basement room under frame addition,
view E of foundation wall with beehive oven
shadow

stone foundation of the house and this wall reveals the shadow of a beehive bake oven, probably removed during the construction of the addition. Inside the original stone-lined cellar, the western-most room below the ell has a large hearth and interior hand pump for well water. The front (east) cellar room underlies the front section of the house.

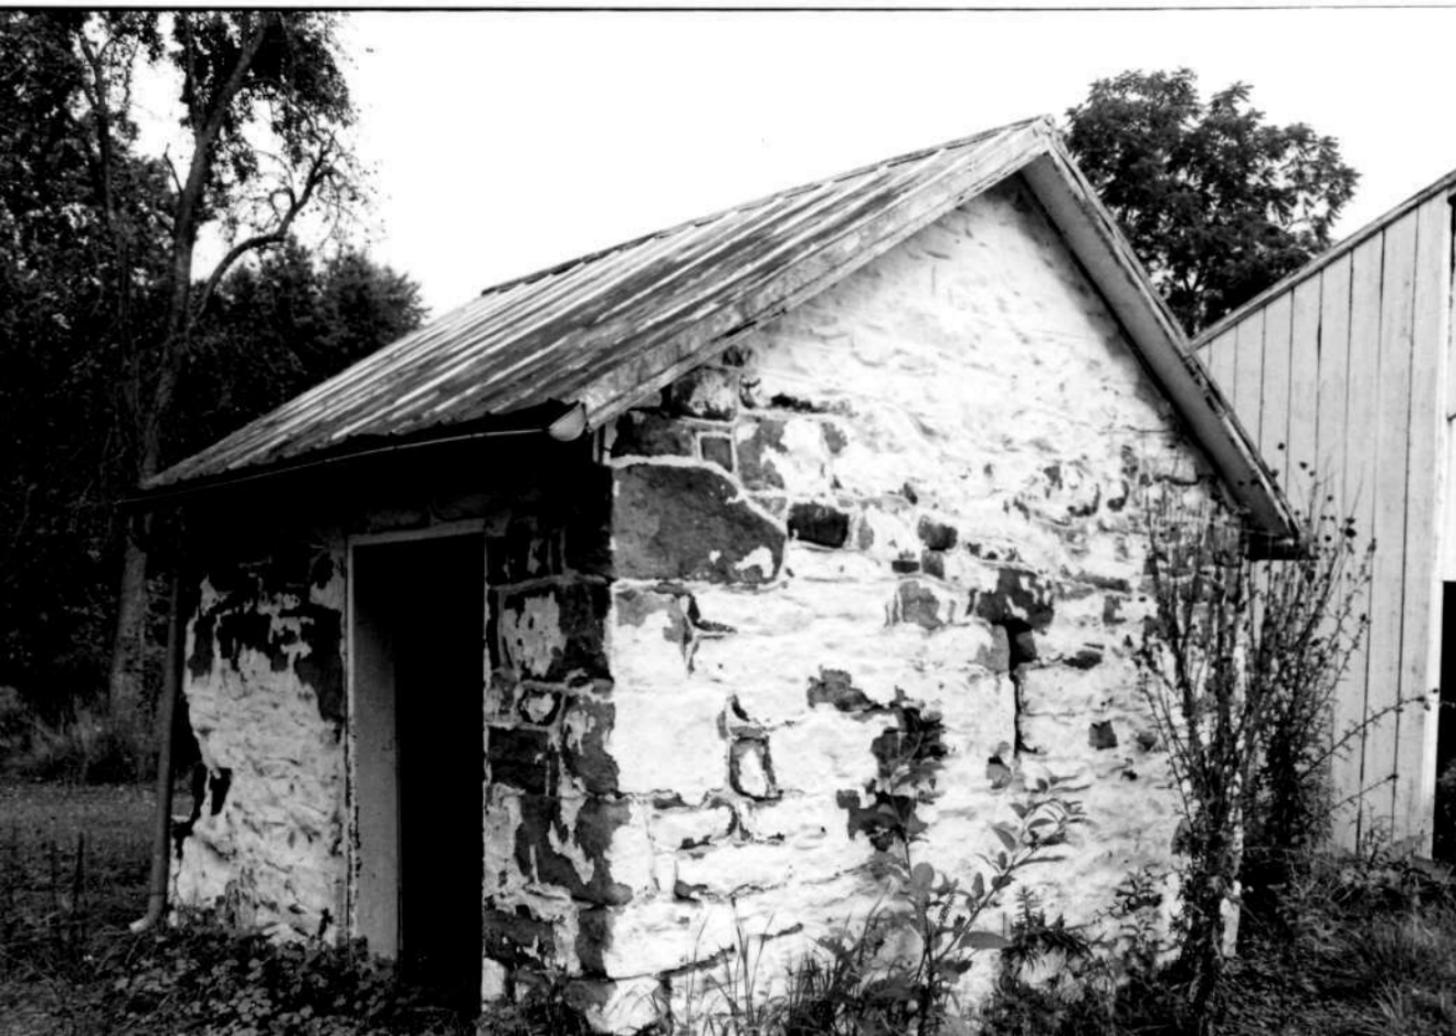
26/47

Smokehouse, view NW

Smokehouse: Constructed primarily of local red sandstone, the smokehouse is a gable end building with the door located in the south elevation. The door is beaded board and batten; the door jam is pegged wood construction. Narrow vertical ventilation slits were built into the stone construction in the north, east, and west walls. The roof is covered with standing seam metal sheets. The smokehouse is located off the northwest corner of the main house.

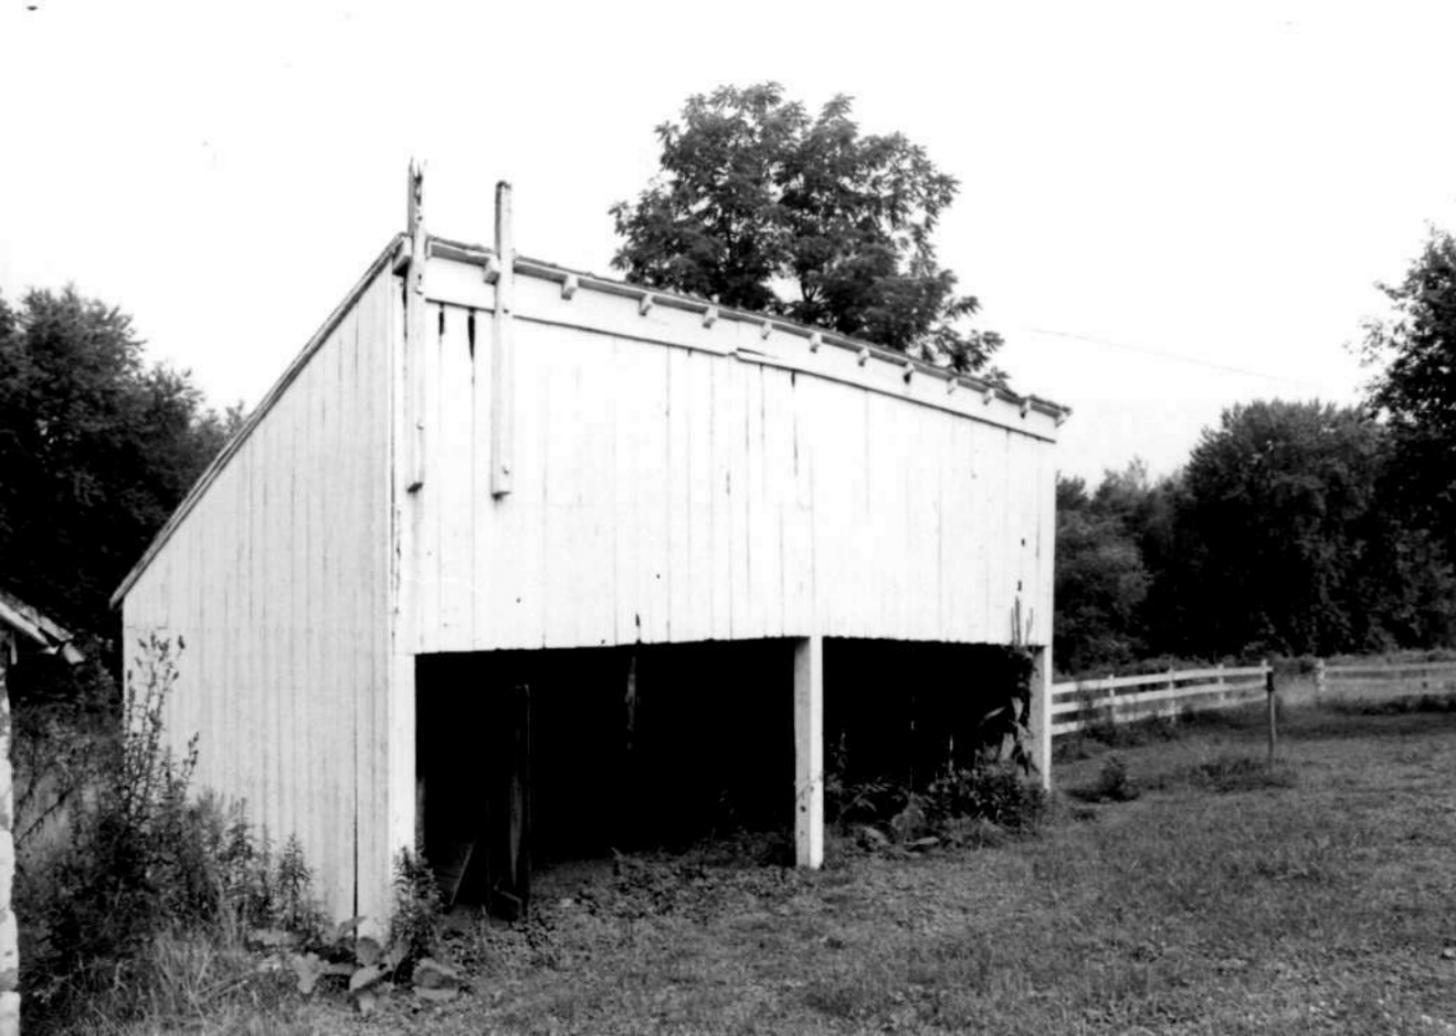
28/47

Wood shed, view NW

Wood Shed: A hewn timber frame structure, the wood shed faces east into the north house yard; it is immediately north of the smokehouse. It is shed-roofed with the east elevation open; there are two doors in the west elevation that open into the field beyond. In the south end of the shed is an enclosed room of unknown use, but possible for tool storage. The building is sheathed with vertical board siding.

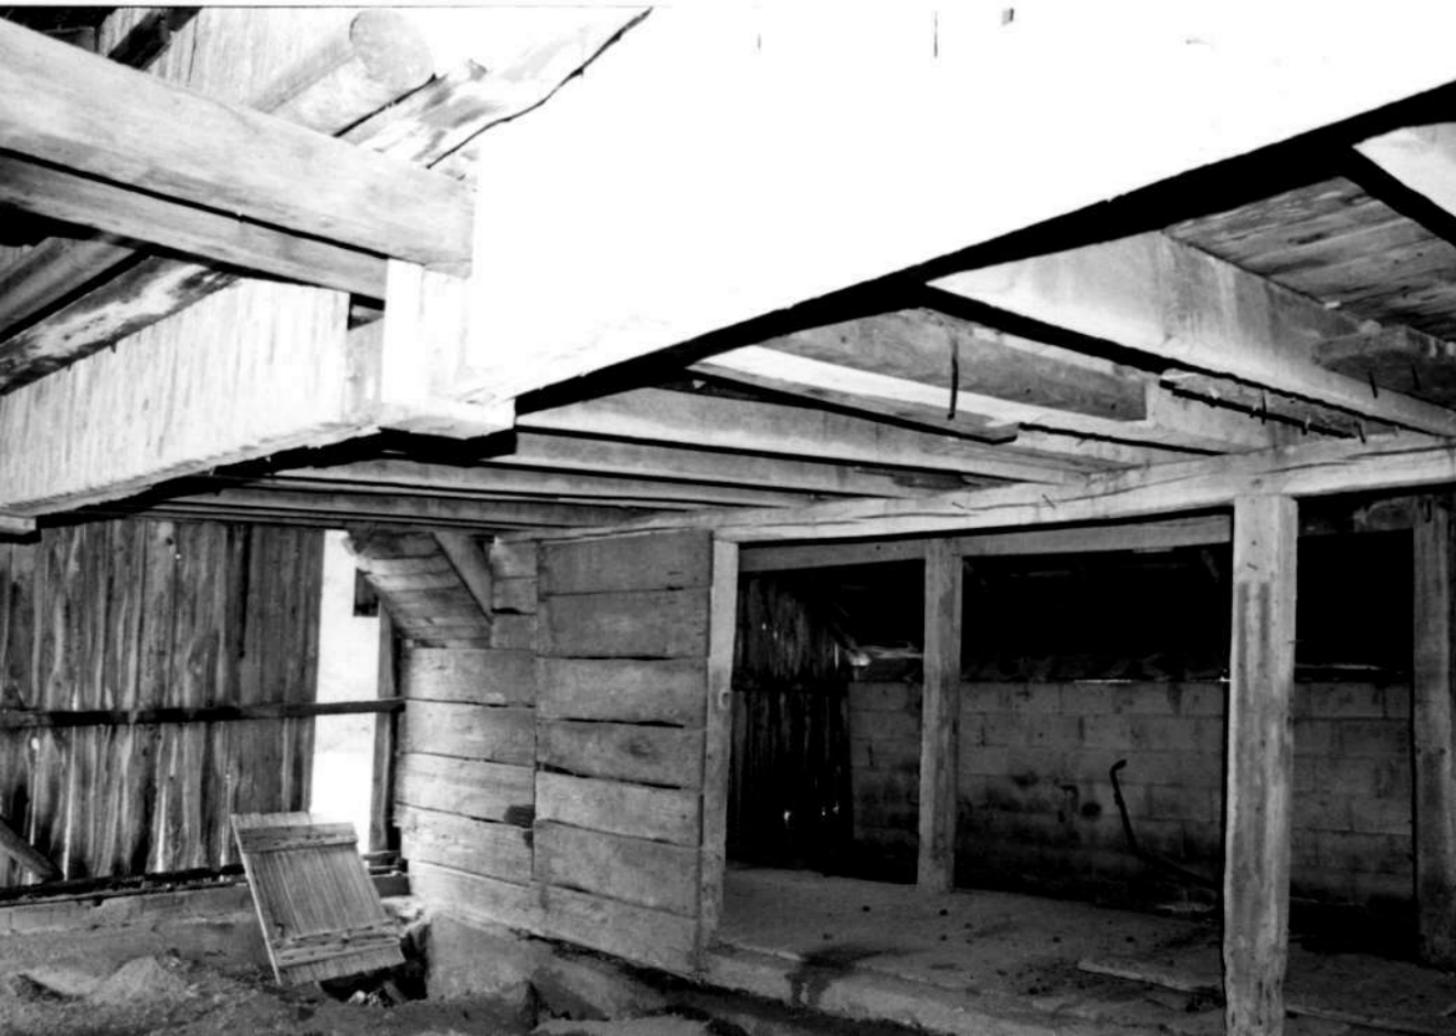
30/47

Interior carriage house, view to NW corner

Carriage House: This hewn timber-framed building is located off the southwest corner of the main house, facing southeast on a curve of the farm lane. The gable end building has a shed extension on the southeast elevation with sliding garage doors to accommodate automobiles. In the northeast gable end is an entrance door leading to a plank floor passage between what appears to be two sections of the original building, probably one side for carriage storage and the other for horse stalls. The northwest elevation of the building has been completely replaced with a concrete block wall. There is access to an upper loft area for hay storage. The exterior walls are covered with vertical board siding; the building sits on a stone foundation. The roof is covered with corrugated metal and standing seam metal sheets.

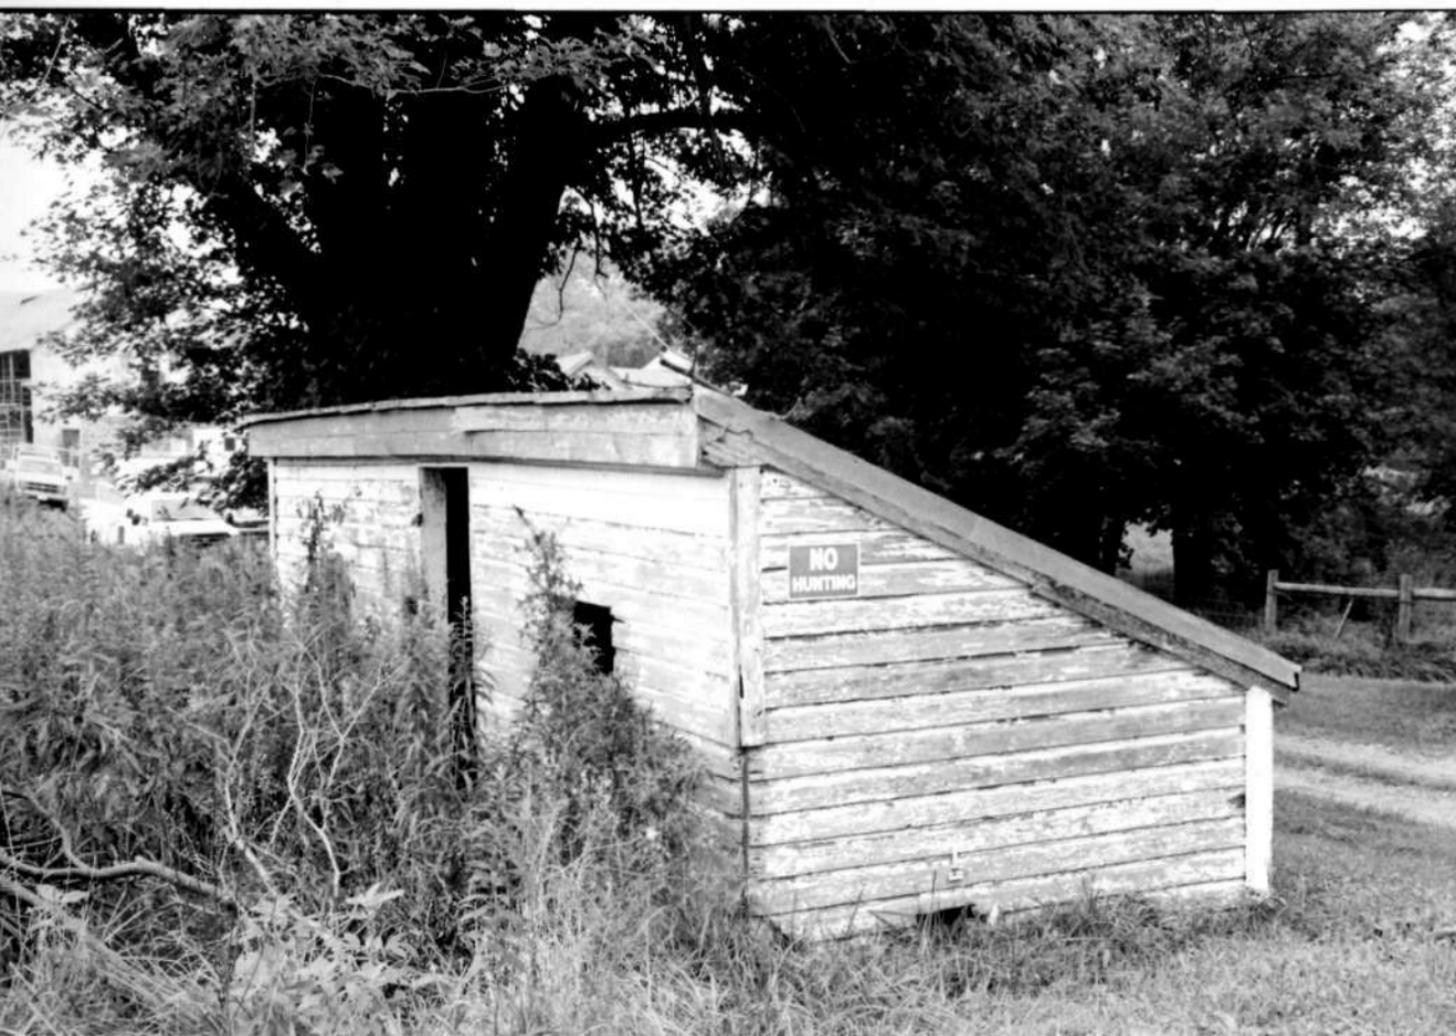
31/47

Chicken coop, view SW

Chicken Coop: On the south side of the farm lane, directly across from the carriage house, is a one-story, frame, shed-roofed chicken house or coop. The small building faces southeast and is covered with German siding and a metal roof.

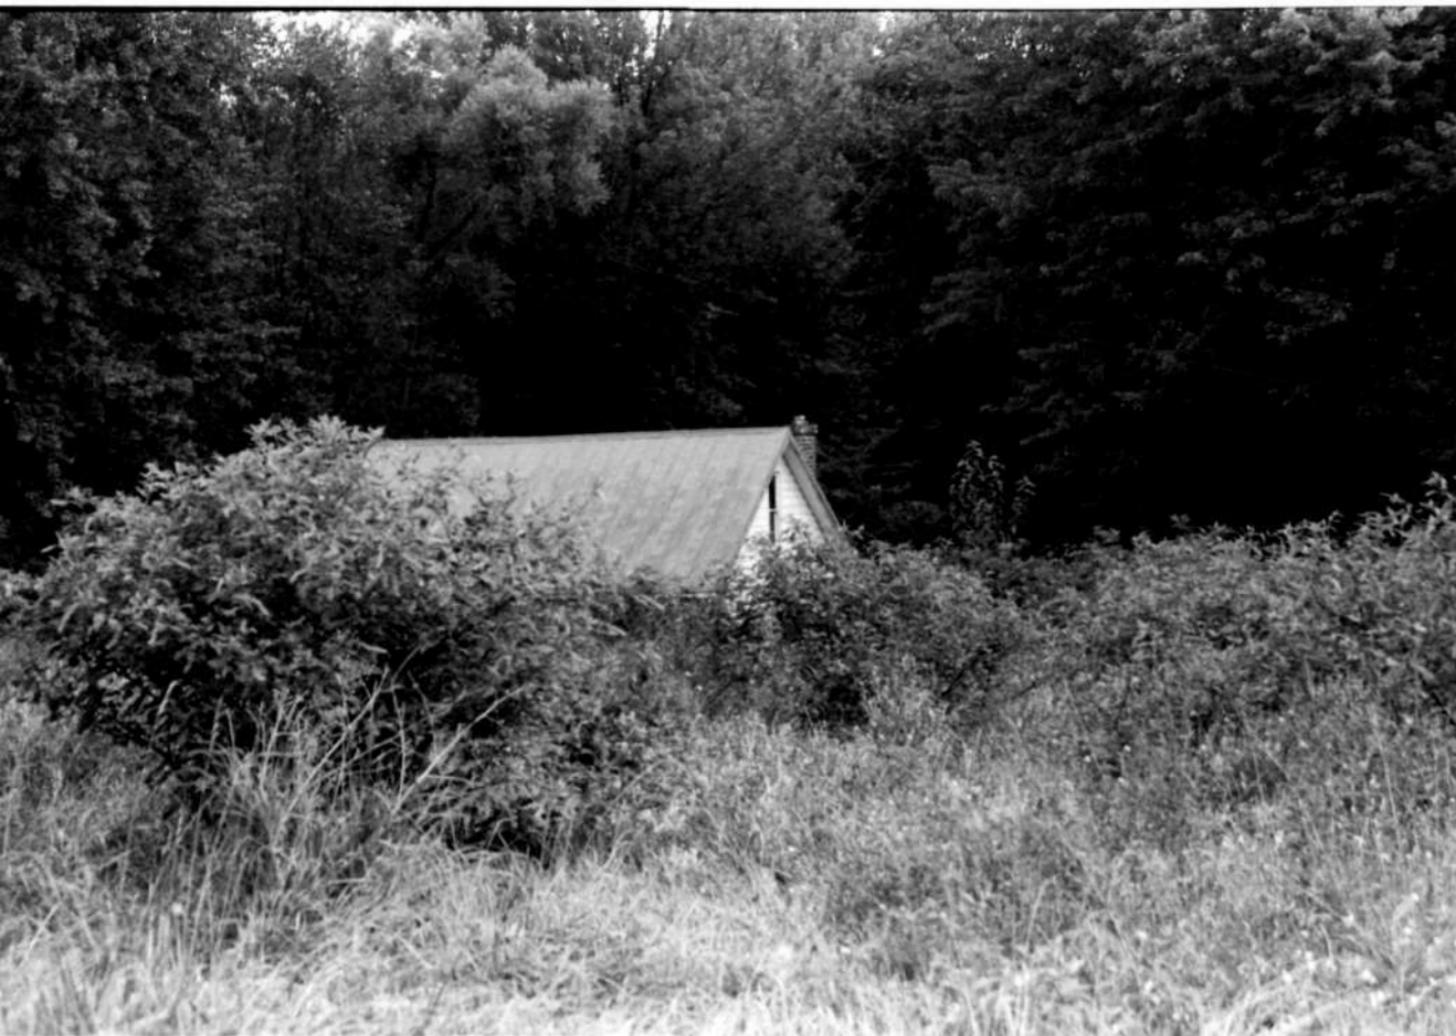
34/47

Springhouse, view NE from near dairy barn

Springhouse: In a relatively isolated location on the west side of the stream, the springhouse is northwest of the main house. It is a one-story stone building with gable ends and two rooms. Two exterior doors, which access each room are located in the southwest elevation. A brick chimney rises near the northeast corner of the building. The roof is covered with metal sheets. (The springhouse was not accessible at the time of this visit and was therefore viewed from a distance.)

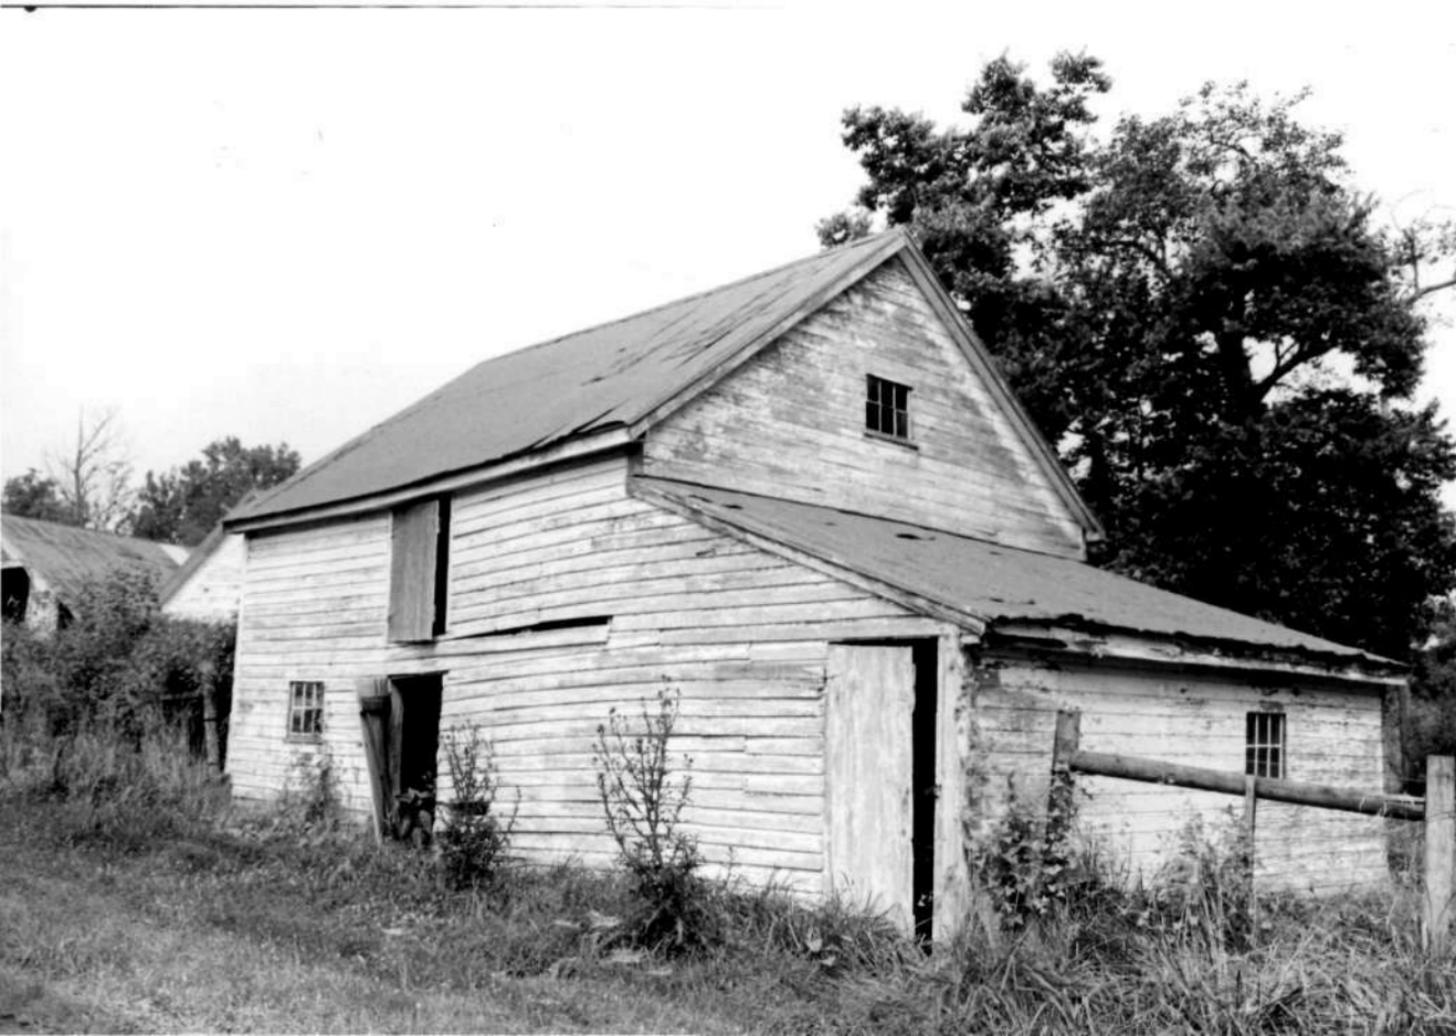
36/47

Carpenter shop w/ blacksmith shop addition
view W

Carpenter Shop/Blacksmith Shop: Continuing southwestward along the farm lane, on the west side of the stream stands the gable end, hewn timber-framed carpenter shop with a shed addition on the northwest end that housed the blacksmith shop. The building is covered with German siding but the interior northeast wall between the two shops (originally an exterior wall) is covered with whitewashed board and batten siding. The carpenter shop is dirt-floored with a large workbench along the southwest wall under a bank of windows. Stairs no long in place were located in the northeast corner of the room. A door in the southeast corner leads into the blacksmith shop, also dirt-floored. Large stones in the northeast corner appear to be the remnants of a stone forge. Exterior doors to each shop are located in the southeast elevation.

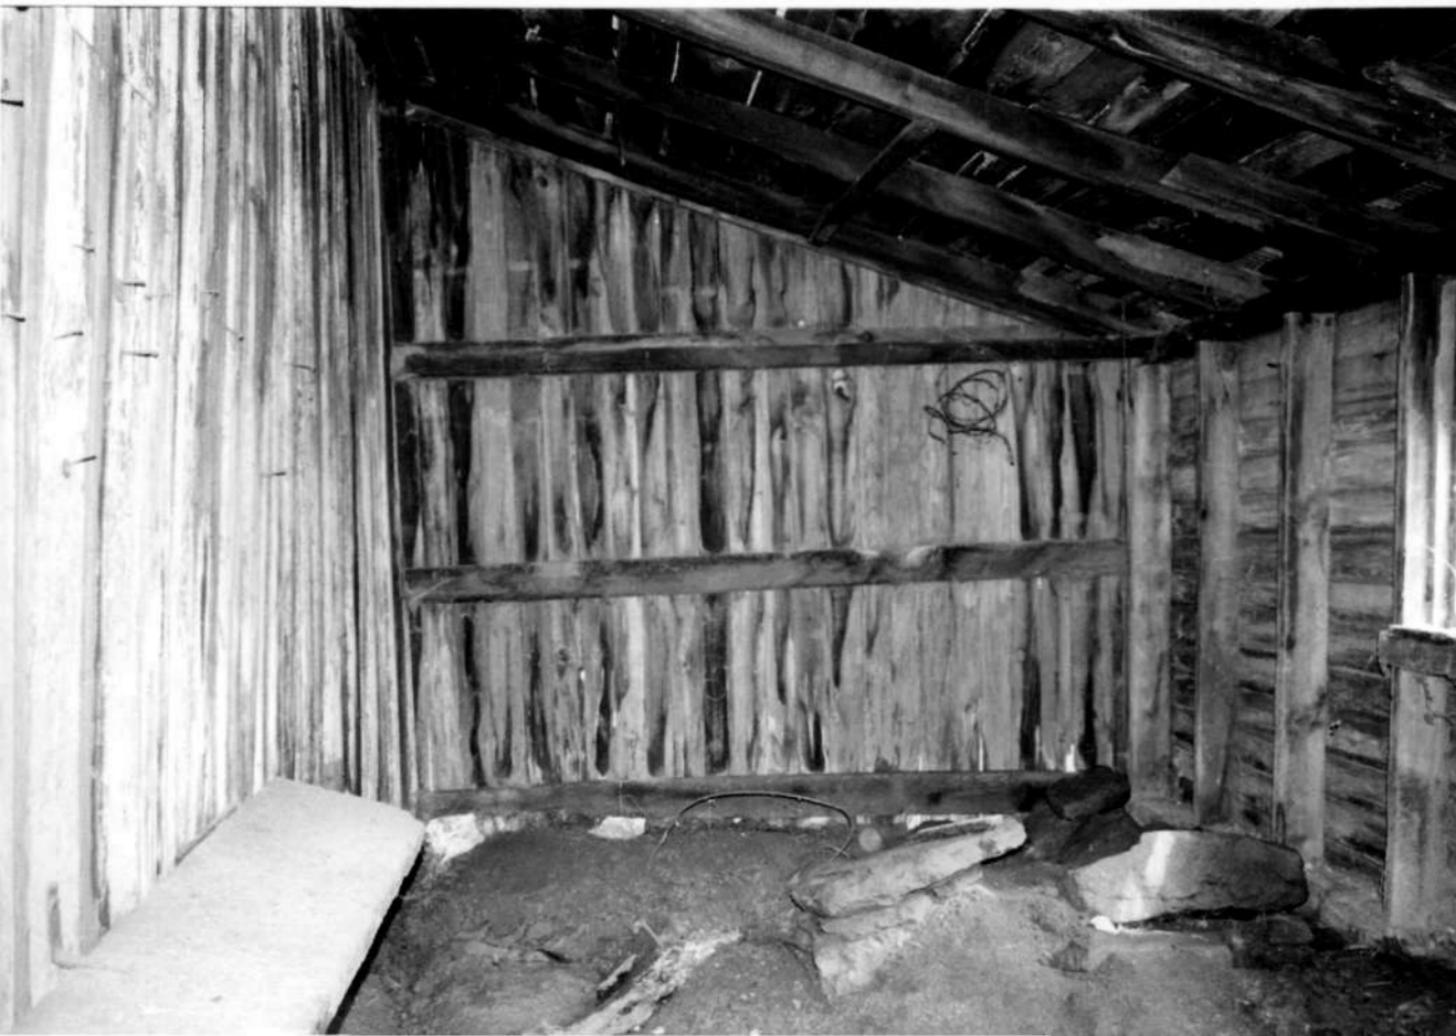
38/47

Blacksmith shop interior, forge stones in floor,
view toward NW wall

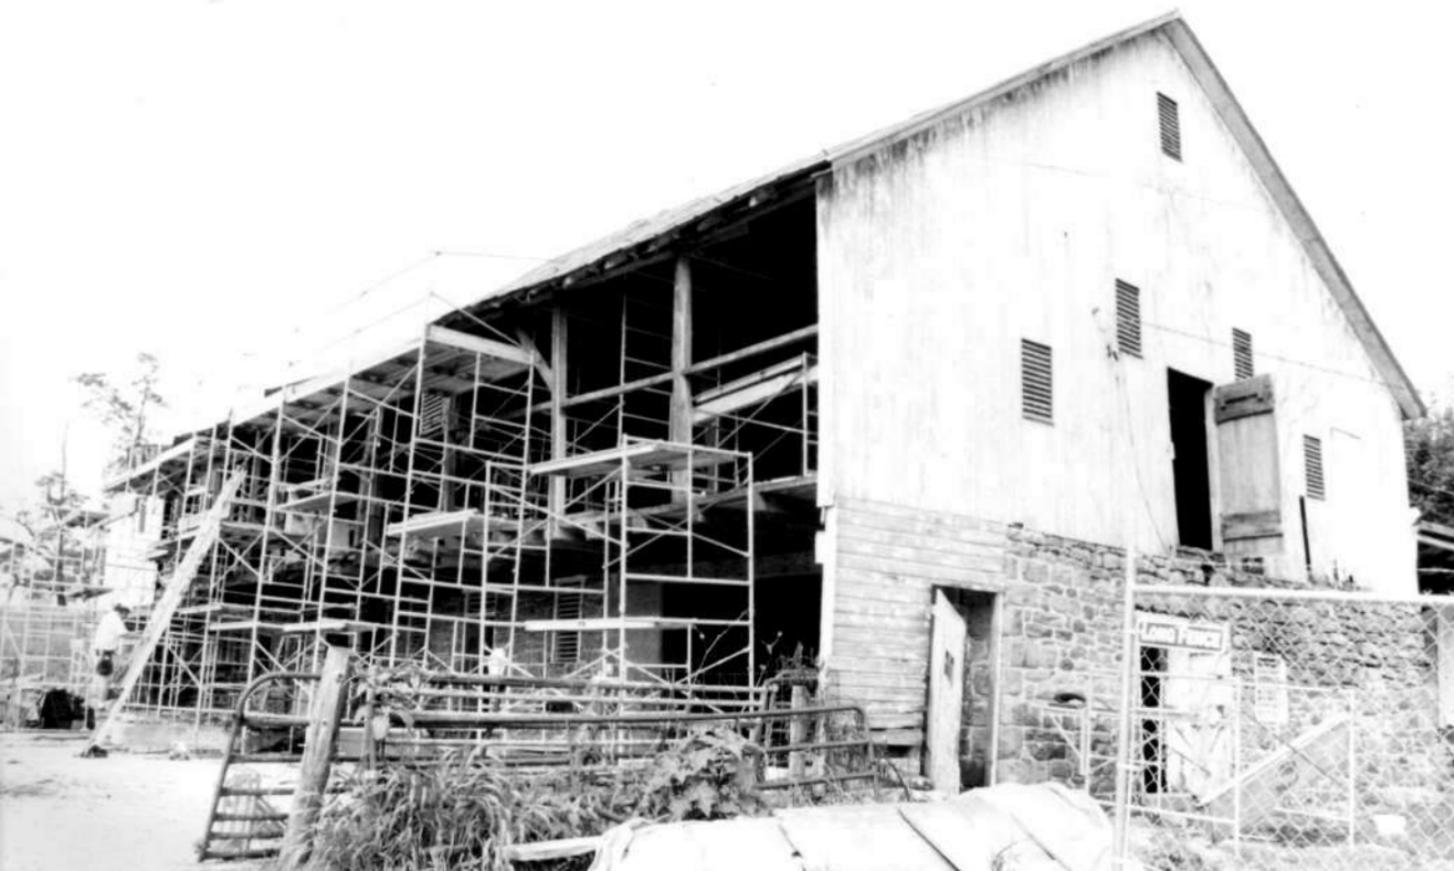
39/27

Bank barn, view W toward forebay

Bank Barn: The hewn timber-framed bank barn is the farthest building southwest of the main house. Sitting on a stone foundation, the forebay faces southeast, with the south end of the forebay enclosed with a stone extension of the foundation. The north end of the forebay was enclosed later with horizontal siding. The framing consists of five bents with double girts. The central threshing floor area and entrance roof is raised, possibly to accommodate threshing machinery. There is a built-in granary north of the threshing floor with the names "Smith, Keefer, and Rice" painted on the side. The barn is sheathed with vertical board siding, pierced with small rectangular vent windows. The roof is covered with standing seam metal sheets and corrugated metal sheets cover the ramp entrance. Access to the barn was limited during this visit as the building is being stabilized.

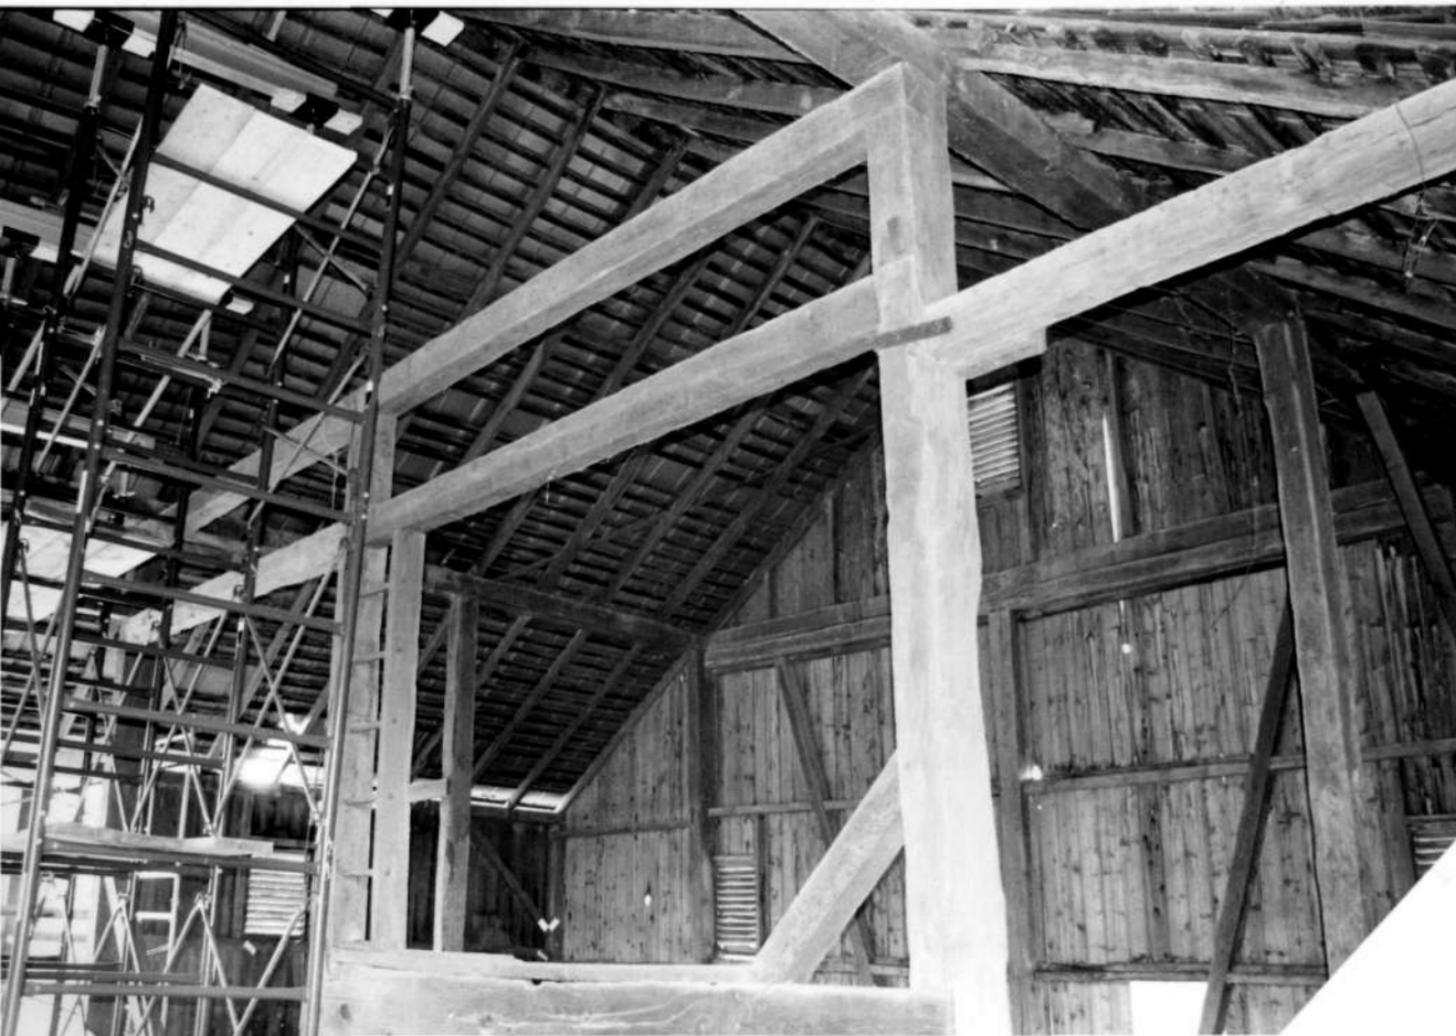
41/47

Bank barn, framing detail, view toward SW
gable end

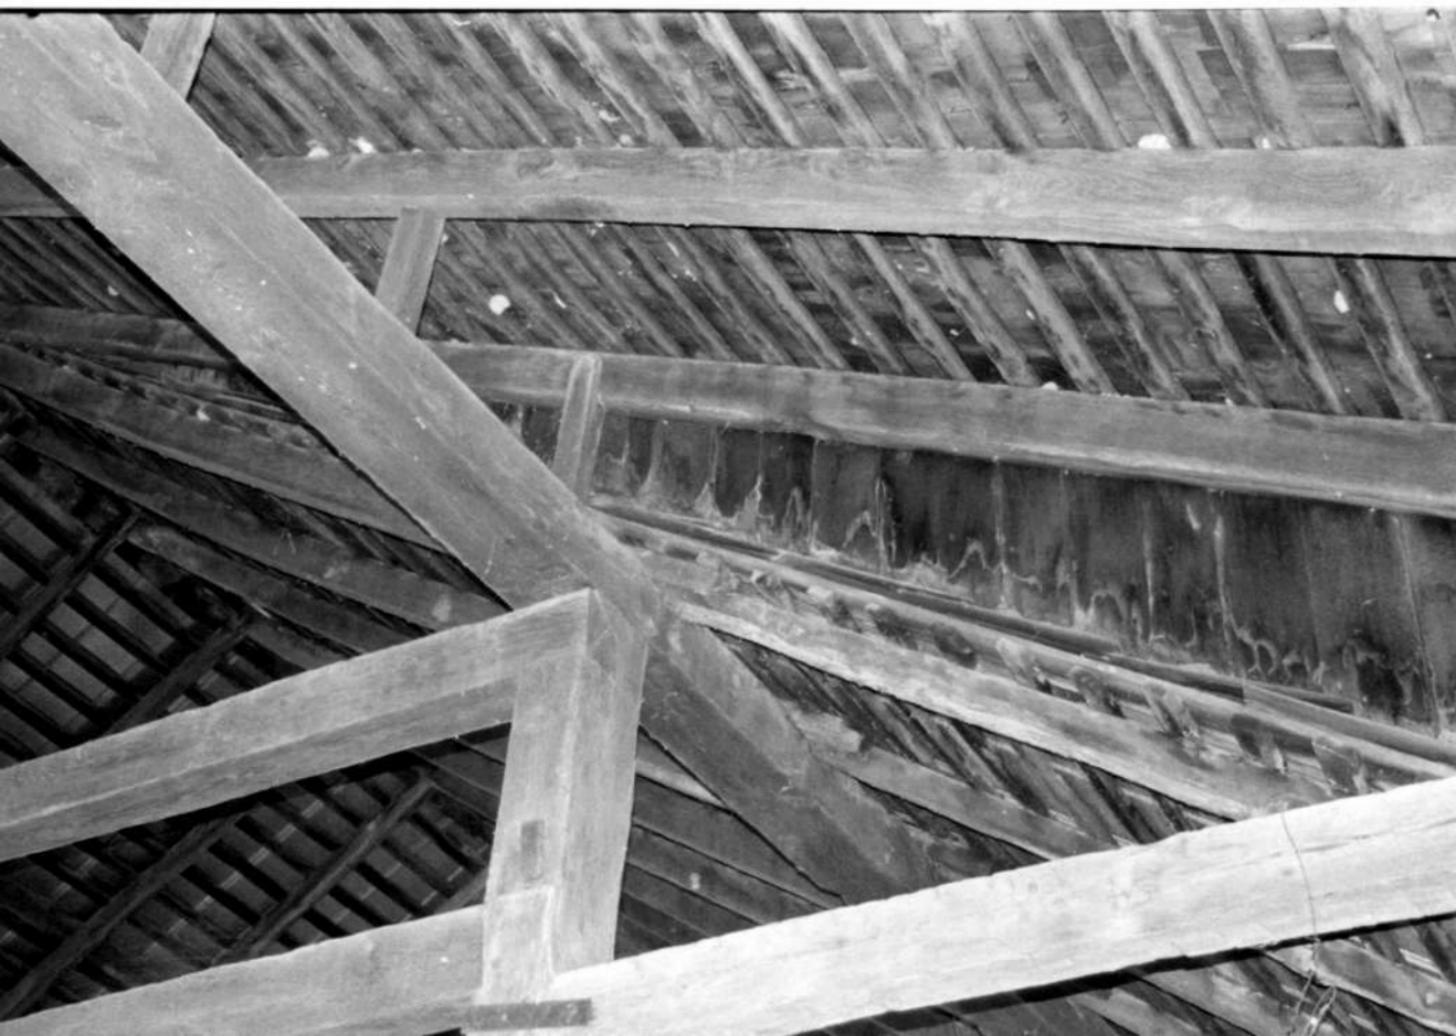
42/47

Bank barn, framing detail of raised entrance
roof

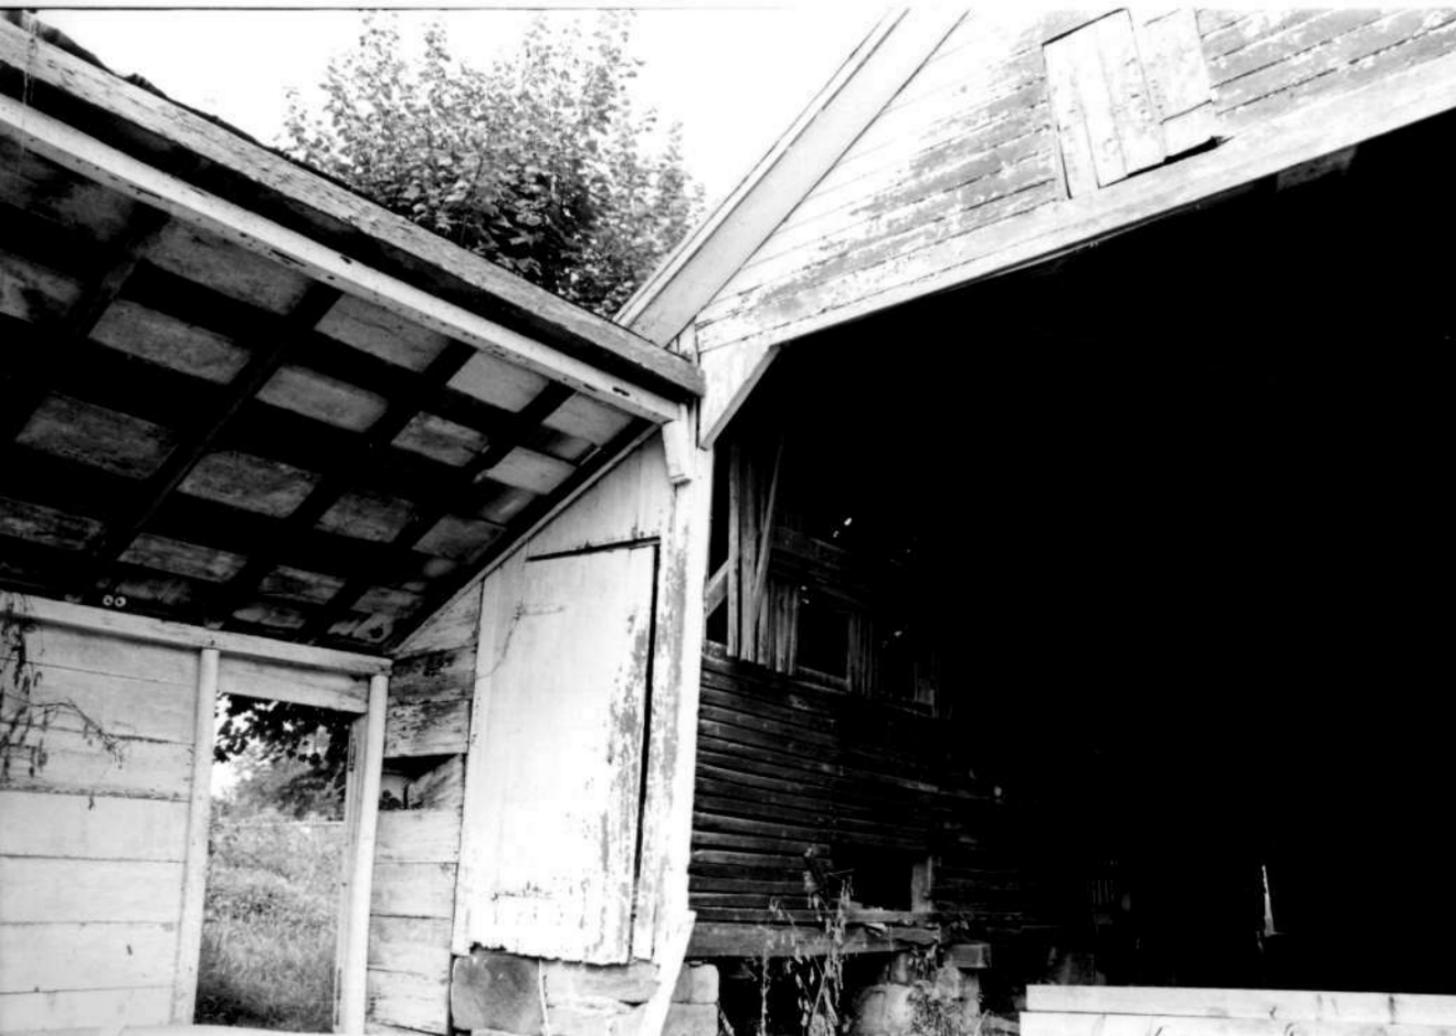
43/47

Wagon shed/corn crib and attached hypheon
view W

Wagon Shed/Corncrib: Immediately off the north corner of the barn and attached to the barn by a covered walkway, is the hewn timber-framed wagon shed with corncrib side walls. The building sits on sandstone piers and the center wagon storage area is open on the southeast end. The northwest end, probably originally open, is enclosed with siding. The corncrib walls are enclosed with vertical slats; access to the corncribs is through board and batten doors on the southeast ends. A shed extension runs along the northeast elevation. The roof is sheathed with metal sheets.
