Capsule Summary

Inventory No. F-3-225

Daniel Snook Farm
10200B Old Frederick Road
Frederick County, MD
Ca. 1840; 1831-1941
Access: Public

Maryland Historical Trust Maryland Inventory of Historic Properties Form

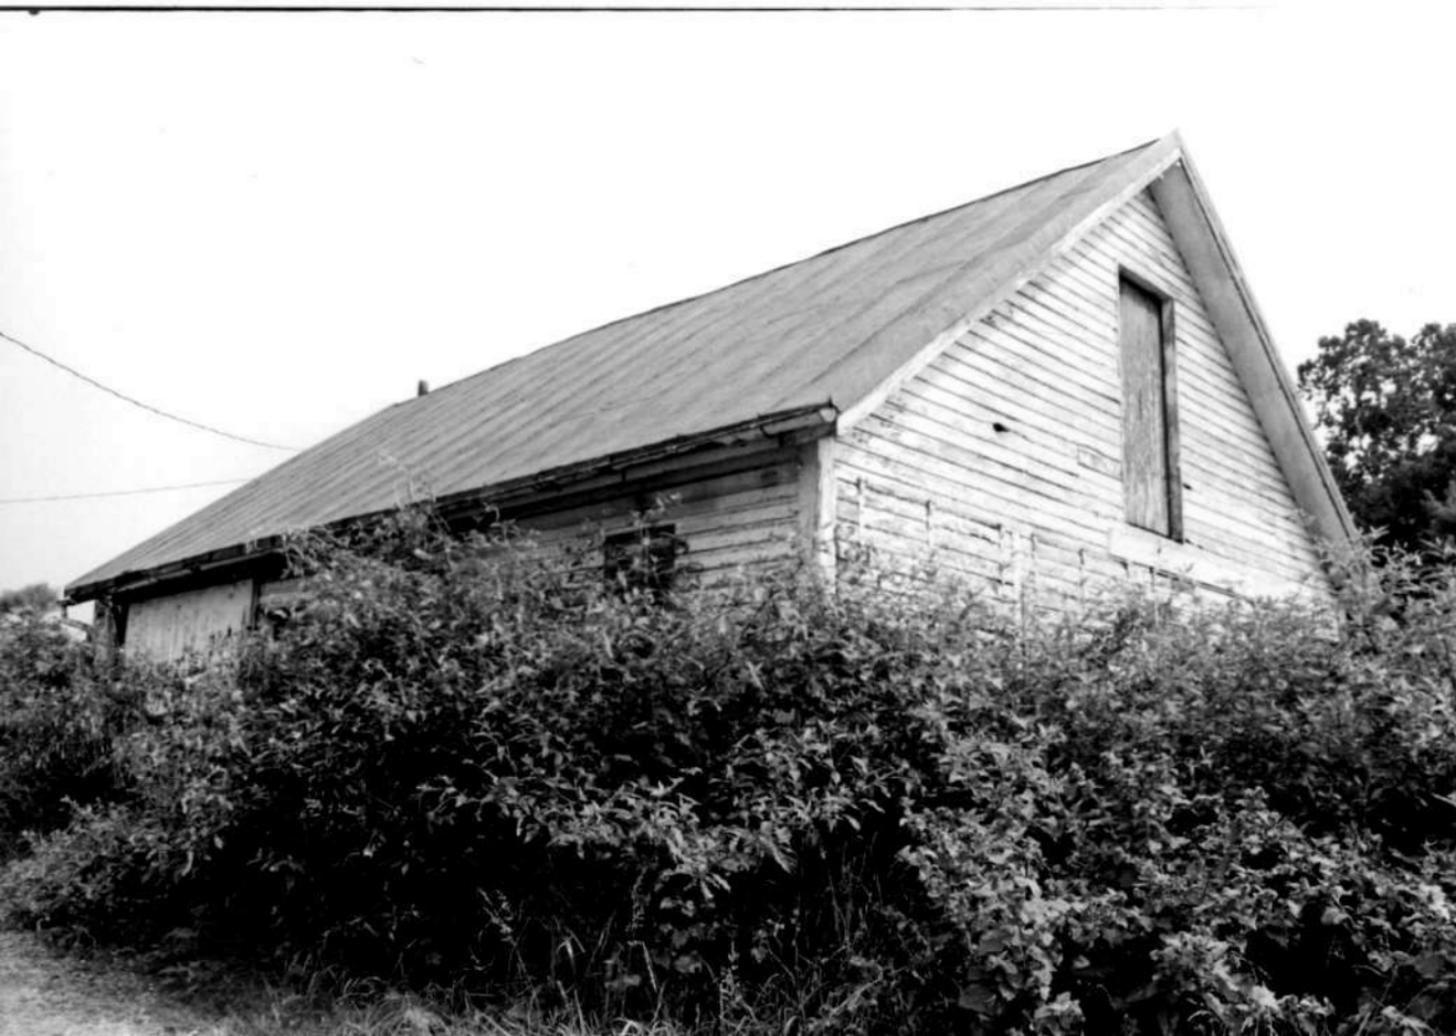
44/47

Hogbarn, view N

Hog Barn: This framed gable end building is located on the northeast side of the farm lane as it turns northwestward between the wagon shed and this hog barn. Entering through a door in the southwest elevation, the southeast end of the building is divided into several hog pens. There are three low-level openings along the southeast gable end that allowed the hogs to access outdoor pens. The northwest end of the building is accessed through a sliding garage-style door and probably housed small machinery. The building appears to have been constructed in the first half of the 20th century.

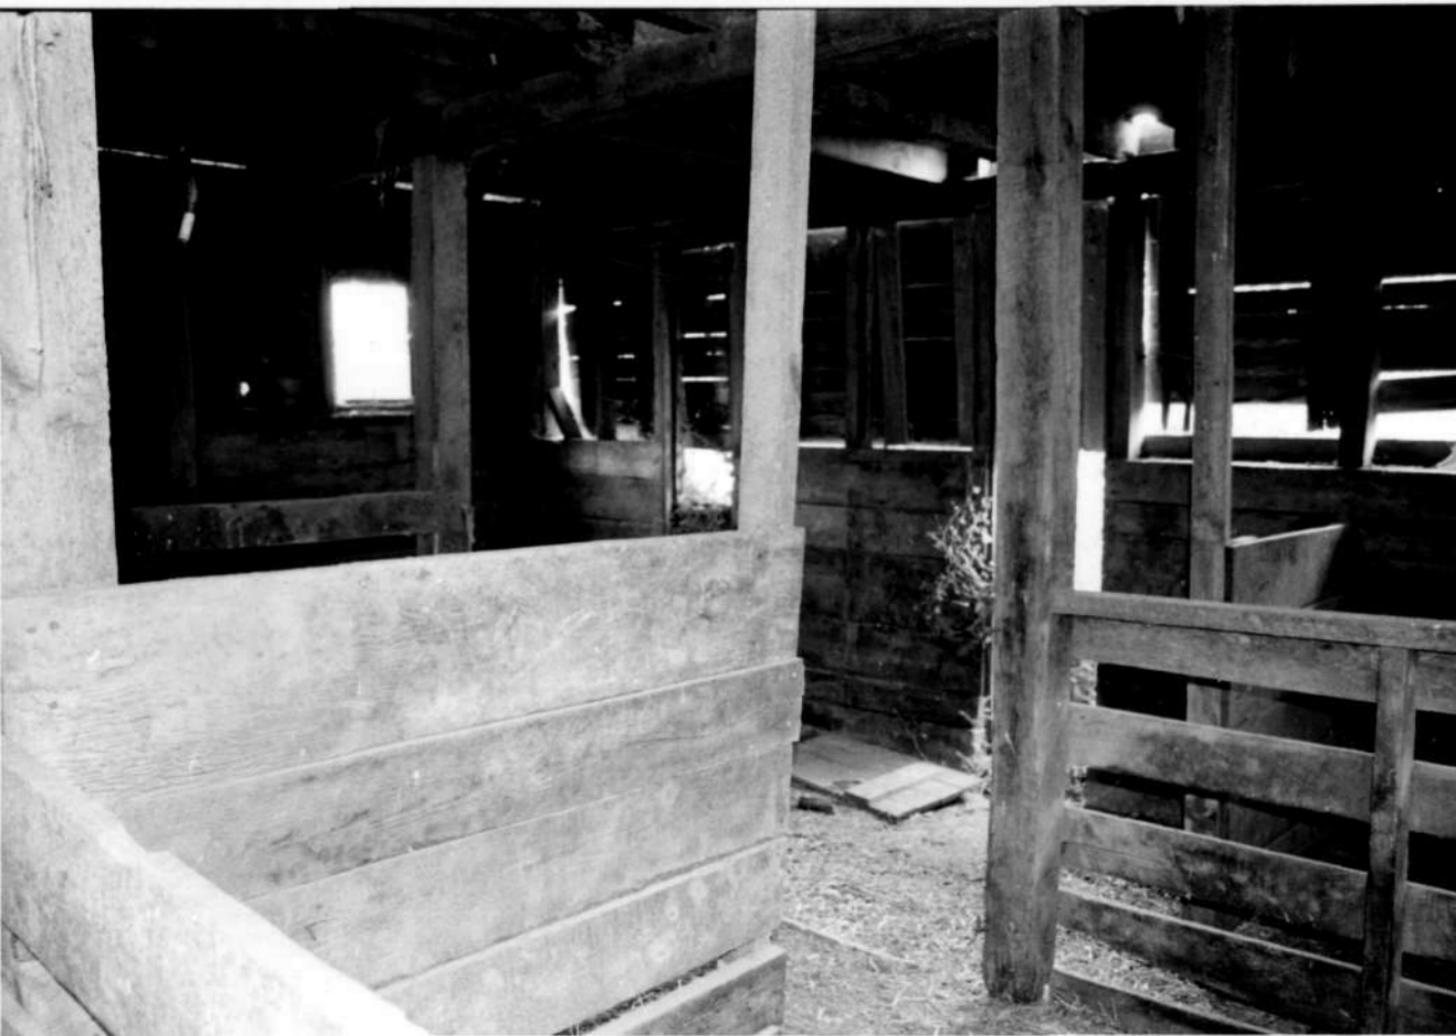
45/47

Hog barn interior, view SE

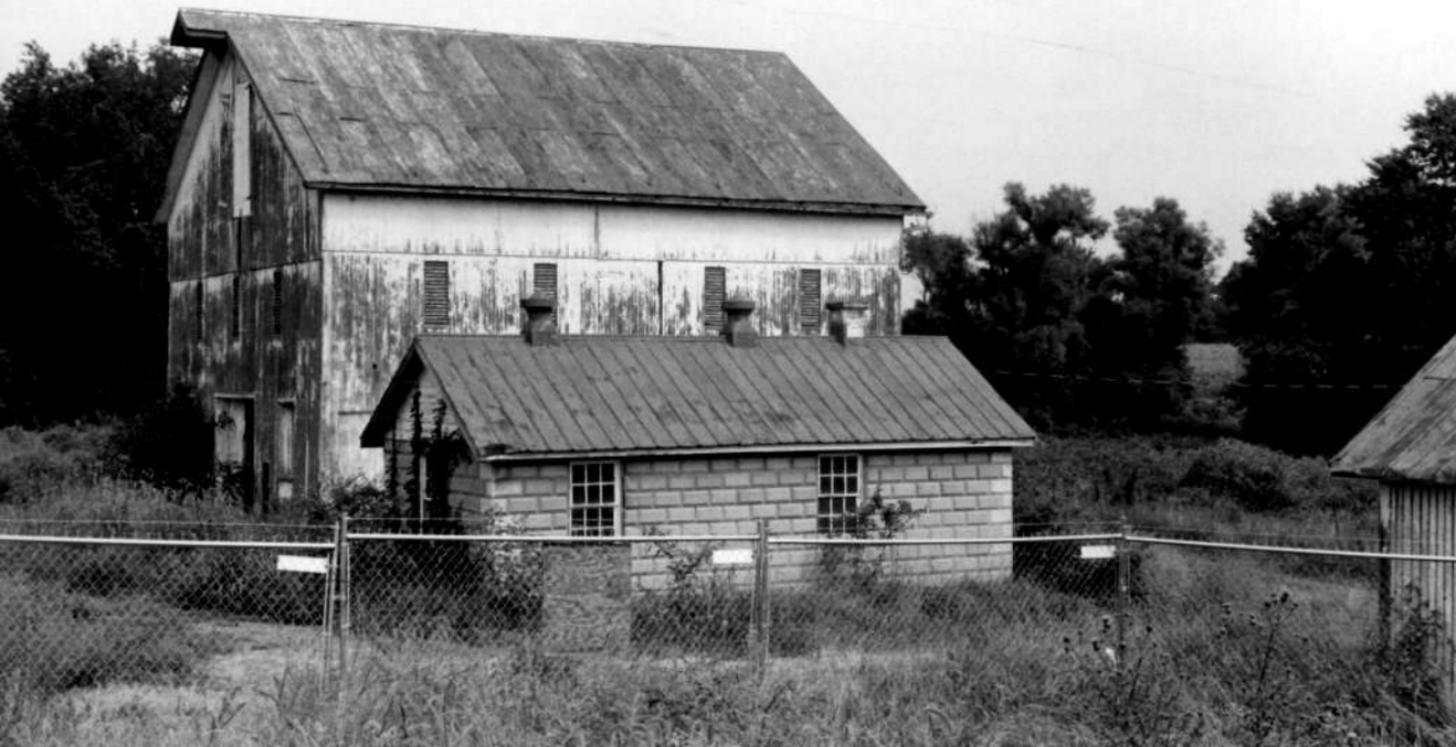
46/47

Milk house (foreground) and dairy barn, view
NW from bank barn

upper story where hay was stored. A hooded overhang for a pulley system for lifting hay bales to the second story extends from the southwest gable peak, providing access to the door in the gable peak. The barn's framing was identified as hewn timber frame construction during a 2003 Historic Structure Assessment (HPTC), and it rests on a stone foundation. The interior of the dairy barn is typical of ca. 1930s dairy barns with concrete floor and two parallel rows of metal stanchions (for 16 cows total). A row of five 6/6 light double-hung sash windows on each of the long walls lights the lower milking room. Three similar windows are in the northeast gable end; two windows and double, hinged doors are in the southwest gable end. The second story elevations are lined with slated vents. The dairy barn, while typical of early 20th century dairy operations on the interior, is not typical of such period barns in its exterior style or construction (more commonly concrete block or lighter frame with gambrel roof) and may indicate an earlier conversion to dairy on the Daniel Snook Farm.

Milk House: Constructed of cast rusticated beige concrete block with white quoins, the milk house is a one-story rectangular building immediately southeast of the dairy barn. The small building is lighted with 6/6 sash windows, has a door in the northwest elevation, and a chimney in the northeast end. The roof is covered with metal sheets and has two metal ventilators on the peak. The building was used to house the milk storage tank and is very typical of 1930s milk houses throughout the central Maryland region.
