F-3-97  
Lewistown Survey District  
Lewistown  
Public and private

# Maryland Historical Trust State Historic Sites Inventory Form

historic Lewistown Survey District

Survey No. F-3-97

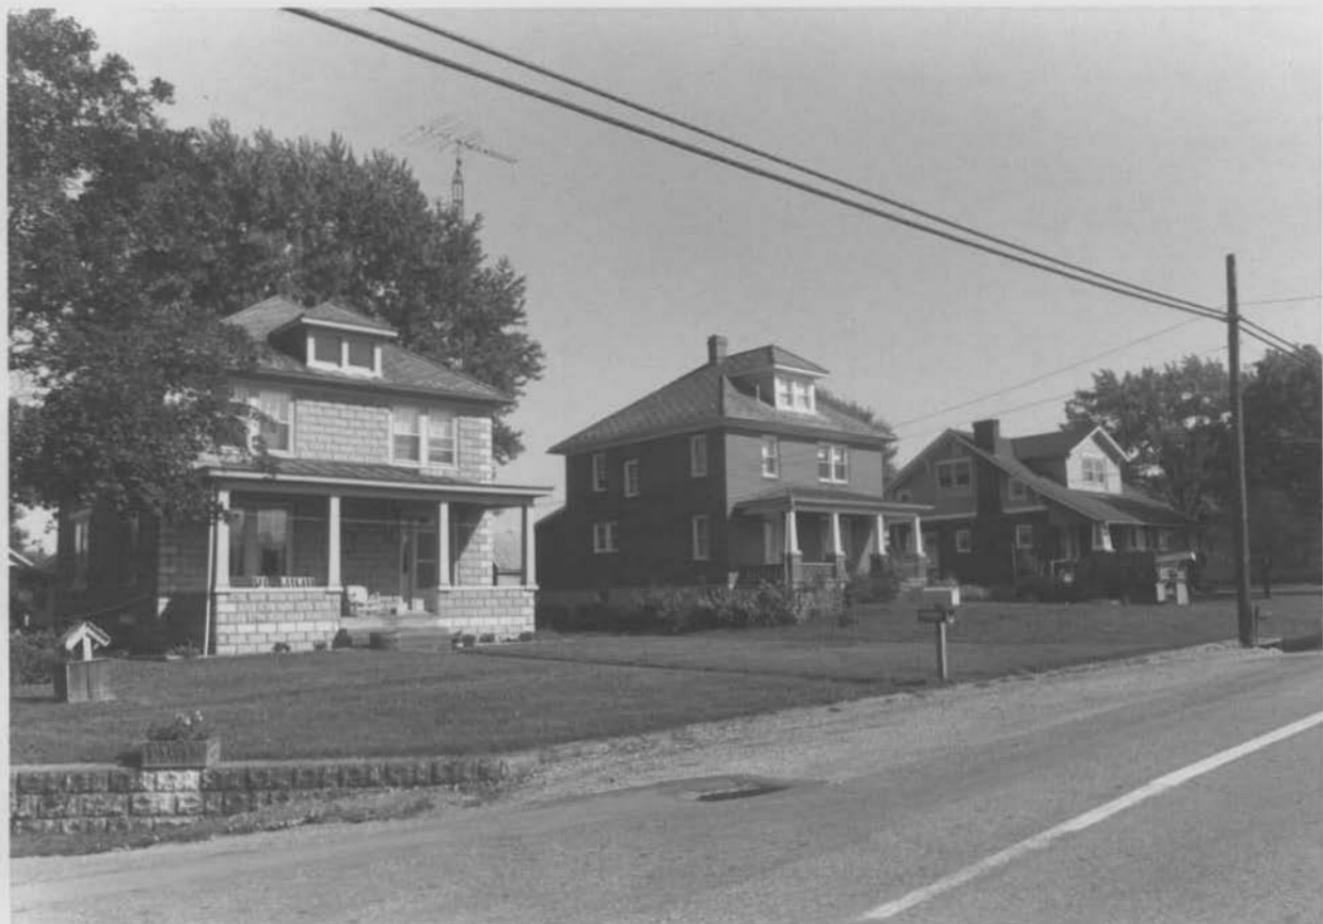
1/22

10927-10931 Hessong Bridge Rd.: This group of three early 20th century dwellings exemplifies the typical architectural styles and types of the period. The southernmost, 10927, is a 1-1/2 story bungalow with a brick veneer first story and stucco on the upper story. The gable roof has extended eaves and brackets on the north and south elevations and a gabled dormer projects above the integral porch on the west elevation. The porch columns are tapered and paneled with a brick base. The northern two houses are Four Squares, with hipped composition roofs with dormers on the west side, one-story porches and two-bay facades. The northern of the two, 10931, has rusticated concrete block walls with lighter colored quoins. The other house is brick. No. 10931 was built about 1920 and the other two houses were erected about 1930-1936.

10931-10927 Hessong Bridge Road (L to R), view  
from northwest

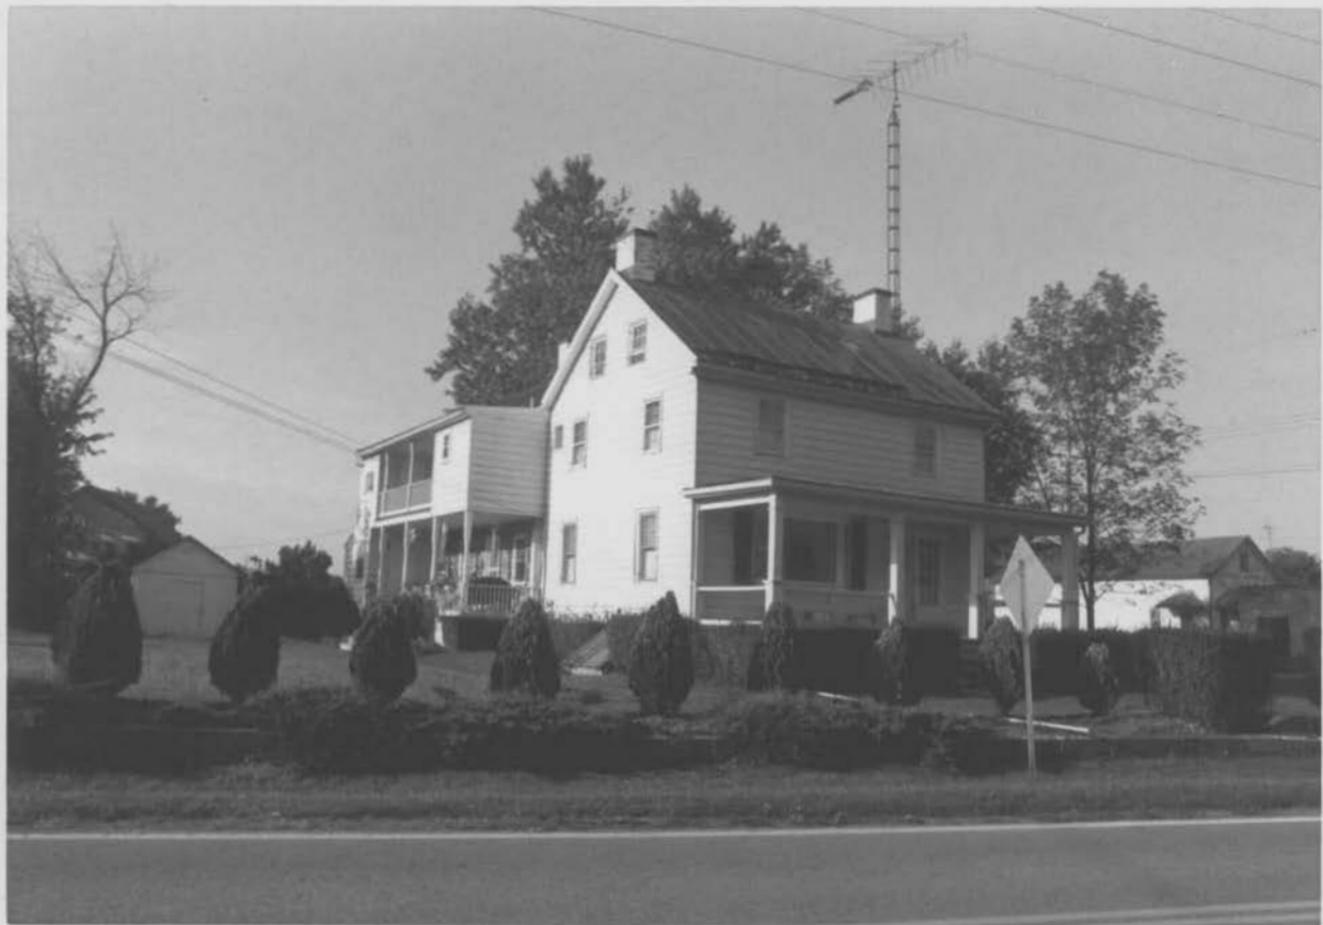
2/22

Schlosser-Ramsburg House, 10940 Hessong Bridge Rd.: The two-story log house was built about 1830-1850 and has vinyl and aluminum siding with an altered main elevation featuring a modern bay window and a replacement door. The one-story porch has dentil molding and square piers. The windows are 6/6 and the roof is standing seam metal. Interior end chimneys are at both gable ends. A much-altered rear wing with an extended and partially enclosed two-story porch faces south. According to the 1858 map, the house was owned by George Schlosser, who had a tanyard just south of the house. In 1870, it was purchased by Alexander Ramsburg, who was much later one of the promoters of the Washington, Frederick, & Gettysburg Railroad, which was merged into the H&F trolley system in 1909.

10940 Hessong Bridge Road, east elevation

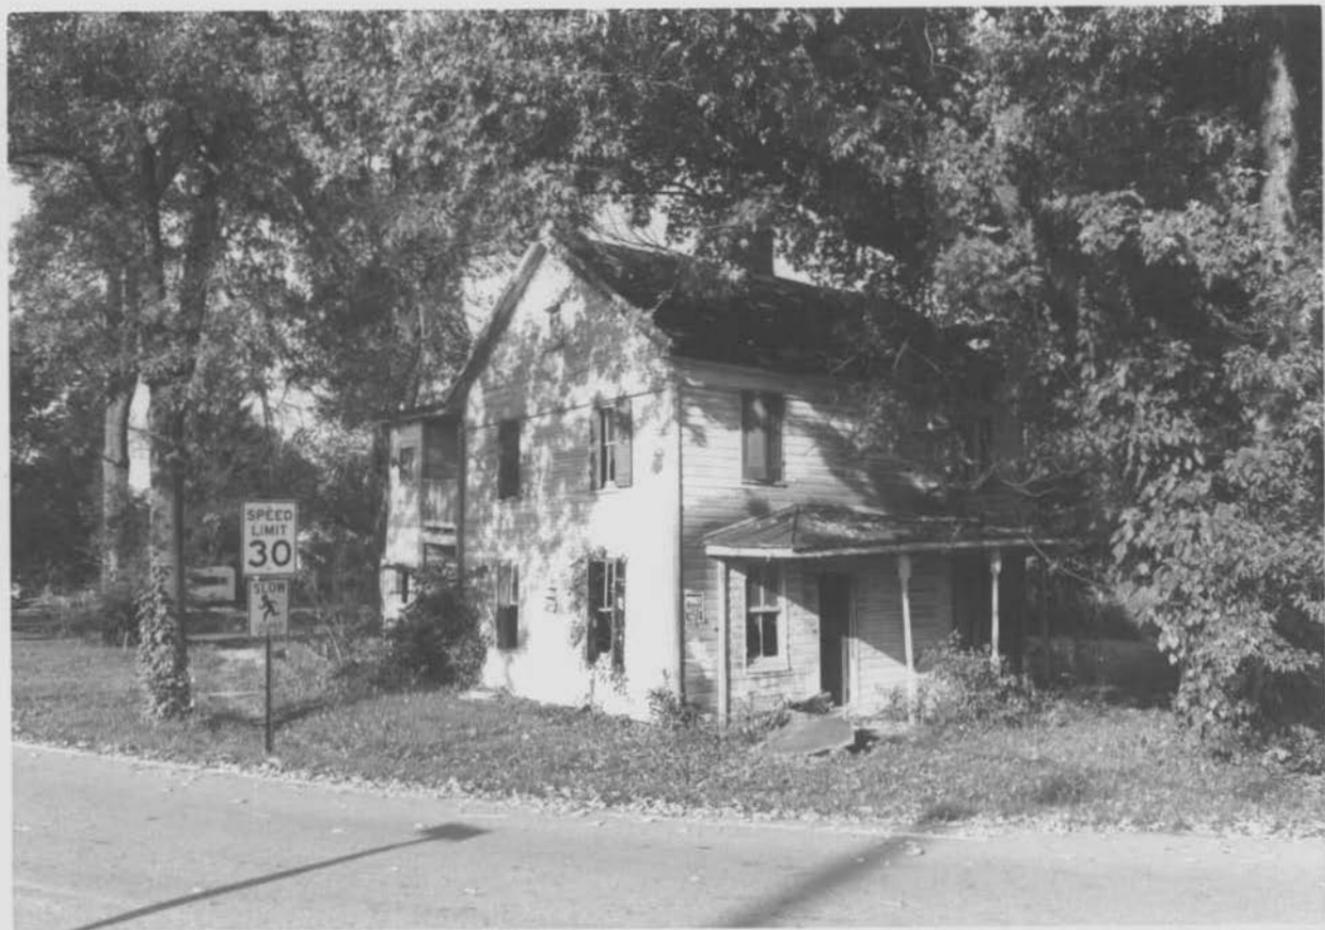
3/22

Eckman House, N.W. corner Hessong Bridge and  
Powell Roads, east elevation

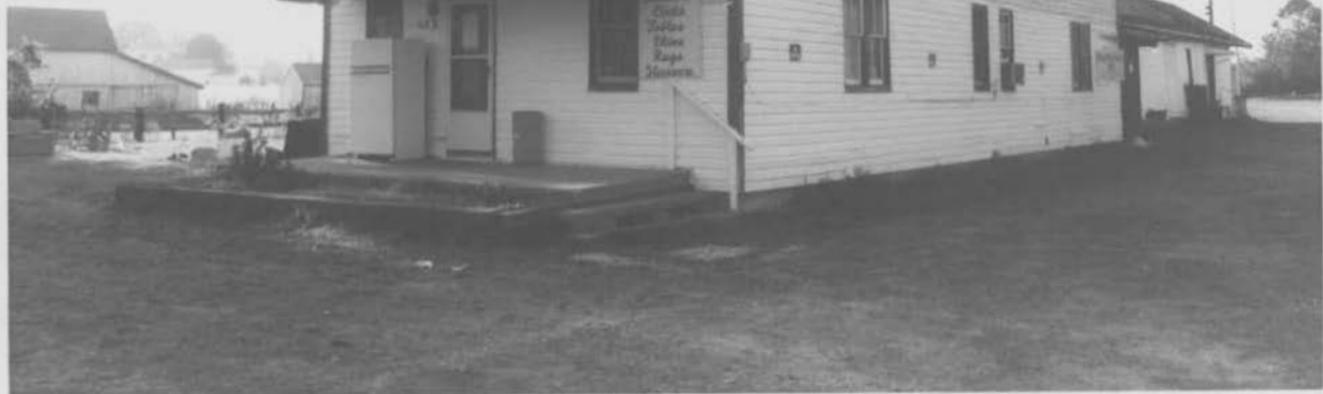
4/22

Hagerstown & Frederick Railway Depot, southwest corner of Hessong Bridge and Powell Roads: The two-story frame building was erected about 1910-1911 by Daniel Snook, who obtained a contract to build the station, a warehouse, and a post office from the Frederick Railroad Company, one of the interim names of the interurban electric railway company which became the Hagerstown & Frederick Railway in 1912-1913. Snook was appointed postmaster in Lewistown in January 1911. The depot is a long rectangular building with the principal entrance in the northeast gable end under a cantilevered porch roof. The windows are functionally placed along both sides of the building, roughly in three bays, and have 2/2 sash. The roof is standing seam metal with a central brick chimney. The exterior is covered with german siding. A one-story freight building adjoins the main structure on the southwest. The building's orientation reflects the direction of the railroad tracks at this point, which were removed after the line's closing in the 1950's, but the right of way is

H & F Railway Depot, Northeast corner view

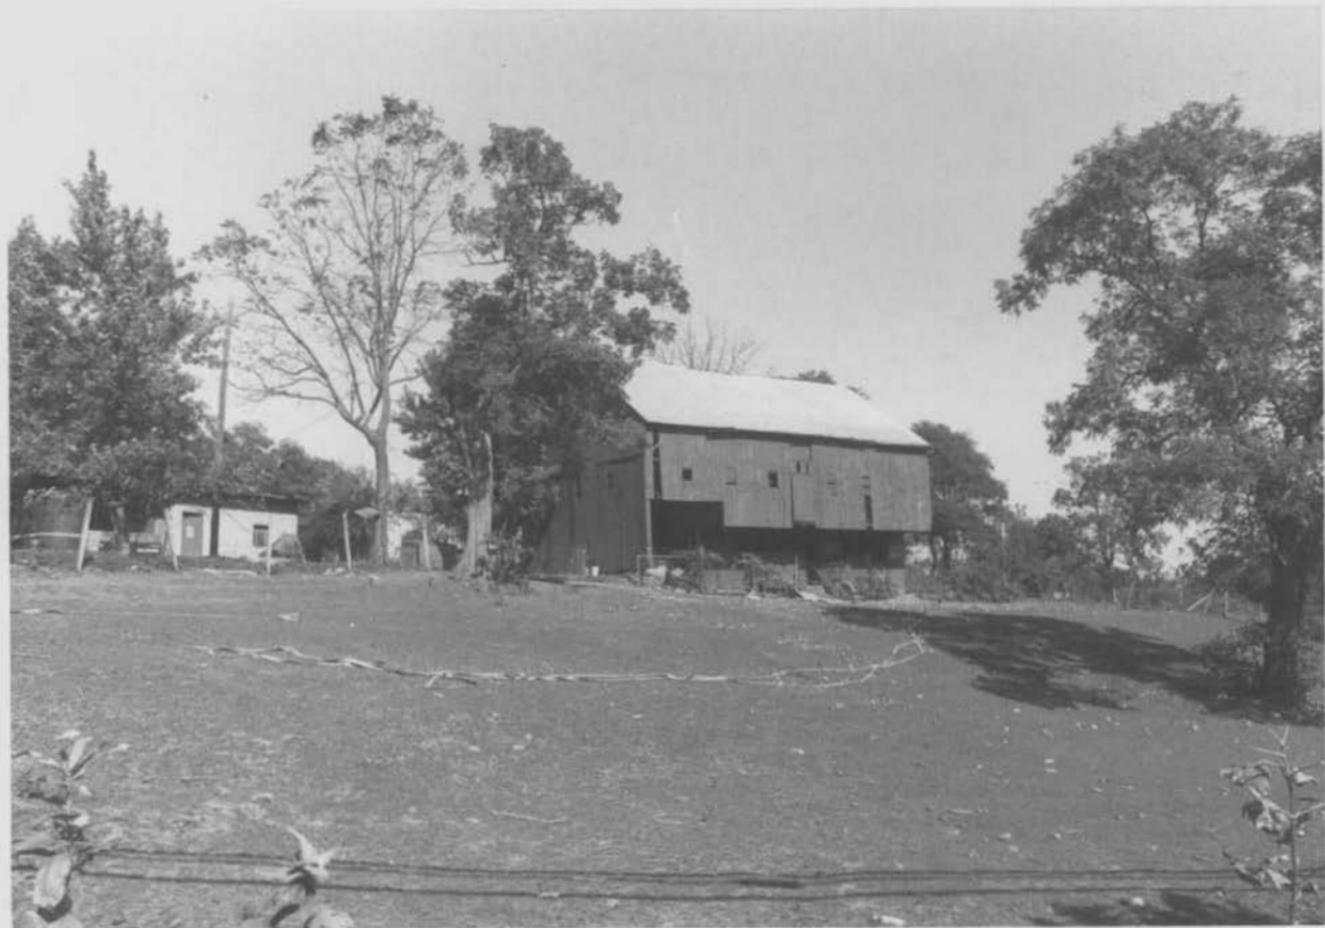
5/22

Flowers - Cronise barn, east of dwelling,  
11015 Hessong Bridge Road, south elevation

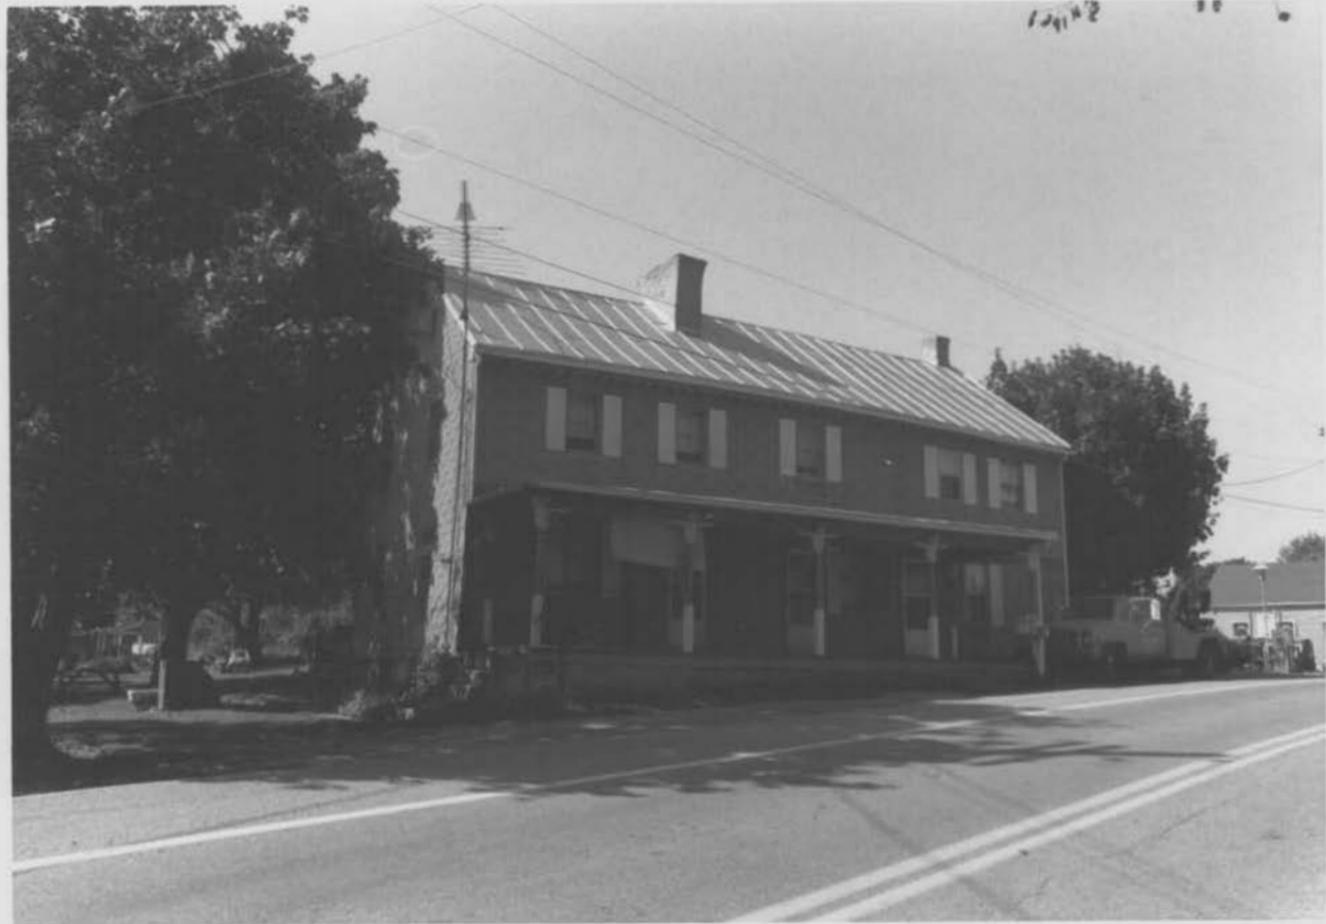
6/22

Clem Hotel, 11020 Hessong Bridge Rd.: The two-story log building has asphalt shingle siding and at least two apparent construction periods. The southeast elevation has five irregularly spaced bays with three entrances on the first story under a porch which crosses most of the facade. The gable roof is standing seam metal with a large chimney rising between the second and third bays from the south. A smaller interior end chimney is located at the north gable end. The windows are 2/2 with replacement shutters. A two-story rear wing extends from the northwest corner. The building is identified on the 1858 and 1873 maps as a hotel, but it was probably converted to private residential use in the early 20th century after the closing of the mill. George H. Clem was the proprietor and owner from 1857 to about 1900. The building's date is probably about 1827-30 in its earliest section.

Clem Hotel, 11024 Hessong Bridge Road,  
southeast elevation

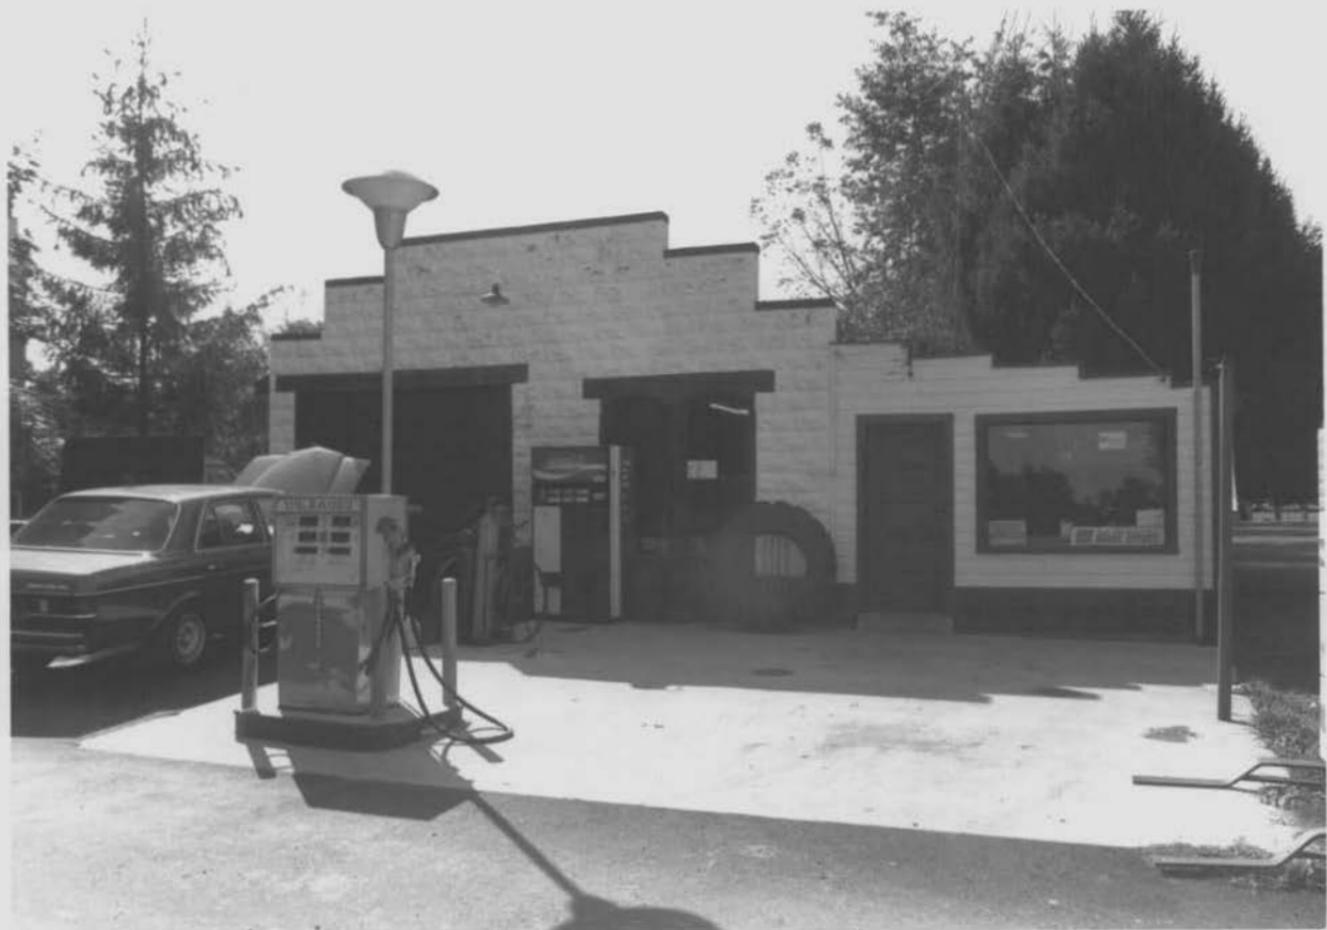
7/22

Service station: Immediately north of the Clem Hotel is a one-story rusticated concrete block service station probably built in the 1920's or early 1930's to serve the increasing automobile traffic in that period along the Frederick-Emmitsburg road. It has a stepped parapet on the east elevation above a wide doorway to the service bay, flanked by an addition on the north. The addition has german siding and continues the stepped parapet of the concrete block structure. The doors are tongue-and-groove in the block section and the window opening between the bay entrance and the addition contains a pair of segmental arched windows. The low gable roof of the building is standing seam metal and the main walls behind the facade are plain concrete block.

Service station, north of 11024 Hessong Bridge Rd.,  
east elevation

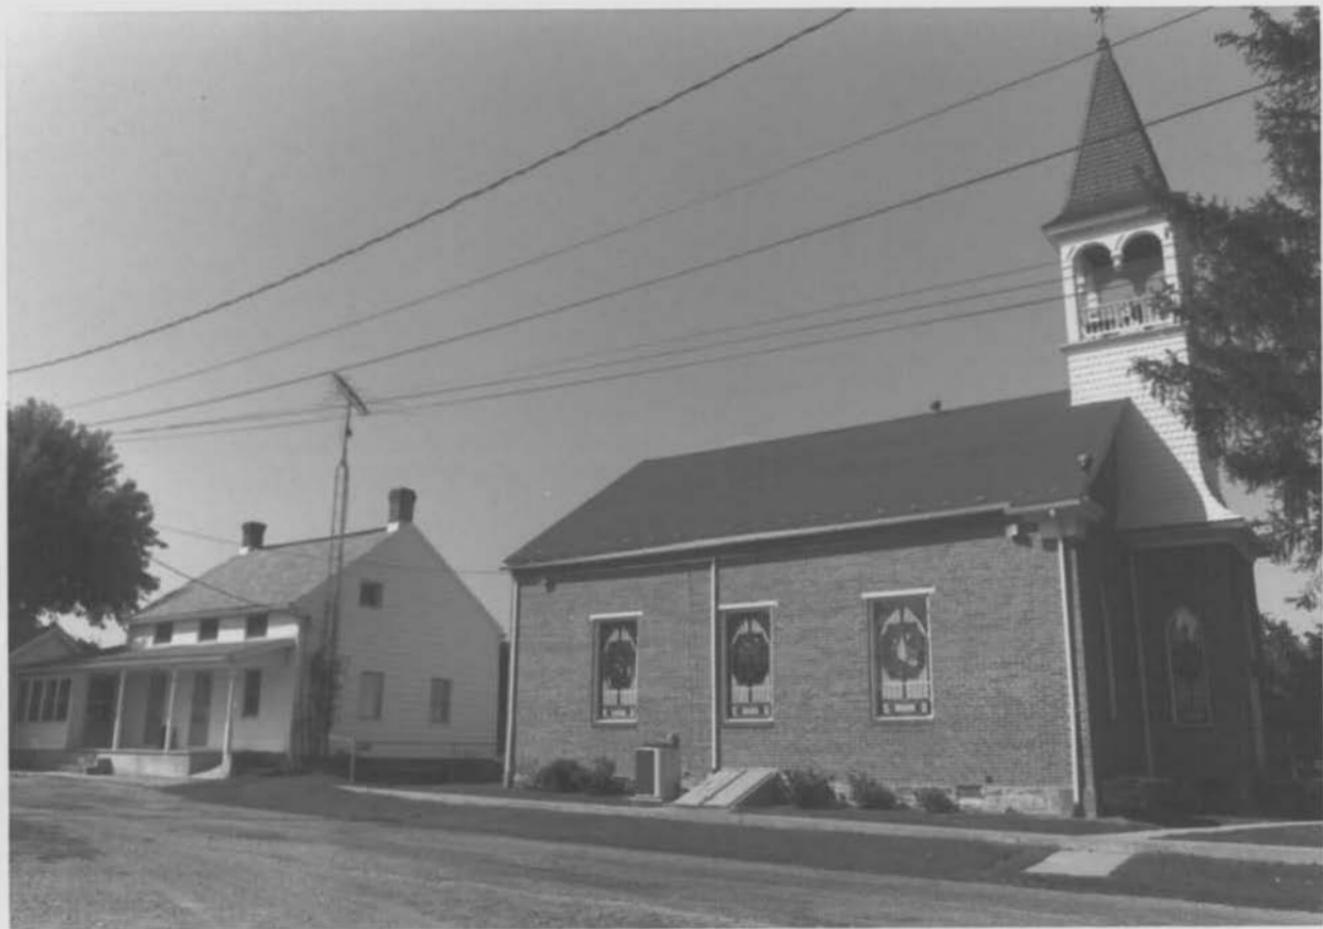
8/22

Lewistown Methodist Protestant Church, 11032 Hessong Bridge Rd.: The brick church was originally built in 1857 and substantially remodeled in 1890, according to the datestone at the northeast corner. The remodeling probably included the addition of the present bell tower which projects from the center of the east gable end with a bellcast upper section covered with decorative wood shingles. The open bell chamber has pendants and a plain railing. The bell tower roof is wood shingles and the main roof of the church is composition. The base of the tower contains the entrance with modern double entry doors. The transom is a Gothic arch with stained glass. The sides of the tower also have Gothic stained glass windows. The north and south elevations of the church have rectangular window openings, three on each side, with early 20th century stained glass windows. At the west gable end is a vinyl-sided projection containing the altar recess. On the north elevation is a 1970 education wing. The 5:1 brick walls have been sandblasted and repointed, probably within the period 1970-1985. The M. P. Church, now the United Methodist Church, is the only religious building remaining in the survey district, an earlier M.P. church on Powell Road having been demolished in the early 20th century, after serving as an African-American church from about 1857.

Valentine House, 11028 Hessong Bridge Rd.: Located immediately west of the M.P. Church, the Valentine House is a 1-1/2 story log dwelling with three bays and a one-story porch on the south elevation. A formerly free-standing summer kitchen is attached to the west elevation by means of a modern infill section. The house has modern artificial siding and two entrances, both with glazed panel doors. The windows are 2/2 and the half story has small square horizontally sliding windows just below the eaves. The house may date from about 1830 and is shown on both the 1858 and 1873 maps. In 1873, it was owned by J. Valentine.

Lewistown Methodist Protestant Church and

Valentine House, 11028 Hessong Bridge Road,

South elevations

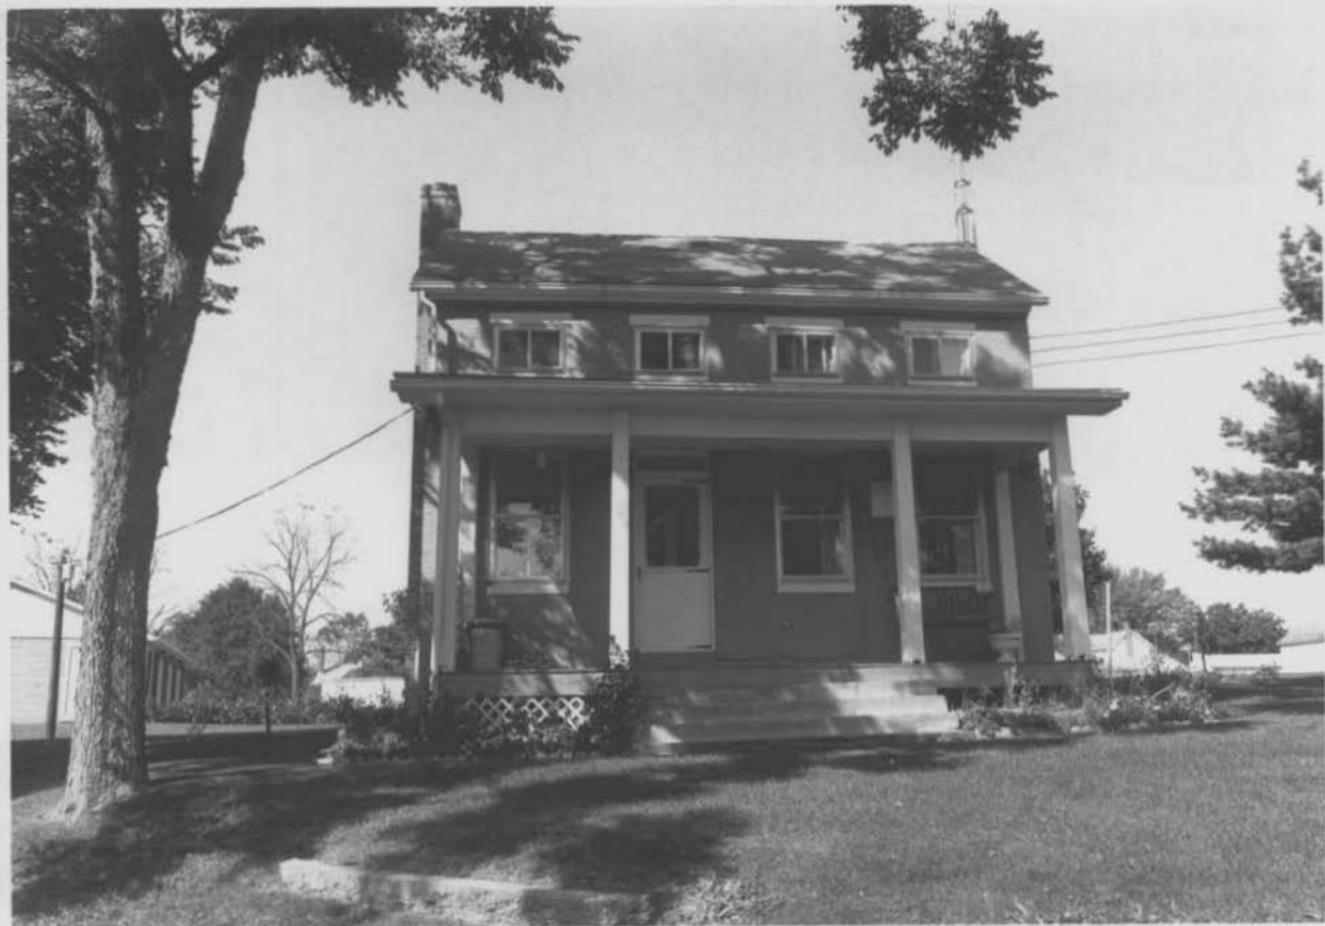
9/22

J. C. Derr House, 11026 Hessong Bridge Rd.: The Derr House is one of the few early brick dwellings, built about 1820-1830 on the north edge of the mill race about 75 yards west of Hessong Bridge Road. It has 1-1/2 stories with a flemish bond south elevation and four bays. A one-story porch with square

posts is probably a replacement of an earlier porch. The windows are 1/1 with small sliding windows on the half story level. The openings have plain lintels. A three-light transom is located above the doorway. The roof is covered with modern composition. The exterior walls are painted green. A two-story brick rear wing extends from the northwest corner and has a two-level open porch with replacement iron columns on the east side. The house was probably built for the manager of the grist and saw mills, built about 1824 by John Brien, later operated by Frederick Schley and John C. Derr. On the 1858 map, the house is noted as "H. Eaton", possibly the mill's manager at the time. In 1873, the owner is shown as J. C. Derr.

Schley-Derr House, 11026 Hessong Bridge Road.

South elevation

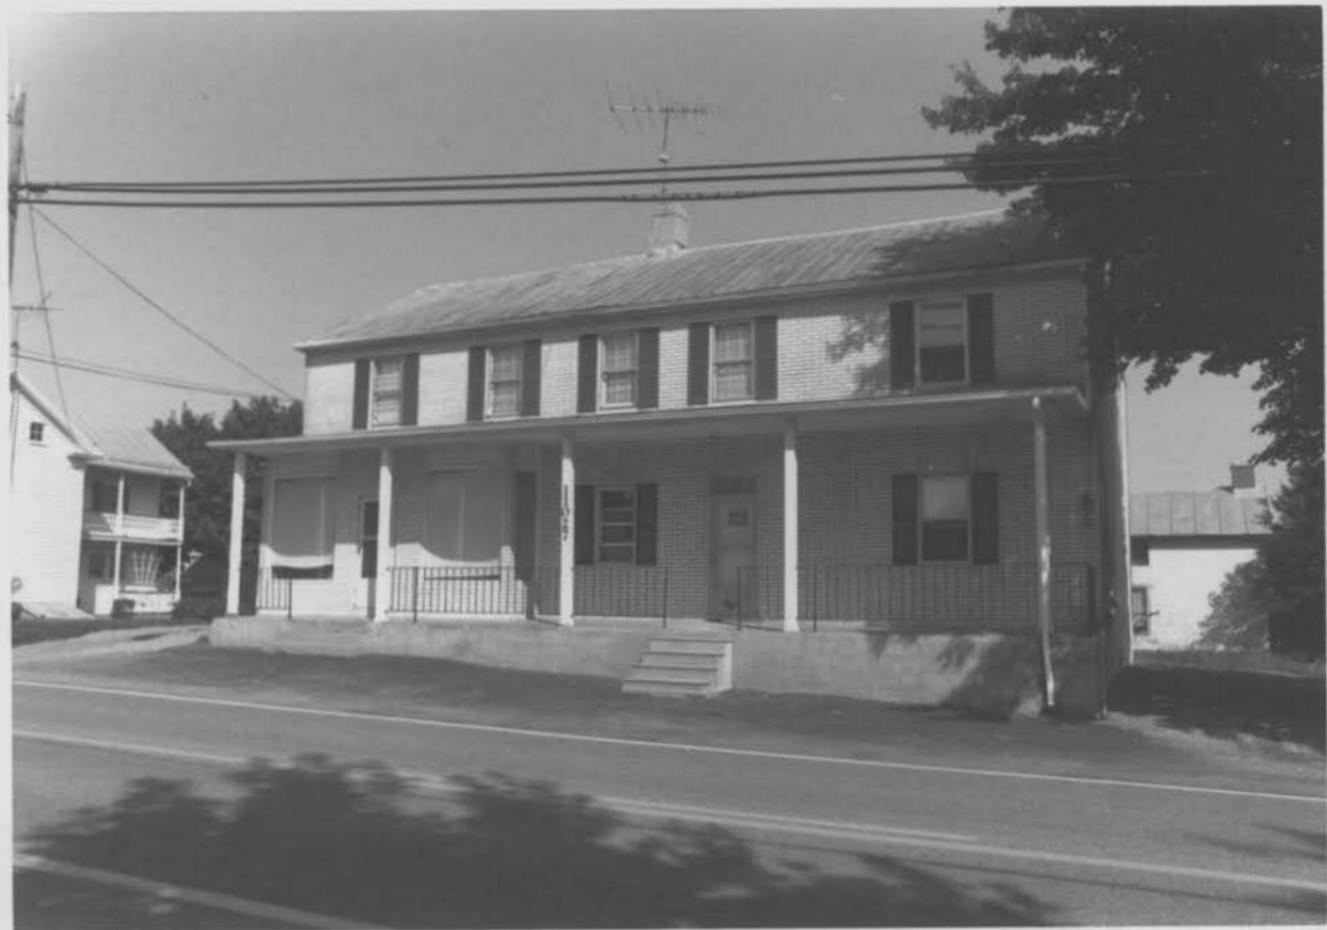
10/22

Green Store, 11027 Hessong Bridge Rd.: The former Joseph Green general store, built about 1860-1870, is a two-story rectangular building on the east side of Hessong Bridge Road. It may have both log and frame structure within its elongated form, now covered with white brick-patterned veneer. The building has the typical form of a combination store and residence, with the projecting former display windows of the store still in place at the north end of the building. The irregular spacing of the window bays and the off-center chimney further underscore the dual original use. A one-story porch crosses the entire west elevation, with plain square posts undoubtedly replacing the original turned columns. The roof is corrugated metal. The building is currently in residential use. Joseph D. Green (1842-1906), a Union Army veteran disabled at the Battle of the Wilderness, apparently built the store section, possibly on an existing structure. He ran the store for several years, selling it to A. N. Cramer, whose name is more closely identified with the store in the early 20th century. The exact date of its closure is not yet known, but probably coincided with the rise in automobile use after World War II, which took former customers to Frederick and Thurmont for shopping.

Green's Store, 11027 Hessong Bridge Road,  
west elevation

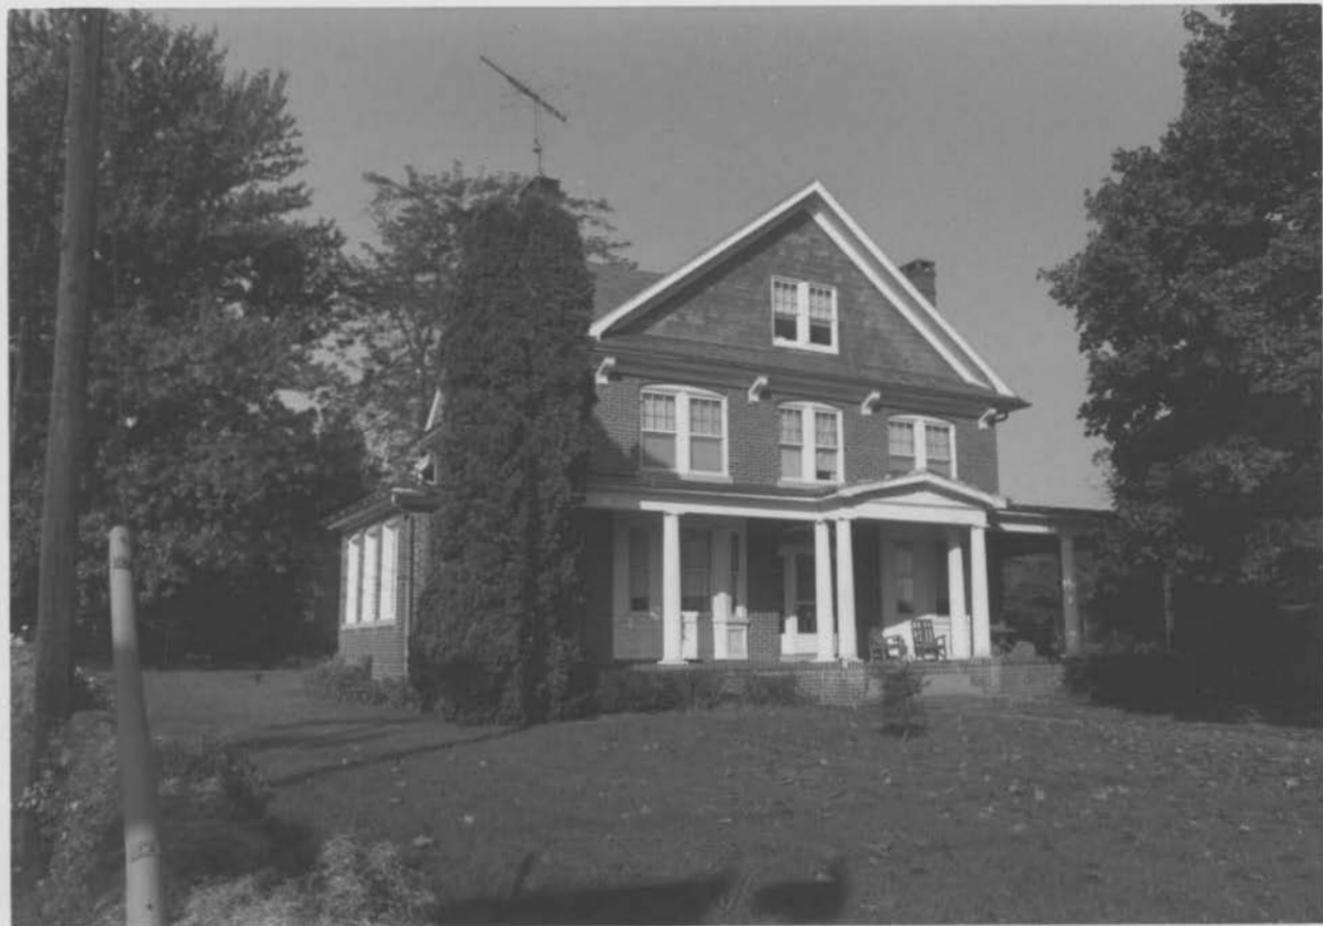
12/22

Palmer House, 11106 Hessong Bridge Rd.: This 2-1/2 story Colonial Revival style house is another of the few brick historic structures in the district and is also a good representative of the early 20th century's melding of many architectural influences. It was built about 1915-1916 by G. Lloyd Palmer, a prominent educator in Frederick County and the founder of the Emmitsburg High School. It has a large slate gable on the east elevation above a three-bay facade with paired 6/1 sash in segmental arched frames. A one-story veranda extends on the east and north elevations with a projecting entrance pediment. The doorway has a fanlight and sidelights. On the south elevation is an enclosed sun room. The cornice has widely spaced brackets. A two-story porch is located at the southwest corner. A separate brick garage behind the house has a slate hipped roof.

Palmer House, 11106 Hessong Bridge Road,  
east elevation

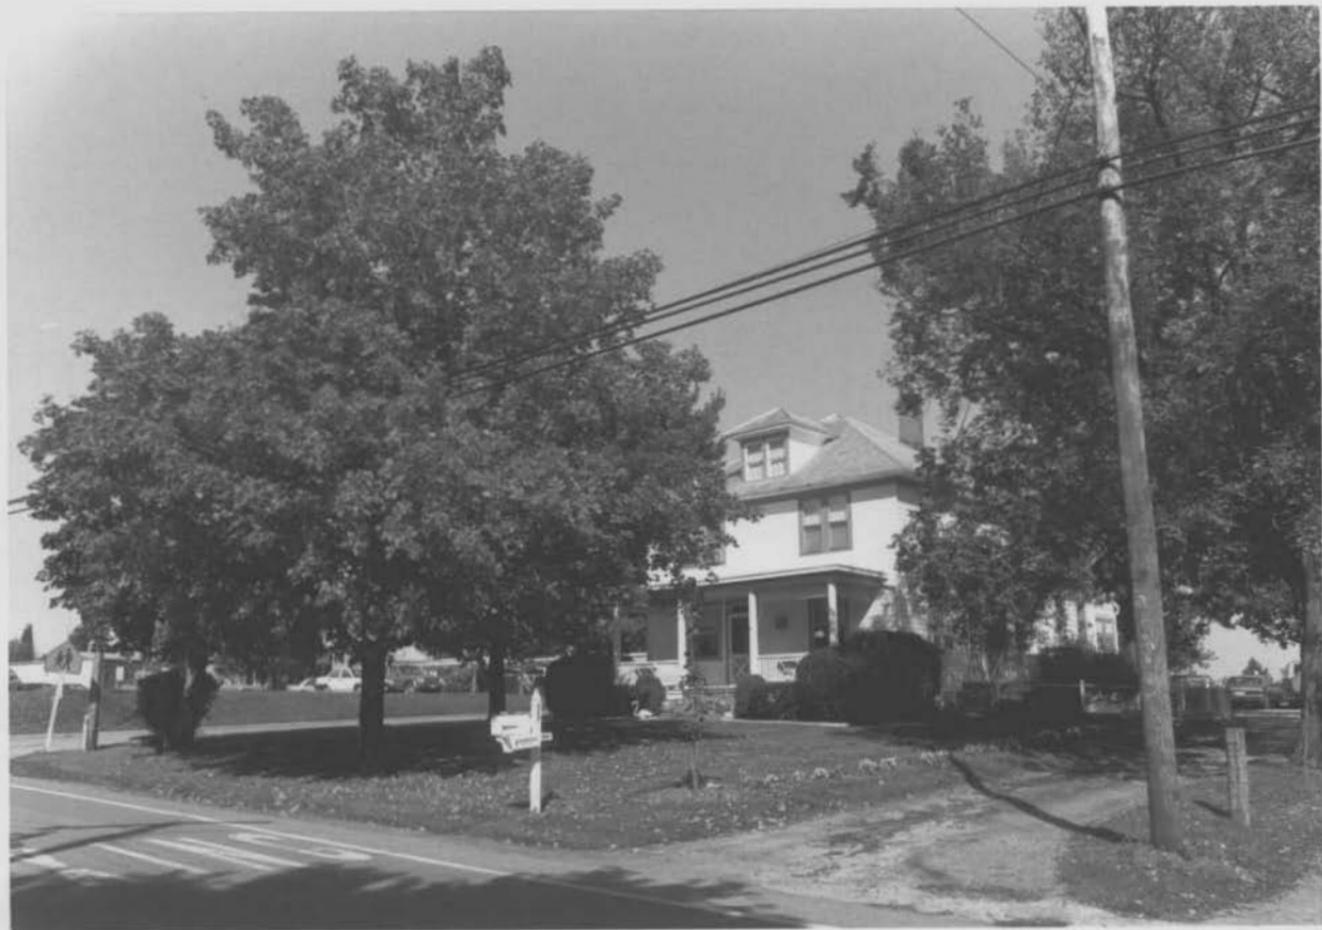
13/22

11113 Hessong Bridge Road, southwest corner  
view

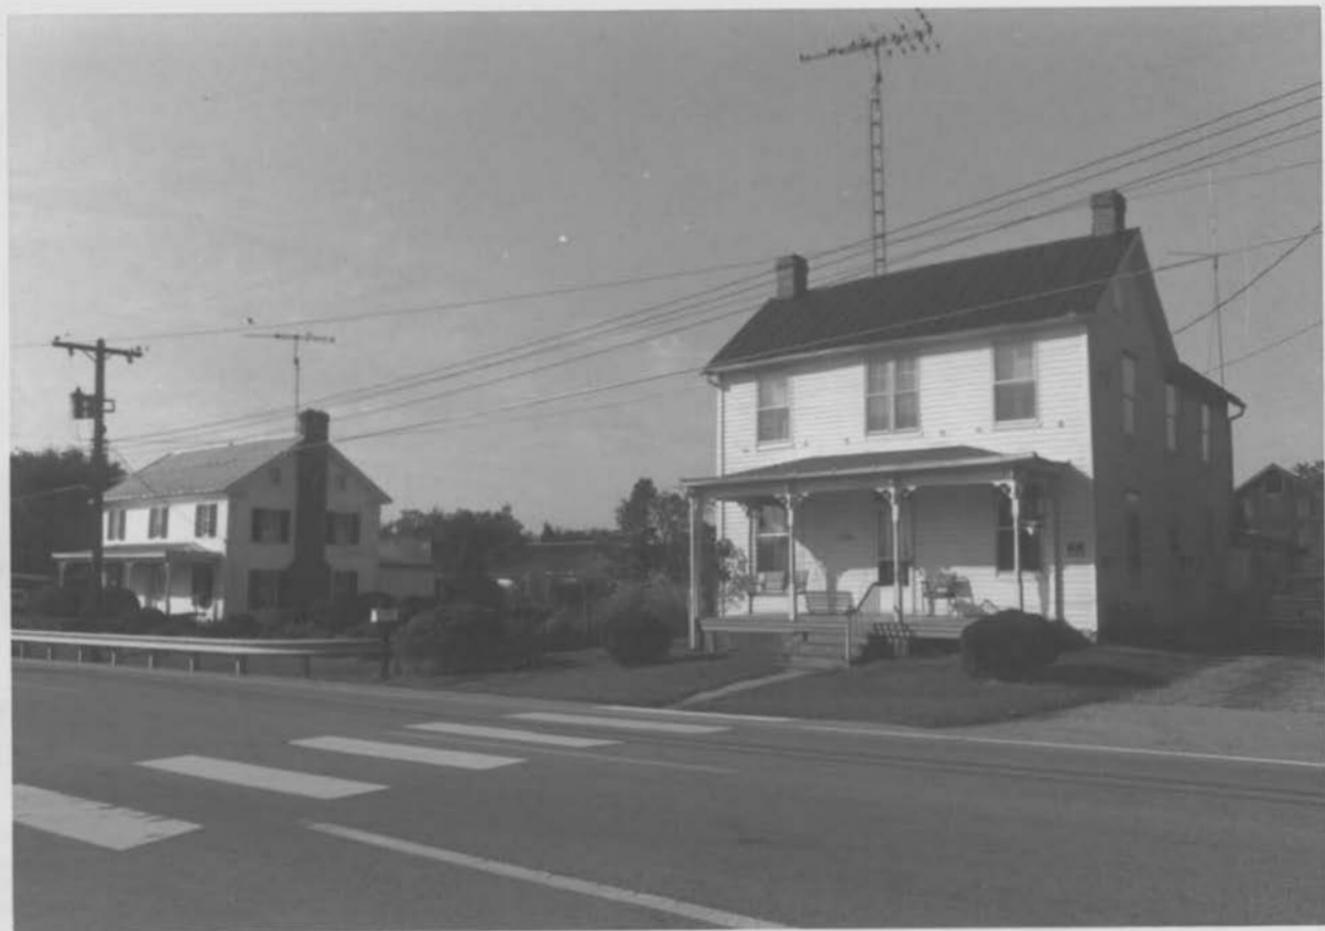
14/22

11118 and 11120 Hessong Bridge Rd.: These two dwellings are probably log structures, with later siding. No. 11118 has german and modern artificial siding and three bays with a one-story bracketed porch, 2/2 sash, and louvred shutters. The original interior end chimneys have been removed and a modern exterior brick chimney is on the north end. The roof is corrugated metal. Several frame outbuildings are located behind the house, including a smokehouse, a chicken house, and a garage. No. 11120 has german siding and a three-bay east elevation which features paired windows in the center bay of the second story. It also has a bracketed porch with turned columns. The sash is 2/2 and the roof is standing seam metal with interior end chimneys. One of the few barns remaining in the he district is located to the rear of the property, along with several other frame outbuildings. The two houses are typical of the mid 19th century period of Lewistown's development and suggest its rural farming roots in their surviving outbuildings.

11118 and 11120 Hessong Bridge Road (L to R)

view from northeast

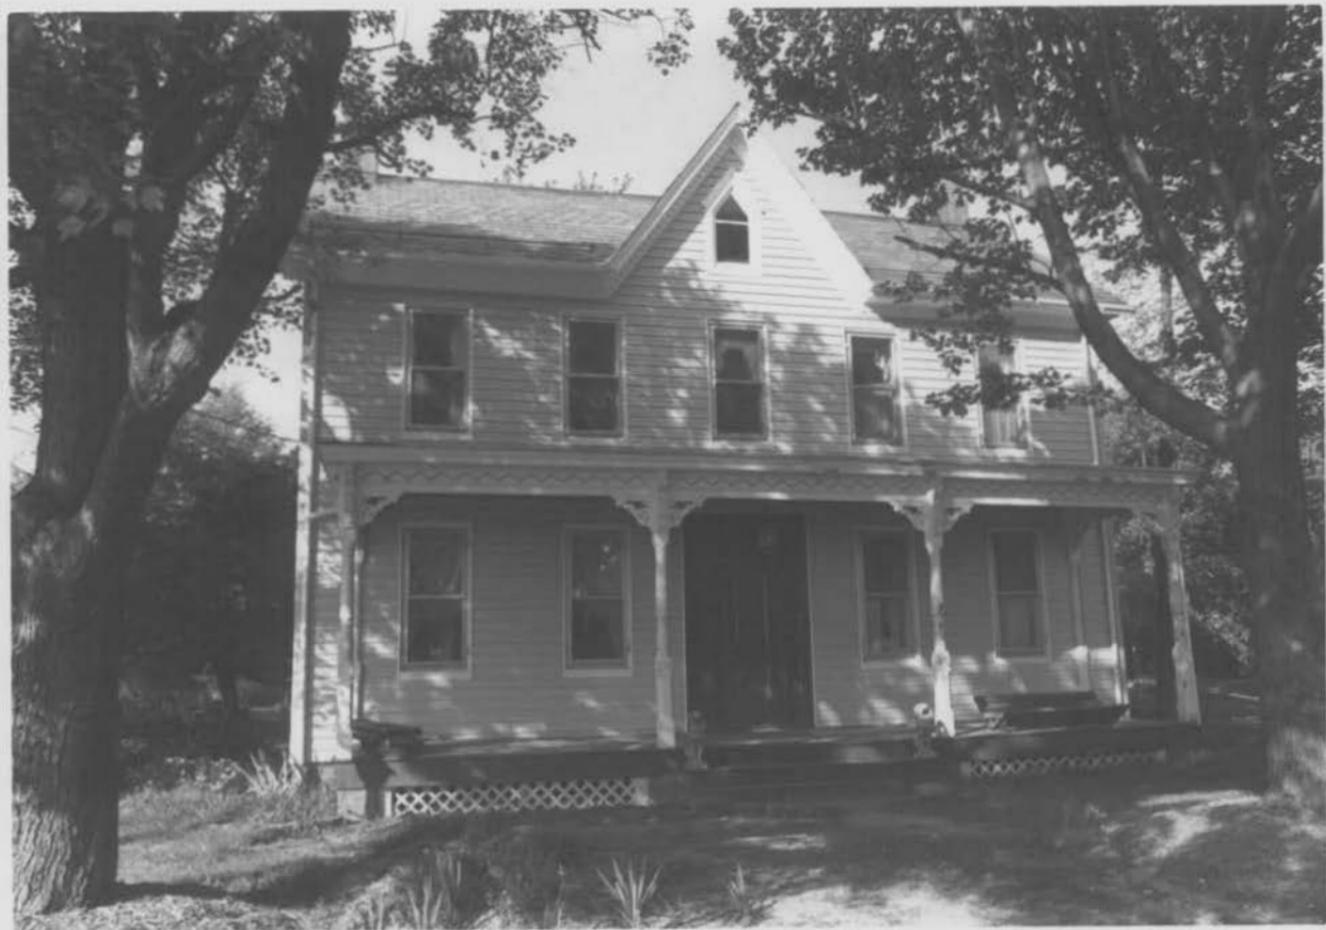
15/22

11128 Hessong Bridge Rd.: This frame house has a cross gable and five bays with vinyl siding probably covering the original german siding. A one-story porch with turned columns, brackets, and a scroll-sawn zig-zag frieze crosses the east elevation. The center entrance has a transom and sidelights. The replacement sash is 1/1 and the roof is patterned slate. This is a good example of the late 19th century in architectural style, with its varied textural surfaces, decorative trim, and larger proportions than the early 19th century structures.

11128 Hessong Bridge Road, east elevation

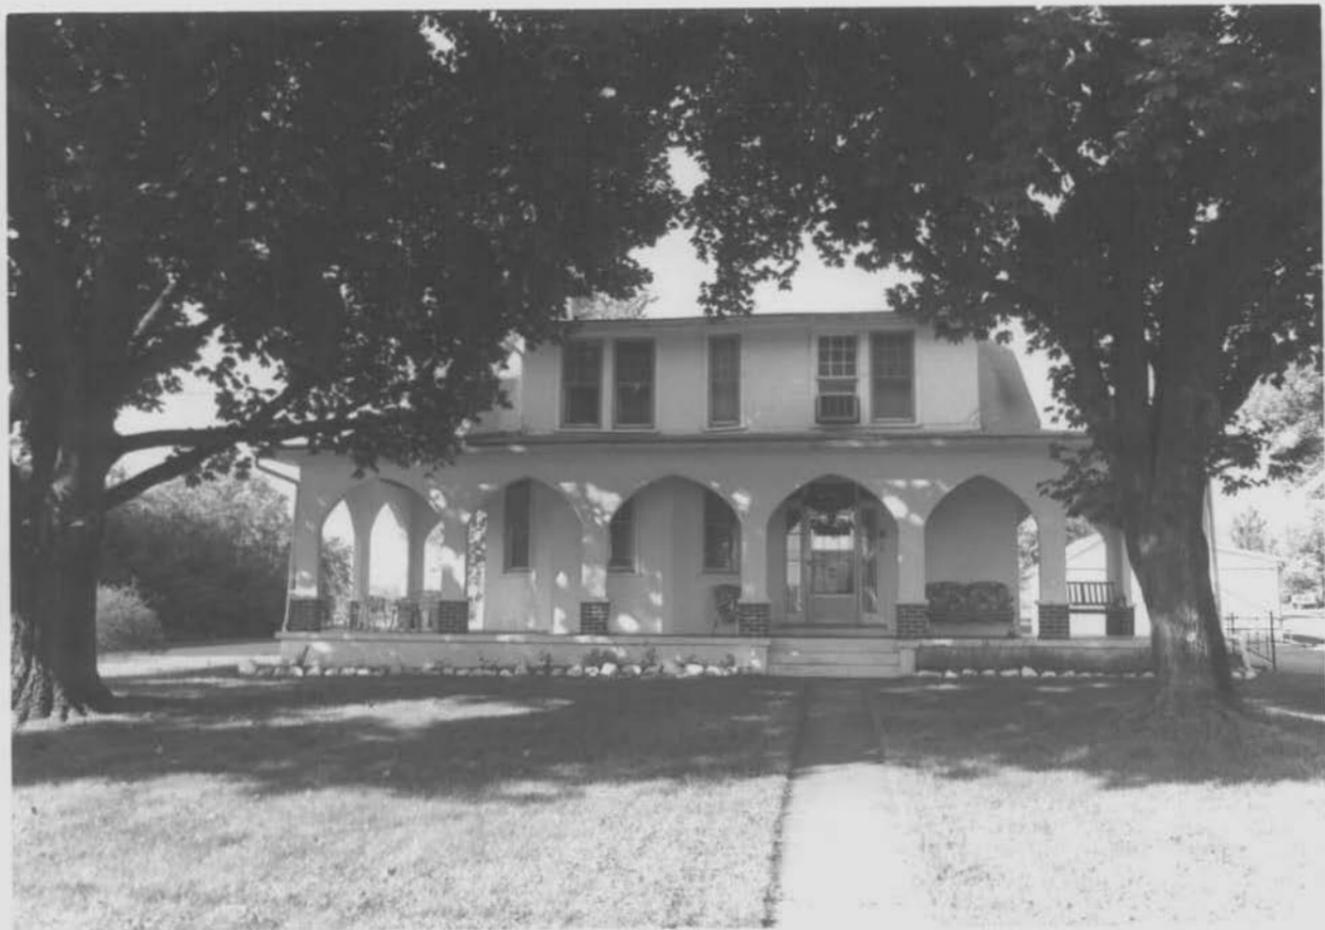
16/22

11202 Hessong Bridge Road: This 1-1/2 story stucco bungalow was built about 1930 and is distinguished by the first story veranda with Gothic arches on three sides. Above the porch on the east elevation is a shed dormer with 9/1 sash. The first story has three bays with a projecting bay and a doorway with transom and sidelights. A narrow 9/1 window is located in the center bay in both the first and second stories.

11202 Hessong Bridge Road, east elevation

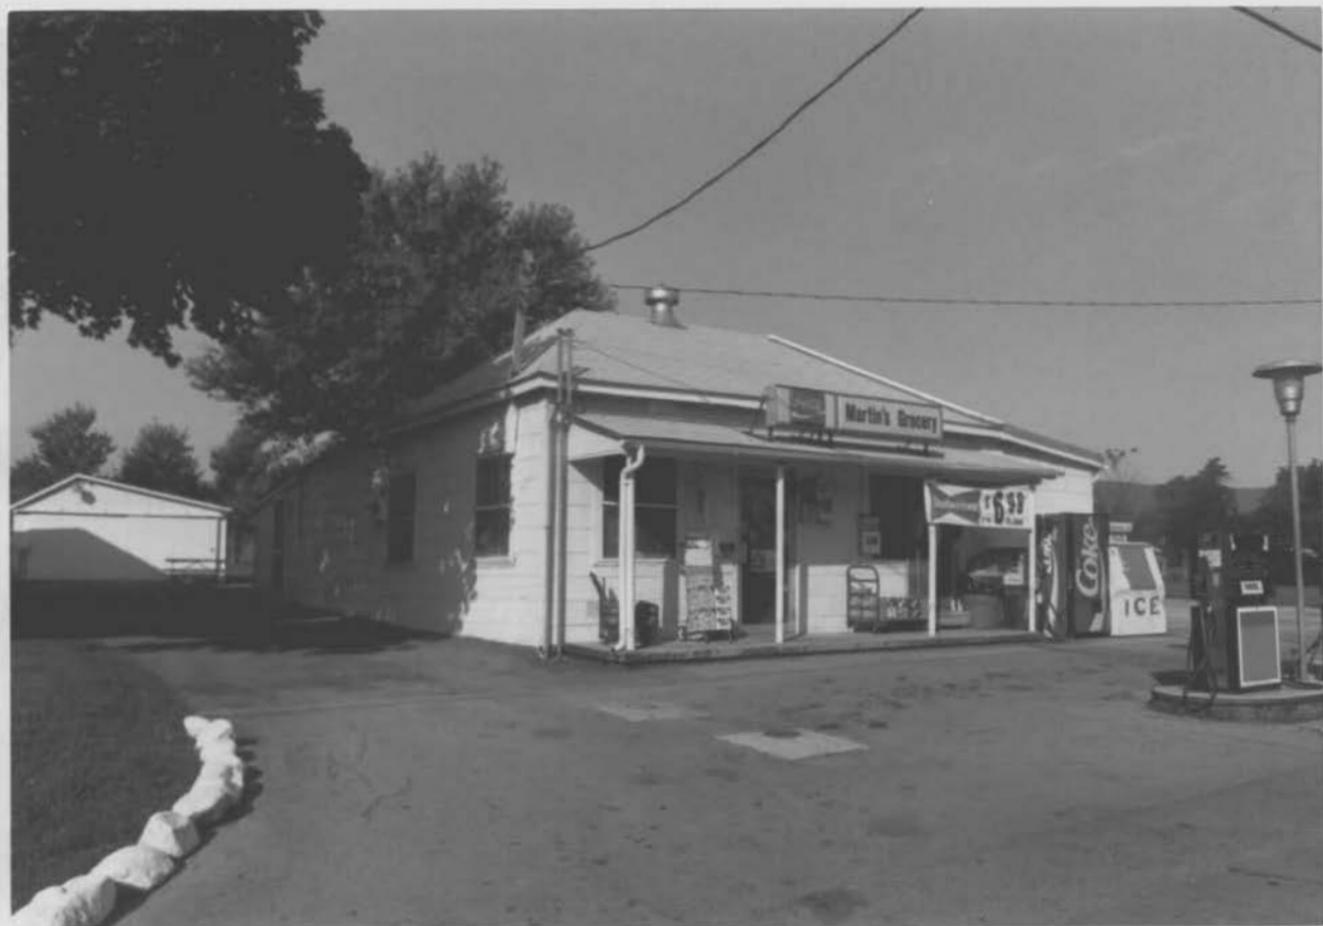
17/22

Martin's Grocery, 11204 Hessong Bridge Rd.: The one-story frame structure now used as a convenience store was once a tourist cabin, one of several which stood in a rough semi-circle west of the store's present location from the 1930's to the 1960's. When the traffic on Hessong Bridge Road was shifted to Md. 15 west of Lewistown, the tourist cabins deteriorated from neglect and were eventually demolished, except this building which was moved near the road and converted to a small store. It has a composition-covered hipped roof and asbestos shingle siding. The windows are 2/2 and the modern plate glass door is located off-center in the east elevation under a shed porch. Extensions for storage have been added to the rear of the building. The interior is almost completely altered, with shelves covering most of the interior wall surfaces.

Tourist cabin/store, east elevation
