F-3-97  
Lewistown Survey District  
Lewistown  
Public and private

# Maryland Historical Trust State Historic Sites Inventory Form

historic Lewistown Survey District

Survey No. F-3-97

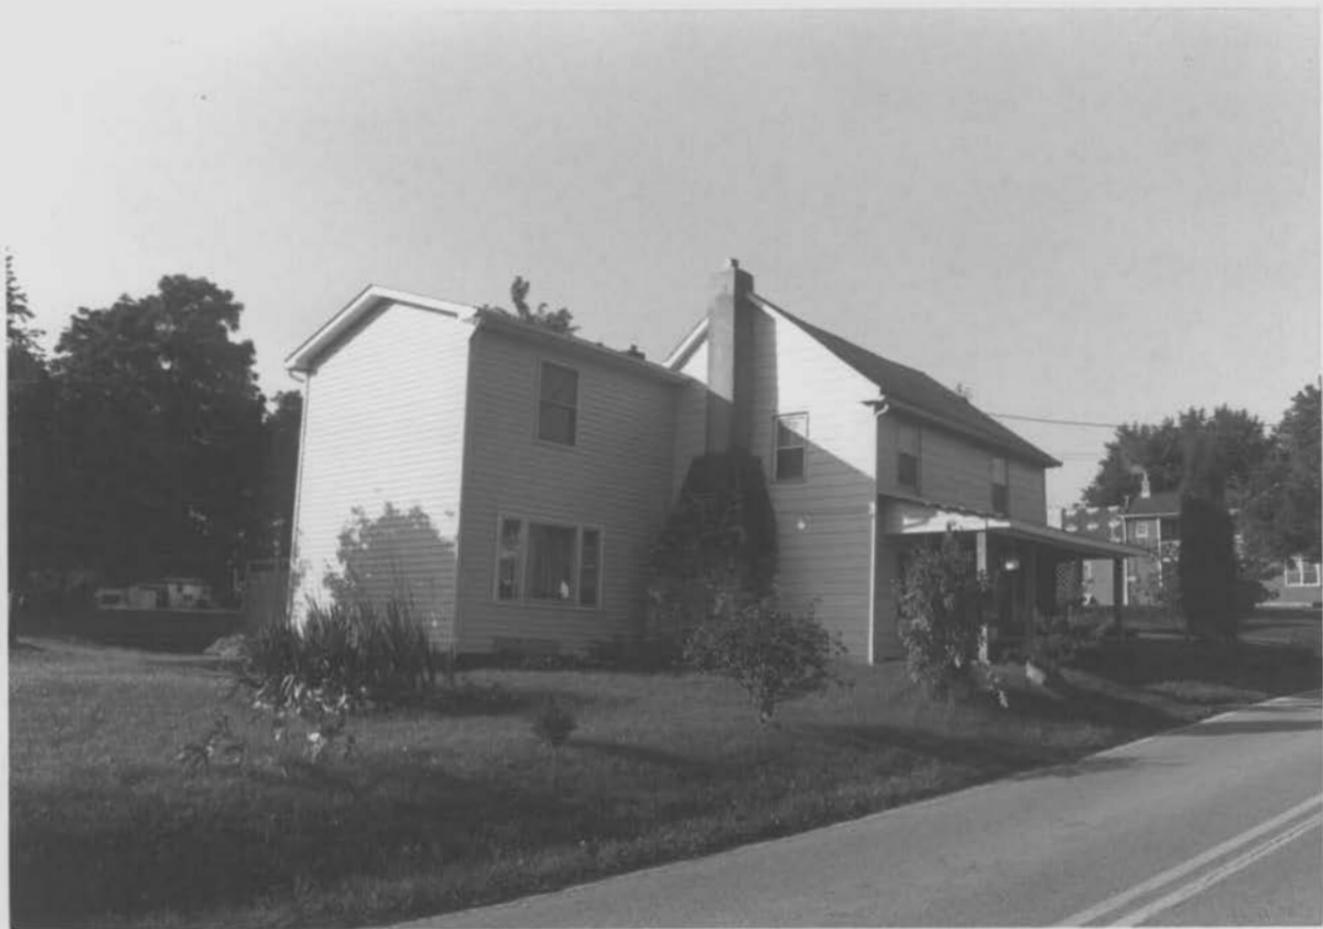
18/22

11039 Powell Road: This log house has been much altered on the exterior, but was probably built about 1820-1840. It has an exterior brick and stone chimney on the east gable end and a modern two-story addition on the southeast and south elevations. The exterior is covered with asbestos shingle siding and the roof is standing seam metal. The north elevation has three bays on the first story and two on the second, with 2/2 sash and a one-story porch with replacement posts. It is the only dwelling in the survey district with an exterior stone chimney, a typical feature of vernacular log dwellings in the first half of the 19th century.

11039 Powell Road, east elevation

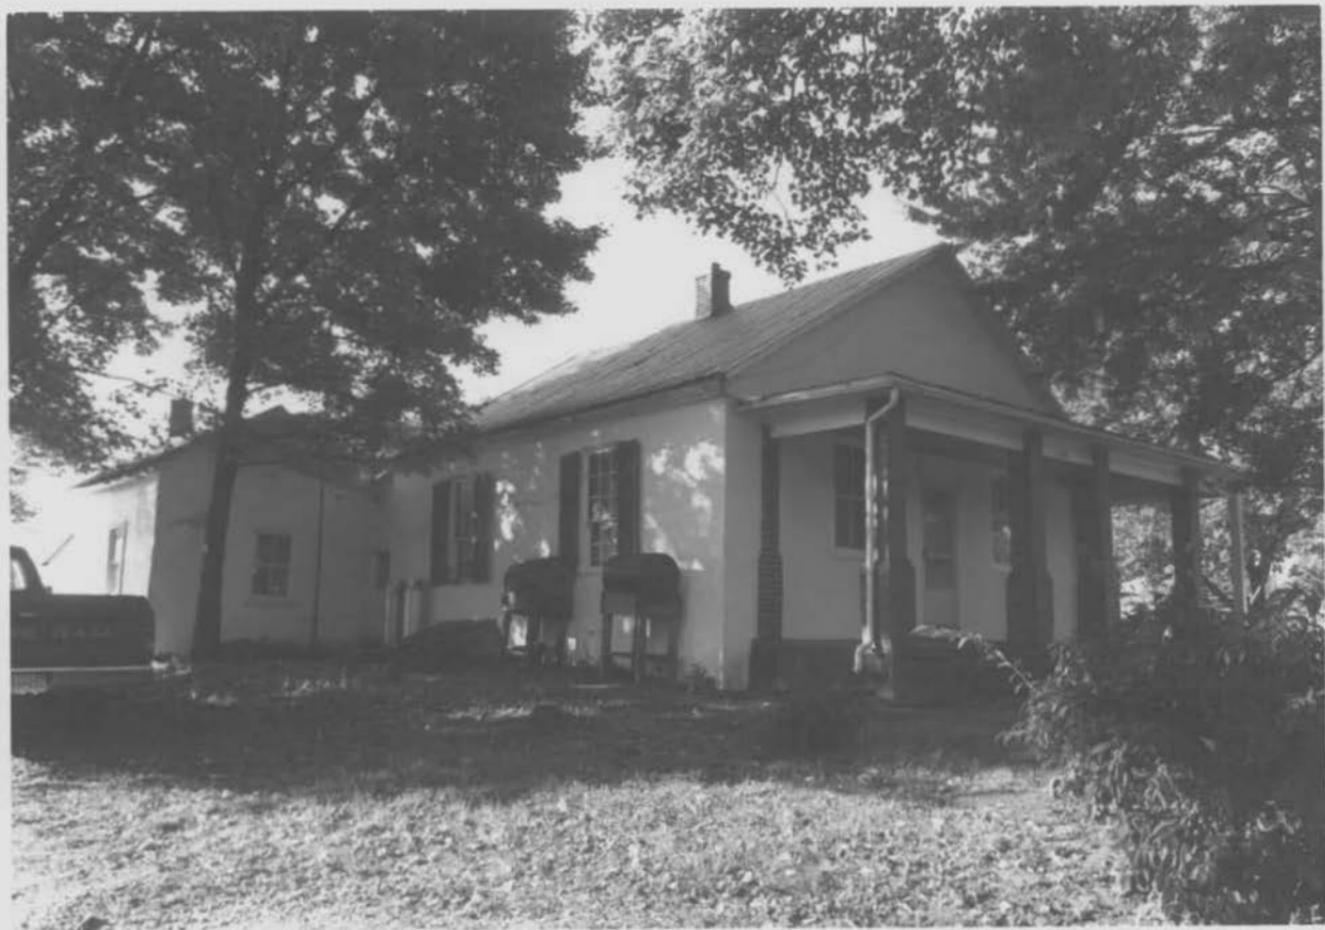
19/22

1840 Schoolhouse, 11031 Powell Road: The one-story gable facade building has a stuccoed exterior, probably concealing stone or brick walls. It has three bays on the north elevation with the entrance in the center bay. A one-story porch with brick piers shelters the facade. The roof is covered with standing seam metal and a center chimney rises from the ridge. The east and west elevations had three original bays and 9/6 windows with louvred shutters survive on the windows openings. A one-story addition, perhaps a summer kitchen built after the building was converted to residential use in 1870, adjoins the southeast corner and obscures one of the original three bays on that side.

1840's schoolhouse, 11031 Powell Road, northeast  
corner view

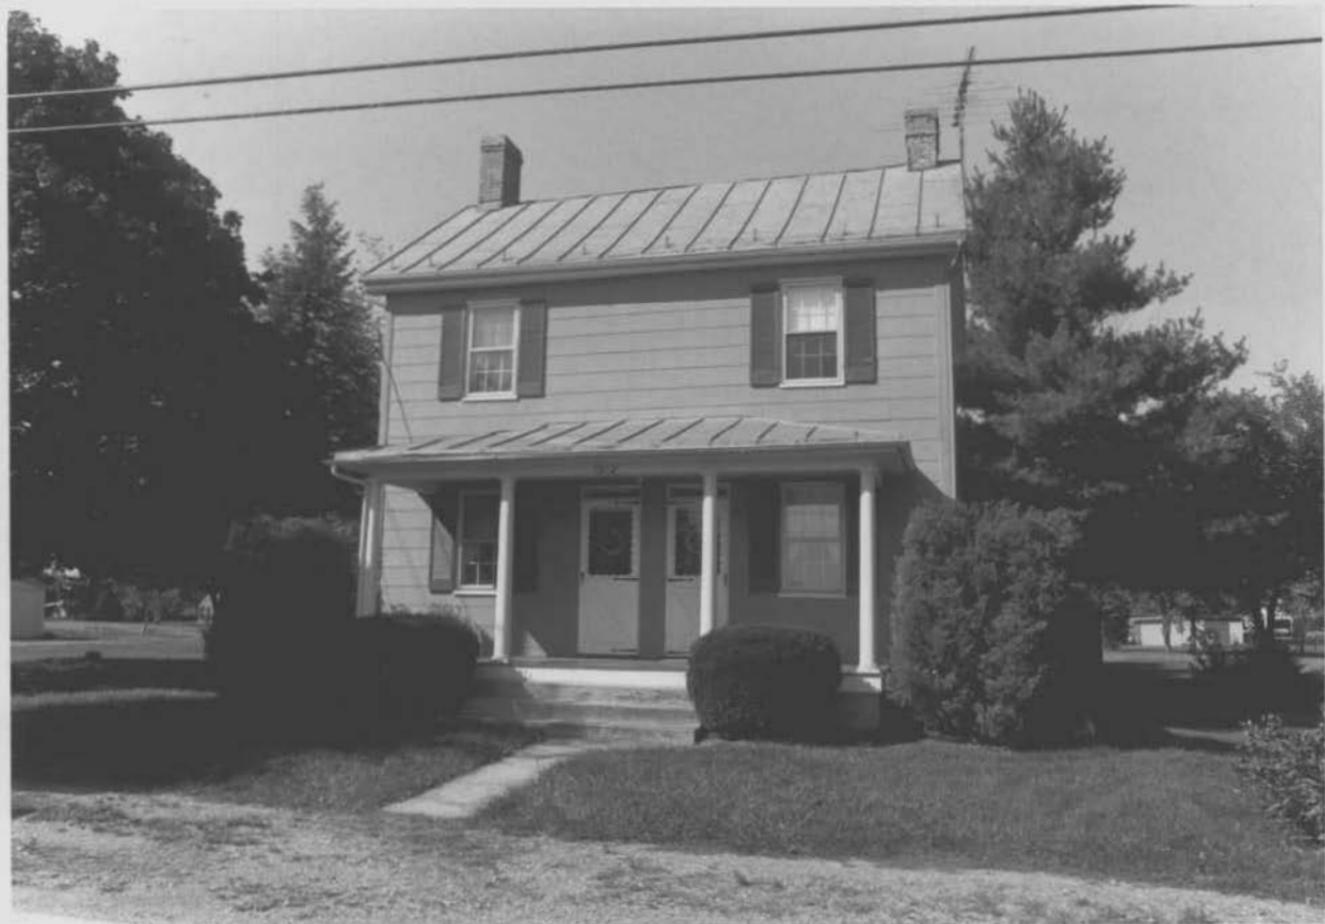
7212 Fish Hatchery Road: This building is also a typical vernacular dwelling of the mid 19th century. It has two stories with a three-bay first story and a two-bay second story. The center bay is occupied by double entrances, a common feature of German houses in the 18th and 19th centuries. A one-story porch with Tuscan columns, a late 19th or early 20th century replacement, is on the south elevation. The windows are 6/6 with louvred shutters.

7212 Fish Hatchery Road, South elevation  
21/22
