National Register of Historic Places  
Inventory—Nomination Form

historic Shafer's Mill (preferred), Ascension Day  
and or common Shafer's Mill

street & number 3018 Bennies Hill Road N/A not for publication  
city, town Middletown X vicinity of Sixth Congressional District  
state Maryland code 24 county Frederick code 021

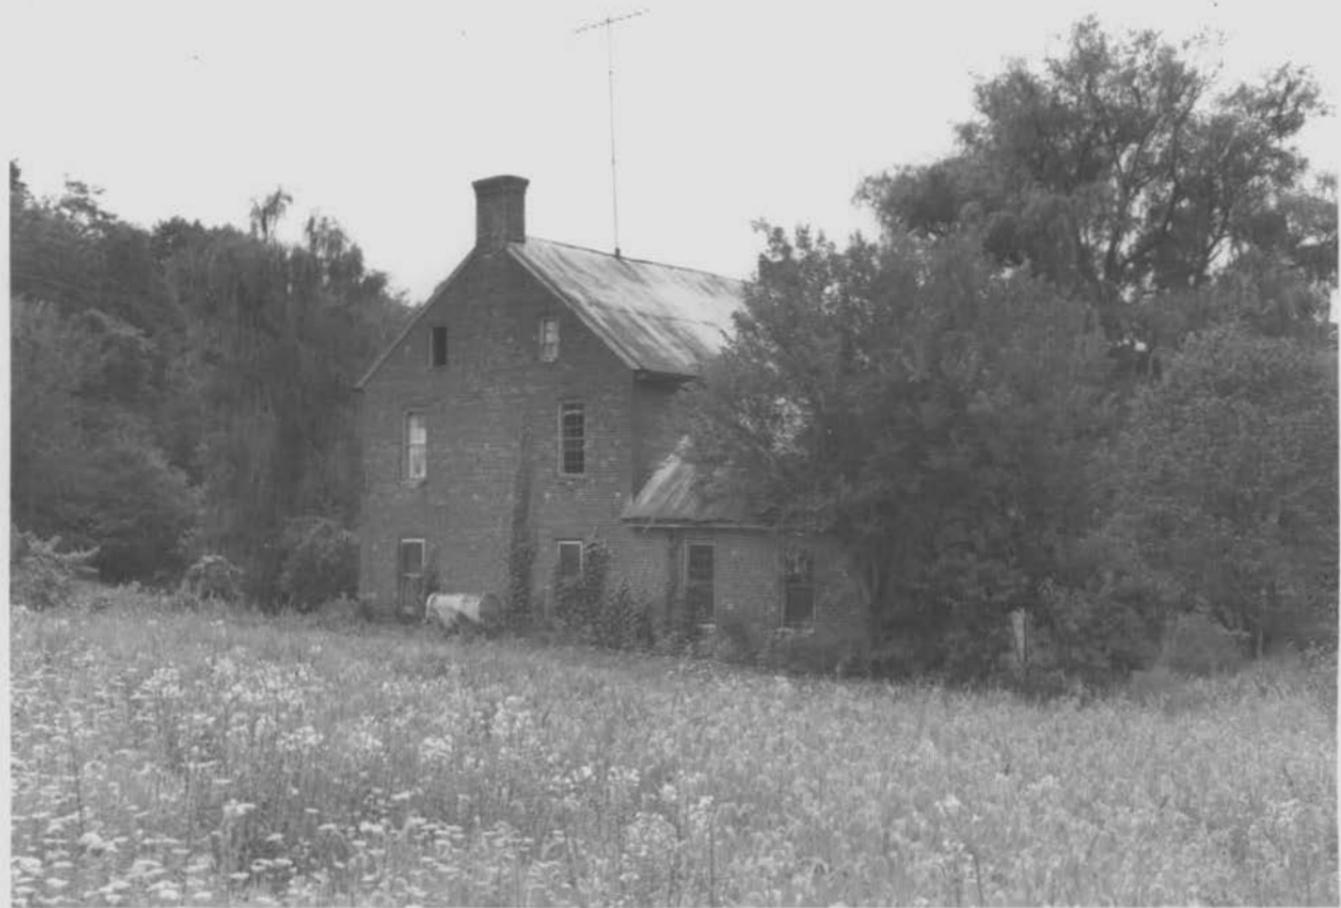
1. Shafer's Mill
2. 3018 Bennies Hill Road  
Middletown, Maryland 21769
3. Michael A. Eggleston
4. 12 August 1985
5. 7656 Wesley Road  
Manassas, Virginia 22110
6. Camera facing South.
7. 1 of 26

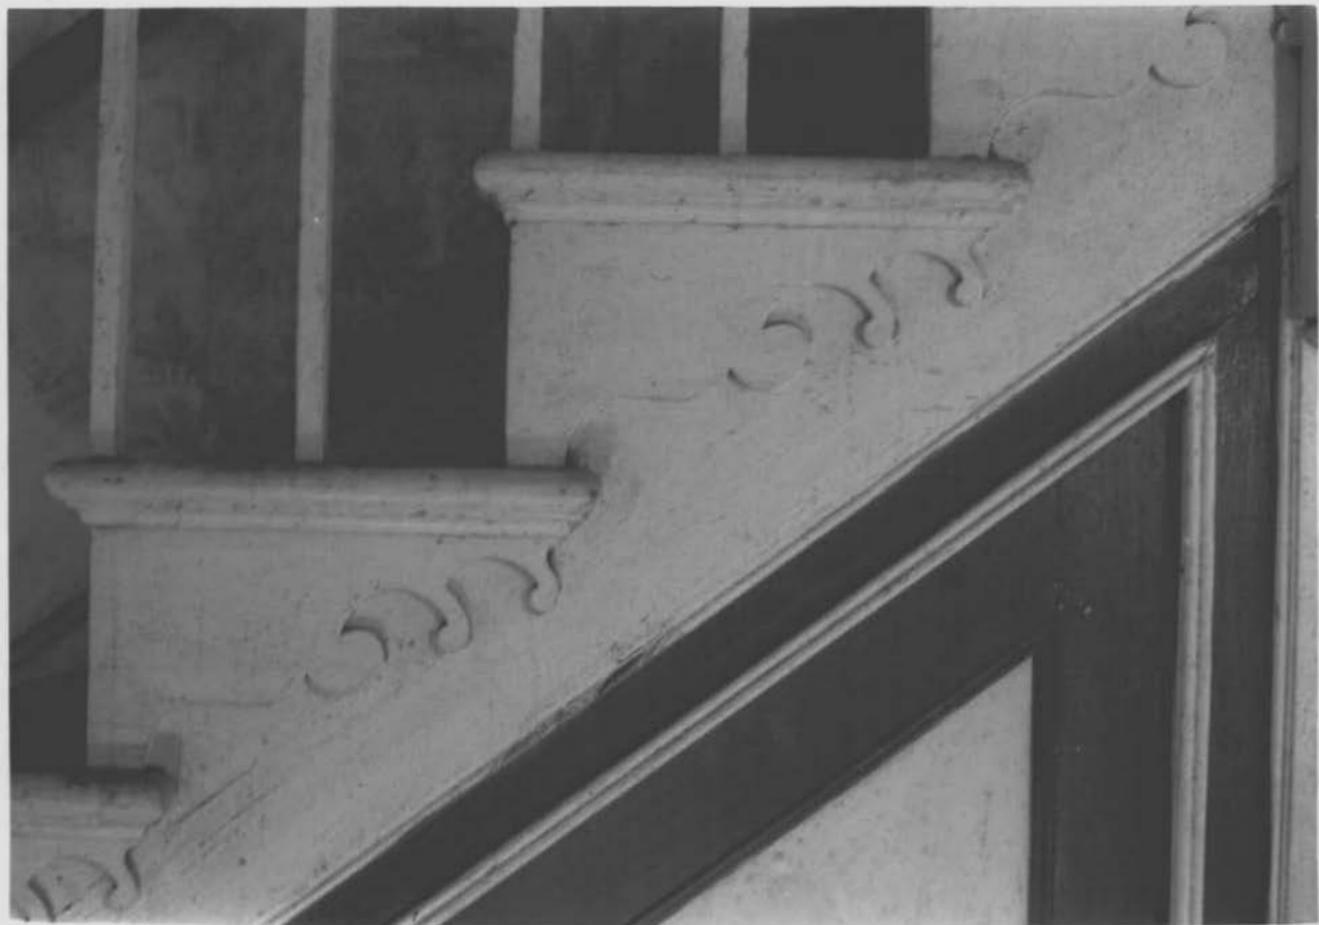
- EH-15
1. Shafer's Mill
  2. 3018 Bennies Hill Road  
Middletown, Maryland 21769
  3. Michael A. Eggleston
  4. 12 August 1985
  5. 7656 Wesley Road  
Manassas, Virginia 22110
  6. Camera facing Southwest showing detail  
on stairs to second floor from entrance  
hall.
  7. 2 of 26

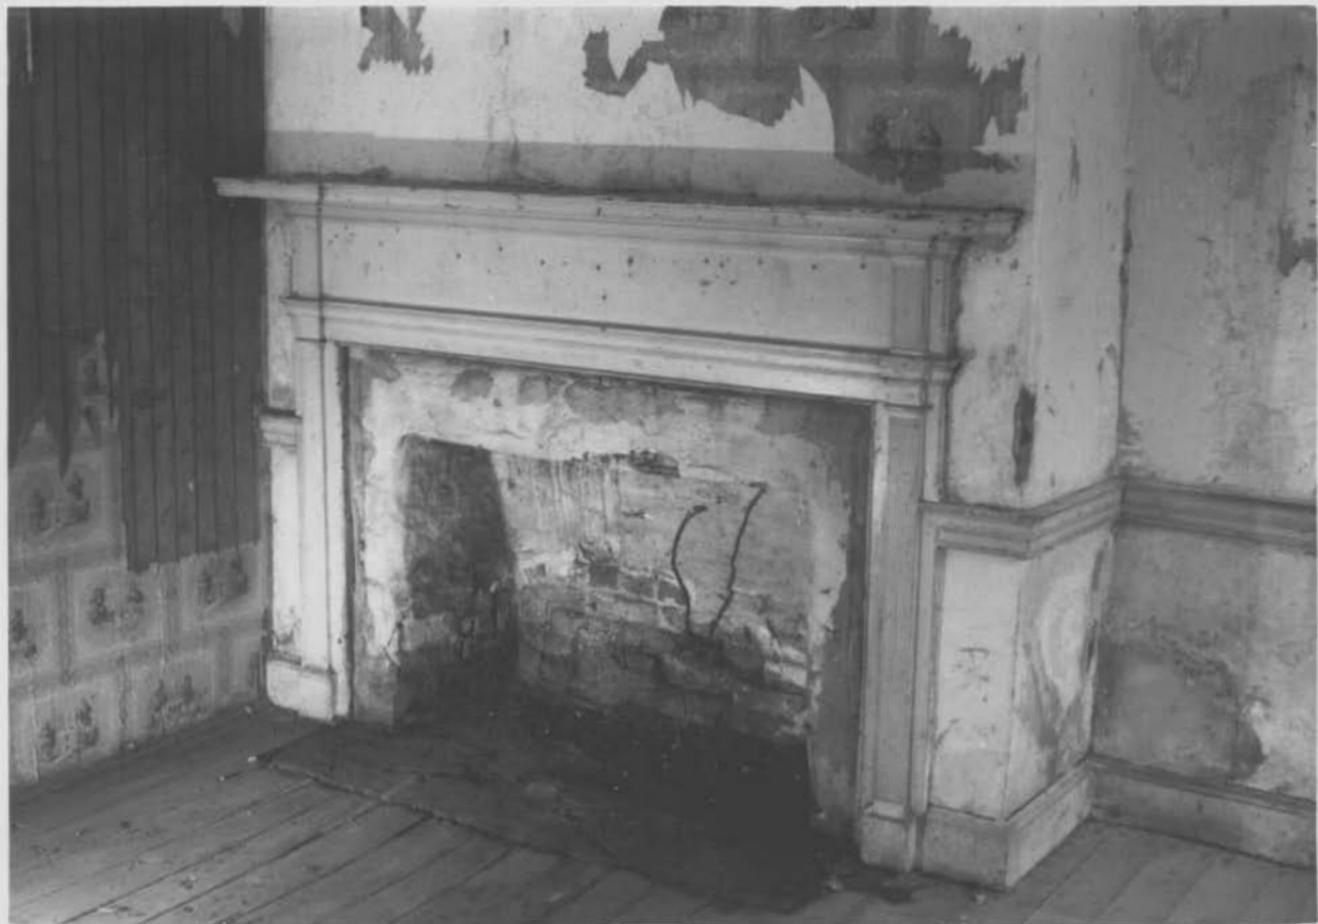
1. Shafer's Mill
2. 3018 Bennies Hill Road  
Middletown, Maryland 21769
3. Michael A. Eggleston
4. 12 August 1985
5. 7656 Wesley Road  
Manassas, Virginia 22110
6. Camera facing North showing detail of  
fireplace in first floor dining room.
7. 3 of 26

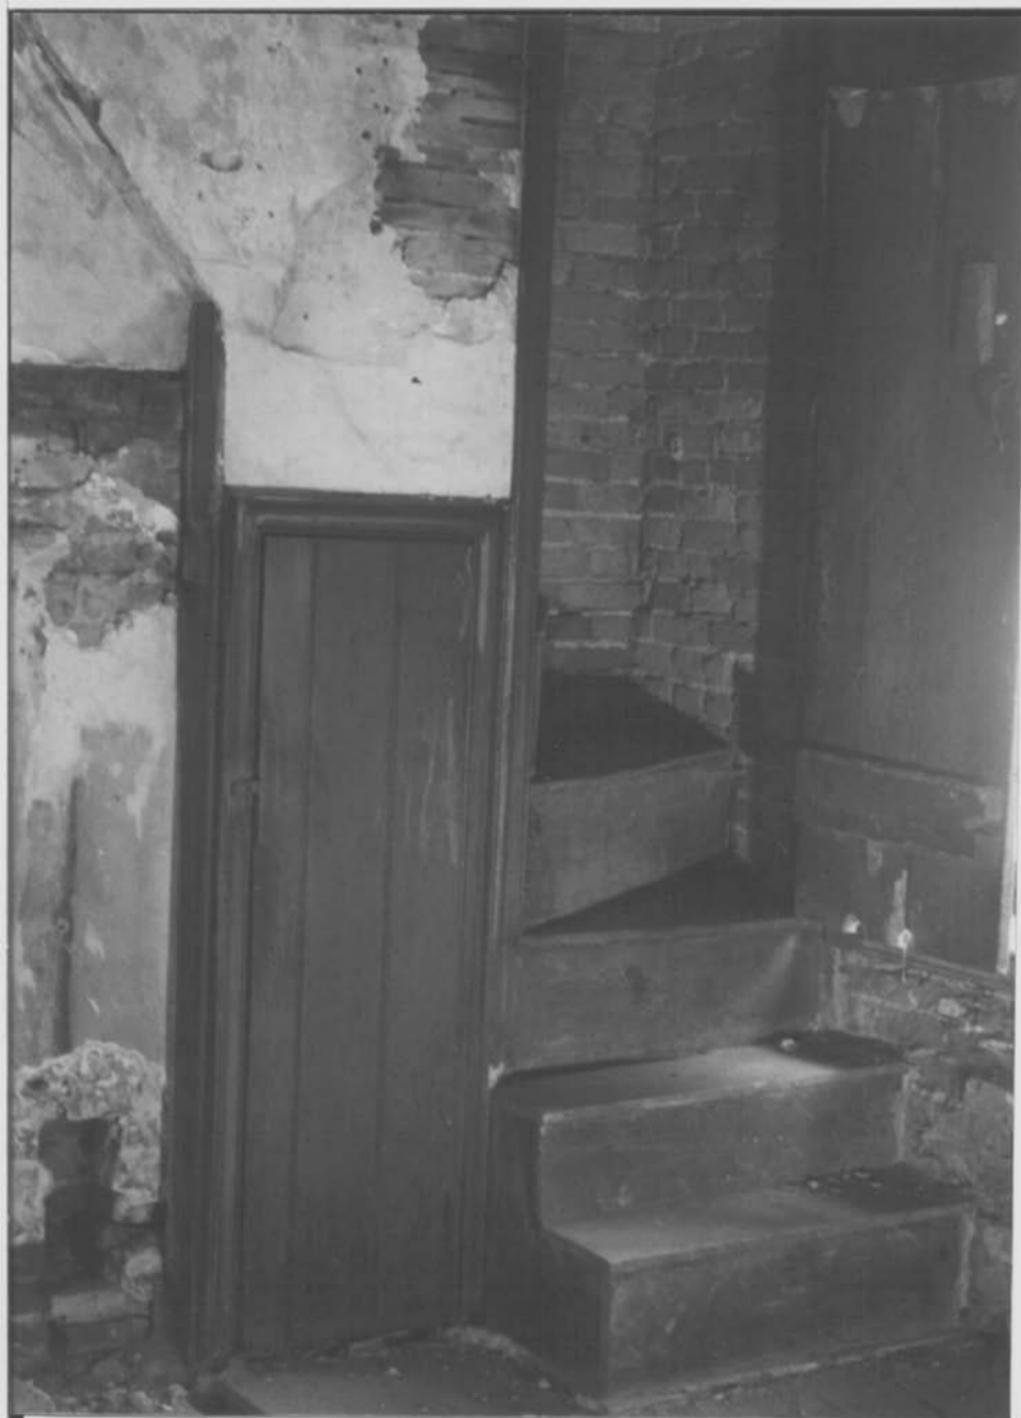
1. Shafer's Mill
2. 3018 Bennies Hill Road  
Middletown, Maryland 21769
3. Michael A. Eggleston
4. 12 August 1985
5. 7656 Wesley Road  
Manassas, Virginia 22110
6. Camera facing North showing steps  
to kitchen attic from kitchen.
7. 5 of 26

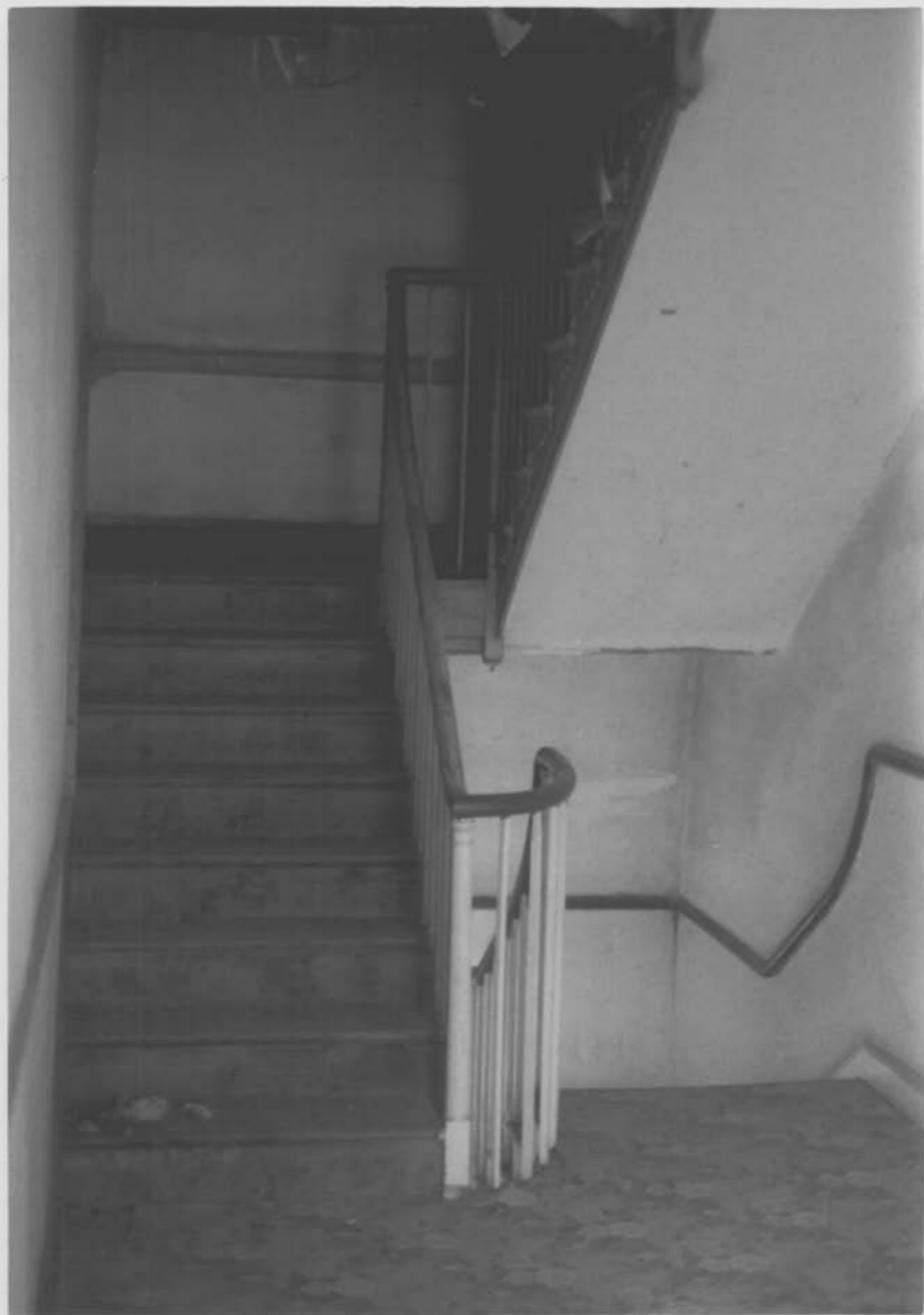
1. Shafer's Mill
2. 3018 Bennies Hill Road  
Middletown, Maryland 21769
3. Michael A. Eggleston
4. 12 August 1985
5. 7656 Wesley Road  
Manassas, Virginia 22110
6. Camera facing Northwest showing  
steps to attic from second floor  
hall.
7. 6 of 26

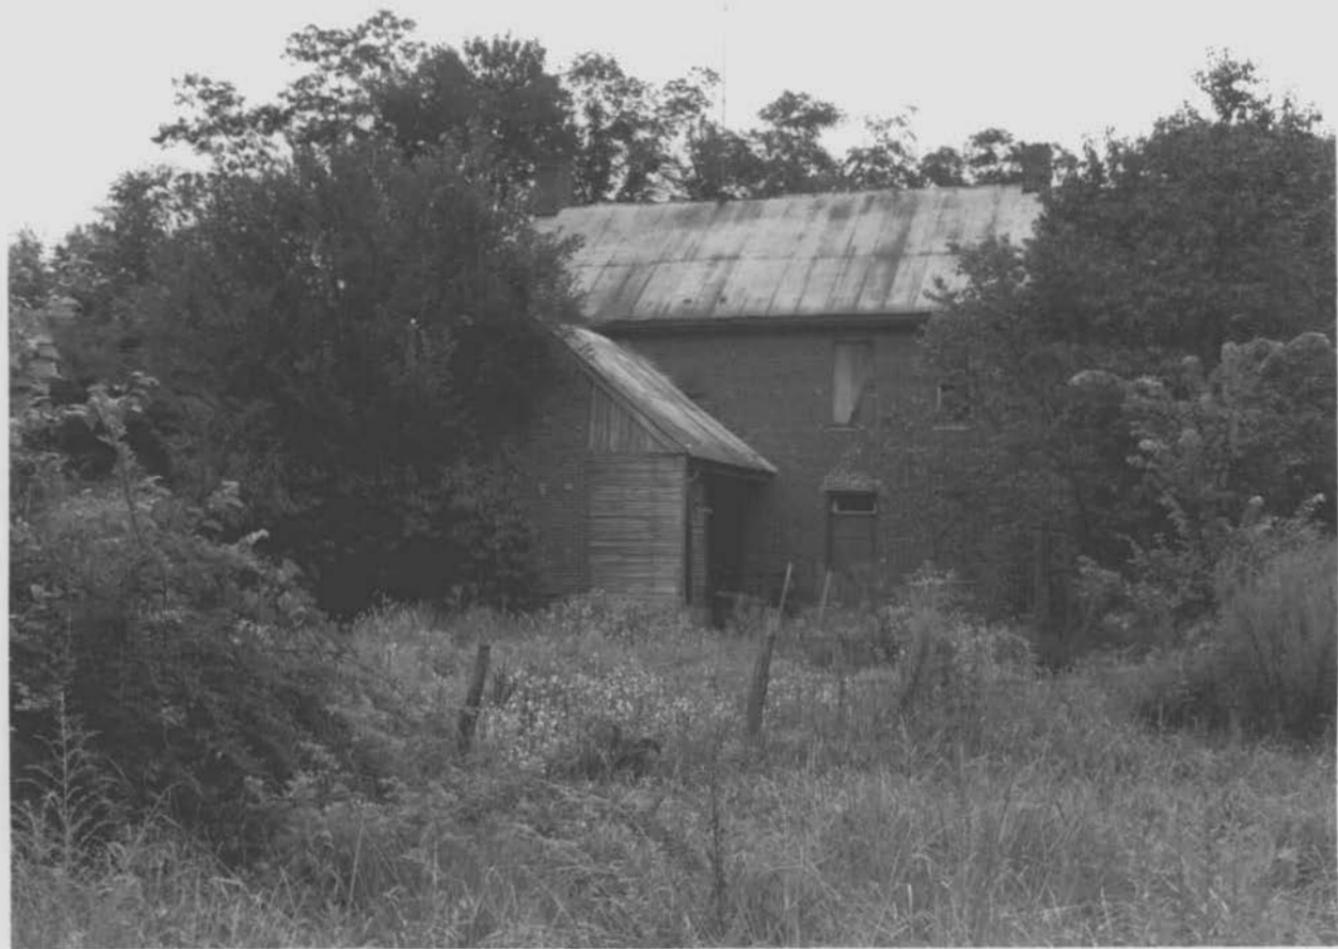
1. Shafer's Mill
2. 3018 Bennies Hill Road  
Middletown, Maryland 21769
3. Michael A. Eggleston
4. 12 August 1985
5. 7656 Wesley Road  
Manassas, Virginia 22110
6. Camera facing Southeast showing kitchen porch and shed.
7. 7 of 26

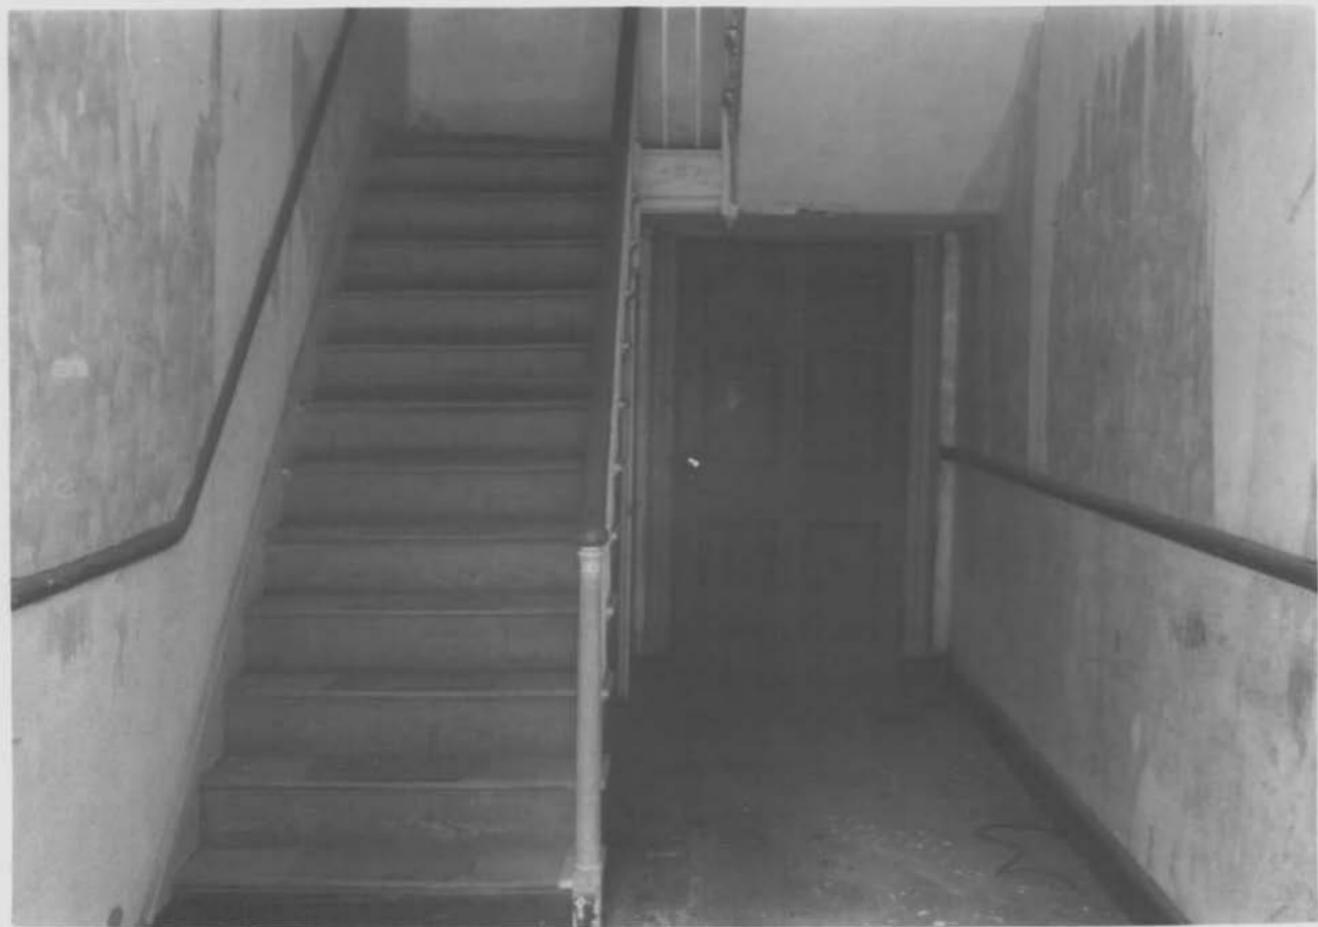
The principal staircase is the open well open string type with two flights and open to the attic. The ends of the steps have decorated brackets. The newels are slender turned columns. The balustrade consists of slender rectangular balusters supporting a round rail. A half round rail forms a chair rail up the staircase and along sections of both floor halls, a feature not commonly found in the state. This half-rail affect is not carried up the staircase to the attic which has the traditional two-step type found generally in the principal rooms of the house.

- F-4-15
1. Shafer's Mill
  2. 3018 Bennies Hill Road  
Middletown, Maryland 21769
  3. Michael A. Eggleston
  4. 12 August 1985
  5. 7656 Wesley Road  
Manassas, Virginia 22110
  6. Camera facing Northwest showing steps  
to second floor from entrance hall.
  7. 8 of 26

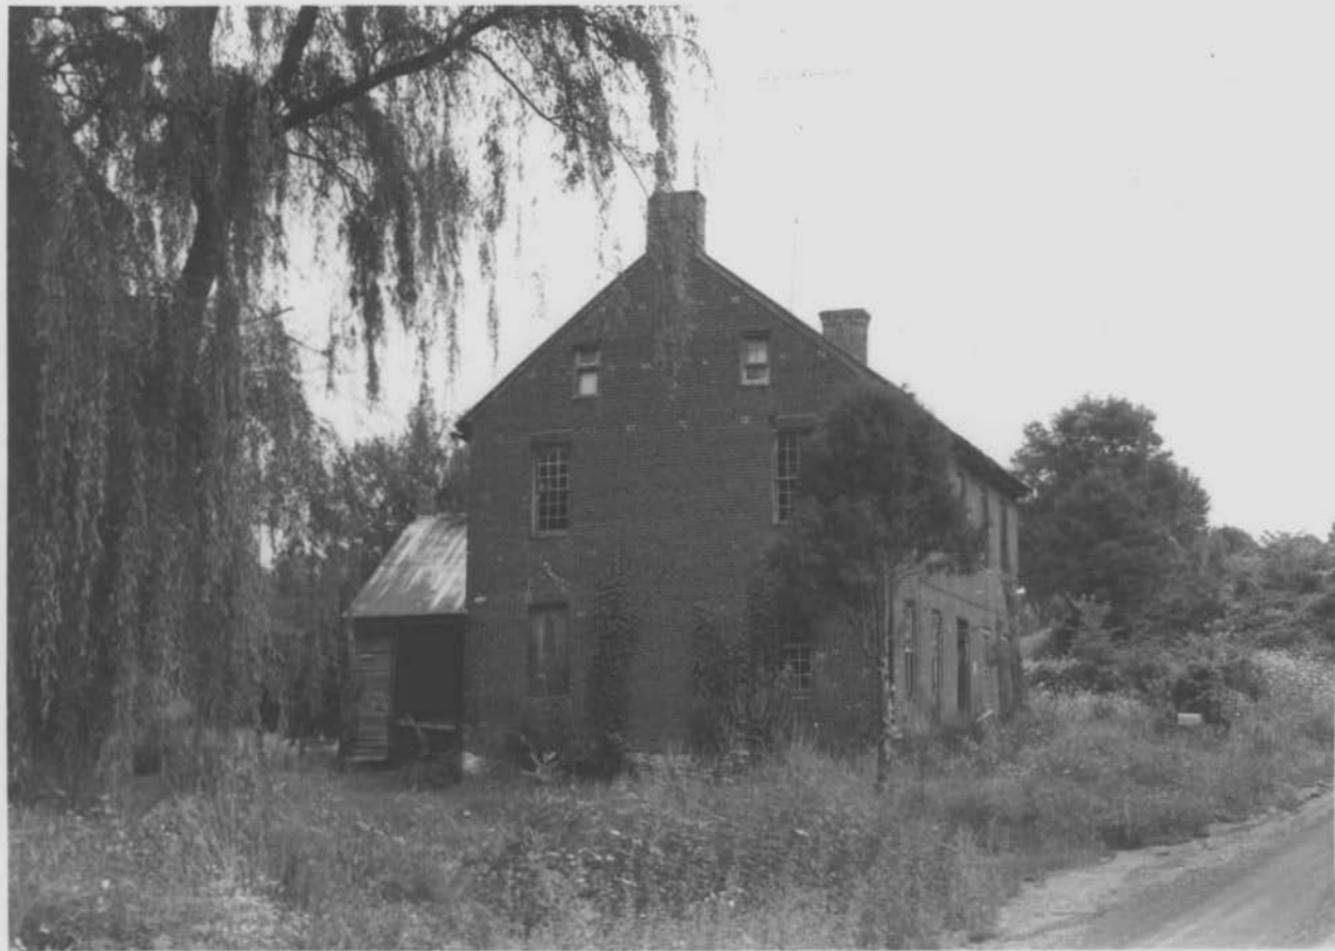
1. Shafer's Mill
2. 3018 Bennies Hill Road  
Middletown, Maryland 21769
3. Michael A. Eggleston
4. 12 August 1985
5. 7656 Wesley Road  
Manassas, Virginia 22110
6. Camera facing Northeast.
7. 9 of 26

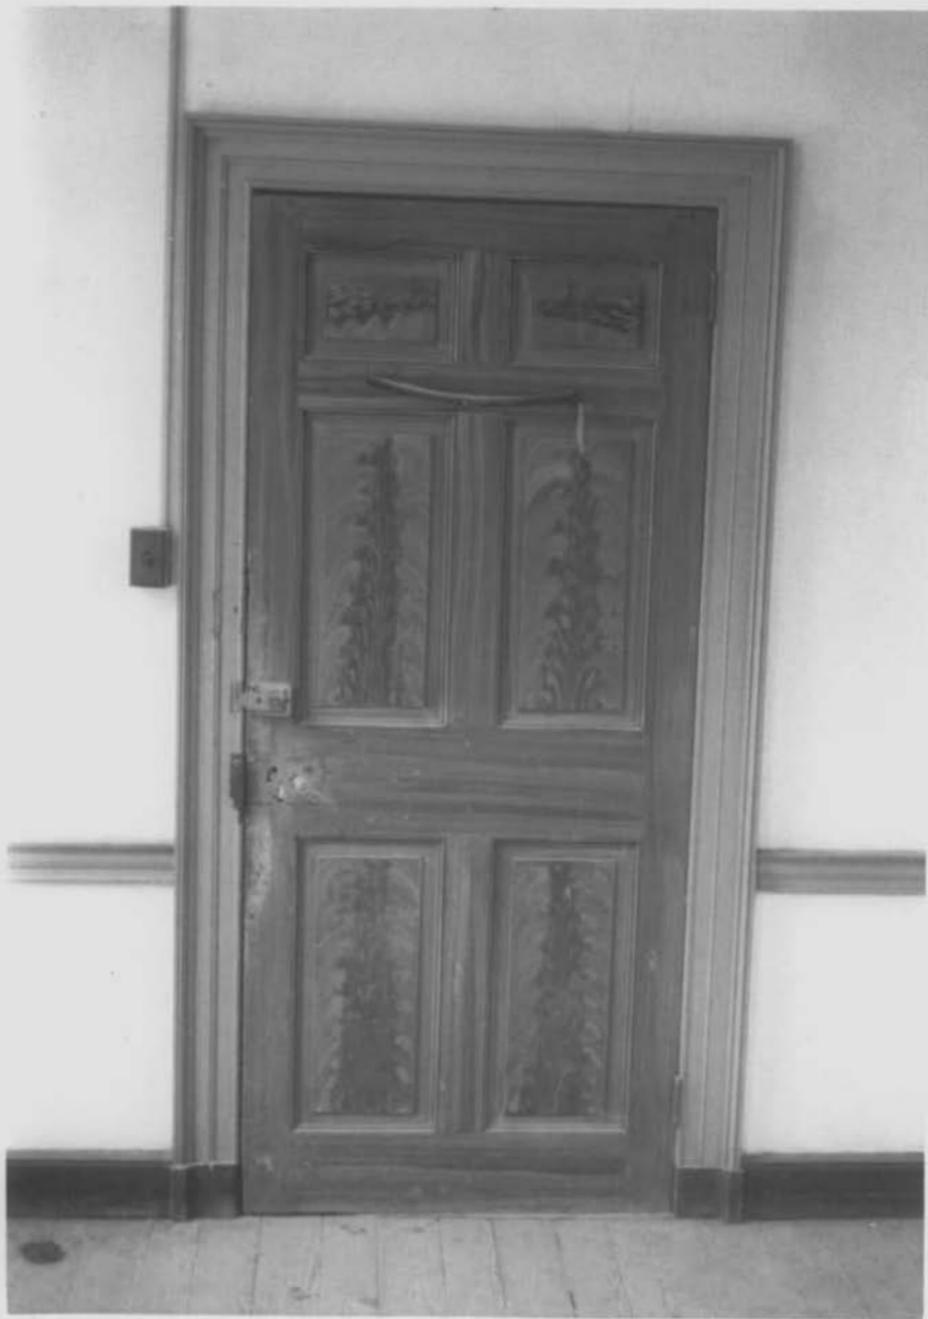
1. Shafer's Mill
2. 3018 Bennies Hill Road  
Middletown, Maryland 21769
3. Michael A. Eggleston
4. 12 August 1985
5. 7656 Wesley Road  
Manassas, Virginia 22110
6. Camera facing Southwest showing detail  
of woodwork and door in East bedroom.
7. 10 of 26

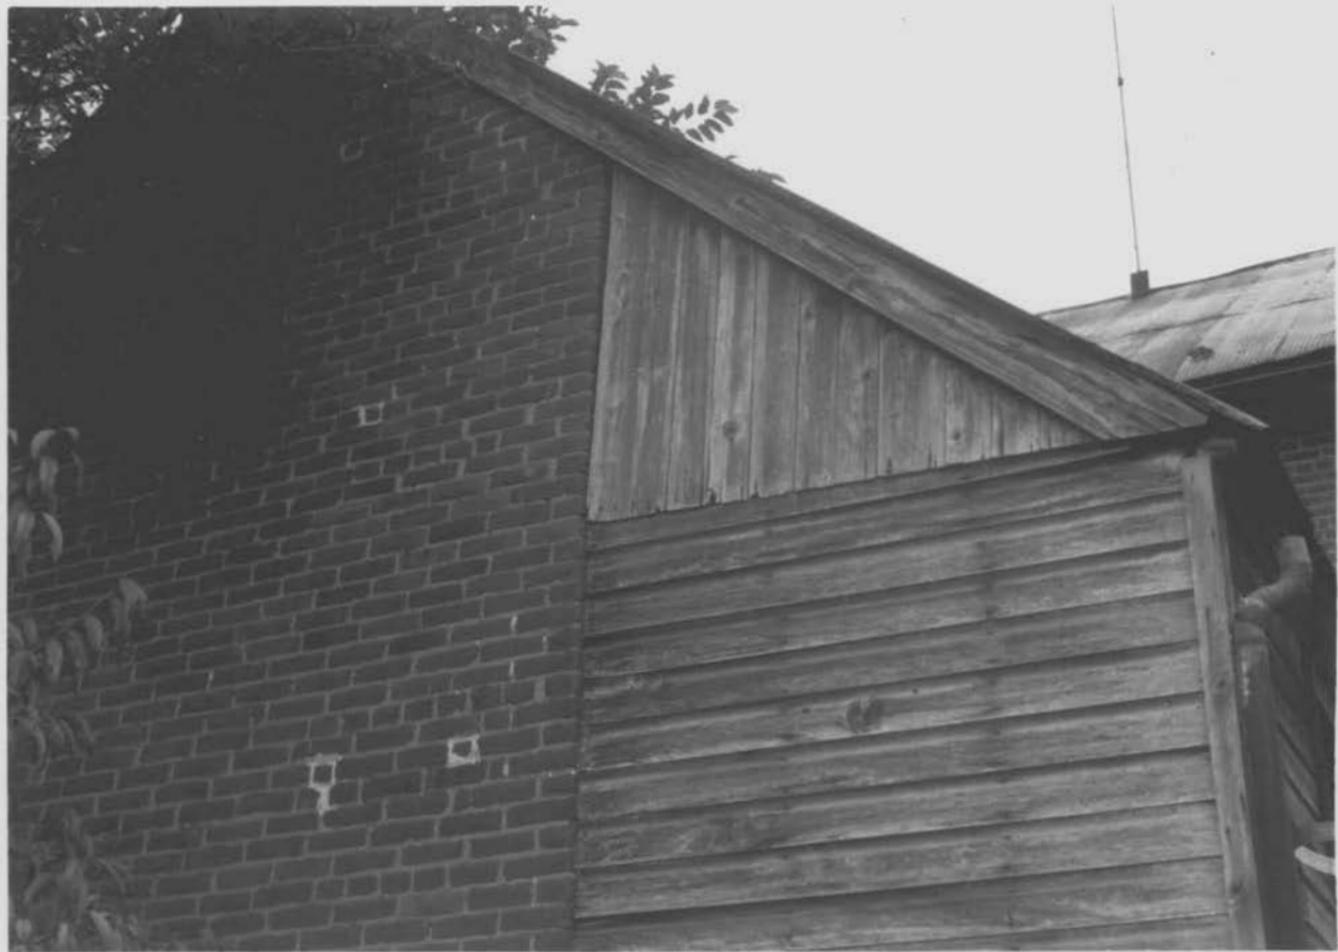
1. Shafer's Mill
2. 3018 Bennies Hill Road  
Middletown, Maryland 21769
3. Michael A. Eggleston
4. 12 August 1985
5. 7656 Wesley Road  
Manassas, Virginia 22110
6. Camera facing Southeast showing  
detail of kitchen shed.
7. 11 of 26

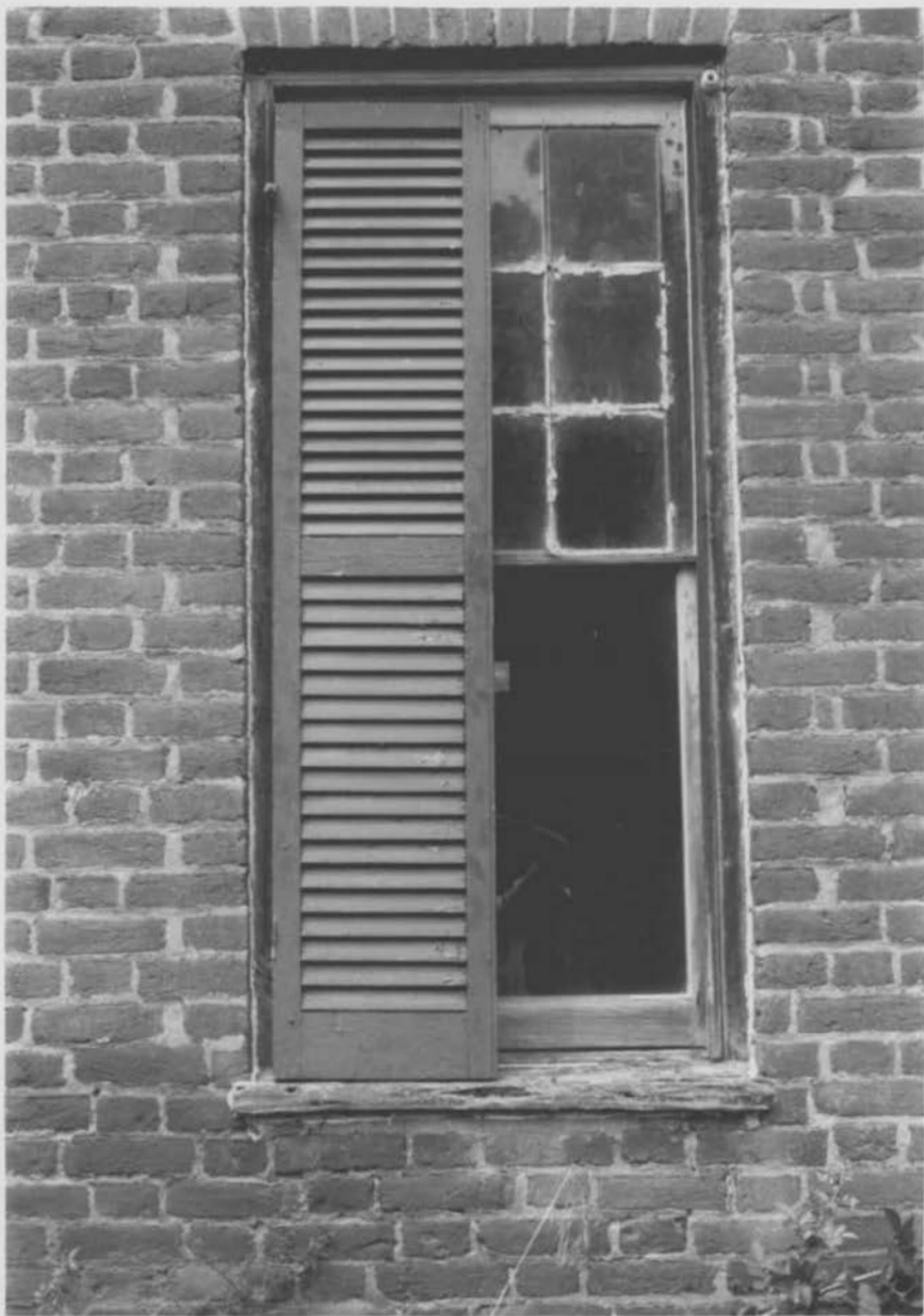
1. Shafer's Mill
2. 3018 Bennies Hill Road  
Middletown, Maryland 21769
3. Michael A. Eggleston
4. 12 August 1985
5. 7656 Wesley Road  
Manassas, Virginia 22110
6. Camera facing Northwest showing  
shutter placed against window.
7. 12 of 26

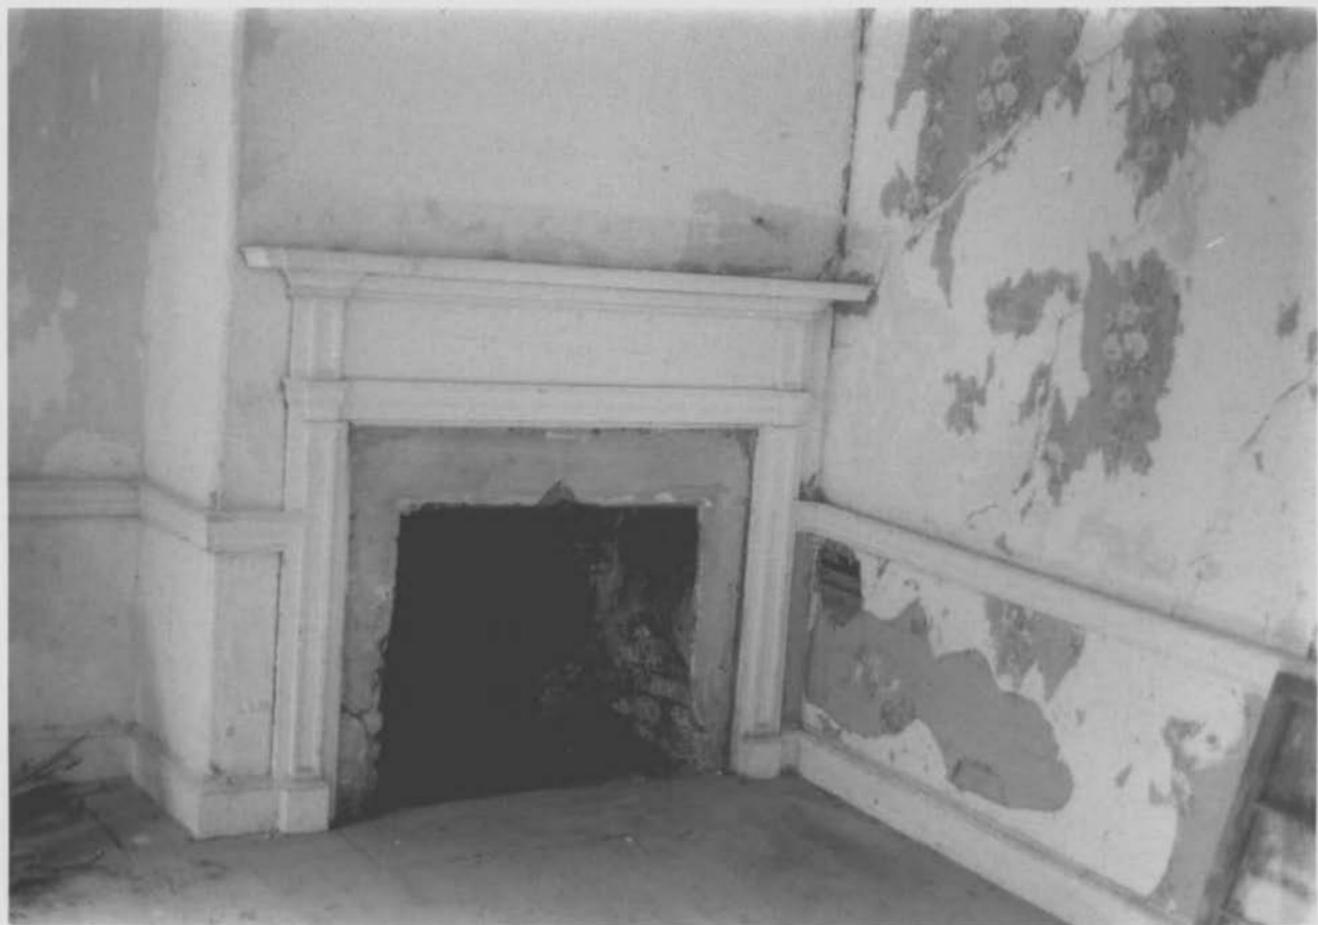
1. Shafer's Mill
2. 3018 Bennies Hill Road  
Middletown, Maryland 21769
3. Michael A. Eggleston
4. 12 August 1985
5. 7656 Wesley Road  
Manassas, Virginia 22110
6. Camera facing Southwest showing  
parlor fireplace.
7. 13 of 26

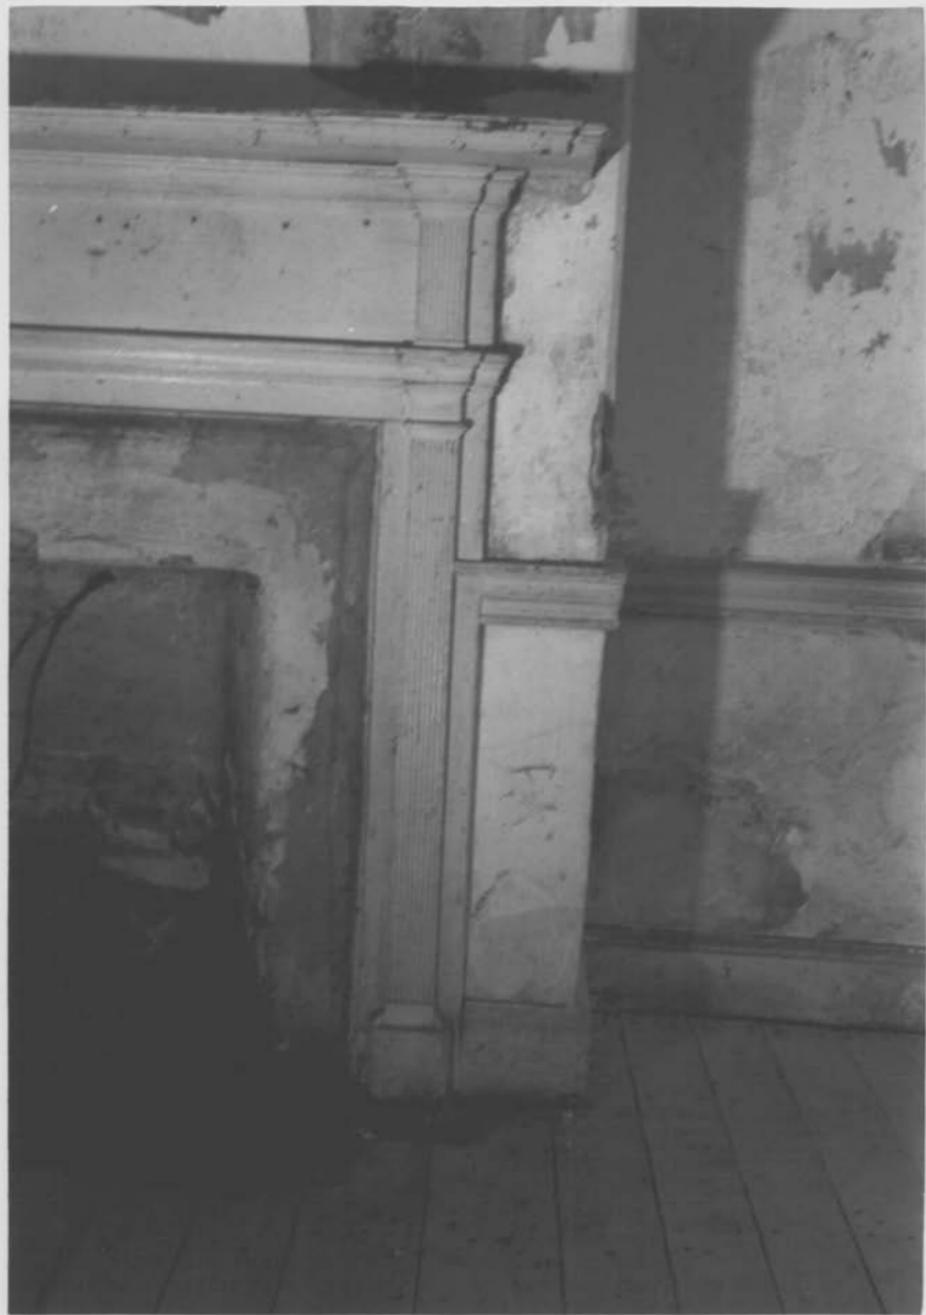
1. Shafer's Mill
2. 3018 Bennies Hill Road  
Middletown, Maryland 21769
3. Michael A. Eggleston
4. 12 August 1985
5. 7656 Wesley Road  
Manassas, Virginia 22110
6. Camera facing Southwest showing  
detail of dining room fireplace.
7. 14 of 26

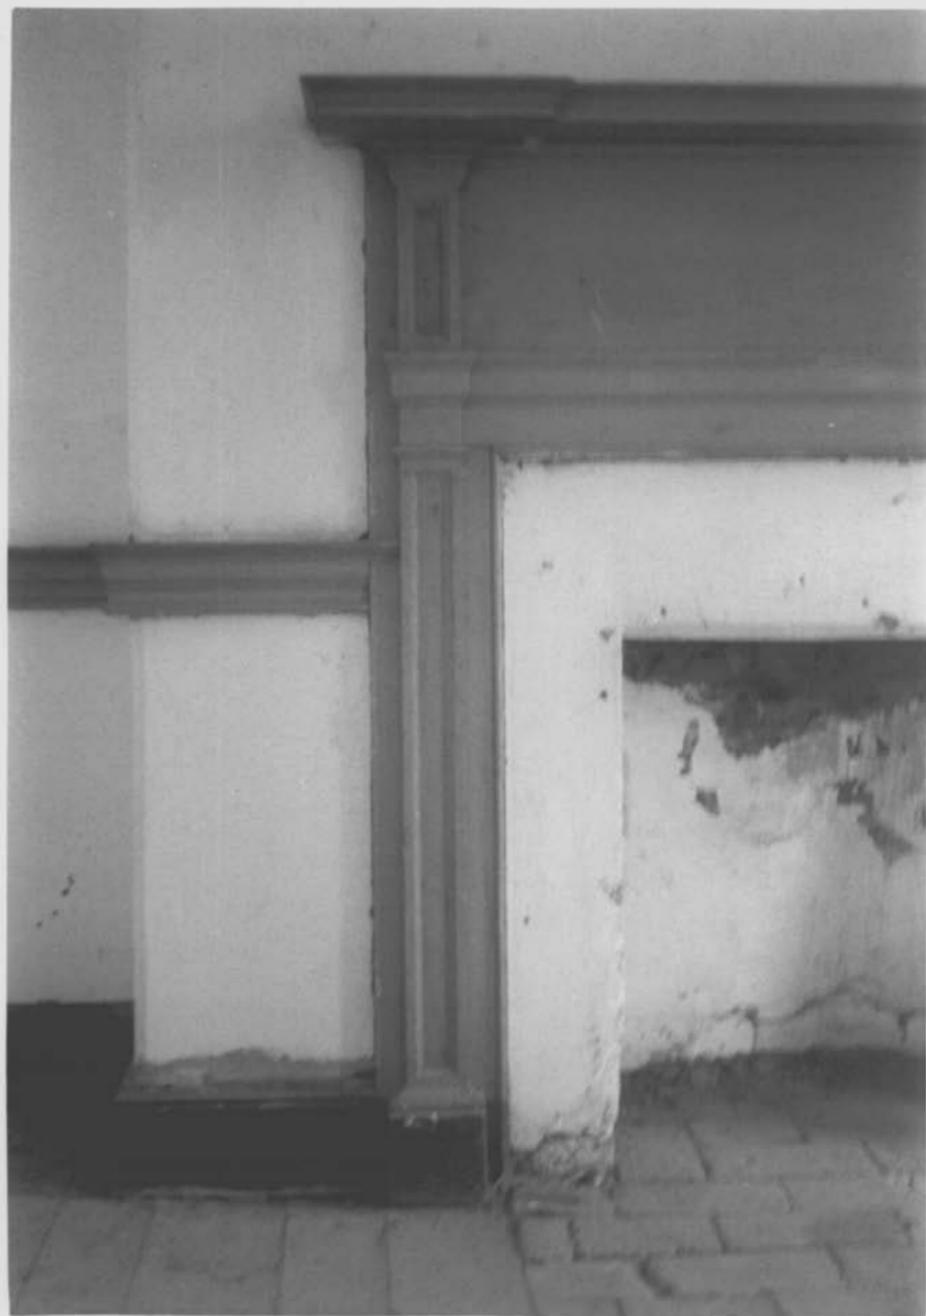
- F-4-15
1. Shafer's Mill
  2. 3018 Bennies Hill Road  
Middletown, Maryland 21769
  3. Michael A. Eggleston
  4. 12 August 1985
  5. 7656 Wesley Road  
Manassas, Virginia 22110
  6. Camera facing Northeast showing  
detail of East bedroom fireplace.
  7. 16 of 26

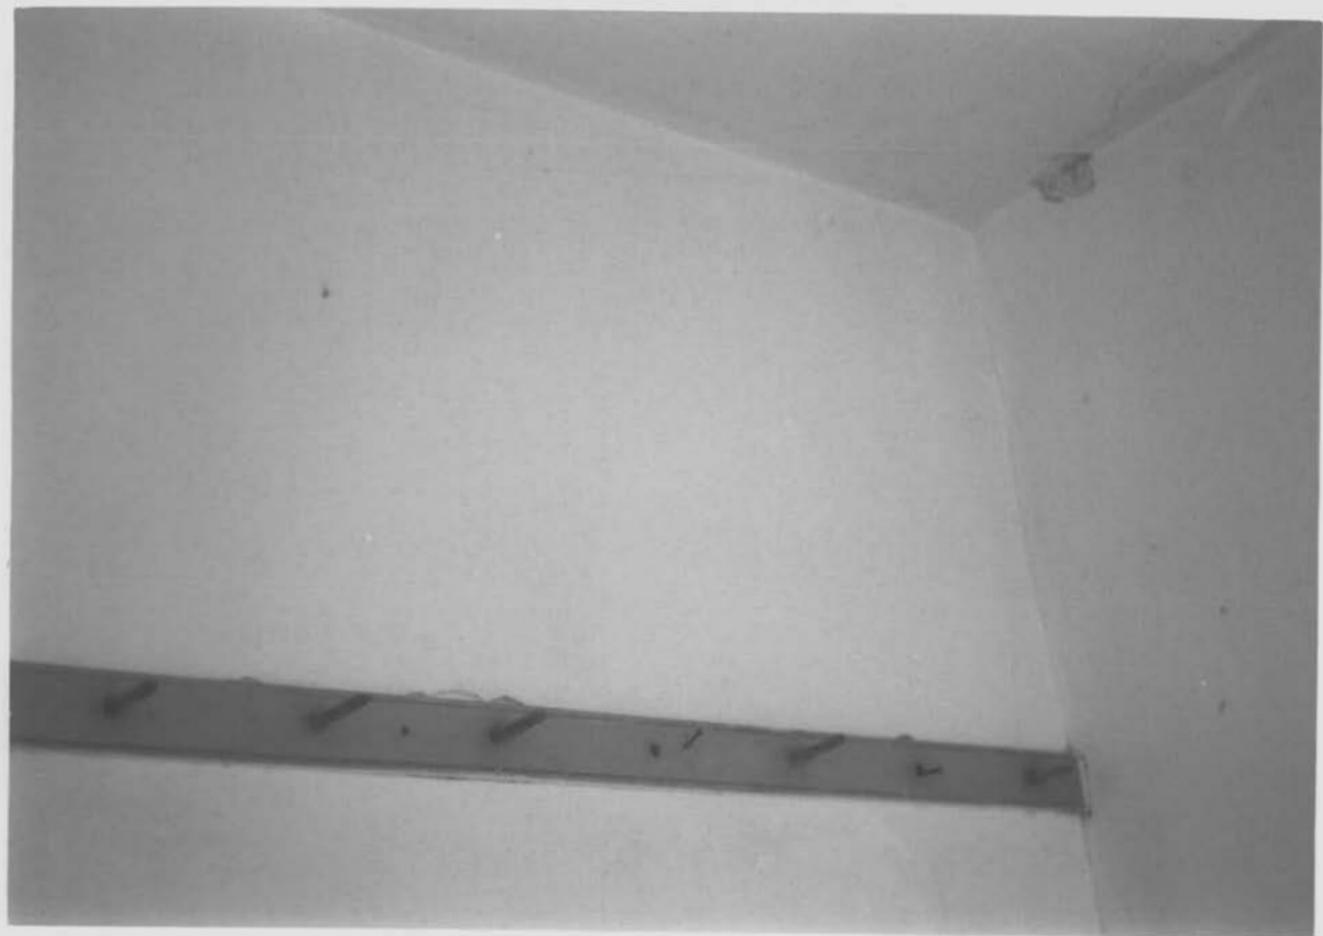
1. Shafer's Mill
2. 3018 Bennies Hill Road  
Middletown, Maryland 21769
3. Michael A. Eggleston
4. 12 August 1985
5. 7656 Wesley Road  
Manassas, Virginia 22110
6. Camera facing Northwest showing  
clothing pegs in East bedroom.
7. 18 of 26

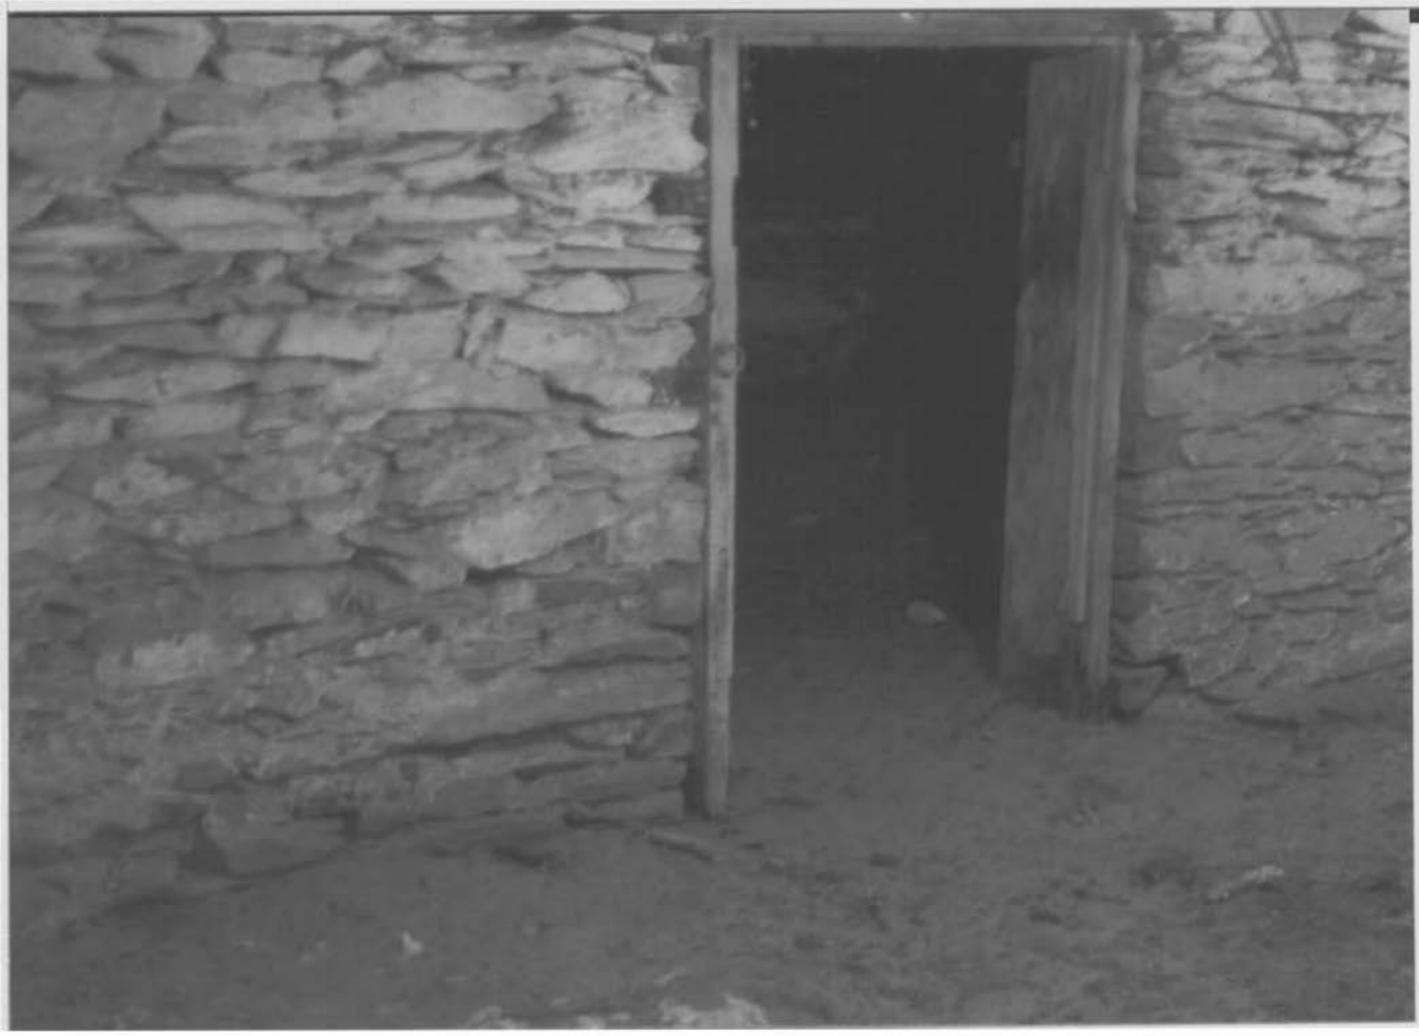
1. Shafer's Mill
2. 3018 Bennies Hill Road  
Middletown, Maryland 21769
3. Michael A. Eggleston
4. 12 August 1985
5. 7656 Wesley Road  
Manassas, Virginia 22110
6. Camera facing East showing  
cellar.
7. 19 of 26

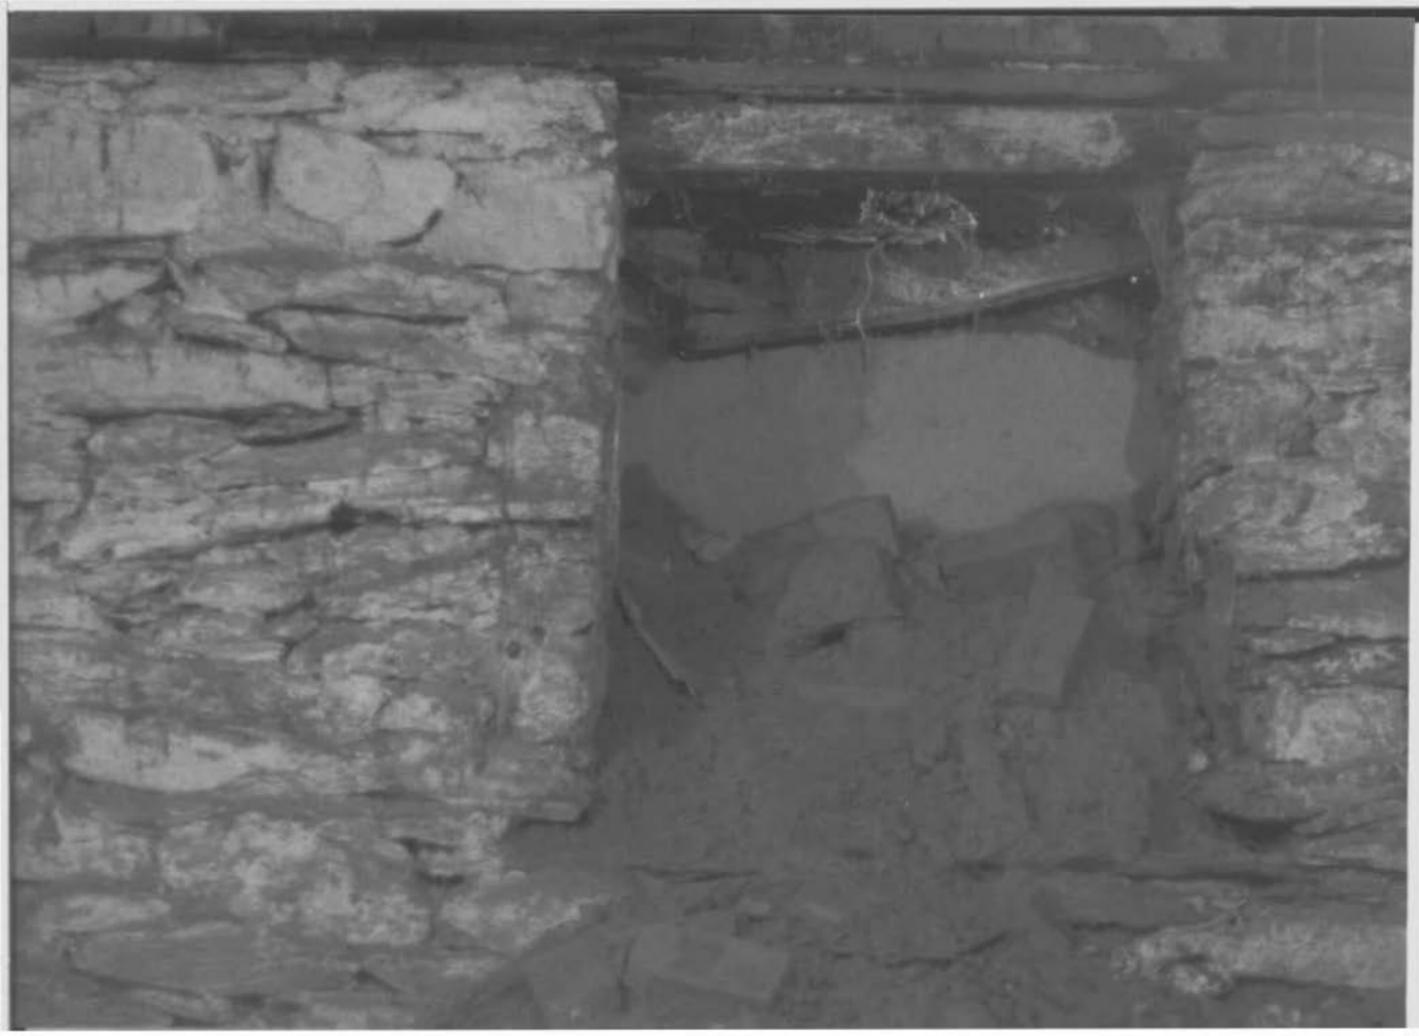
1. Shafer's Mill
2. 3018 Bennies Hill Road  
Middletown, Maryland 21769
3. Michael A. Eggleston
4. 12 August 1985
5. 7656 Wesley Road  
Manassas, Virginia 22110
6. Camera facing Southeast showing  
cellar window.
7. 20 of 26
