National Register of Historic Places  
Inventory—Nomination Form

historic Shafer's Mill (preferred), Ascension Day  
and or common Shafer's Mill

street & number 3018 Bennies Hill Road N/A not for publication  
city, town Middletown X vicinity of Sixth Congressional District  
state Maryland code 24 county Frederick code 021

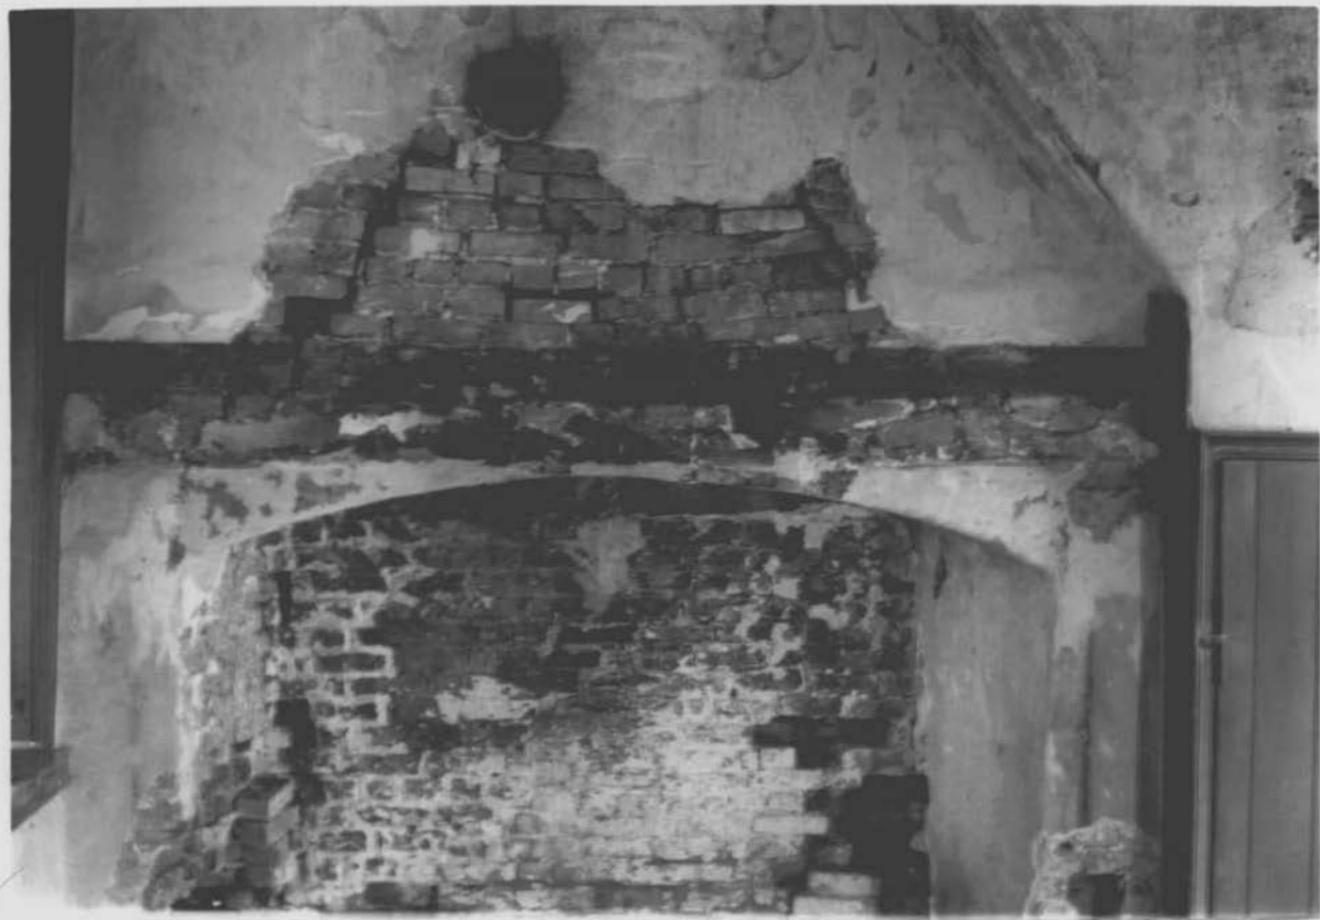
1. Shafer's Mill
2. 3018 Bennies Hill Road  
Middletown, Maryland 21769
3. Michael A. Eggleston
4. 12 August 1985
5. 7656 Wesley Road  
Manassas, Virginia 22110
6. Camera facing Northwest showing  
kitchen fireplace.
7. 21 of 26

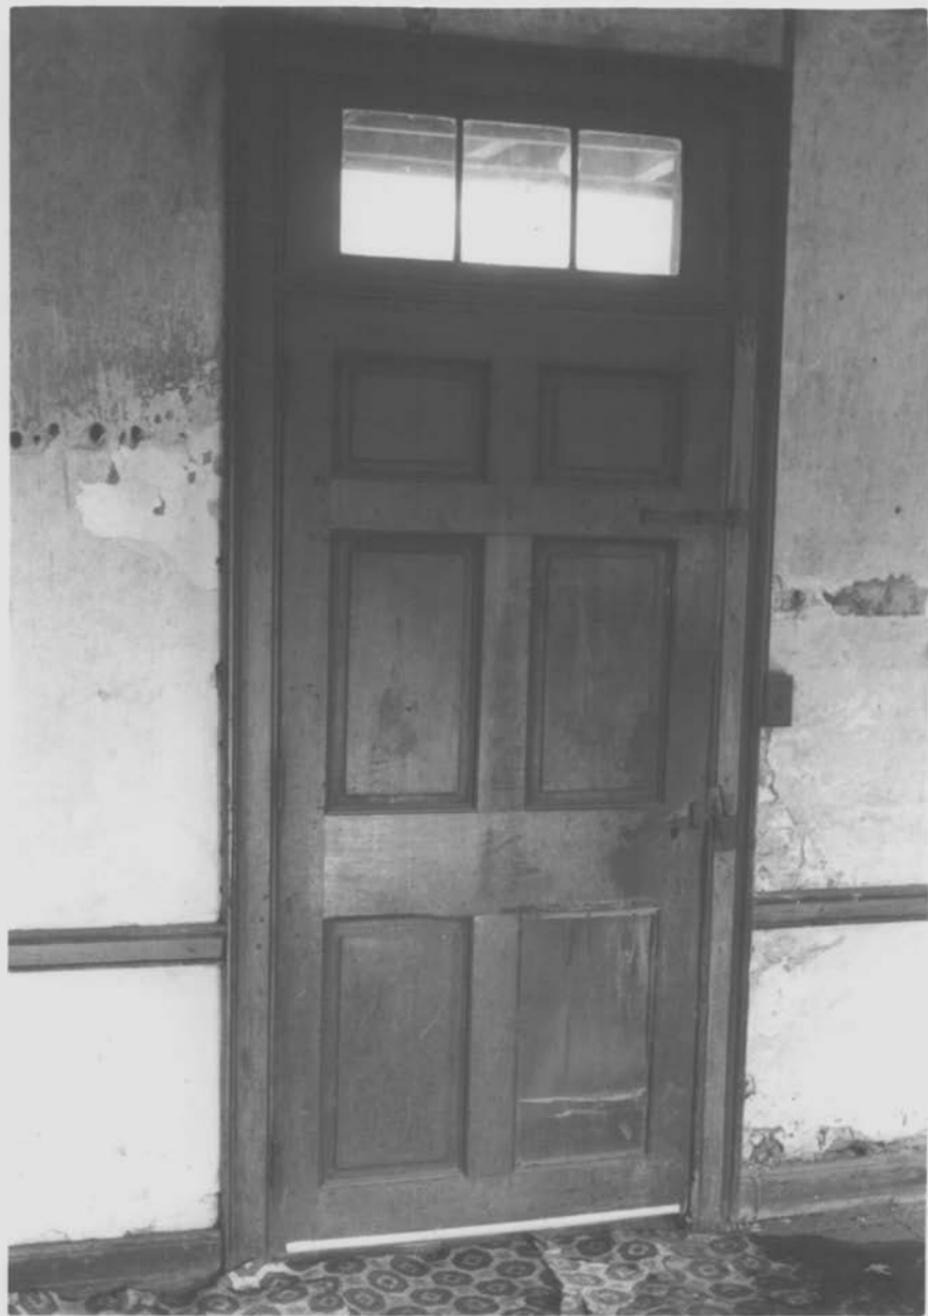
1. Shafer's Mill
2. 3018 Bennies Hill Road  
Middletown, Maryland 21769
3. Michael A. Eggleston
4. 12 August 1985
5. 7656 Wesley Road  
Manassas, Virginia 22110
6. Camera facing West showing  
kitchen door.
7. 22 of 26

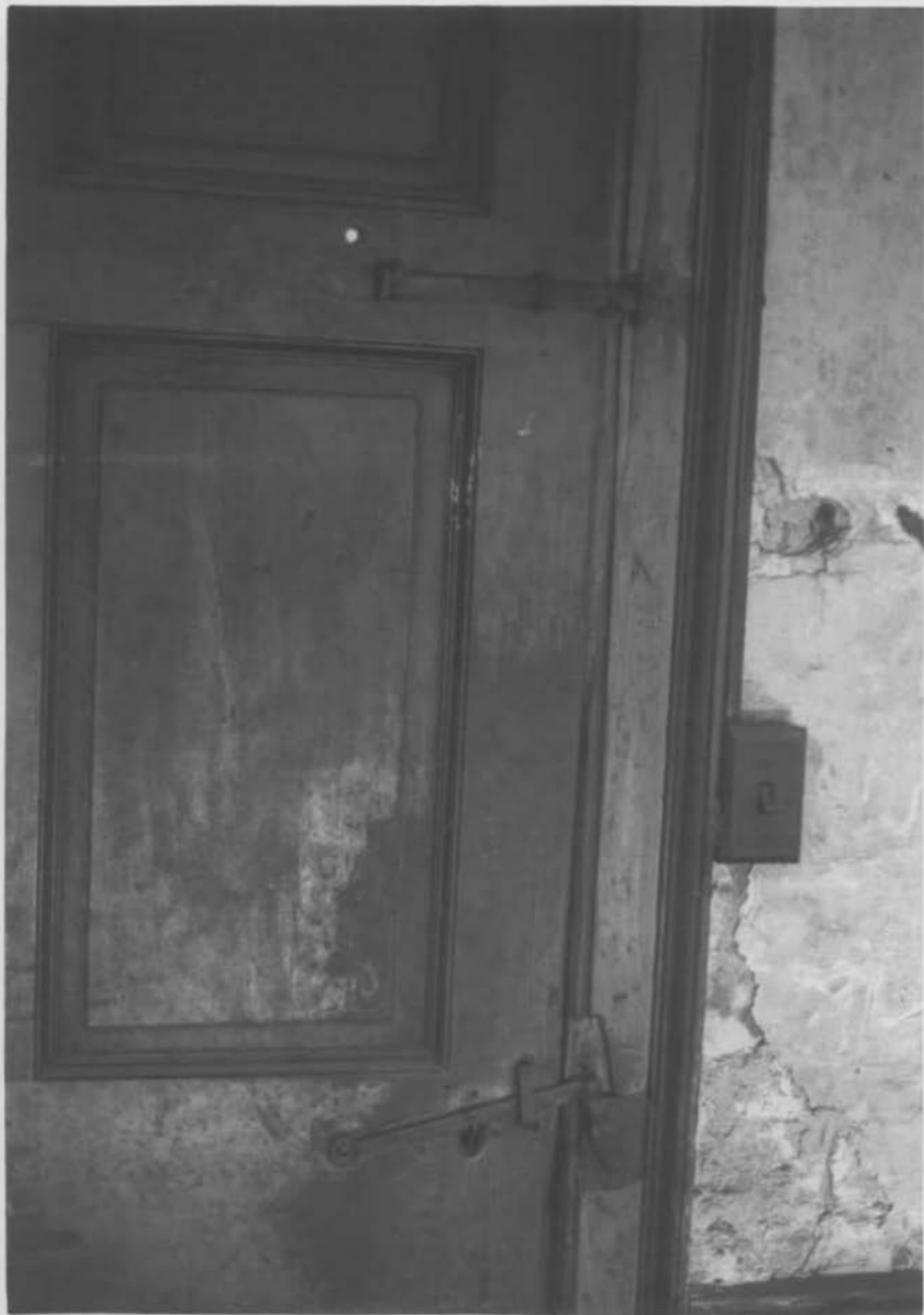
1. Shafer's Mill
2. 3018 Bennies Hill Road  
Middletown, Maryland 21769
3. Michael A. Eggleston
4. 12 August 1985
5. 7656 Wesley Road  
Manassas, Virginia 22110
6. Camera facing West showing  
detail of kitchen door.
7. 23 of 26

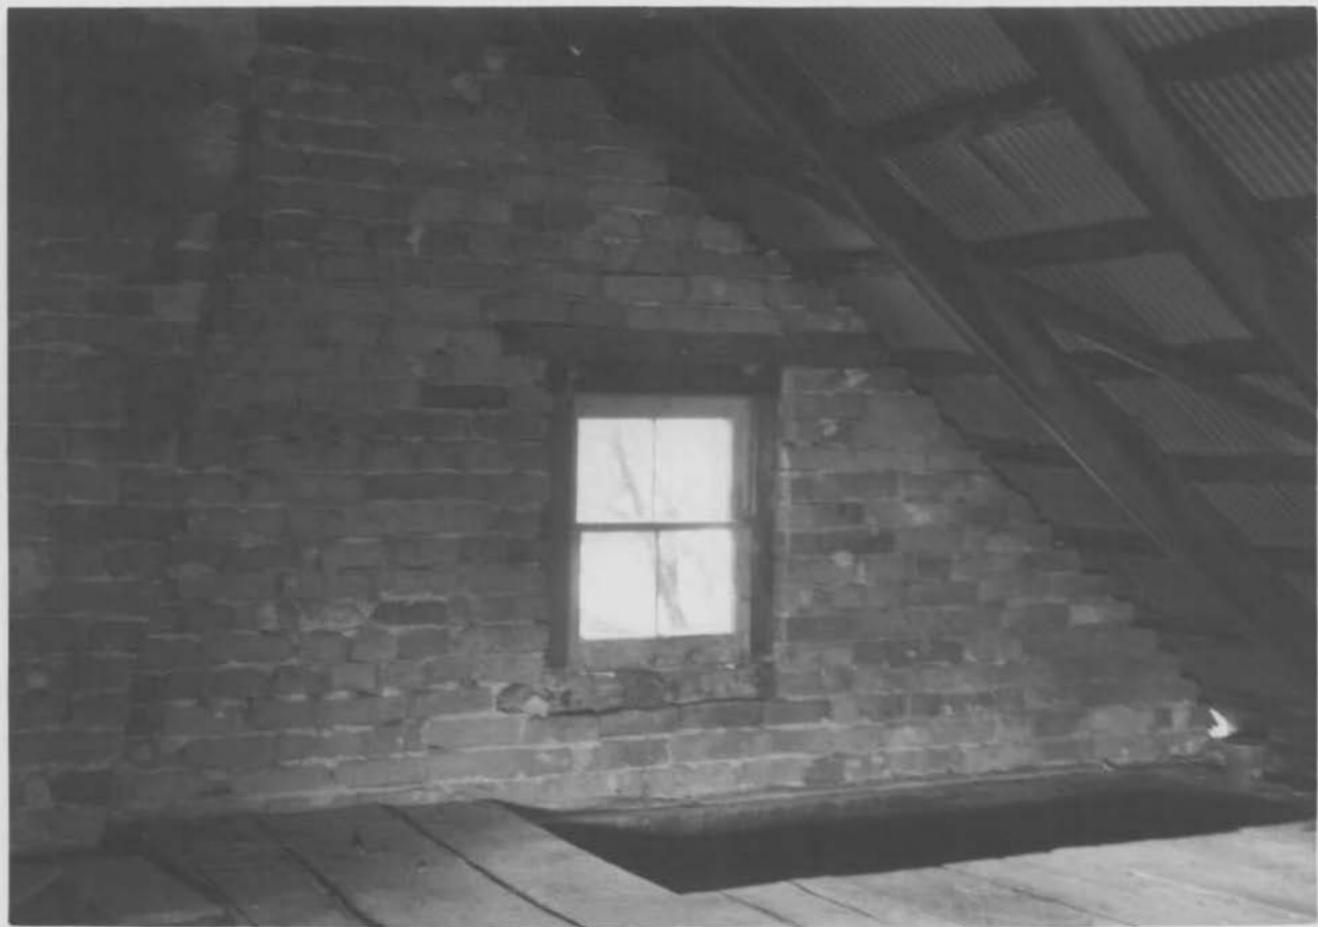
1. Shafer's Mill
2. 3018 Bennies Hill Road  
Middletown, Maryland 21769
3. Michael A. Eggleston
4. 12 August 1985
5. 7656 Wesley Road  
Manassas, Virginia 22110
6. Camera facing North showing  
kitchen attic.
7. 26 of 26
