F-4-31
Enos Doub Farmstead
Myersville vicinity
Private

F-4-31
Enos Doub Farmstead
Myersville
Frederick County

Maryland Historical Trust State Historic Sites Inventory Form

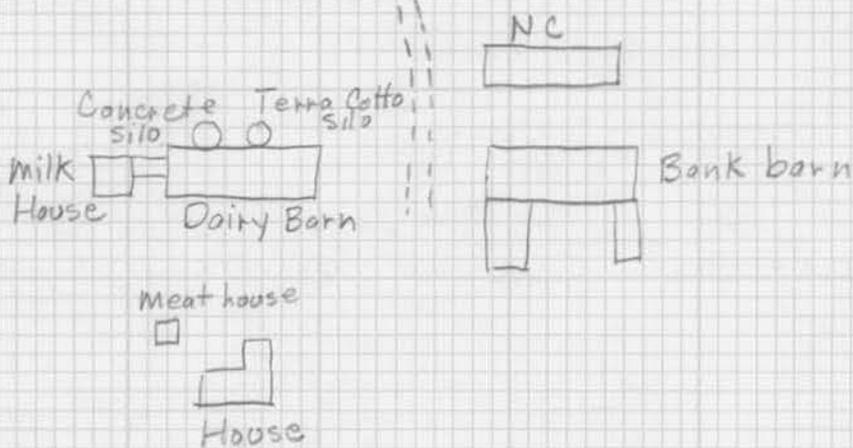
Myersville Road (Md. Route 17)

Wagon Shed/
Corn Crib

Shed with
granary

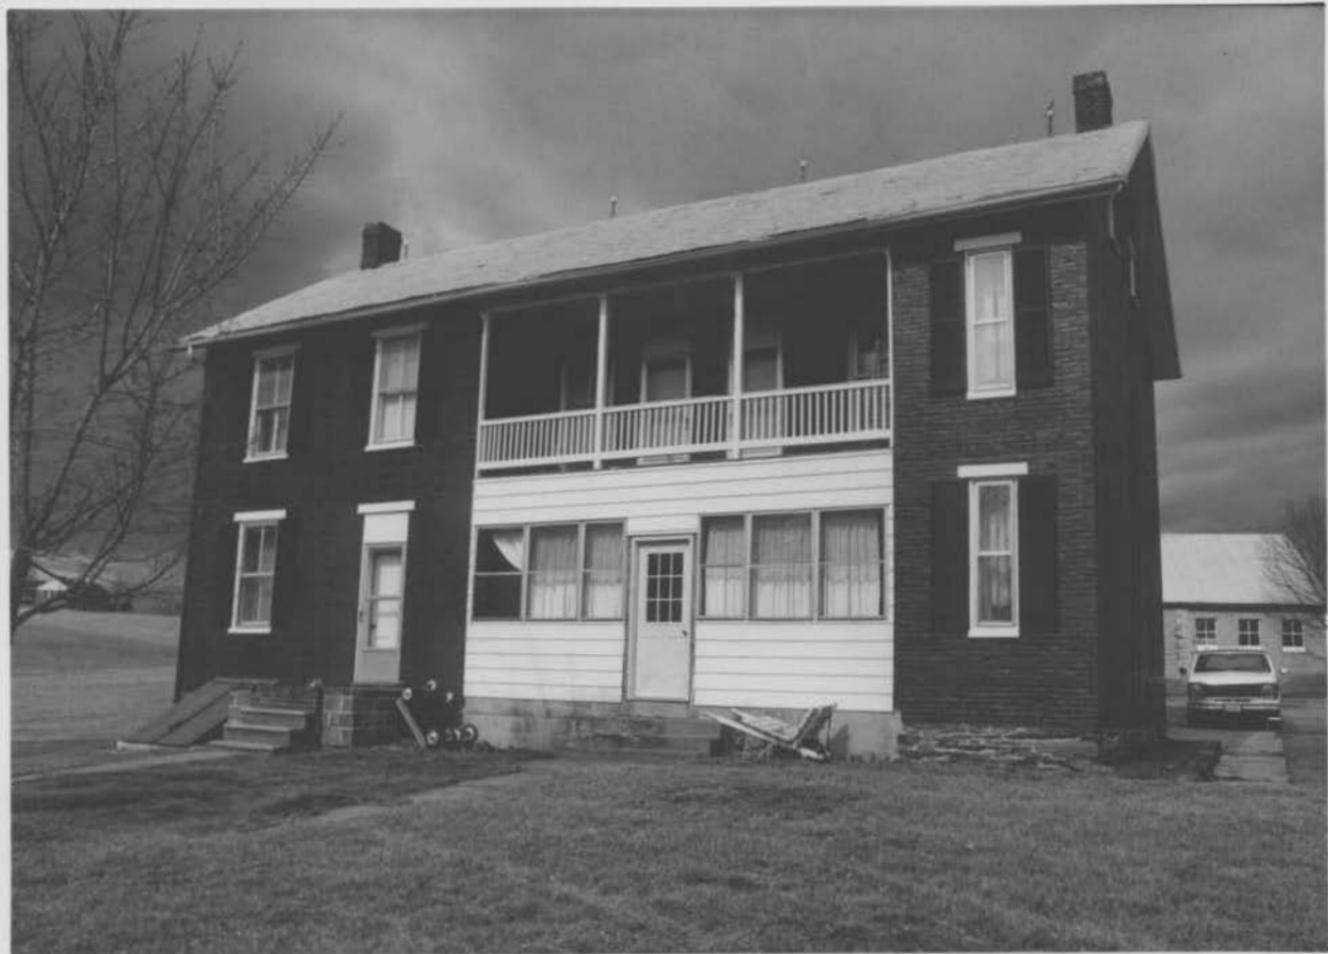
1/6

South elevation

The residence has a two-bay main section facing south with the wing adjoining on the east side. The main section has 5:1 American bond walls painted brick red. The entrance is in the west bay and has a 4-panel door under a covered transom. The window openings have plain lintels with 2/2 sash and louvred shutters. The gable roof has extended eaves and has no cornice. The roof is currently covered with pressed metal. The west gable end has no window openings except a pair of 2/2 attic windows. The side wing has an integral two-story porch on the south elevation. The eastern bay of the porch is brick. This end bay has very narrow 1/1 windows. The first story of the porch is enclosed with aluminum siding and aluminum sash windows. The upper level has the same window details as in the main section. The east gable end of the wing has no window openings. At the rear or north elevation of the house is a one-story wing with frame or log structure under modern wood siding and a corrugated metal roof. A modern enclosed link joins what appears to have been an originally free-standing log or frame summer kitchen to the house. The kitchen section has the same siding as the rest of the wing, modern aluminum windows, and a rebuilt exterior brick chimney. The roof is corrugated metal. It is currently used as a shop. The interior of the house was not accessible for this survey.
