Peter Shafer Farmstead
Middletown vicinity
Private

Ca. 1818-1920

Maryland Historical Trust State Historic Sites Inventory Form

Survey No. F-4-34

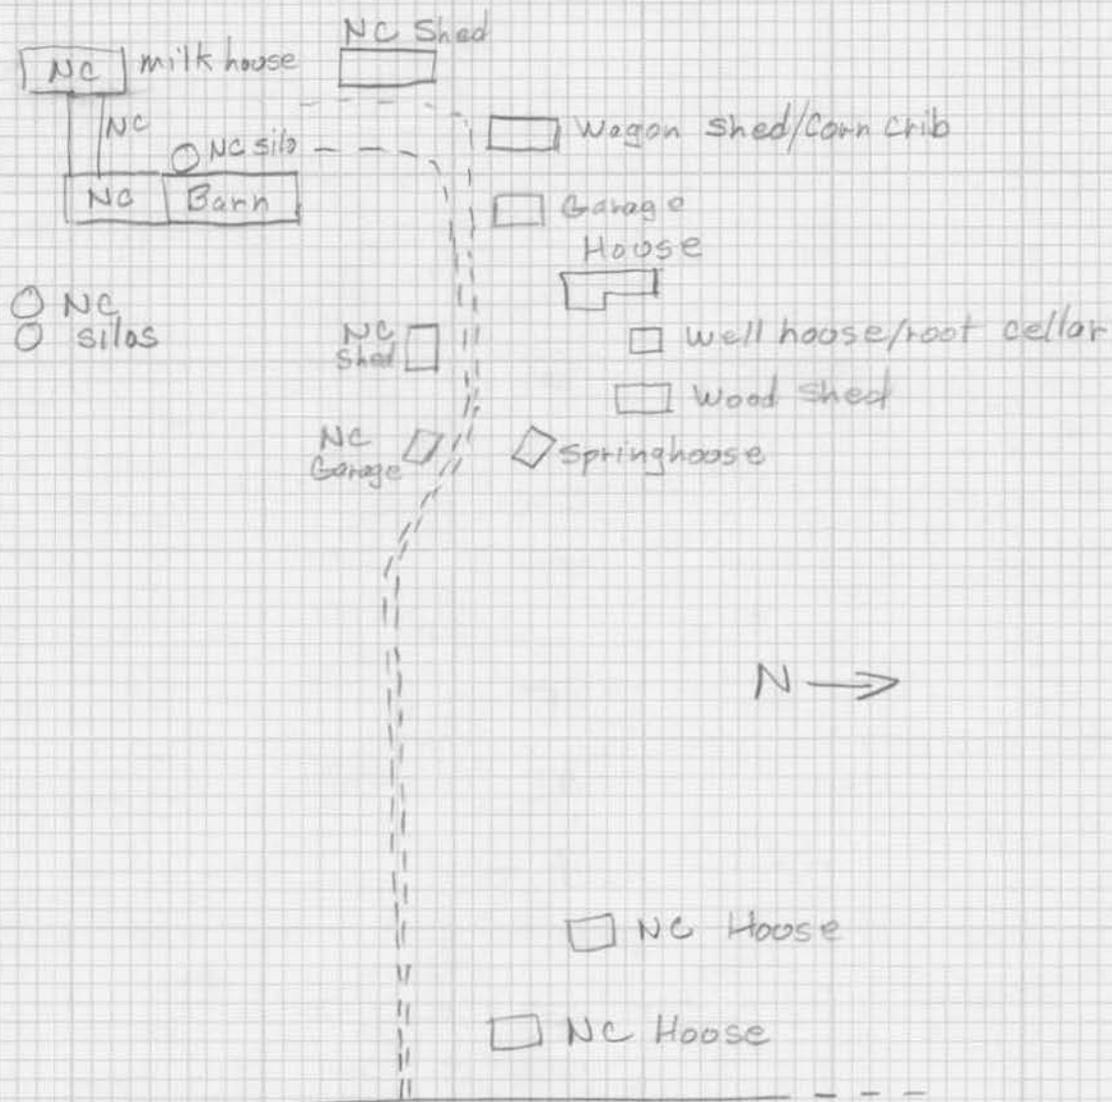
Roy Shafter Road

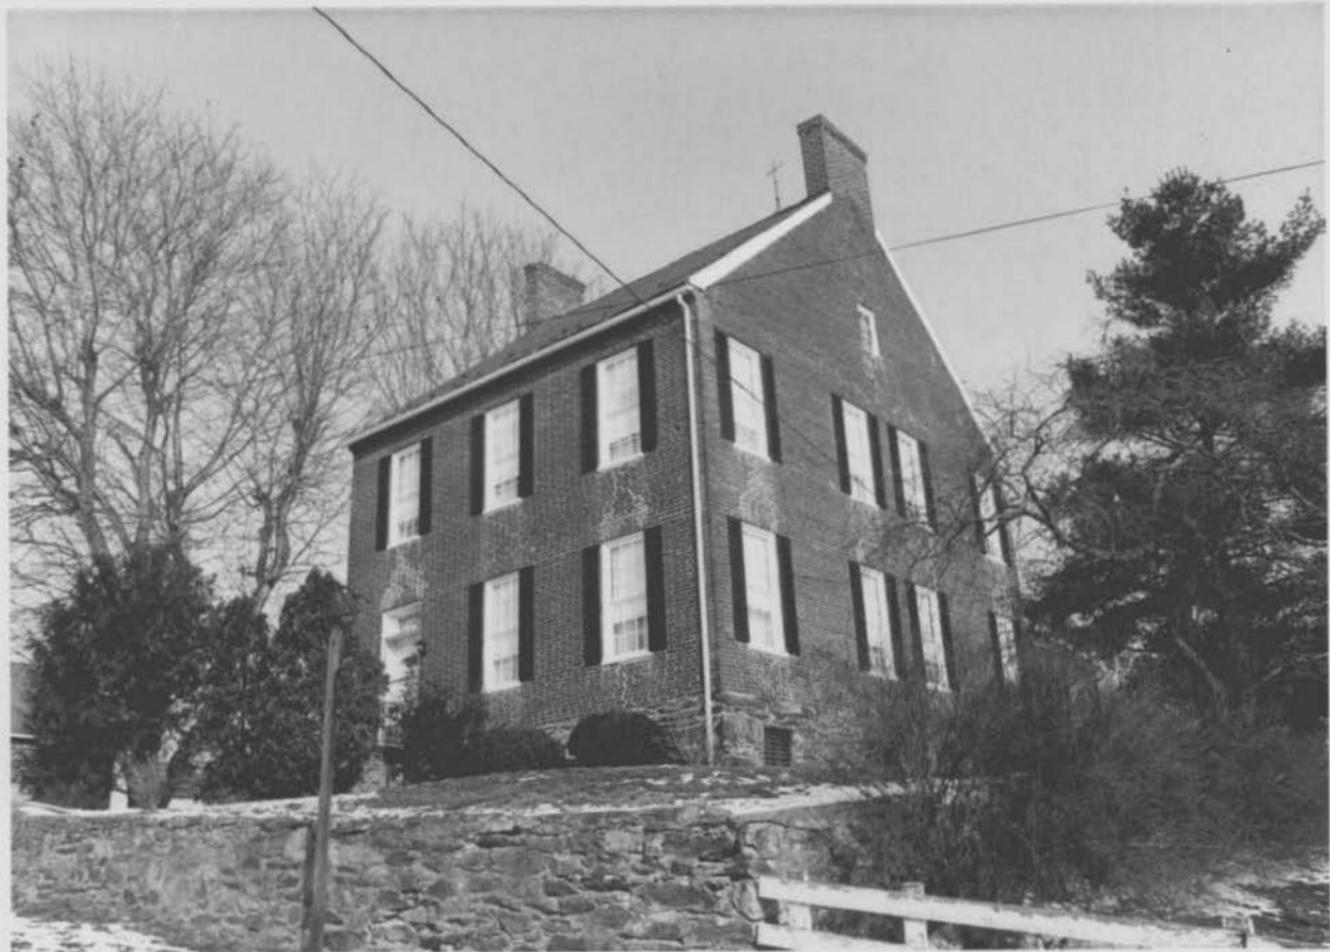
1/8

The dwelling house is a two-story brick residence with a three-bay principal facade facing south. A rear one-story wing extends from the northwest corner of the house. An open porch is located on the east side of the wing. The main facade and west elevation are laid in flemish bond and the east elevation and rear wing are in American bond ranging from 4:1 in the lower courses to 5:1 on the upper levels. The main entrance is in the west bay with a rectangular transom with fan tracery over an 8-panel door. The window openings have gauged brick arches and wood sills with 9/8 sash and replacement louvred shutters. Some repointing has taken place in the spandrels of each bay between the first and second floors. The cornice is molded, corbeled brick and interior chimneys are located at the east and west gable ends. The roof is covered with corrugated metal. The east elevation has four bays with 9/9 windows on both floors and a single 4/2 attic window. Two entrances to the cellar are located in the stone foundation, each with vertical board doors. The cellar has two wood-barred windows in this elevation. The west elevation has two bays near the southwest corner, the north portion being occupied by the interior staircase. The rear wing has two entrances on the east side. The 9/9 windows and replacement shutters are the same as on the main section. The wing's roof is covered with pressed metal. The porch is integral to the roof, but the supports are now modern cast iron replacements. Two chimneys rise from the wing, one in the center and one at the north gable end. Evidence of a removed bake oven projection is visible in the repointed and spalled bricks of the north elevation.

Southeast corner view

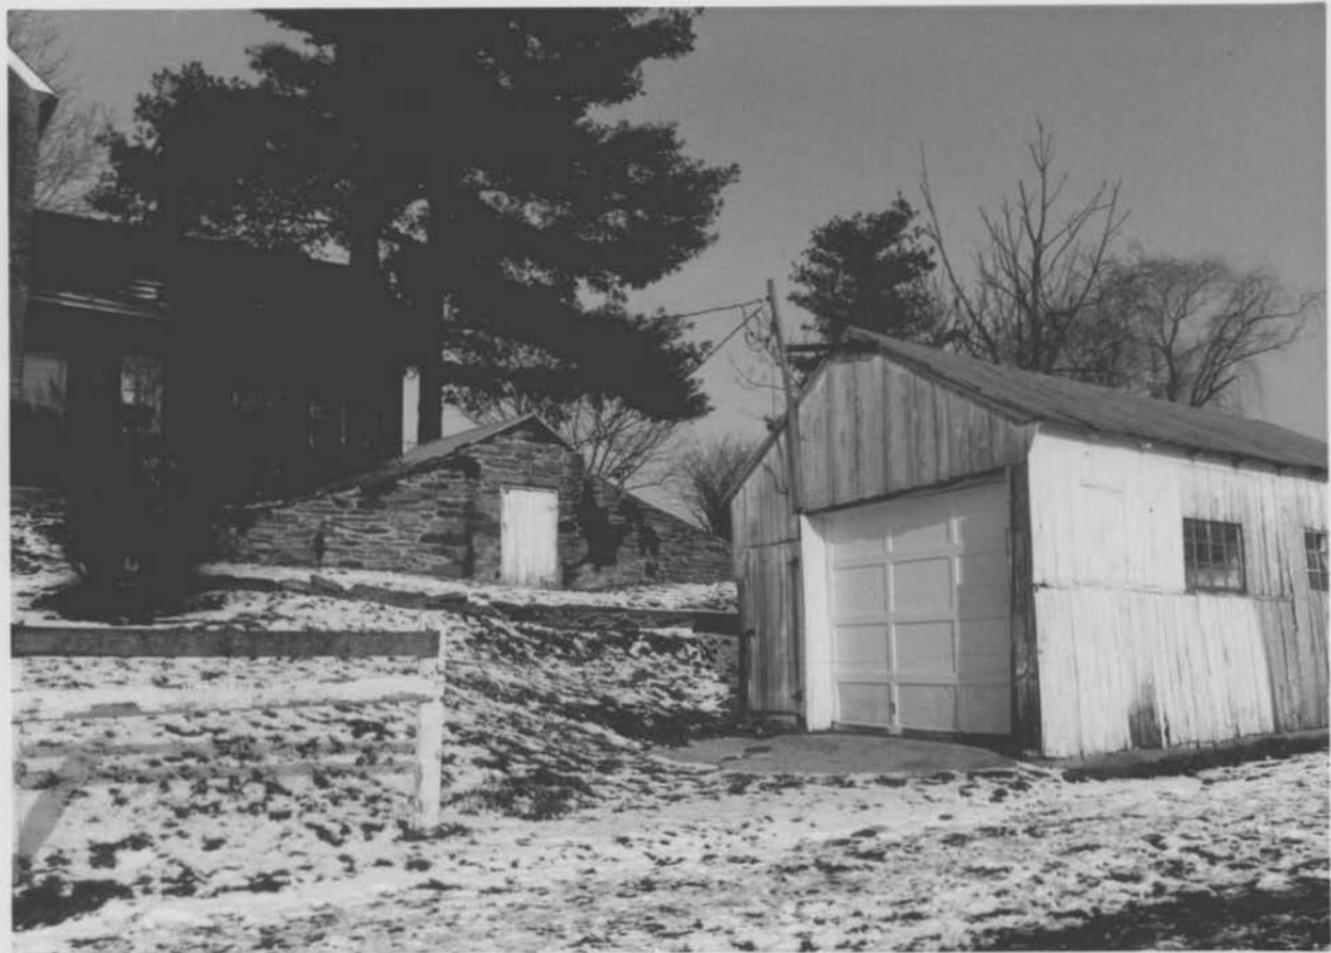
2/8

Well house and root cellar: The entrance to the well house is a stone wall built into the slope northeast of the house. A vertical board door and a corrugated metal gable roof cover the top. Above the roof is a late 19th century pump. The well house and root cellar probably date from about the same period as the main house, although the gable roofed section was probably built out at a later date.

Well No. 4 west 1/2 S 1, view from east

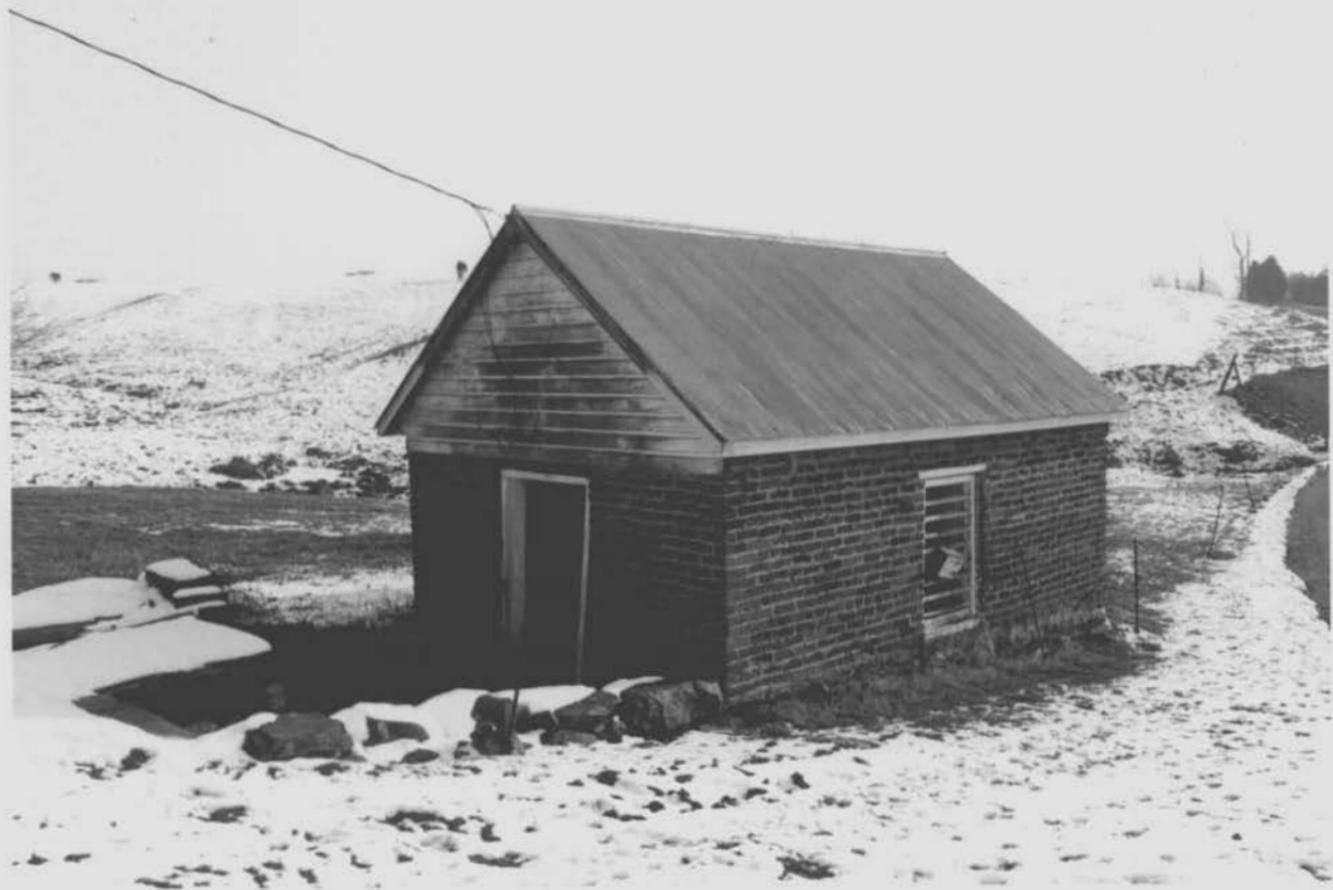
3 1/2

Springhouse: The brick springhouse is a rectangular building located southeast of the wood shed. It was built about 1918 with the bricks of the original brick bank barn which was replaced with the present barn. It has a corrugated metal gable roof and german sided frame gable ends. A single doorway is located in the northwest gable end and the windows on the side elevations have wood bars. In Mrs. Rice's 1890's photo of the farm, the original brick, two-story springhouse appears in the same location.

Springfield. Sp. 1st 1000

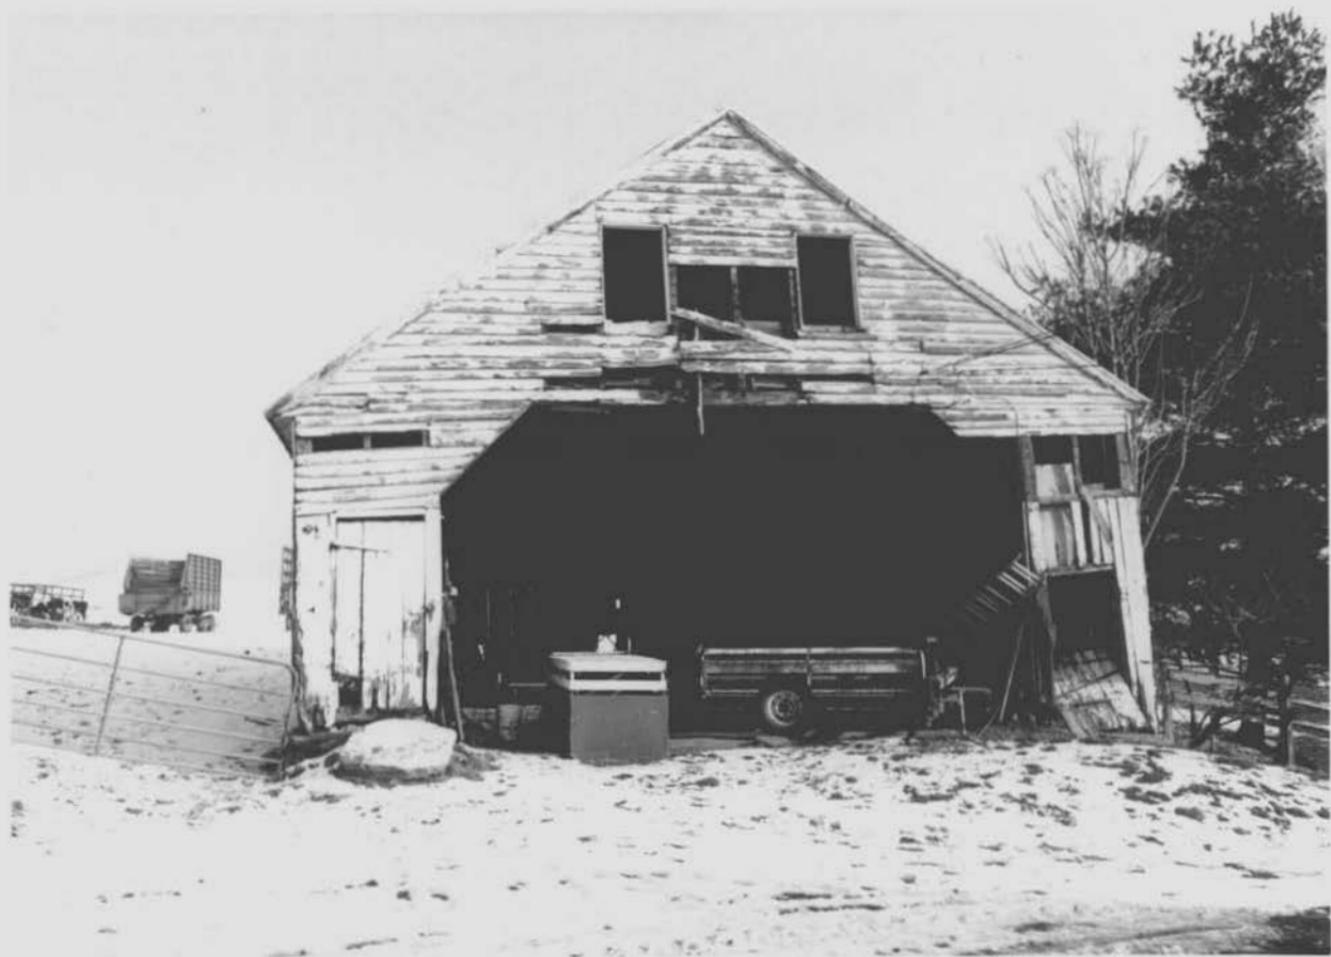
5/3

Wagon shed/corn crib: The frame wagon shed/corn crib was built during the last quarter of the 19th century. It has clapboard siding and two window openings in the south elevation above the drive-through bay. The gable roof is corrugated metal. The structure is in deteriorated condition.

Wagon shed, low elev., south elevation

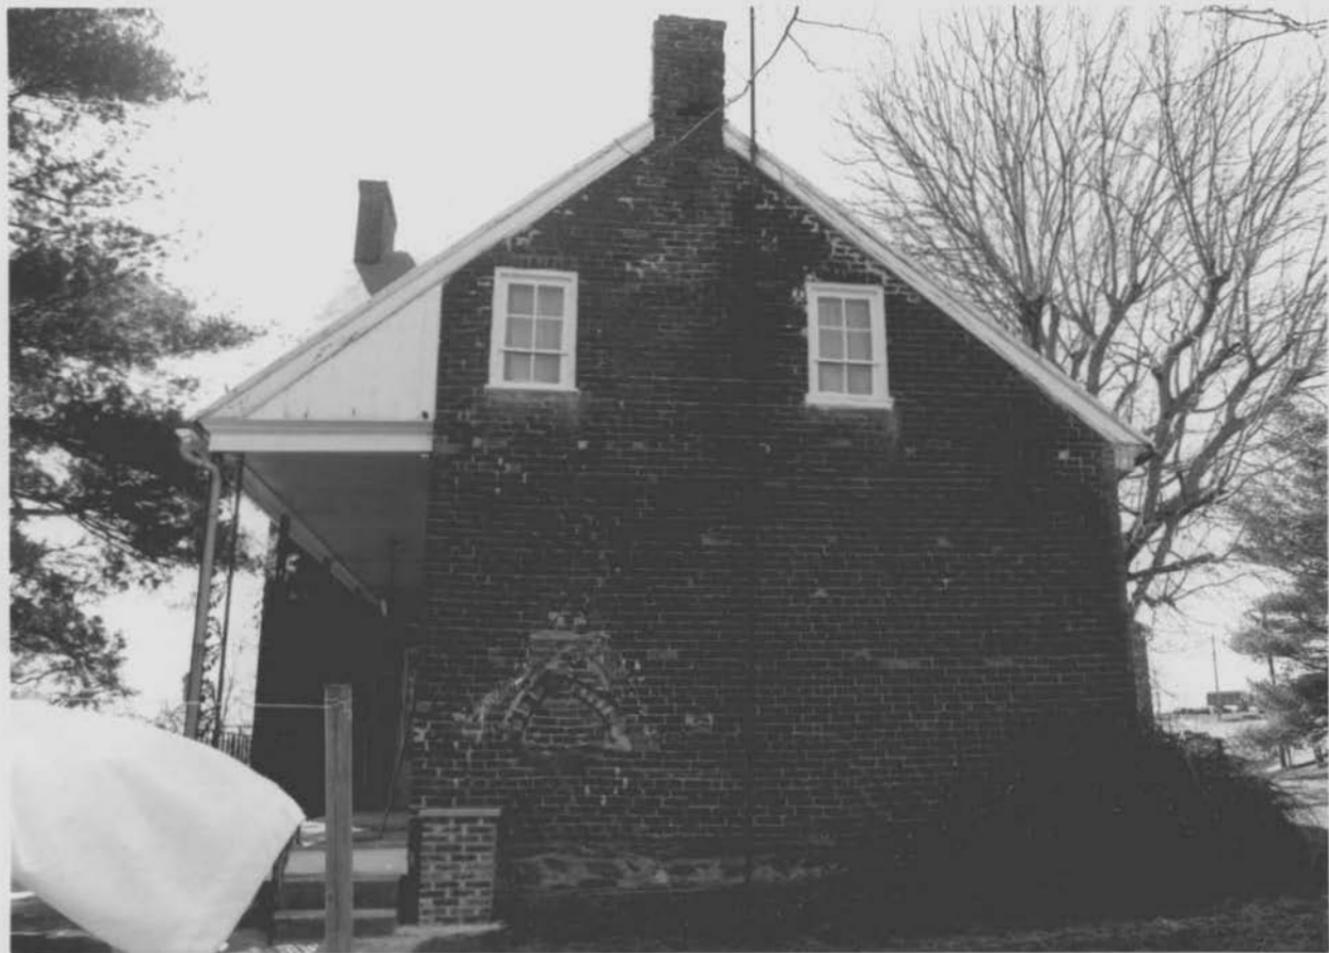
6/8

North elevation of farm with location
of oven
