F-4-45

Martin Warrenfeltz Log House  
Middletown vicinity  
Private

Ca. 1850-1870

# Maryland Historical Trust State Historic Sites Inventory Form

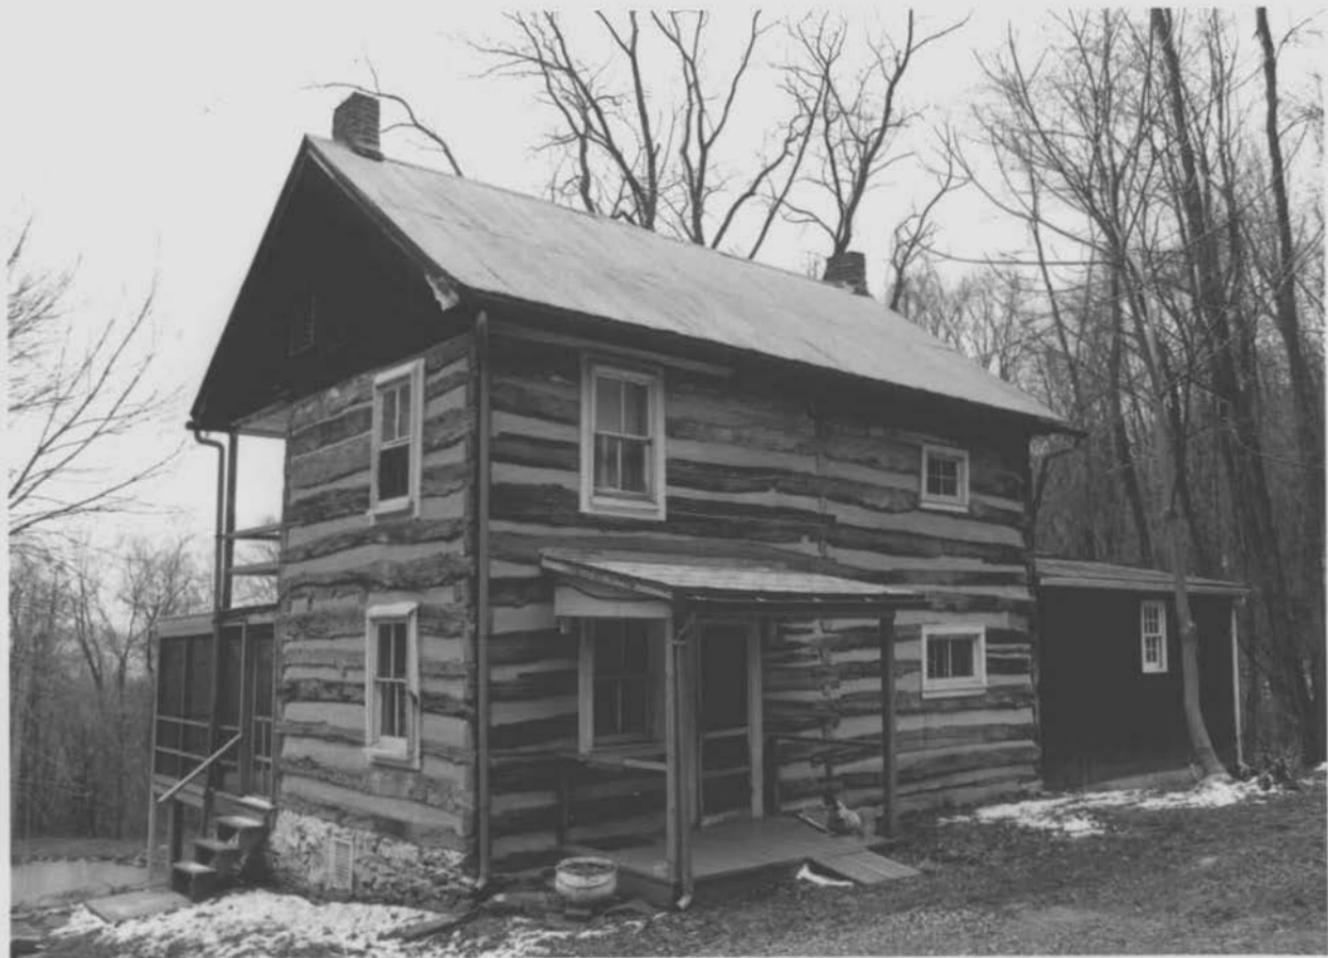
1/4

Northwest corner view

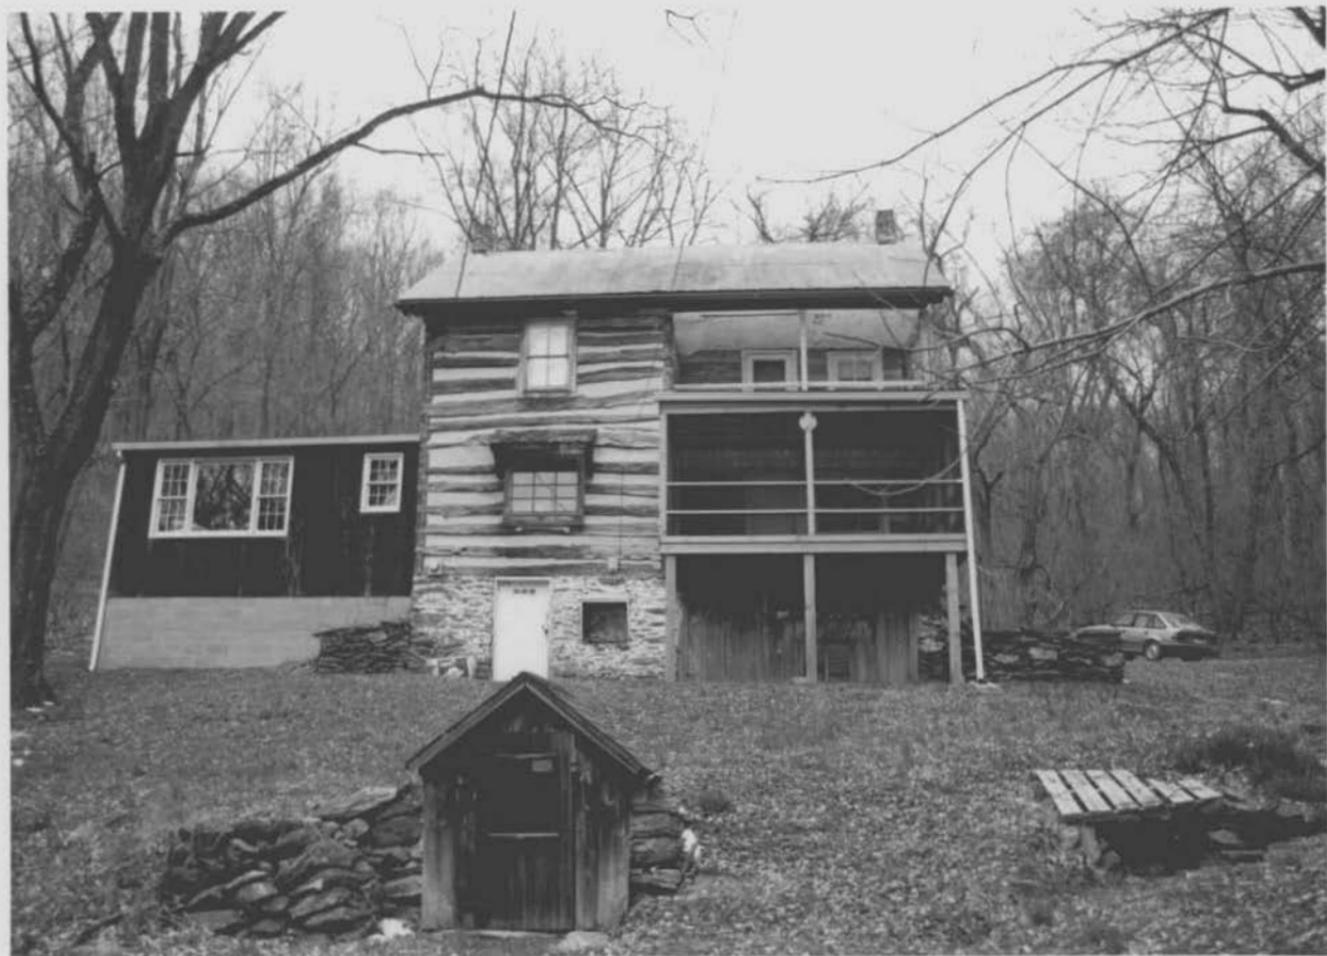
2/4

The house appears to have been built in two sections, possibly about 20 years apart. The first section was a single room, generally square plan building on a stone foundation exposed on the east elevation, with the characteristic V-notching of German vernacular log construction. It may have been a one-story building with a doorway and a window opening on the east and west elevations with the chimney on the south gable end. The second period of construction apparently enlarged the building in both height and width. The addition was made on the south elevation and the pattern of V-notches on the southwest corner of the original section is obscured by the raising of the roof to build the second floor and the integration of the second section. The pattern above the original part includes several half-notched joints secured by nails. On the east elevation, the second section projected beyond the front wall of the first part, leaving an L-shaped angle which is now filled in by a two-story porch under the enlarged roof covering the entire house. The porch has been extended into a screen-enclosed deck on the first story. The stone foundation under the deck has been filled in with concrete block and a modern door is located in the stone foundation of the second section. The doors in the house are four-panel types and may be replacements of the originals. The sash varies, with modern multi-pane replacements in the first floor east elevation and 2/2 in the west elevation, which are probably the original windows. The east elevation of the second section has a central, multi-paned window on the first story with a small wood shingled projecting hood. A small entry porch shelters the door and window on the west elevation. A modern one-story frame addition with vertical siding is located on the south elevation of the house. The roof over the log sections is corrugated metal and interior end chimneys rise above the roof. The new addition has a composition roof. The gable ends of the log section are faced with stained german siding. The interior of the house was inaccessible for this survey.

East elevation

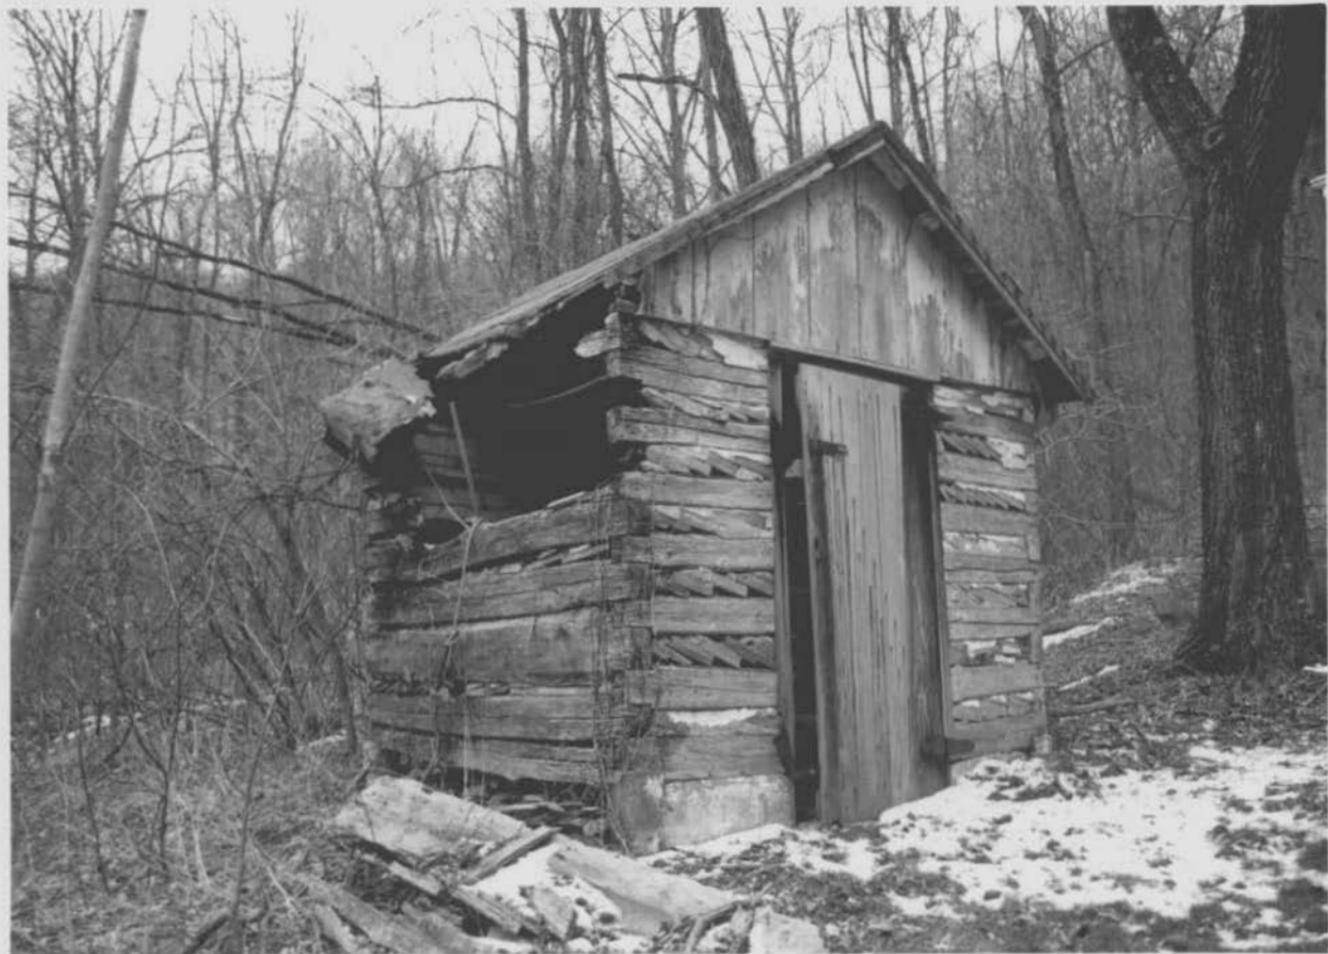
3/4

Meat house: The deteriorated exposed log meat house is located a few yards down the slope east of the house. It has a partially collapsed gable roof covered with composition material. The joinery of the logs is the half notch type of the second section of the house, indicating it was probably built about 1870. The square plan structure has a vertical board door in the north elevation and the gable ends have vertical board siding. The interior has traces of whitewash and two iron cross bars with S hooks.

Meat house, northeast corner view

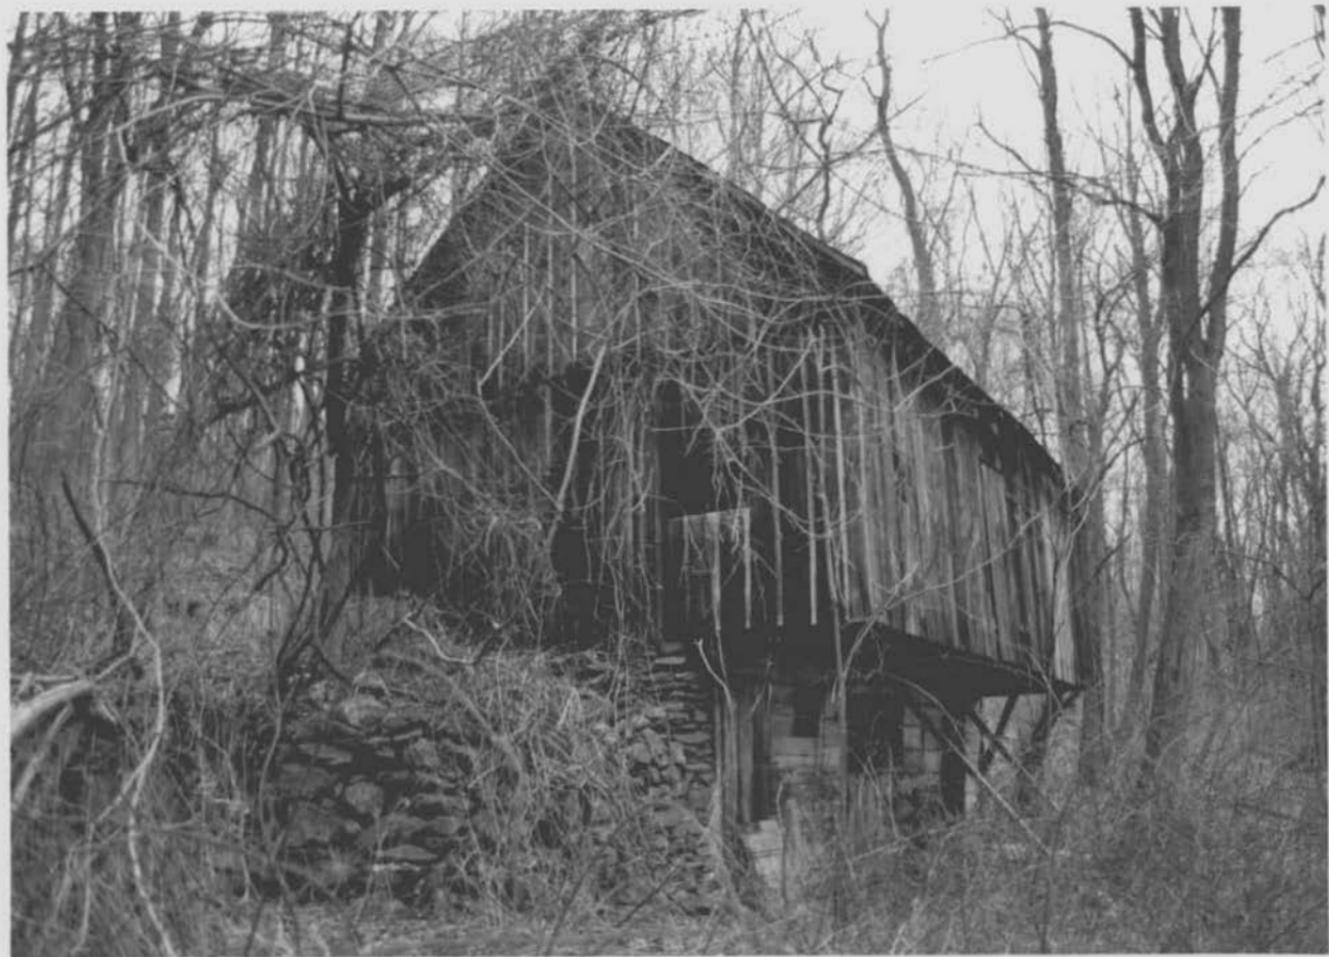
4/4

Barn: The deteriorated frame barn is located on the south side of the access drive from Frostown Road. The stone lower level is banked into the slope below the drive and the hay storage upper level is at the level of the driveway. The barn is a small rectangle in plan with vertical siding on the upper level. A large center opening is located on the north elevation and a vertical board door with iron strap hinges is at the northwest corner. The roof is corrugated metal. The stone lower level on the south elevation has three openings, the center one a dutch door into the stalls and the flanking doors vertical board doors presumably into a feed aisle and a storage area. The lower level is enclosed by horizontal flush boards.

Born view from west

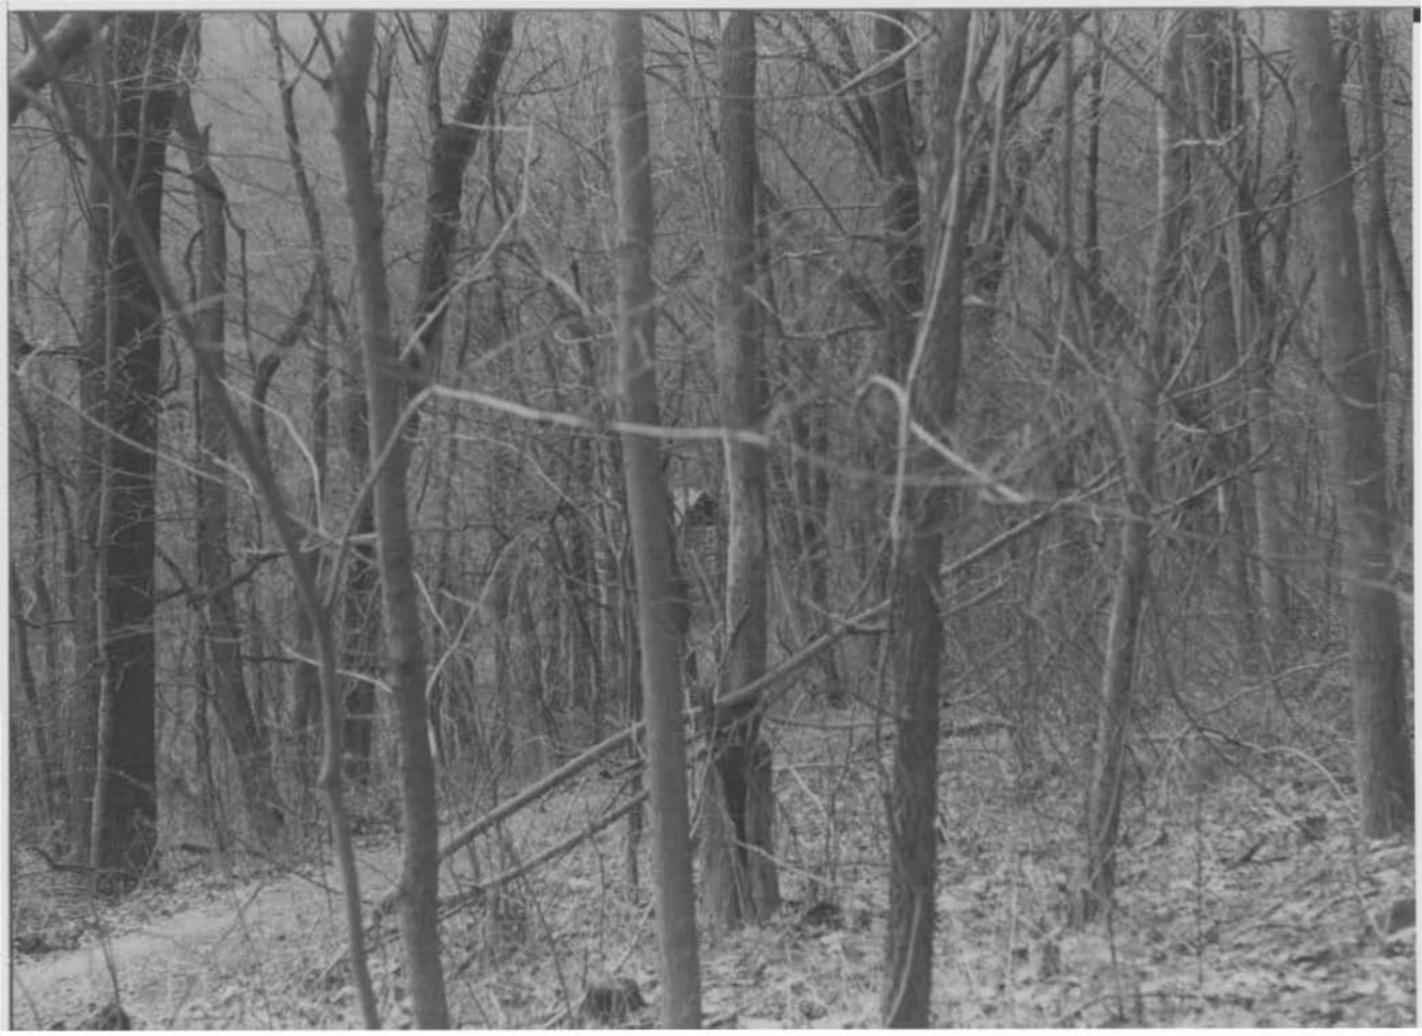
1/2

N elevation of house from Frostown Rd

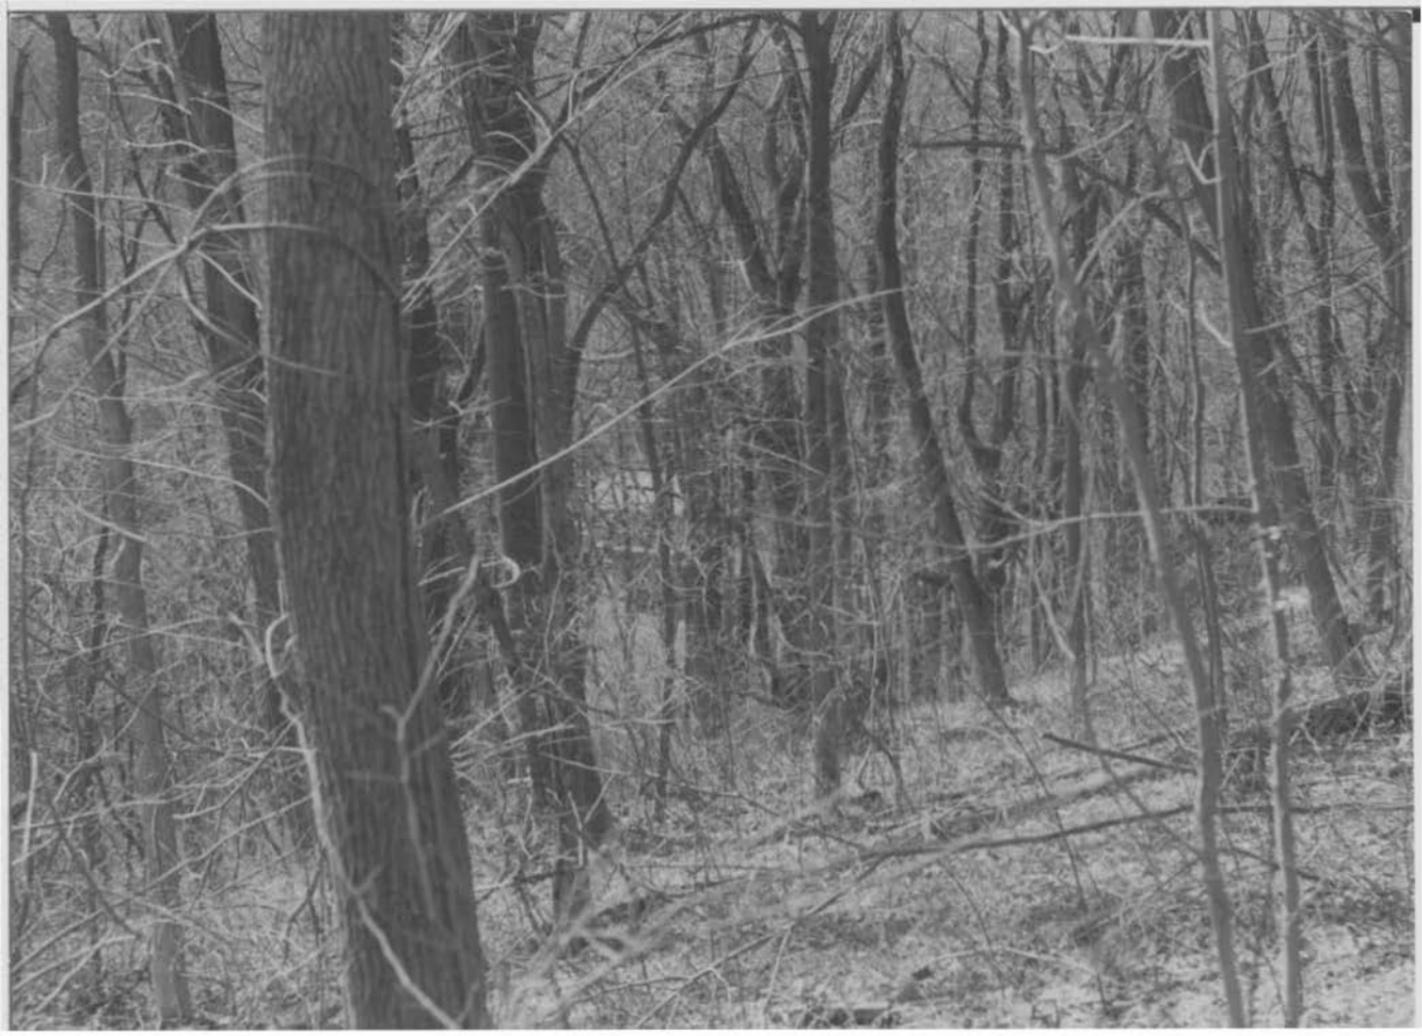
2/2

Elevation of house from Frostburn Rd.
