INDIVIDUAL PROPERTY/DISTRICT
MARYLAND HISTORICAL TRUST
INTERNAL NR-ELIGIBILITY REVIEW FORM

Property/District Name: Myersville Survey District _____ Survey Number: F-4-53

F-4-53
Myersville Survey District
Myersville
Frederick County

MARYLAND INVENTORY OF HISTORIC PROPERTIES

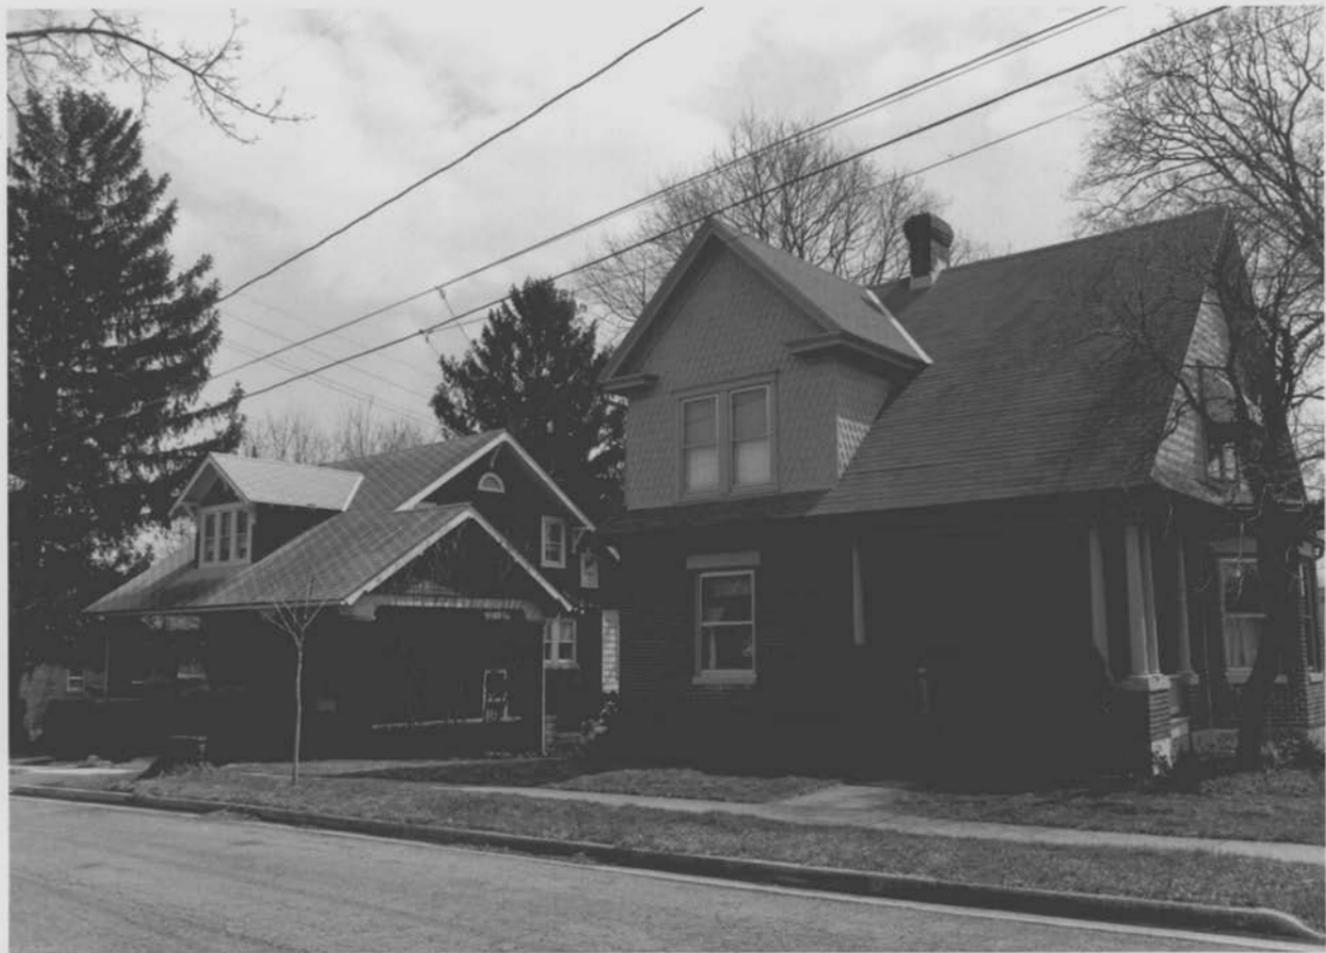
21/23

Typical early 20th century outbldg. remains
of 1 Harp Place & former kitchen of 517 Main
View from north.
