INDIVIDUAL PROPERTY/DISTRICT
MARYLAND HISTORICAL TRUST
INTERNAL NR-ELIGIBILITY REVIEW FORM

Property/District Name: Higgins-Bennett House Survey Number: F-5-85

Project: New Market Loop 230 kV Transmission Line Agency: DNR/PSC

Maryland Historical Trust State Historic Sites Inventory Form

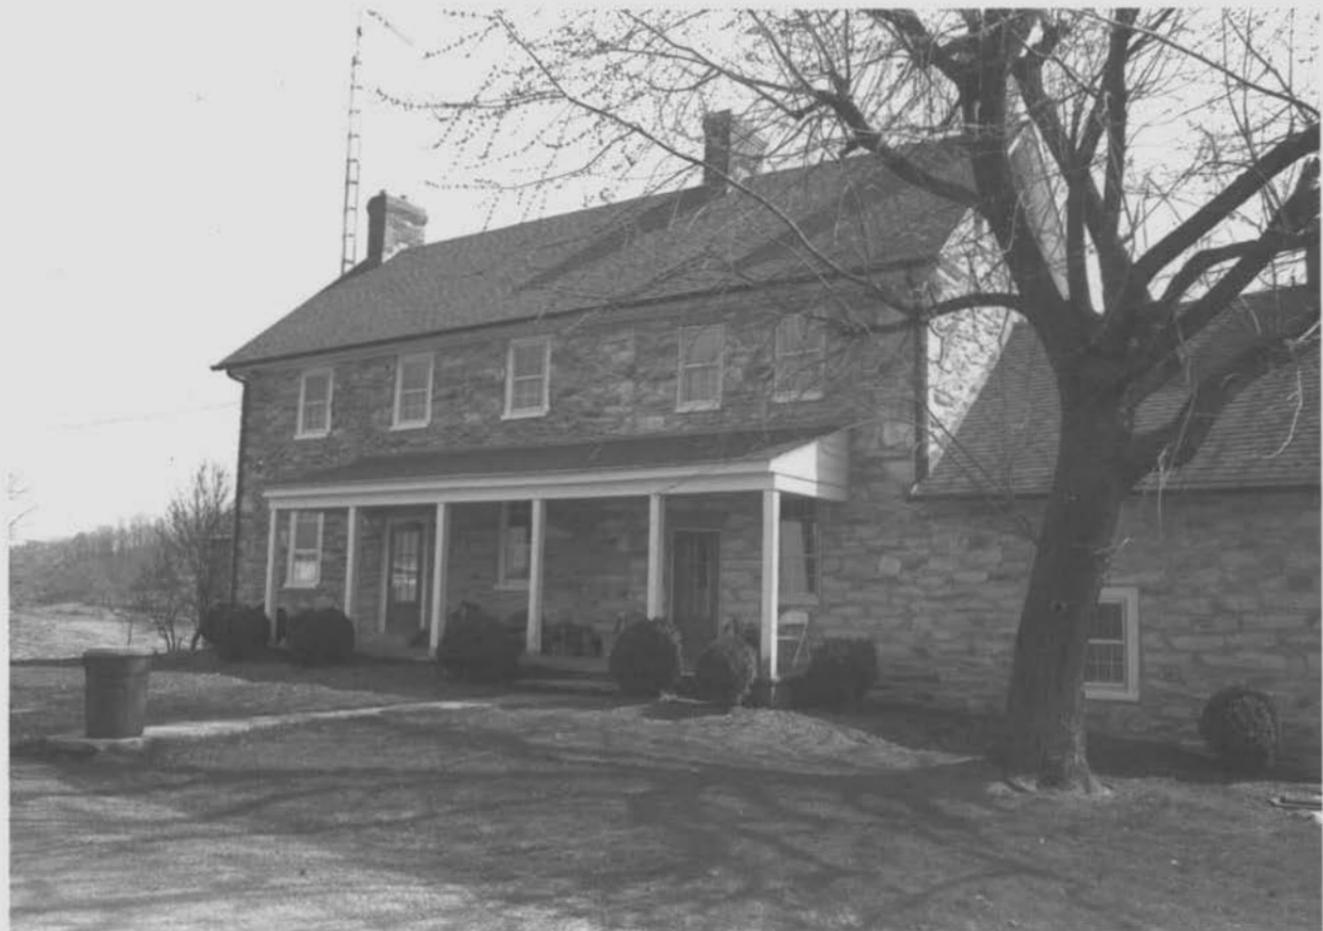
1/7

North elevation

The dwelling's north elevation has five bays with the clearly visible sections demarcated by a joint line separating the three-bay earlier section from the two-bay addition on the west gable end. A modern one-story shed porch with a flagstone deck extends across the facade, covering all bays except the easternmost. The fieldstone is darker and the general size of the stones is smaller in the eastern section and large stones forming rough quoins emphasize the joint line. The roof is composition shingles and interior end chimneys are at the end walls of the original section and of the addition and the 1-1/2 story kitchen addition on the west. Entrances are located in the center bay of north elevation in the circa 1790 section and in the eastern bay of the addition. Windows are 6/6 replacement sash except on the first story which has 9/6 sash. The doors are glass paneled replacements. Above the doorway in the addition is a stone shaped to resemble a voussoir. A single low 6/6 window is in the 1-1/2 story kitchen wing.

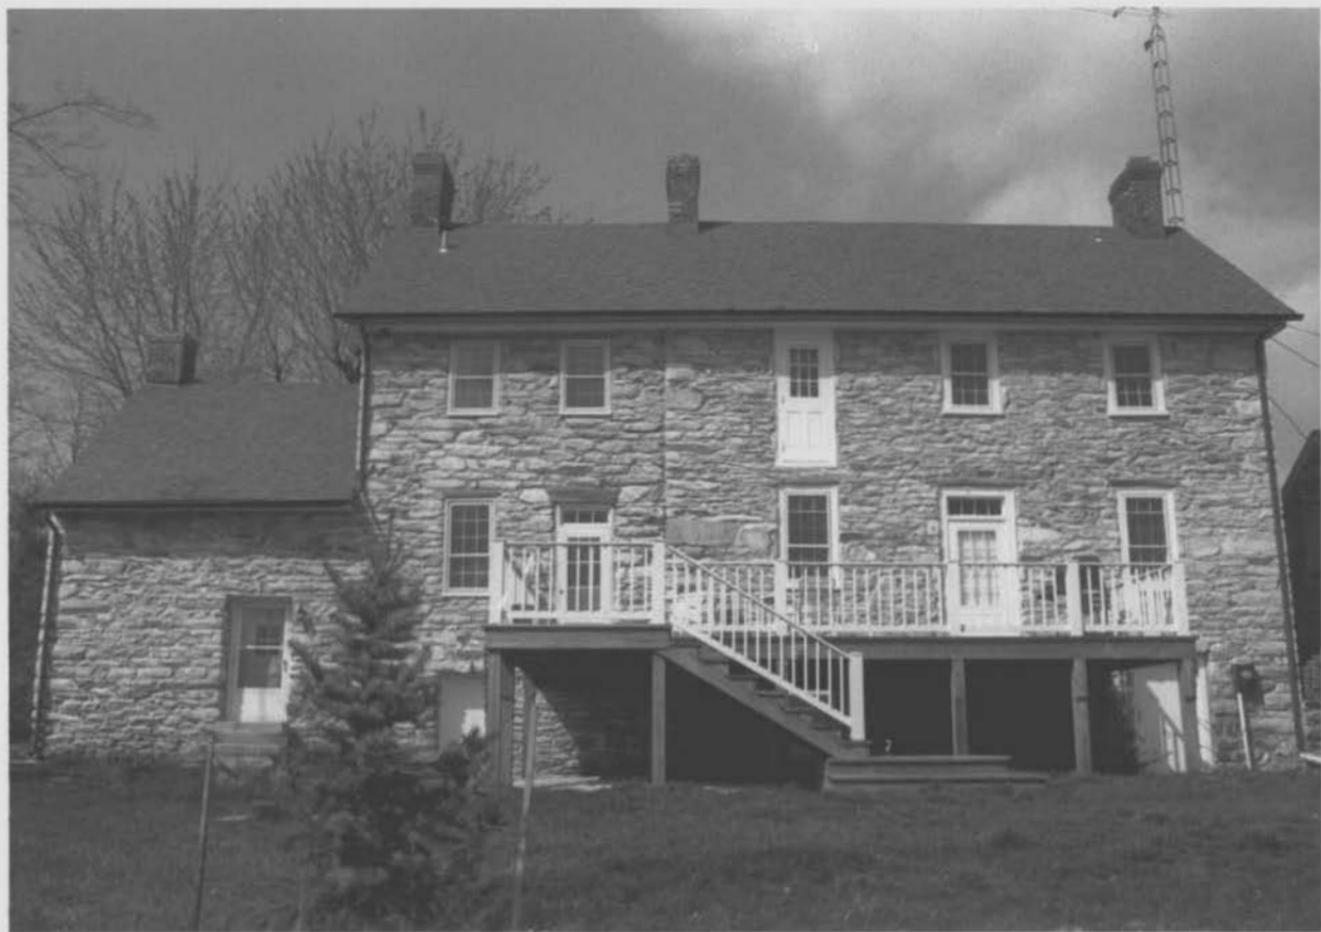
2/7

South elevation

On the south elevation, the bay arrangement is the same as the north elevation, but a modern open deck with a railing extends across the bays. The doorways have transoms of four lights in the eastern section and three lights in the western addition. Narrow flat stones form the lintels in the circa 1790 section and shaped voussoirs are in the addition. A single doorway opens from the kitchen wing. A window on the second story of the 1790's section was converted to a door in the mid-20th century to facilitate furniture moving. At the exposed cellar level are three doorways with vertical board doors. At the gable ends are 2/2 attic windows flanking the interior chimneys. The two-story stone smokehouse is built about five feet from the east gable end with its upper level door in the west elevation. No access from the ground is currently present, but a wood stairway of functional design was probably used in the 19th century. A fieldstone platform fills in the space between the dwelling's east wall and the smokehouse and was probably the base of the stairway. The smokehouse has a second vertical board door on the south elevation at the lower level and a small smoke vent in the east gable end from the lower level. The roof of the smokehouse is composition shingles.

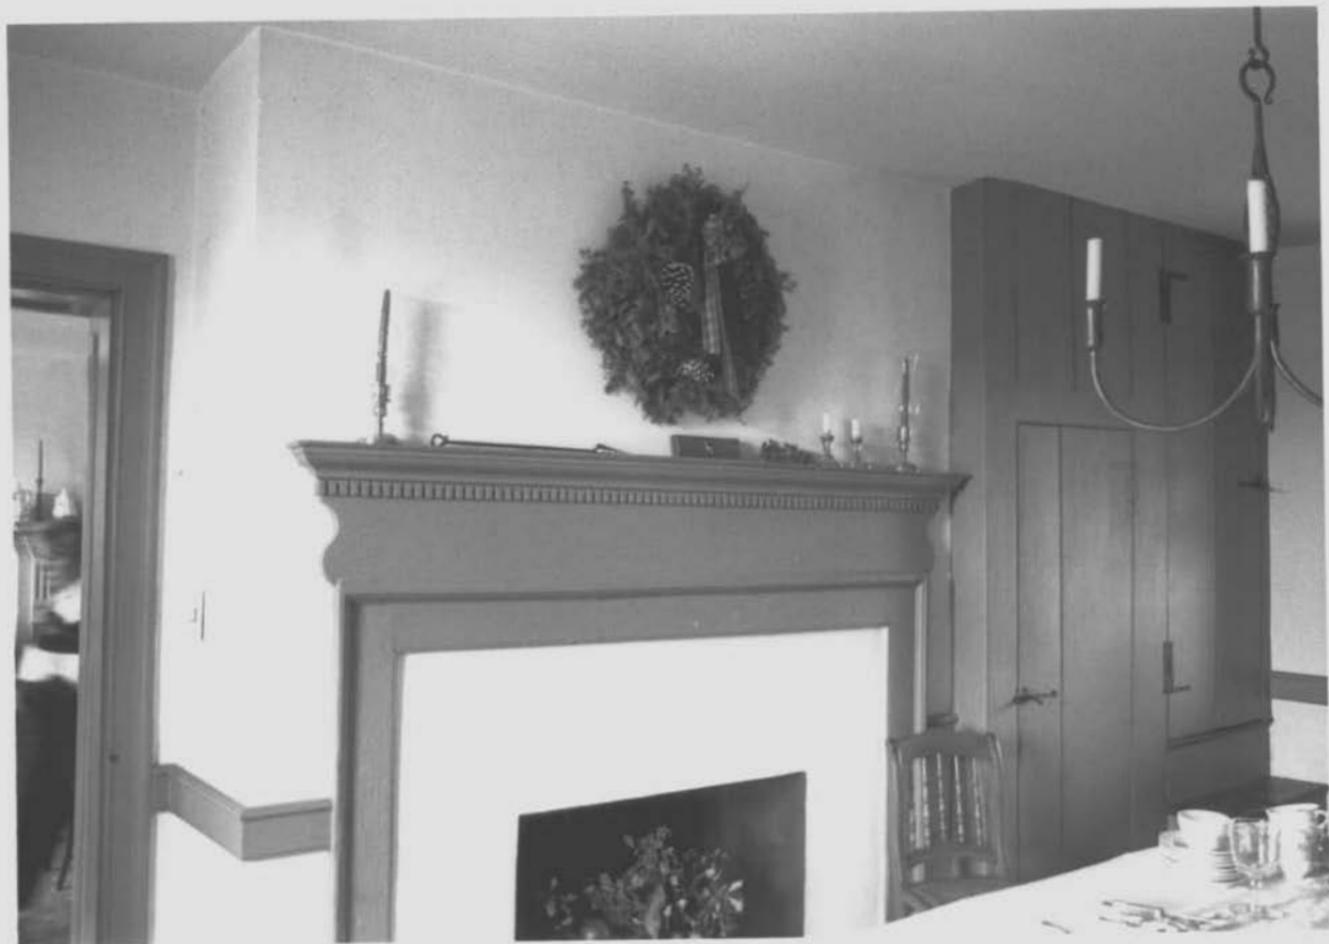
3/7

West parlor mantel

The interior plan of the dwelling is basically a linear progression of rooms linked by doors roughly arranged enfilade near the south side of the house. The circa 1790 section as built had a two-room plan with gable end chimneys and enclosed winding corner staircases in each room. The east room also contained the main entrance. In this room, the fireplace is flanked by a cupboard on the left side which has original graining on the inner surfaces. The mantelpieces in both rooms have a simple molding enframing of the fireplace opening with a flat ogee curved frieze panel rising to a molded shelf with dentil trim. The east room mantel has a reproduced ogee frieze panel. The fireplace openings have been reduced in size in rehabilitations of the house over the period about 1976 to the late 1980's. The molded chair rail in the east room is original, but has been reproduced in the west room. The floors and baseboards are original. The cupboard doors in the east room have raised panels, while those in the west room have beaded vertical flush boards. Much of the original hardware, including latches and HL hinges, is still in place.

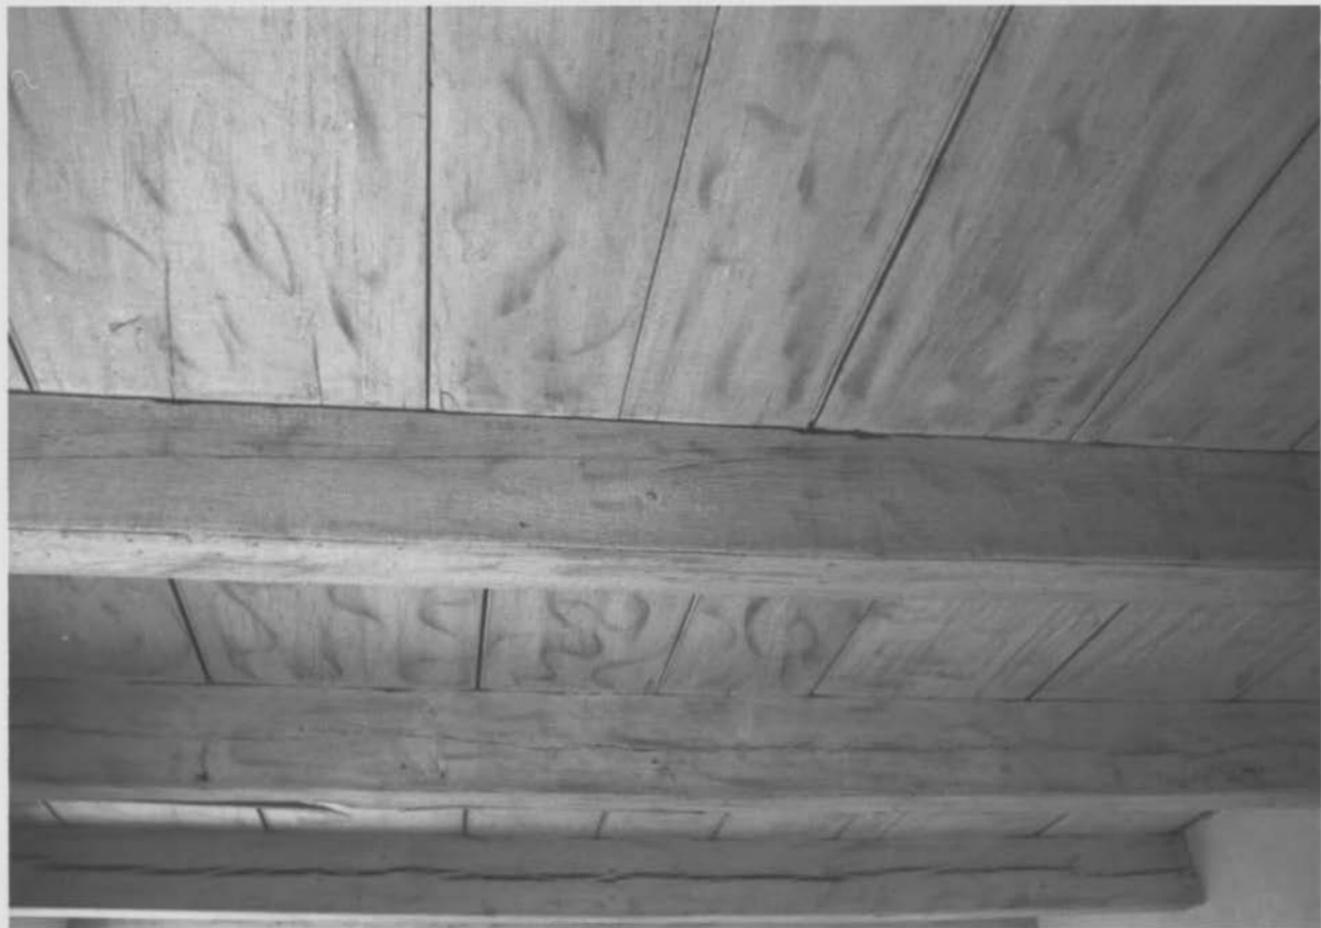
4/7

Smoke graining on ceiling, second floor
Southeast room

The second story plan is unusual in that there were no access doors between the two sections of the house or from the 1-1/2 story wing to the main section until renovations made after 1976. In the 1790's section at the east end are two small chambers with exposed beamed ceilings in which apparently original painted finishes are in good condition. The main room has a light blue wash finish and the small room at the southeast corner has a light pinkish white shade with black graining to resemble smoked markings.

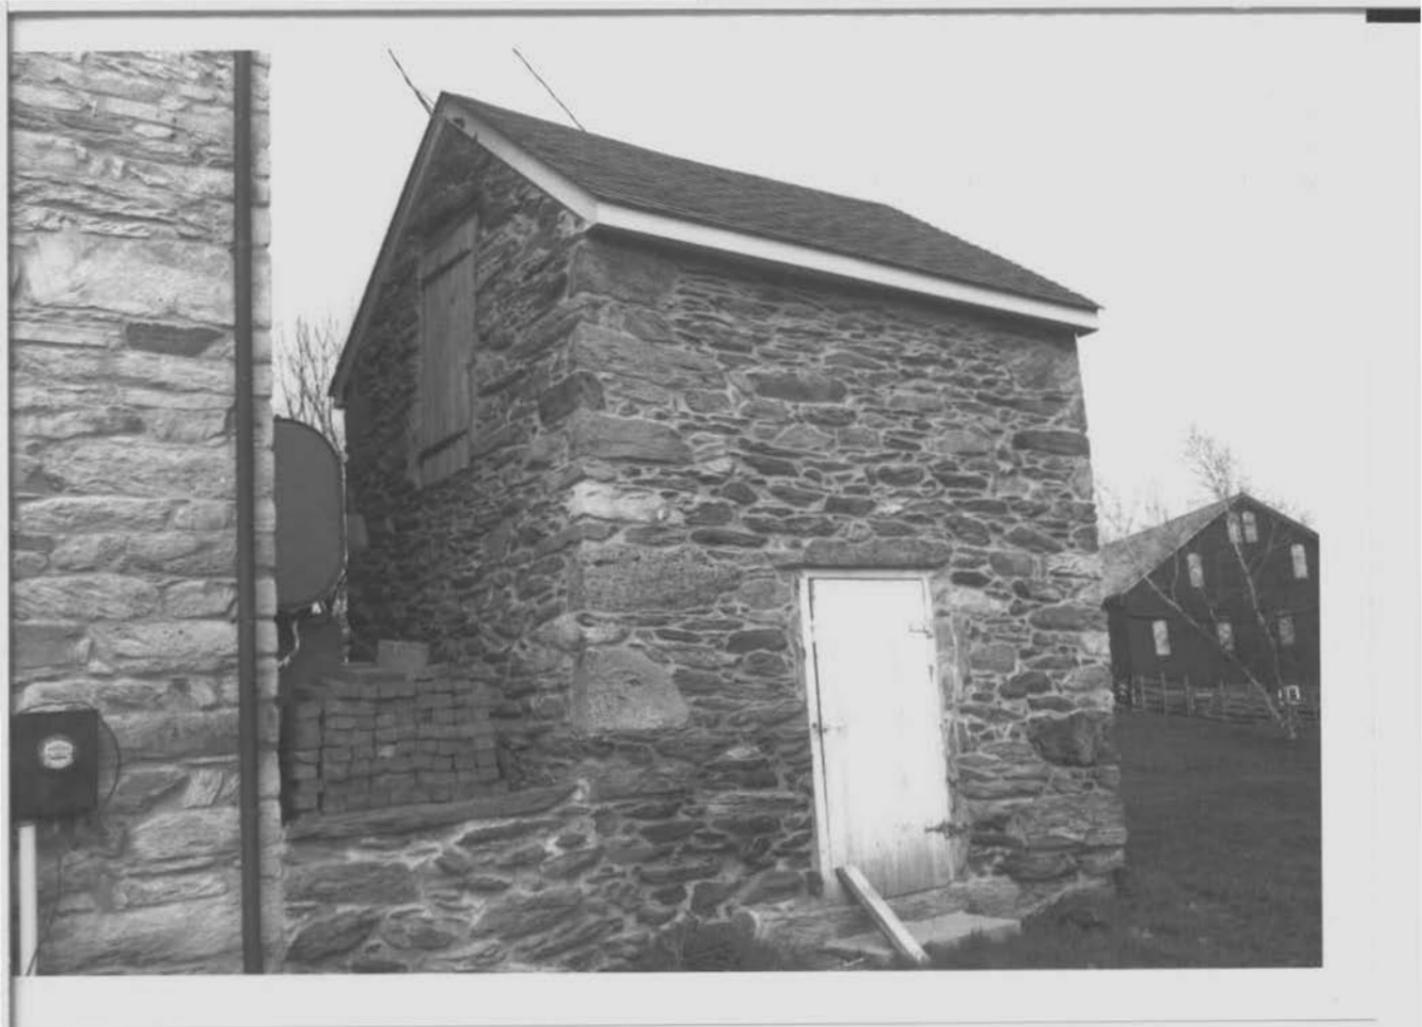
5/7

Smokehouse, south elevation

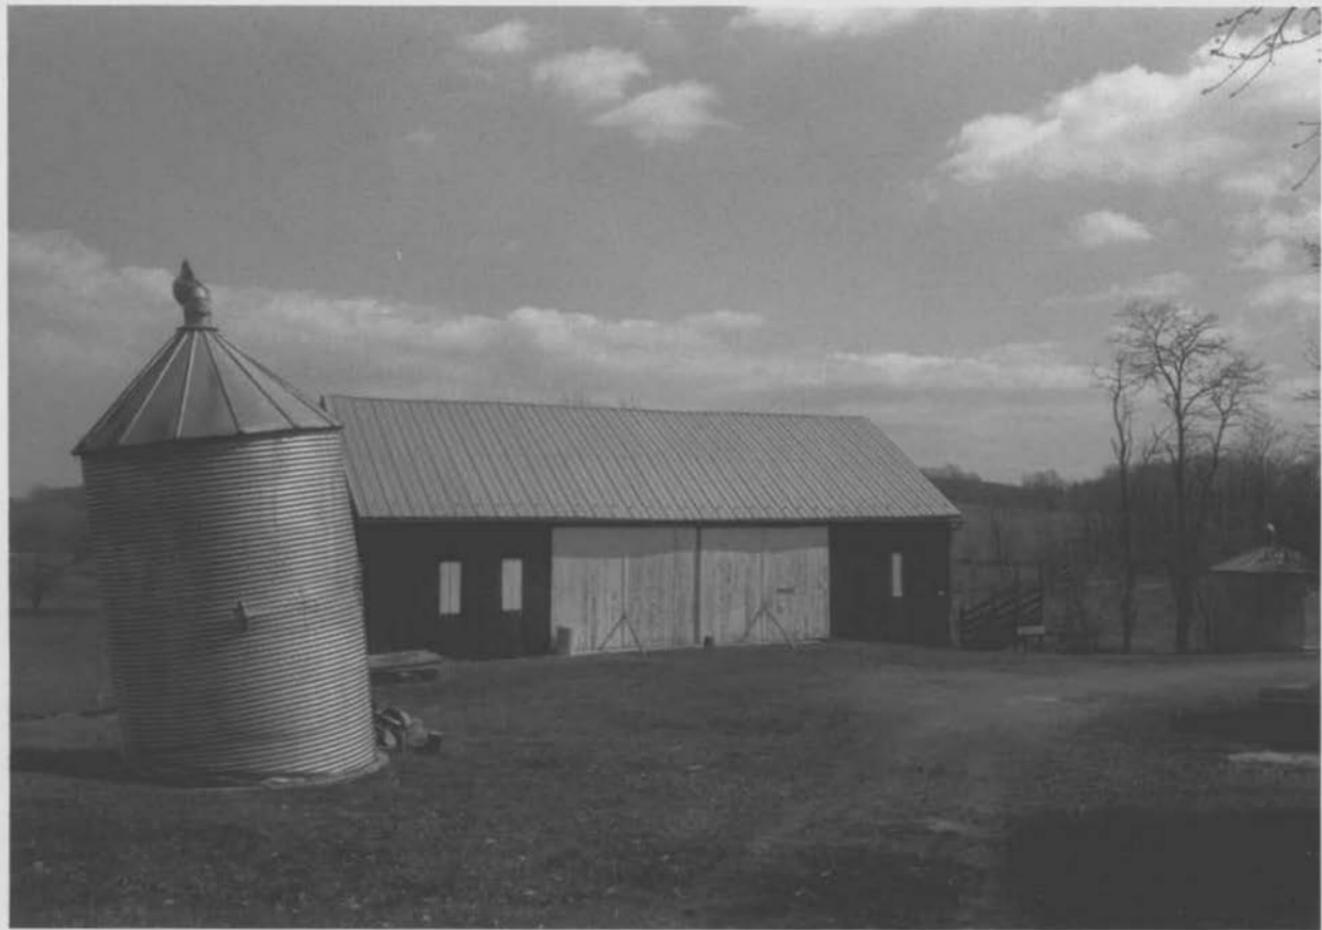
6/7

Barn and granaries, view from northwest

Barn and granaries: The bank barn on the north side of Lime Plant Road has a stone foundation with a frame upper structure and a forebay on the east elevation. The foundation appears to be of the period about 1800-1815, while the exterior vertical siding with arched louvred vents is typical of the second half of the 19th century. The stall level wall is all fieldstone with alternating vertical board dutch doors to the feed aisles and window openings with 3/3 sash, probably dating from the early 20th century. A pair of double swing doors is located in the center of the stone wall. Adjoining the barn on the north gable end is a mid-20th century concrete block loafing shed. The west side of the barn has two sets of vertical board swing doors. The roof is corrugated metal. Two corrugated metal cylindrical grain bins are located near the barn. These date from about the 1920's and have perforated walls and standing seam conical roofs with vents in the peaks.
