F-5-99
Oliver P. Harding House
New Market vicinity
Private

F-5-99
Oliver P. Harding House
New Market
Frederick County

Maryland Historical Trust State Historic Sites Inventory Form

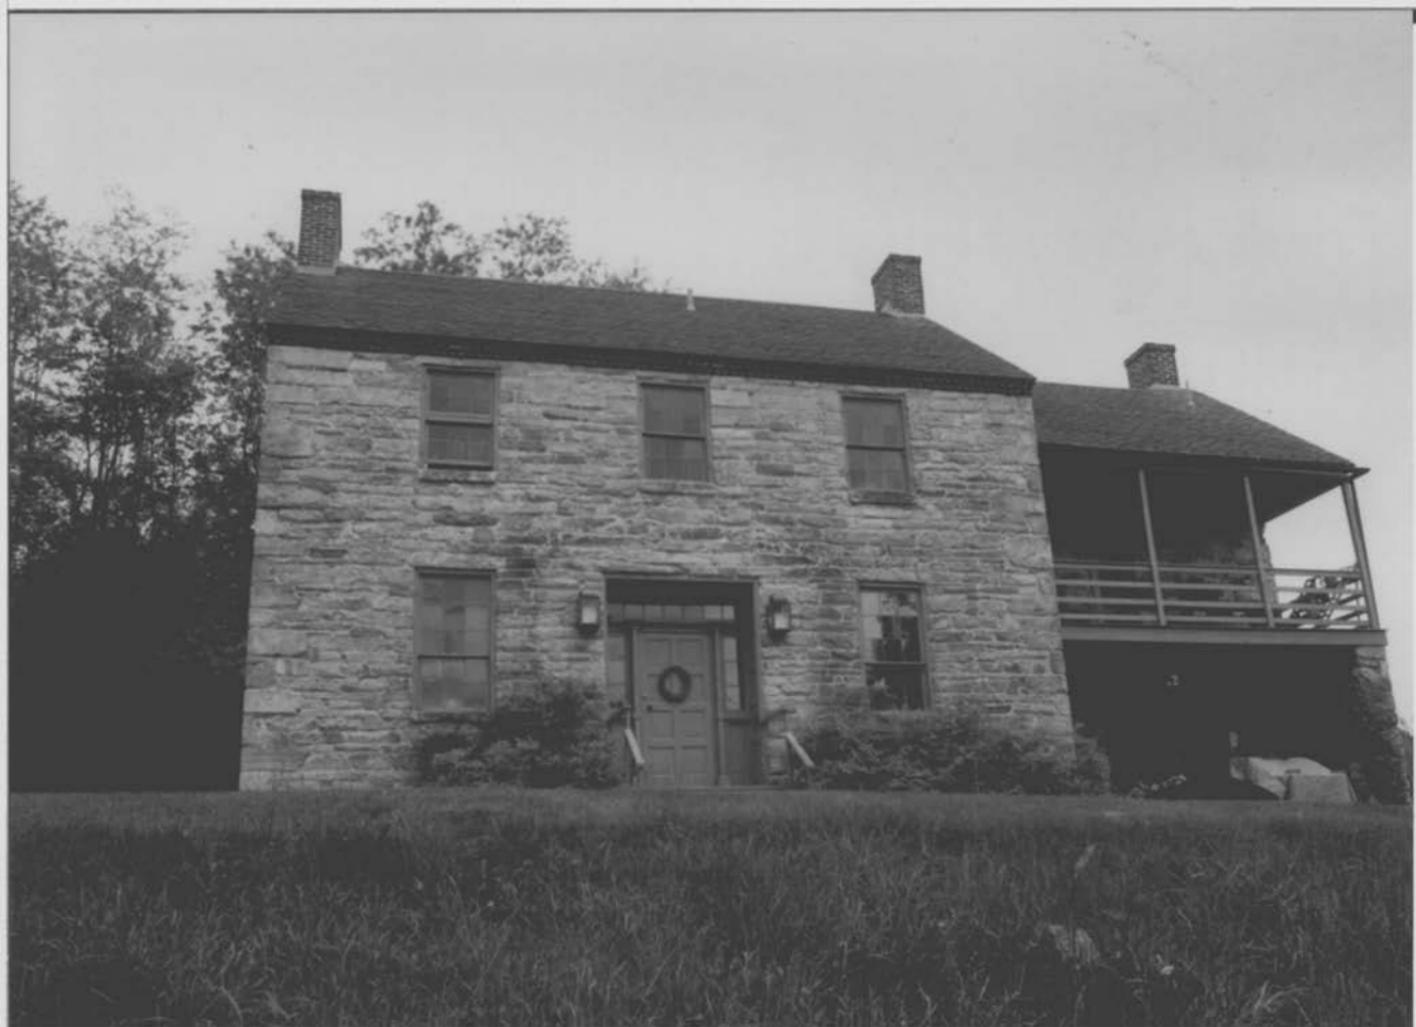
1/6

South elevation

The main section of the house is a three-bay structure with a center entrance which was apparently enlarged with a transom, sidelights, and a paneled soffit during the early 19th century alterations. The door has eight panels. The outline of a demolished entry porch is discernible on the stone wall surrounding the doorway. The first story windows are 9/6 and the second story sash is 6/6. The cornice is corbeled brick and the roof is modern composition material. Interior end chimneys rise at the gable ends. The west gable end has no openings except two small windows at the attic level. Adjoining the east gable end is the recessed, two-story side wing with a two-story open porch. The porch has been rebuilt to duplicate the deteriorated original porch, with plain posts and horizontal railings. The wing has two bays with a doorway on each level flanked by a 6/6 window. The north elevation of the main section also has three bays with a center doorway which originally opened on the rear of the center hall, a feature which was extensively remodeled in the early 19th century. The north side of the side wing is completely obscured on the first story by the modern kitchen addition. A single bay on the second story is visible and the roof has a dormer window added in the modern period of rehabilitation.

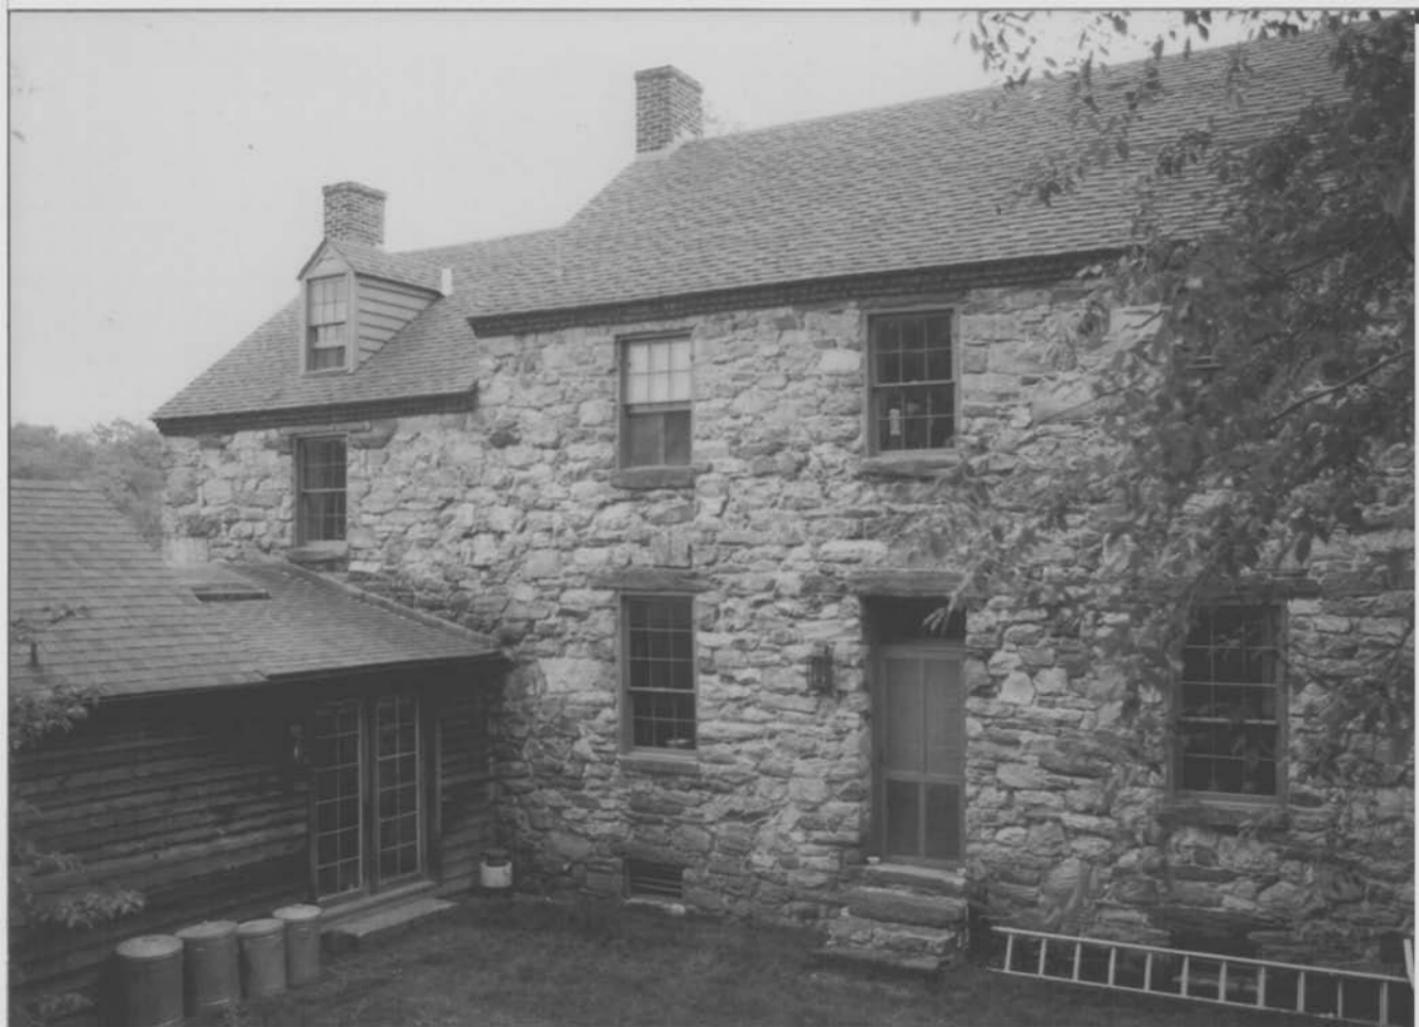
2/3

North side, down

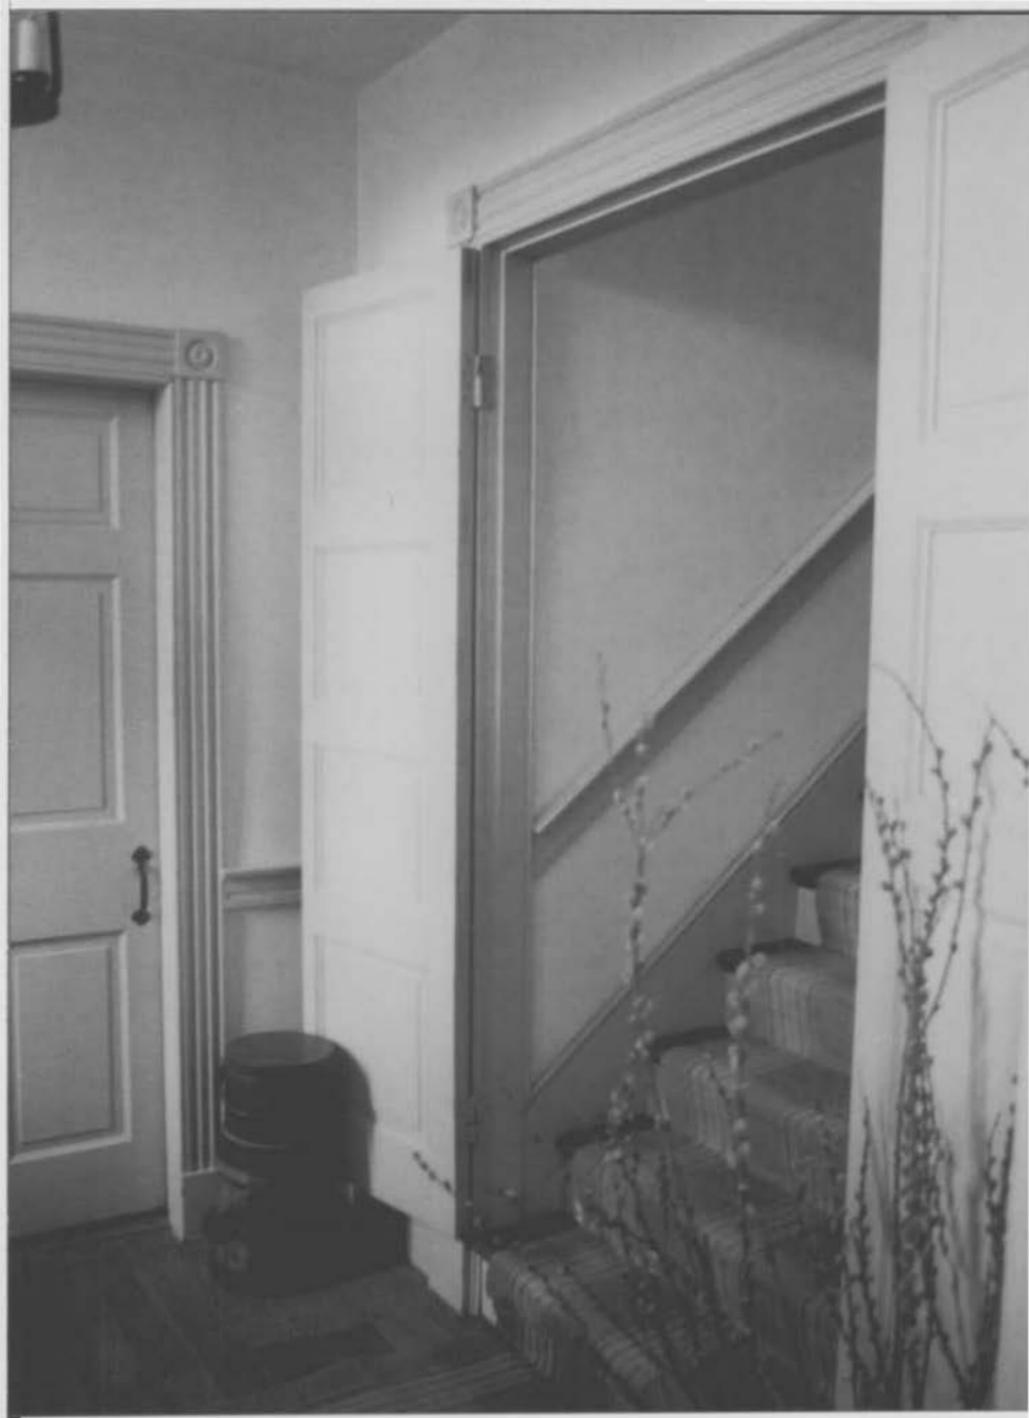
2/3

Main foyer and staircase

The interior of the house originally had a center-hall plan with flanking parlors. In the period about 1820-1830, the staircase was relocated to begin directly opposite the main door and was enclosed on each side. Double 4-panel doors with a molded architrave and bull's eye corner blocks were placed at the foot of the staircase. The doors to the side parlors were also given the same surround, but the doors are 5-panel types. The original exterior doorway was also enlarged and given the transom and sidelights as described in the previous paragraph. The east parlor has its original wide board floors, but the walls have been insulated during the most recent rehabilitation work. The change is noted in the additional trimwork around the deep paneled window soffits to bring the window surround out to the new wall surface. The windows have built-in drawers below the sills, with a curved apron panel dropping from the sill. This feature is found in both the north a

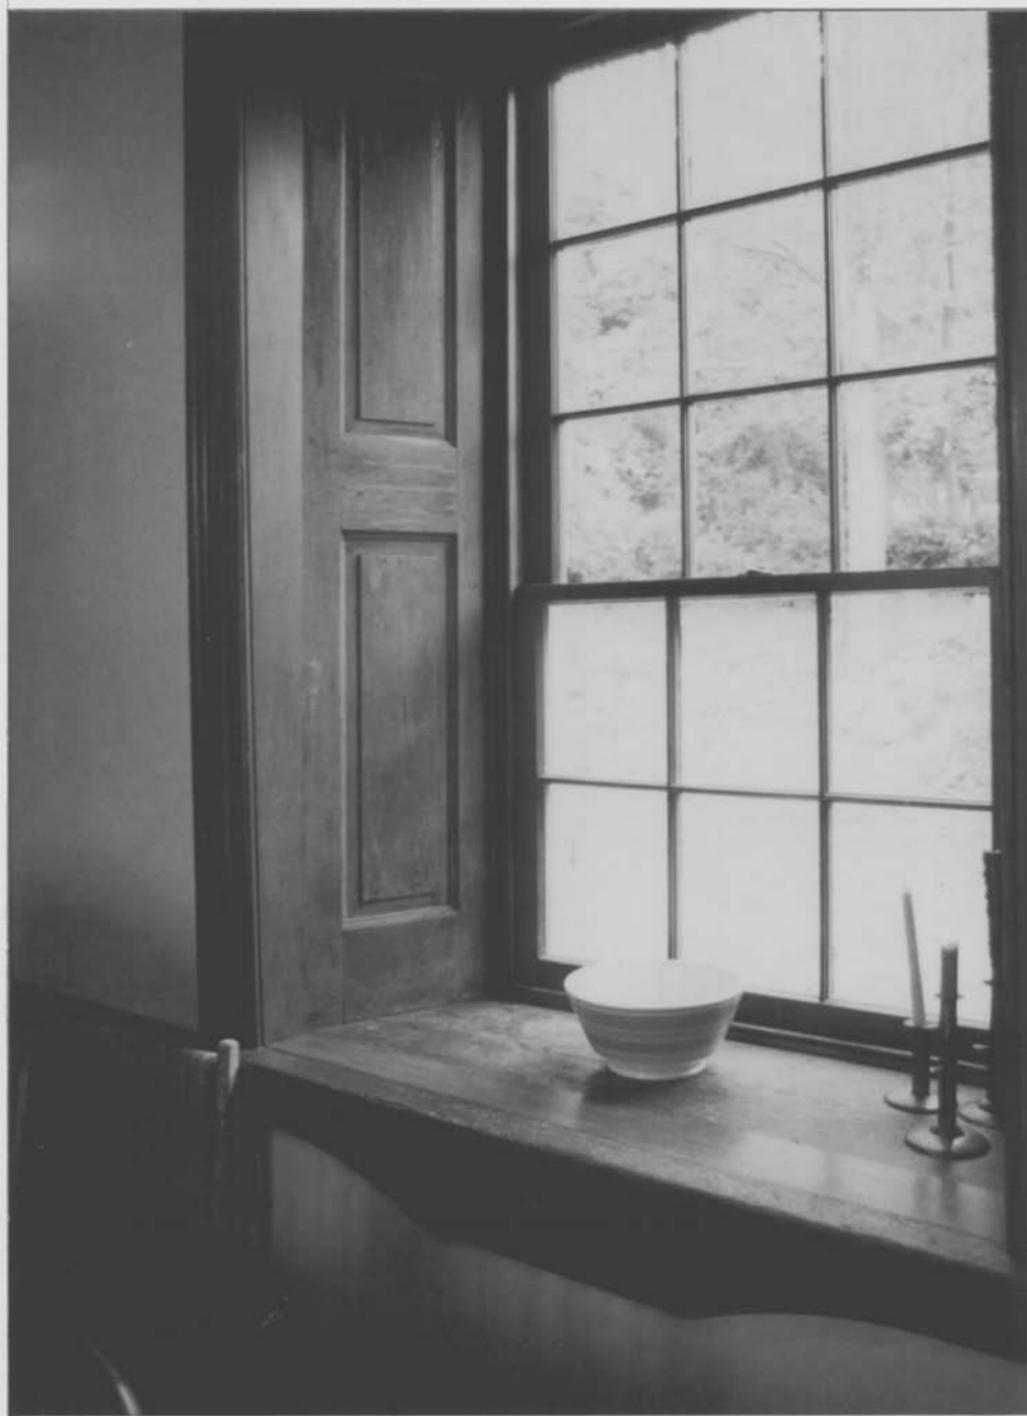
4/6

Neg. loc. is Md. State Arch. Greenmount, Md.
Window on pl. in joint and sill staver,
east quarter

south windows of the room and, with its location next to the kitchen wing, indicates that the room was without doubt used for dining, where table items and flatware were probably stored in the drawers. Mrs. Slater has determined that the grained finish on the drawers covers original slate blue paint. The drawer feature is also found in a nearby stone house of approximately the first quarter of the 19th century, the Milton Mealey house (F-5-98), and has been reported by Mrs. Slater in a third house not yet surveyed located on Lime Plant Road. The mantelpiece is a simple paneled type. The ceiling beams in this room are exposed.

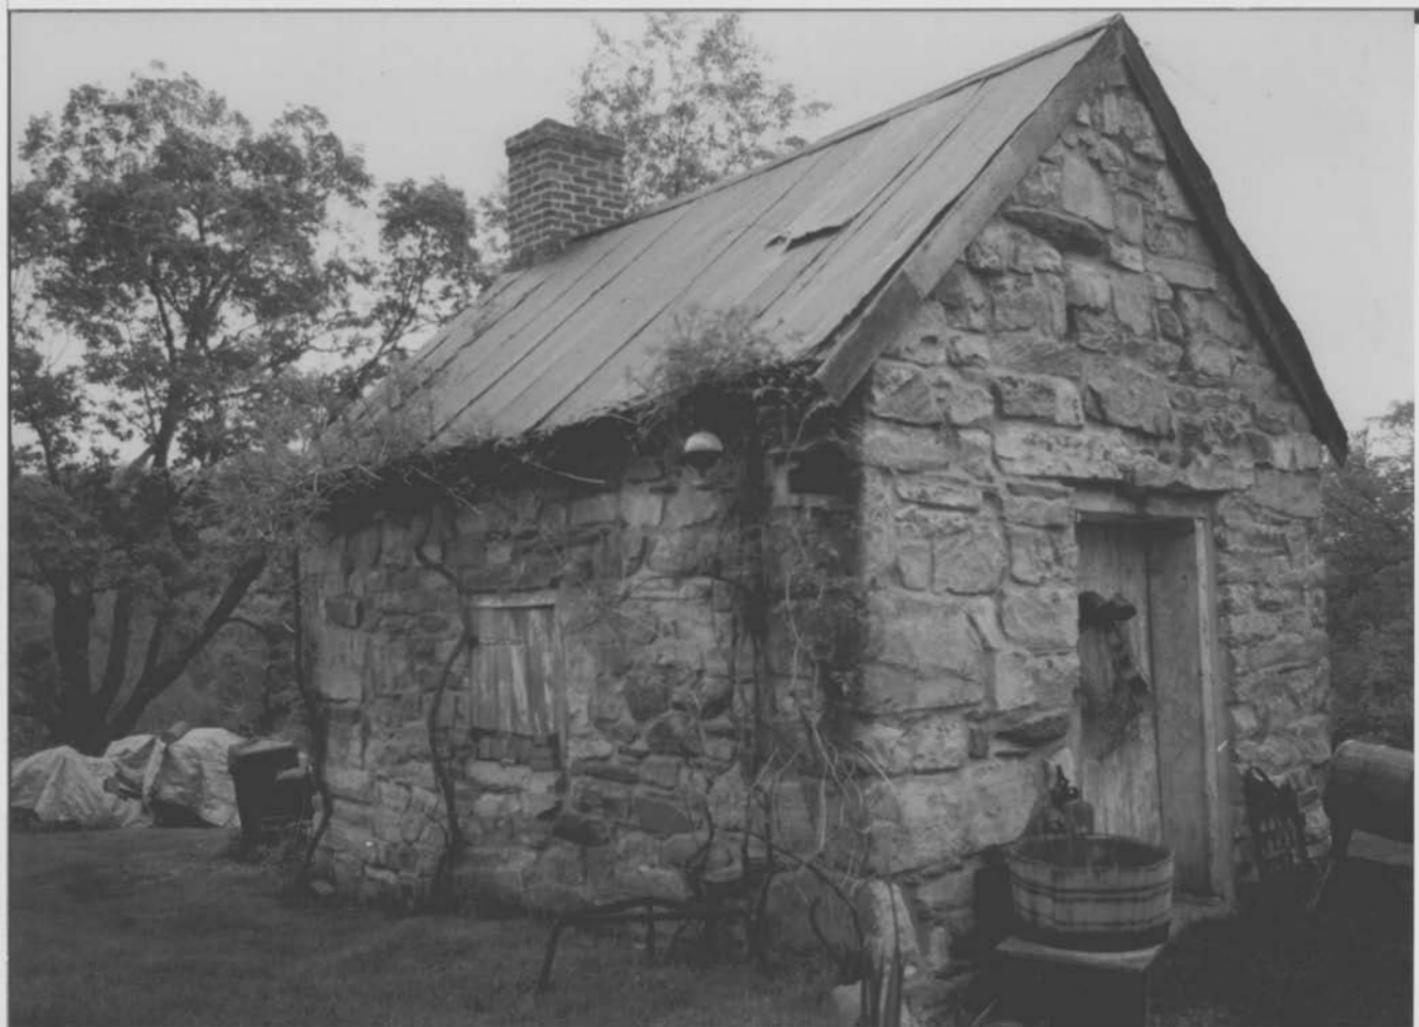
5/

Smithers, North, east side view

Smokehouse: The fieldstone smokehouse located just northeast of the dwelling was built at the same time, about 1780-1820. It is a one-story building with a corrugated metal roof and a shuttered window in both the north and south elevations. The west elevation has vents in the gable above a vertical board door with a large box lock and key.

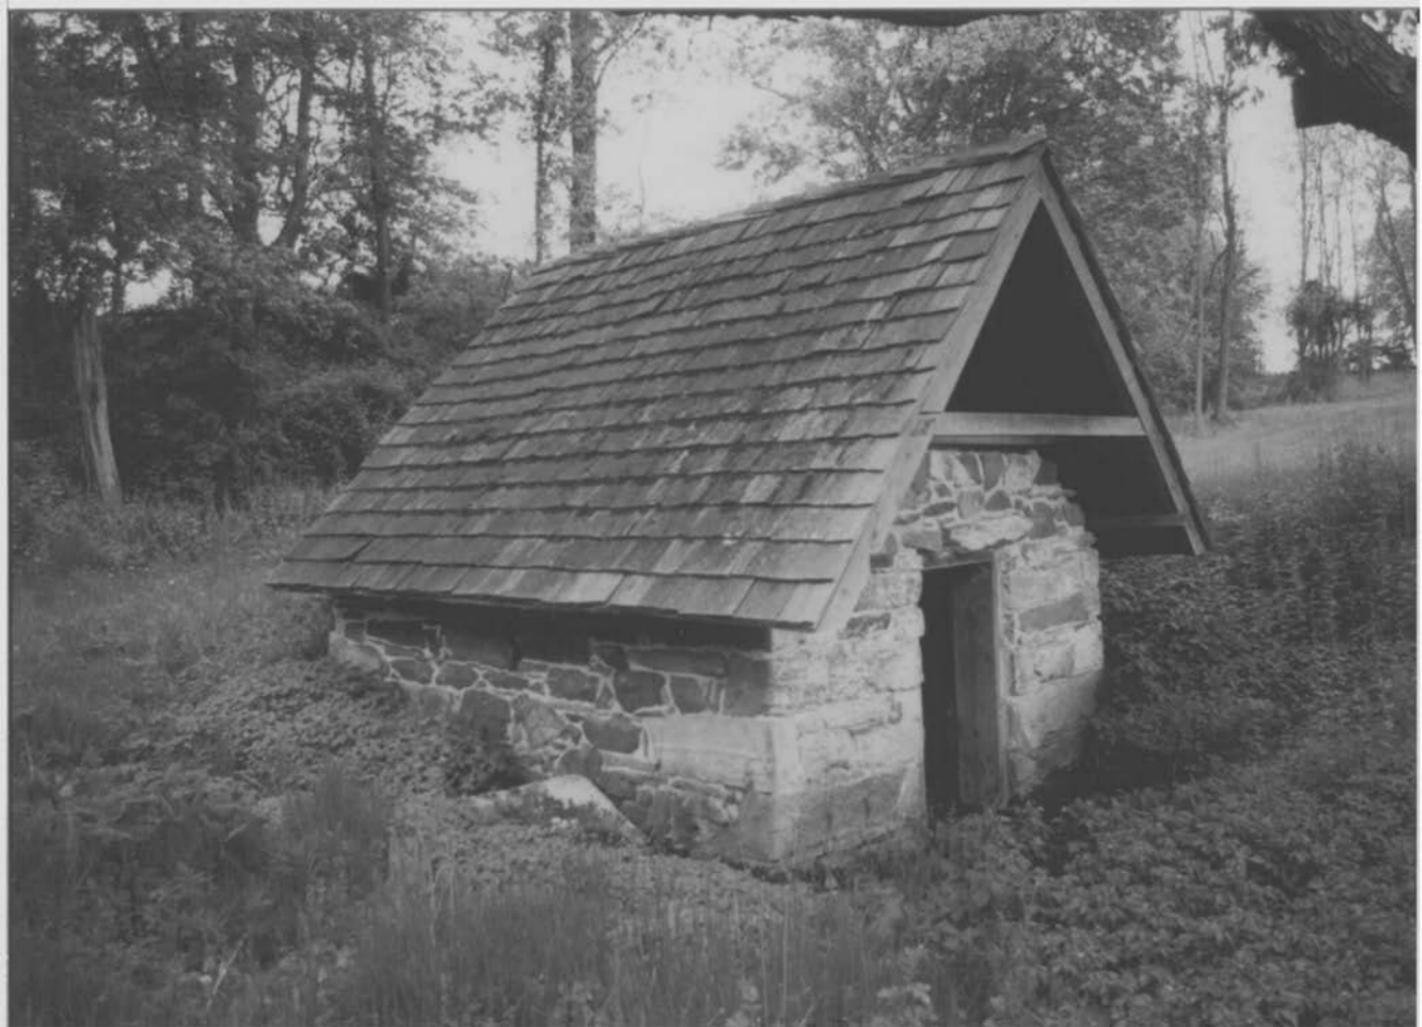
6/3

Springfield, Northwest corner of

Springhouse: Down a slope to the southeast of the house is the one-story stone springhouse which has been given an oversized replacement roof to cover the open top of the building. The door on the north gable end is missing. Small vertical openings in the south, east, and west elevations served as vent holes. The springhouse has the same random fieldstone courses as the smokehouse and the dwelling and its date is therefore in the same period of the late 18th or early 19th century.
