Jacob Harbaugh Farm

Sabillasville, Maryland

**Maryland Historical Trust
State Historic Sites Inventory Form**

Survey No. F-6-53

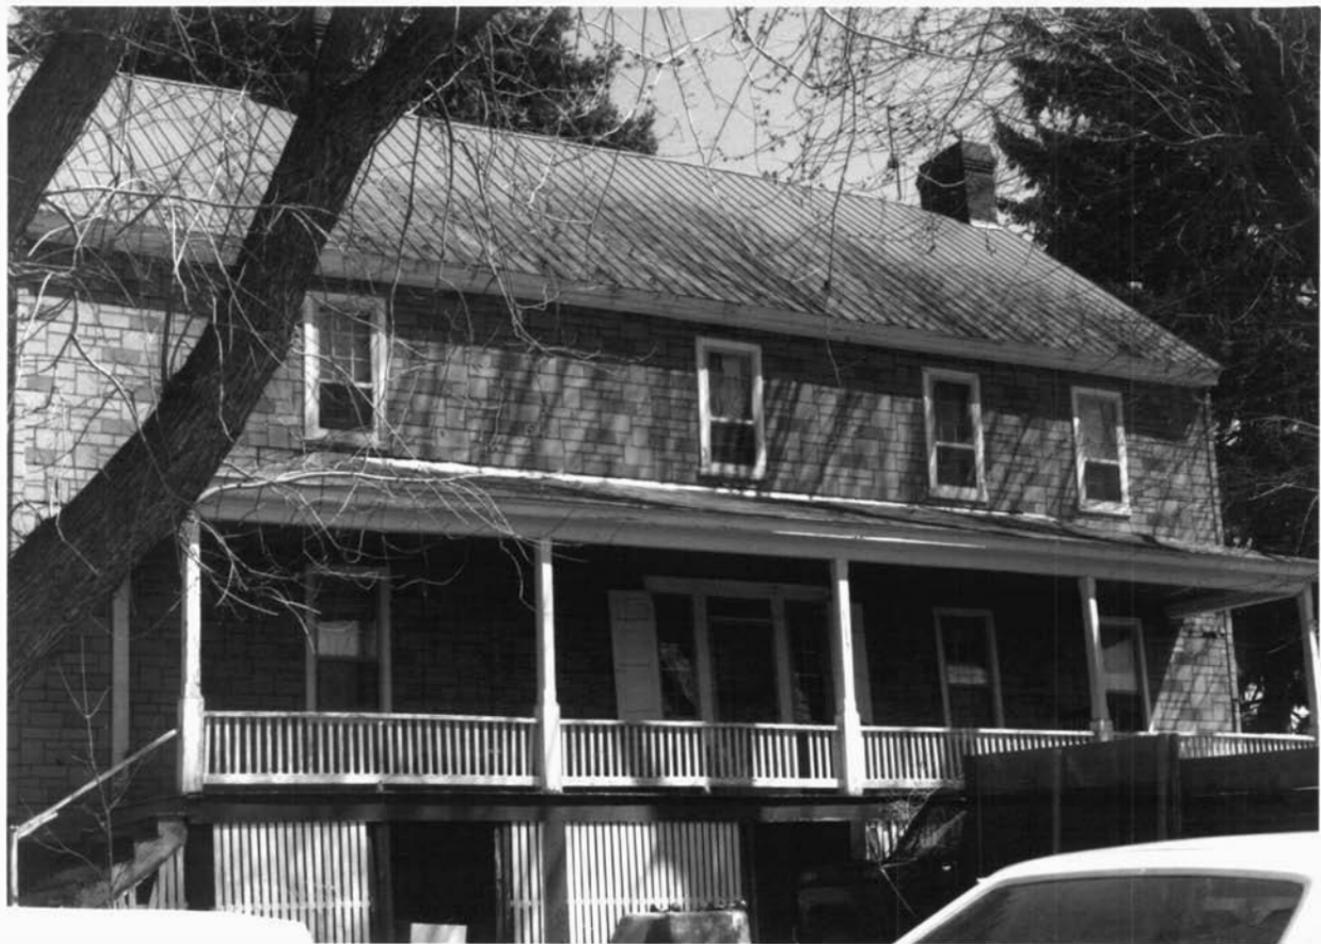
1/2

west elevation

The Jacob Harbaugh Farm (or Har-Valley Dairy Farm) contains a 2 story log and frame dwelling sheathed in asphalt shingling located on the Harbaugh Valley Road approximately 1/4 miles from Sabillasville, Maryland. The principal elevation faces west and is 4 bays wide. The property consists of 12 domestic and agricultural outbuildings that date from the farm's origins in the nineteenth century.

The house rests on a raised stone foundation that banks into a hill on the east. It contains a side gable roof of standing seam tin with two brick chimneys, one off-center and one interior end. The house was constructed in two sections: the off-center chimney marks the division. The section closest to the north is of log; the other 3 bay section is frame. The west facade consists of a center entrance with an elaborate design that includes 10 sidelights on each side, a 4 light transom and a sunburst pattern beneath the transom. Fenestration on all elevations is 9/6 light double hung sash windows with symmetrical placement. The facade has an open porch with a hipped roof and chamfered columns that covers the raised basement level and the first floor. The basement level of the porch is enclosed with widely spaced vertical boards.

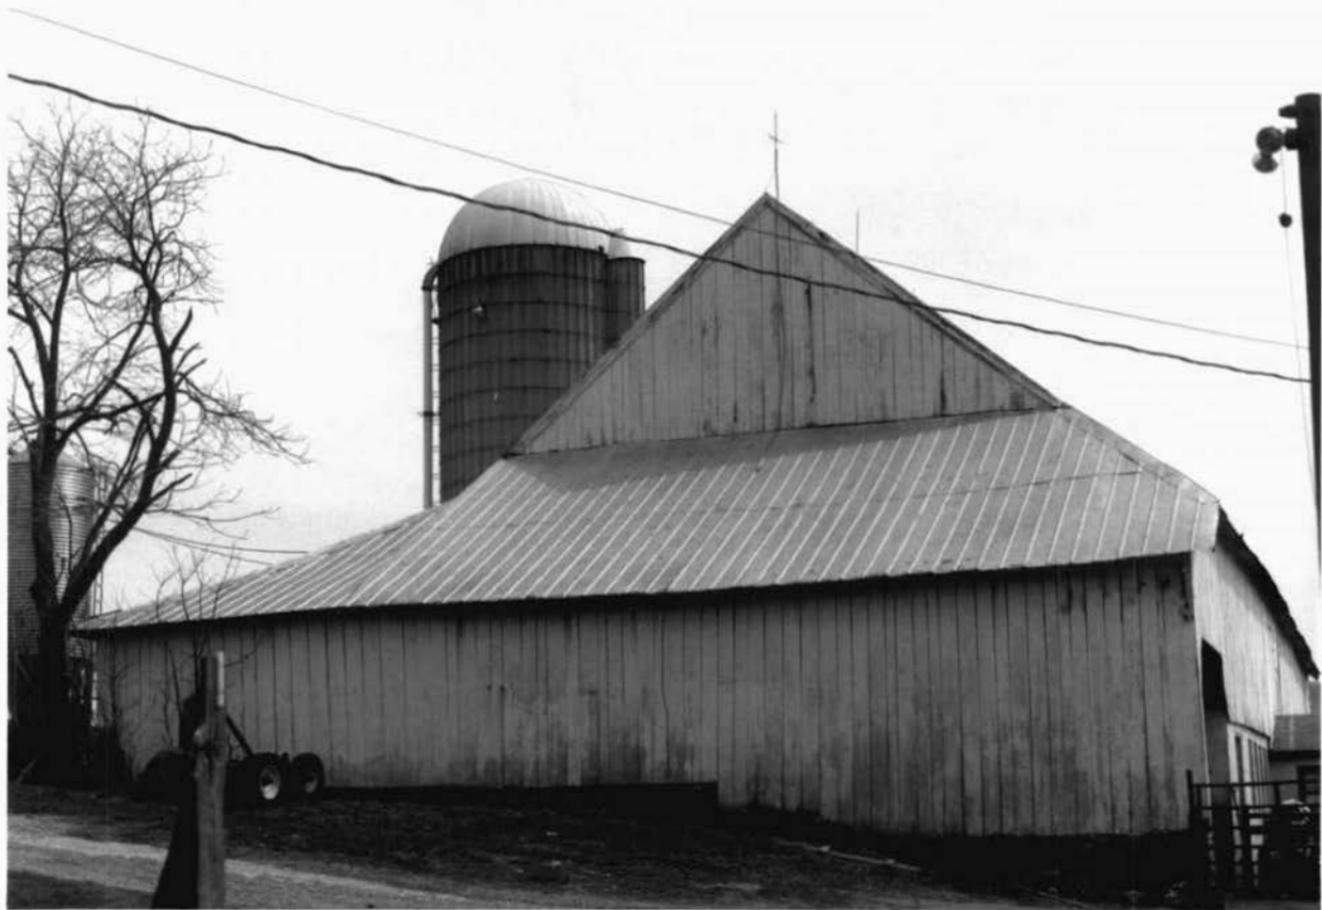
2/2

Barn + silo - looking south

Outbuildings on the property include an icehouse which is now being utilized as a feed shed, a smokehouse with tongue and groove siding and a formstone milking house which are situated close to one another several feet to the southwest of the house. Larger agricultural buildings including a bank barn converted to a dairy barn in the 1940s with an attached dairy shed, a brick, stone and frame grainery, a chicken coop replaced with cinderblock and a corncrib are located directly west of the house.
