F-6-76

Shriver-Davis Farm

Emmitsburg vicinity

**Maryland Historical Trust
State Historic Sites Inventory Form**

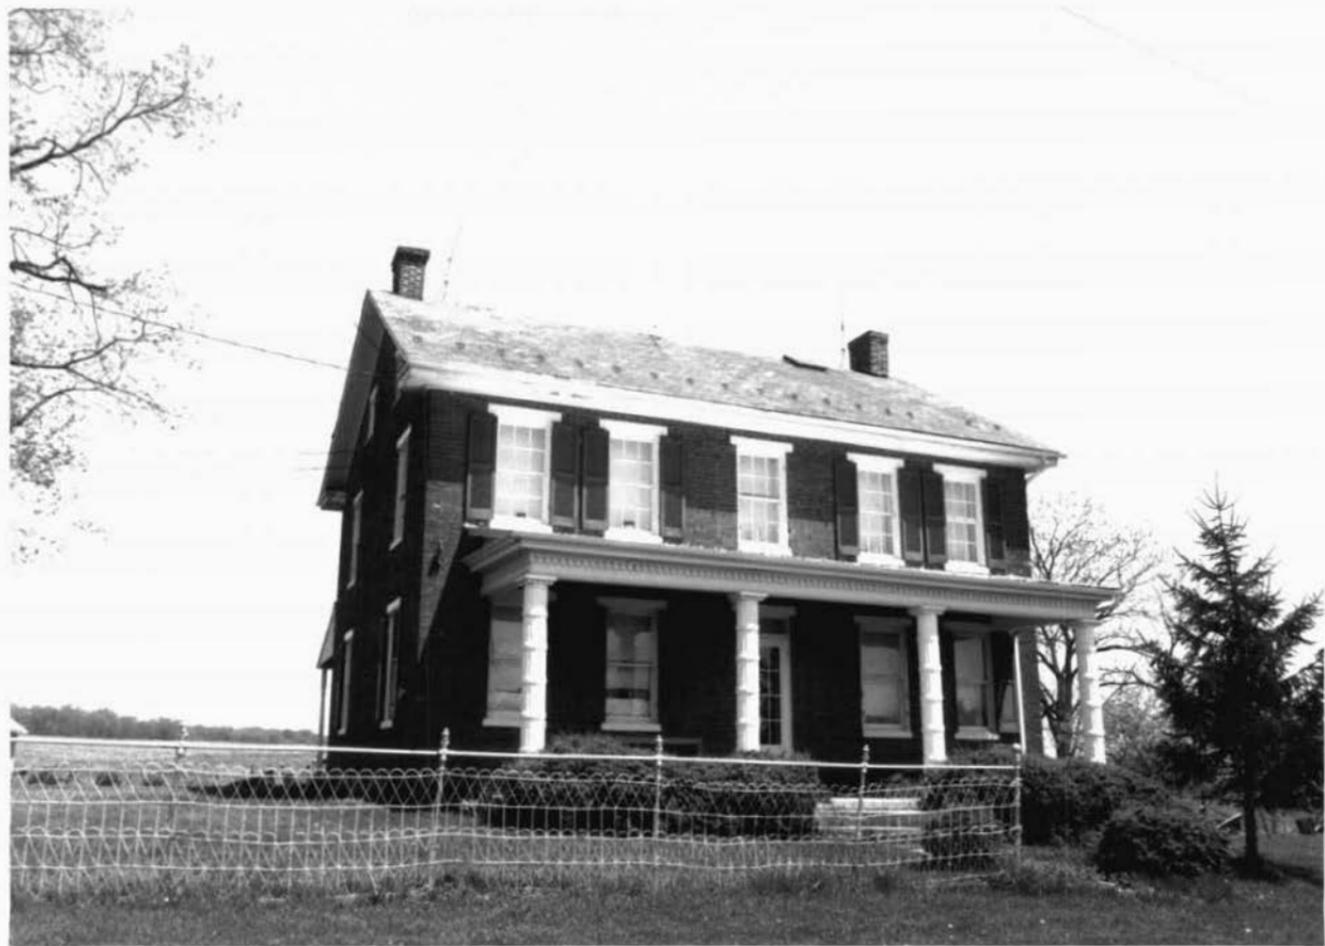
Y₄

west elevation

The main (west) facade has a center door with a transom and is flanked by 1/1 replacement windows. Windows on the second floor are 6/6. All openings have flat wooden lintels. A one story open porch runs the full facade with a dentilled cornice. There are 4 fluted columns with acanthus leaves and dentilled capitals. The east elevation is three bays wide. The first floor has an enclosed porch with a shed roof and turned columns. The second floor has three 6/6 windows.

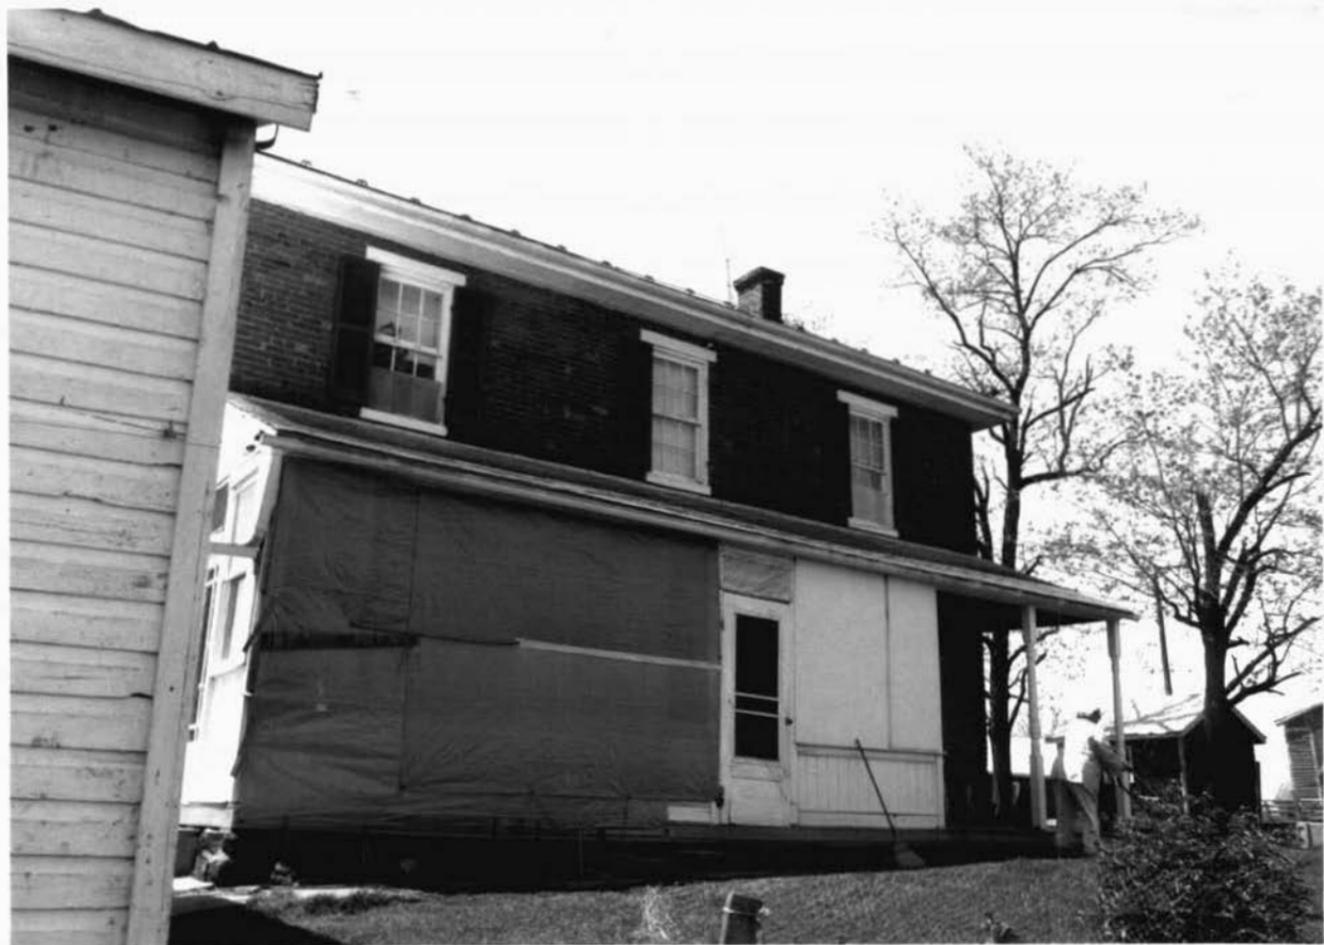
2/4

East elevation

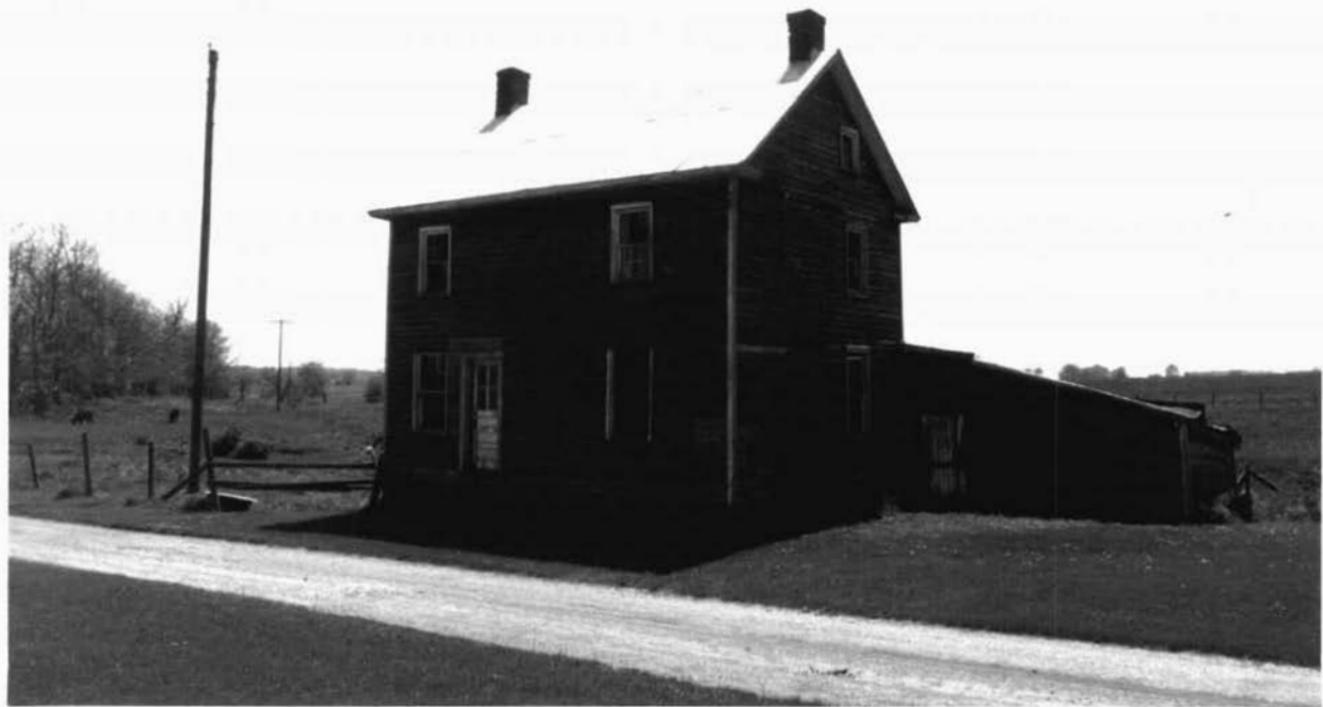
3/4

Tenant House - East Elevation

A two story frame tenant house on a stone foundation is located several yards to the west of the main house. It is sheathed in german siding and has a gable roof of standing seam tin. There are two interior end brick chimneys. Windows are 6/6 lights. The interior plan has three rooms. In the attic, there is a carved date and name: Frank Aldwell, March 18, 1887. A shed addition, german sided, extends from the west elevation of the building. The building is presently utilized for hay storage.

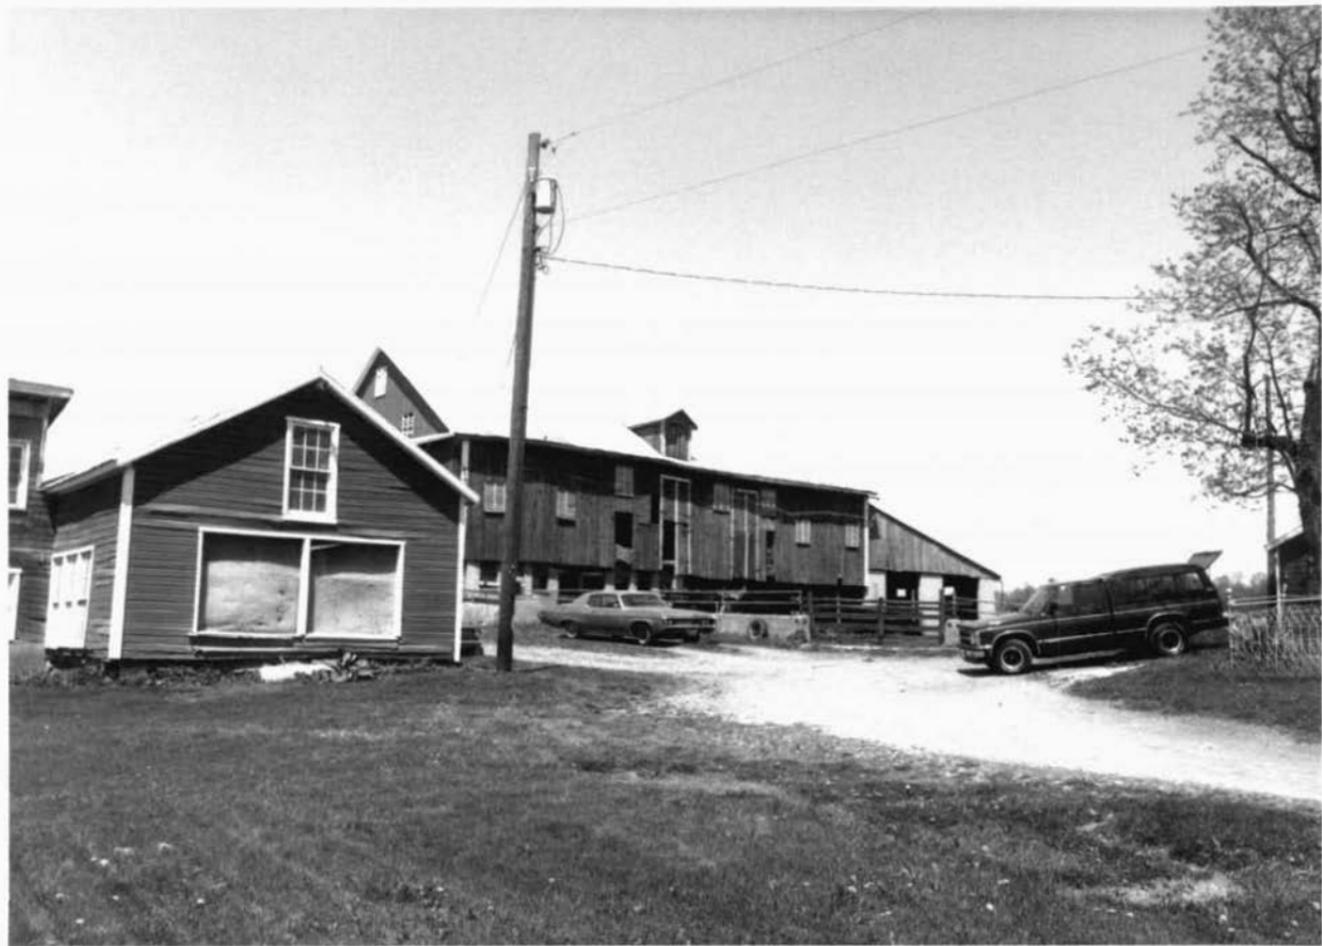
4/4

Agri-bldgs - looking north

Agricultural operations include a bank barn with a stone foundation and vertical siding. It is decorated with louvred vent windows and has a standing seam tin roof. Two shed roof additions are attached to the west and east elevations. A cinder block silo is located to the north of the barn. A large shed roofed chicken coop is sheathed in german siding. It has multiple windows on the east elevation. A garage with a gable roof of corrugated tin is also sheathed in german siding. It has 6/6 windows and a panelled door. A vertical sided shed with a corrugated tin gable roof serves as a goose house.
