**MARYLAND HISTORICAL TRUST  
NR-ELIGIBILITY REVIEW FORM**

Property Name: Bridgeport Survey District Inventory Number: F-6-89

Project: Bridgeport, Nextel Cell Tower MD-2259 Agency: FCC

**Maryland Historical Trust  
State Historic Sites Inventory Form**

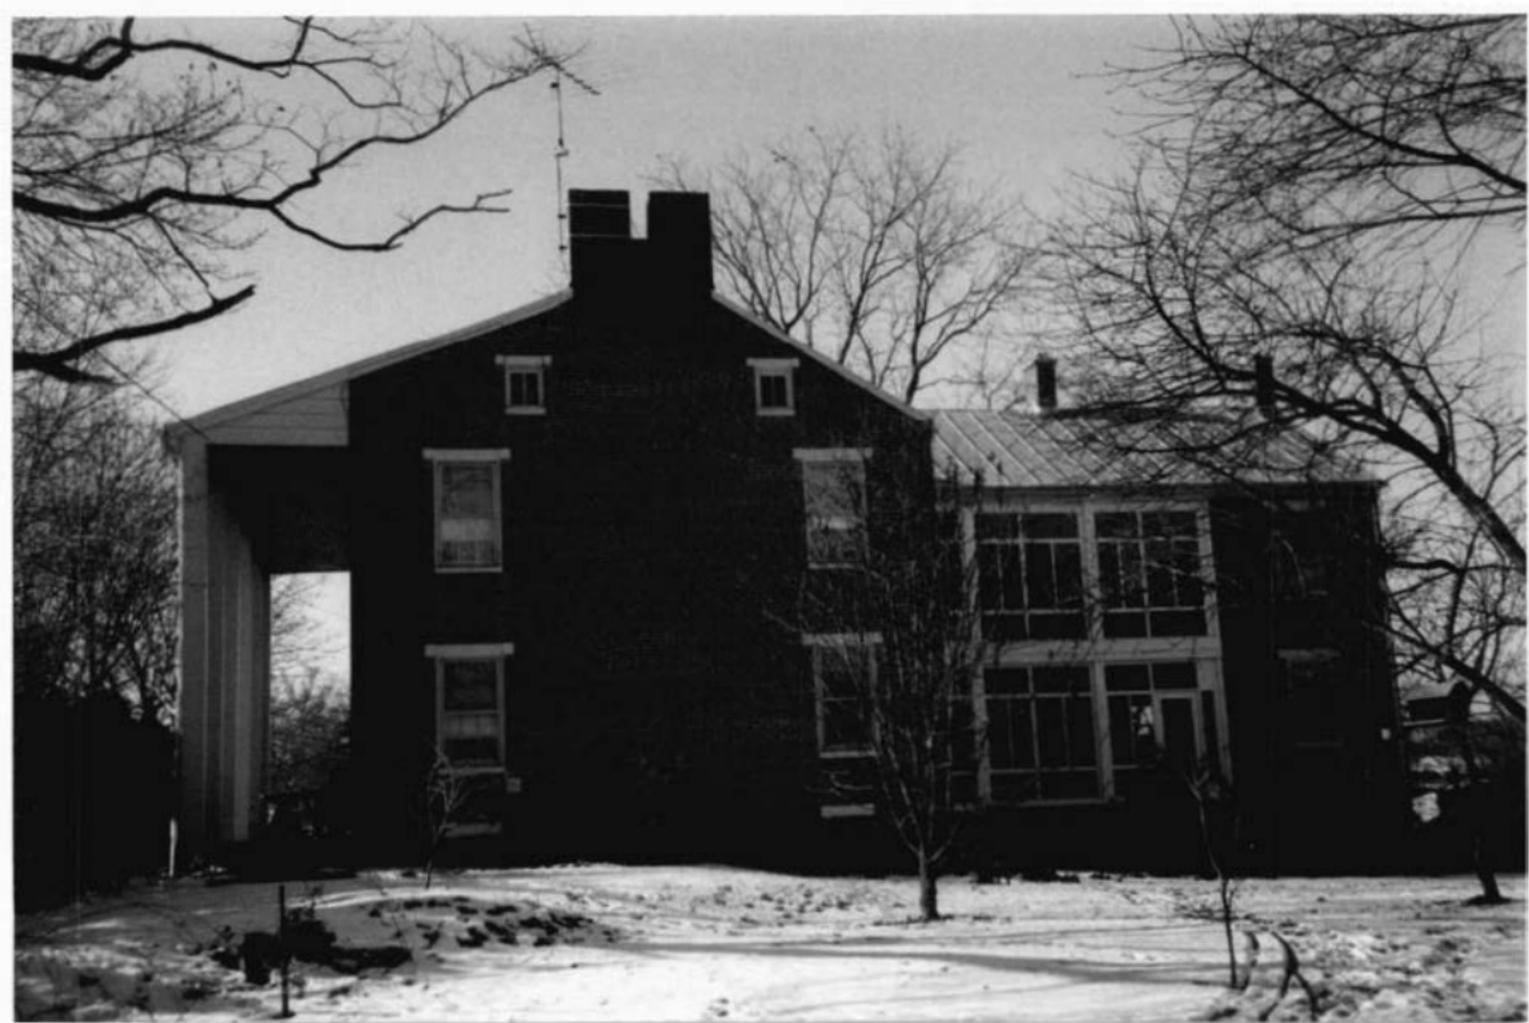
1/8

Christian Correll Tavern

(2) The Christian Correll Tavern is located at 12240 Taneytown Pike, Bridgeport, MD. It is a two-story building with common bond brickwork resting on a stone foundation and is an example of large and elaborate I-House construction. According to its owner who lives there, Mr. Makosky, the Christian Correll Tavern was constructed in 1830. The façade of the side-gable main

section faces south. It is five bays wide and two bays deep. Two-stack chimneys are flush at both gable ends. A rear two-story ell contains a three-quarter wide recessed two-deck porch. It contains two chimneys, one flush at the north gable end, and one internal midway at the peak. The rear ell is also configured five-by-two bays in area. Intended as a tavern and inn, the building's interior was divided into a number of small rooms. Later, walls between some of the rooms were torn out. Other developments mitigate against recommending placing the tavern on the National Register of Historic Places. The main façade has six square columns that replace the original full width two-deck open porch. Likewise, the open two-deck porch on the rear ell also has been compromised. It is currently contained behind a modern enclosure of wood frame and glass.

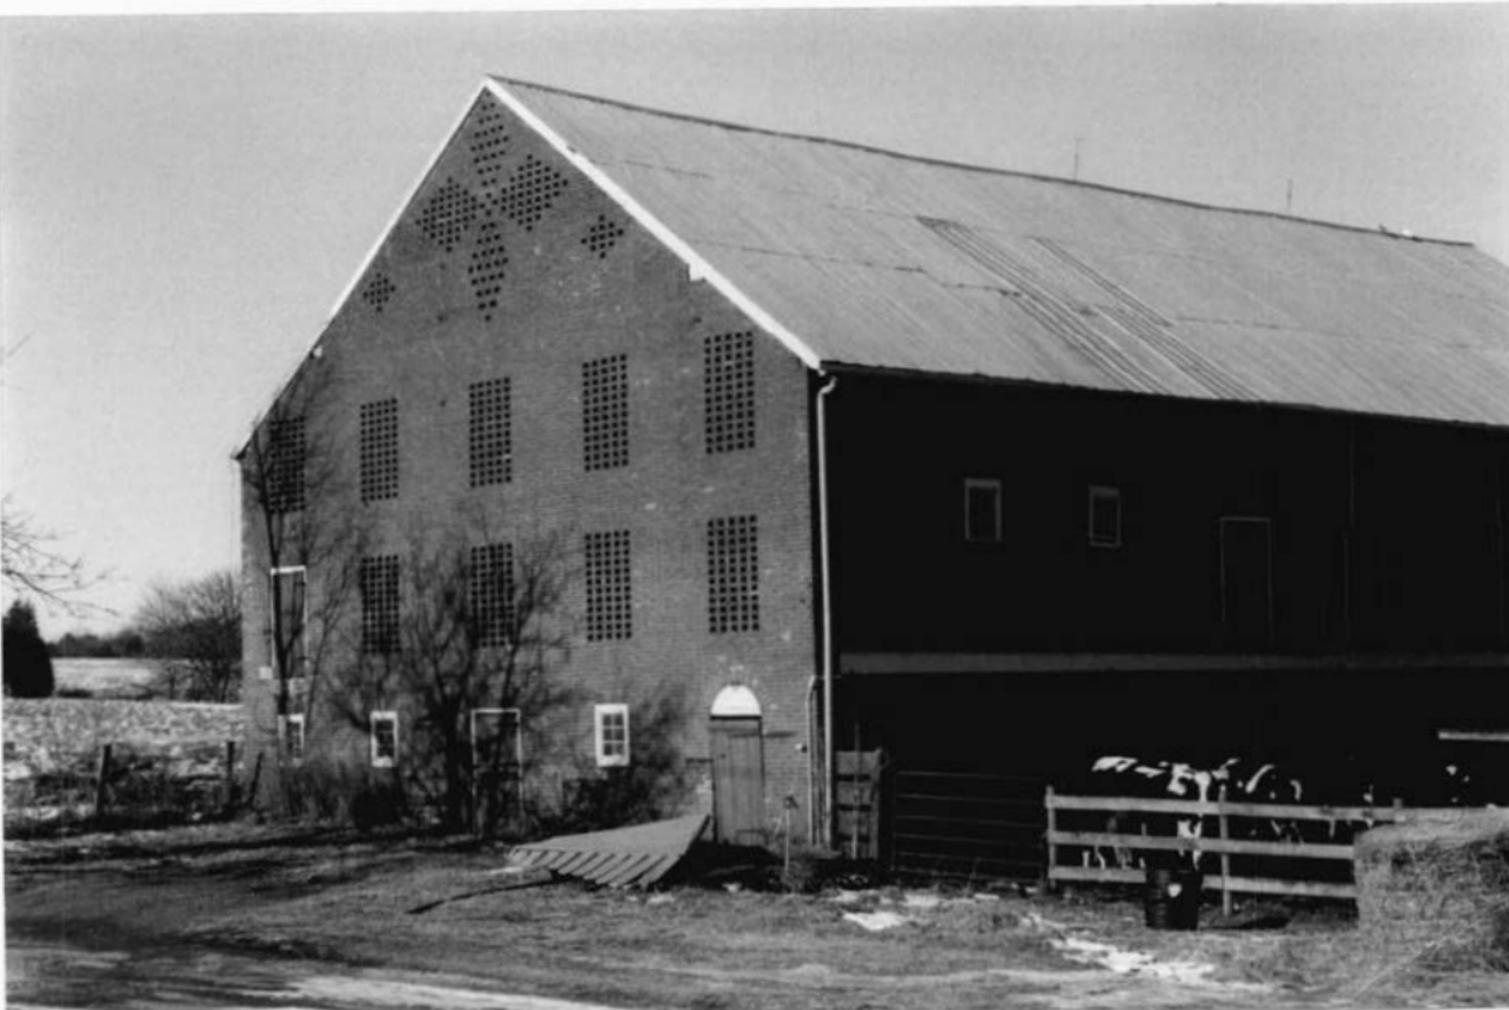
2/0

Christian Correll Barn

The Christian Correll Brick Bank Barn is located to the west of the tavern. This brick-end bank barn rests on a stone foundation. The gable roof of corrugated tin runs north to south. The banked elevation is on the west. The east elevation has a weatherboarded jetty overhang. On the ground level, stall openings are placed between brick piers. The south gable end, facing the road, is the most decorative facade. It has Flemish bond brickwork and

patterned ventilation. There is "unfolding lily" pattern and two diamonds beneath the gable peak and square ventilators in the center. Windows have jack arches; one door has a rounded arch.

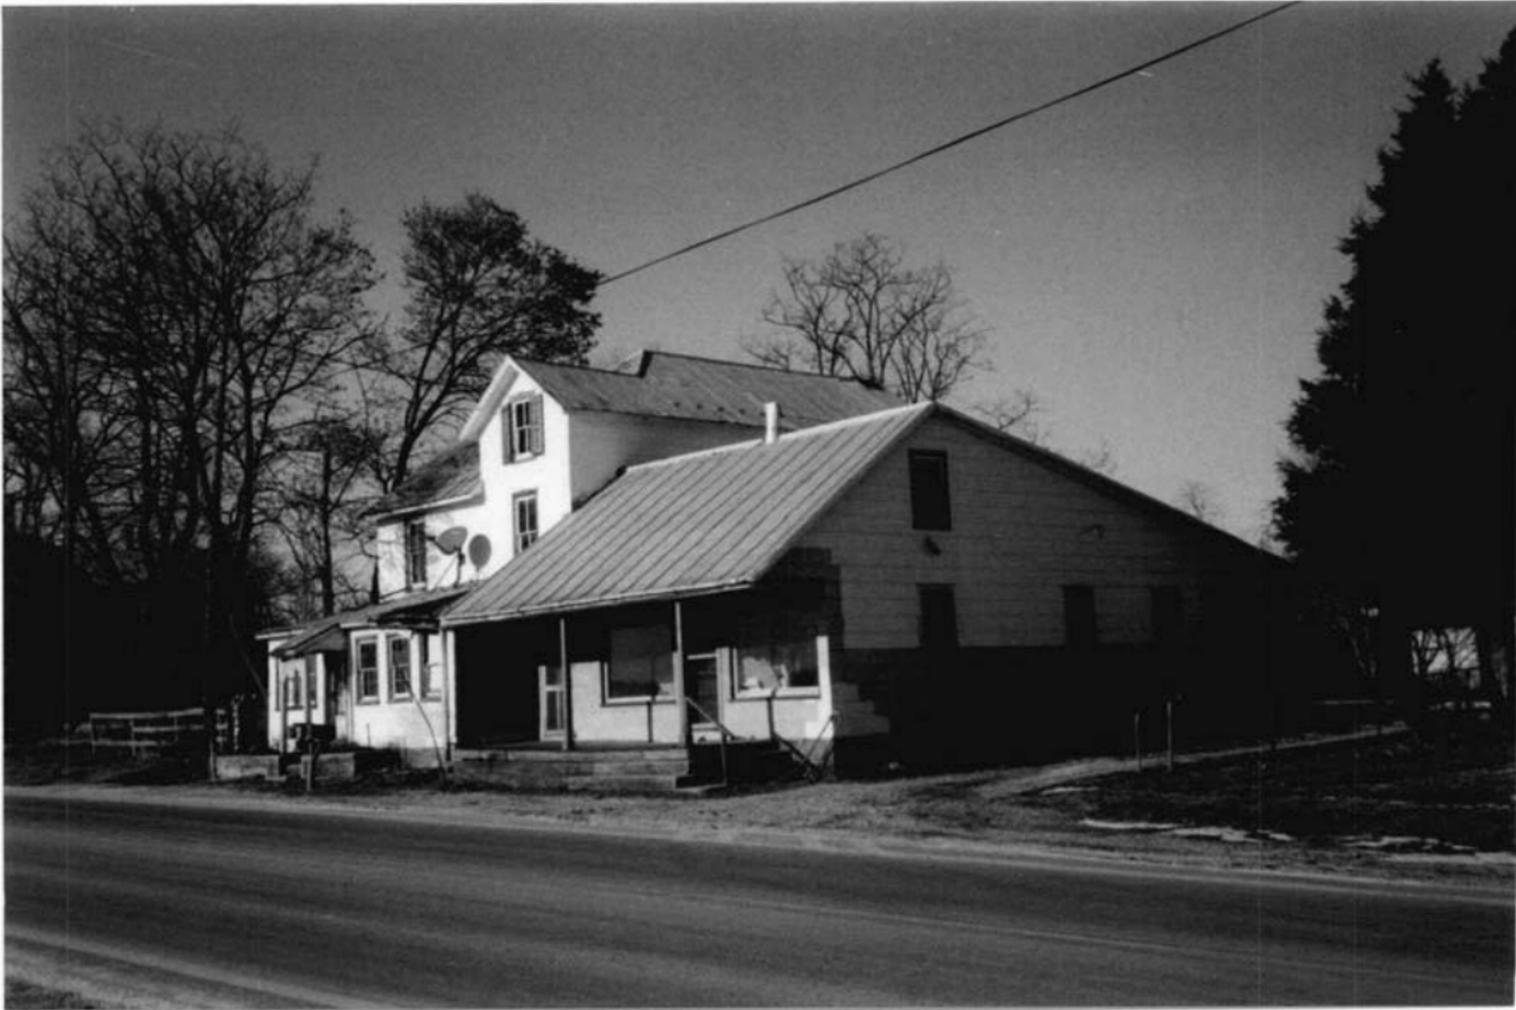
3/8

Post office and General  
Store

(3) The Post Office and General Store is located at 12306 Taneytown Pike, Bridgeport, MD. It is a commercial and residential building constructed in multiple stages. There are two attached main buildings and one addition. The oldest block is two stories high with a chimney at the west gable end. It appears to have been built approximately in the mid-nineteenth century. According to Mr. Makosky, owner of the adjoining property containing the Christian Correll Tavern and Bank Barn, the old section is constructed from logs. The gable-sided building faces south. The building appears to be three bays wide and two bays deep. An enclosed porch with a half-hip roof spans the full-width of the south elevation. A rear ell extends on the north side. It is two-by-two bays in configuration. A one-story addition with a cinder block chimney extends from the rear ell northward. Built approximately during the mid-nineteenth century, this vernacular frame has Greek Revival details seen in its pedimented windows and the cross-gabled section one bay wide extending from the roof and raising the south façade, like a huge dormer, suggesting a third floor. The older block is clad in asbestos shingles. The second block is attached to the east elevation of the oldest block. Its main façade faces south. This one-and-one-half-story is two bays wide and one bay deep with a saltbox extension. This portion of the building probably contained the post office and general store, although these facilities originally may have served the public from the old section as indicated in an 1873 map that depicts them in this location. A number of elements found in this structural composition mitigate against recommending it for inclusion in the National Register of Historic Places: the original block is clad in asbestos shingles, as is the enclosed porch; the gable-end chimney in the rear extension has been removed; a one-story addition erected during this century extends from the rear ell; there currently is a satellite antenna on the porch; and the saltbox building attached to the east elevation was constructed approximately 100 years after the original old section.

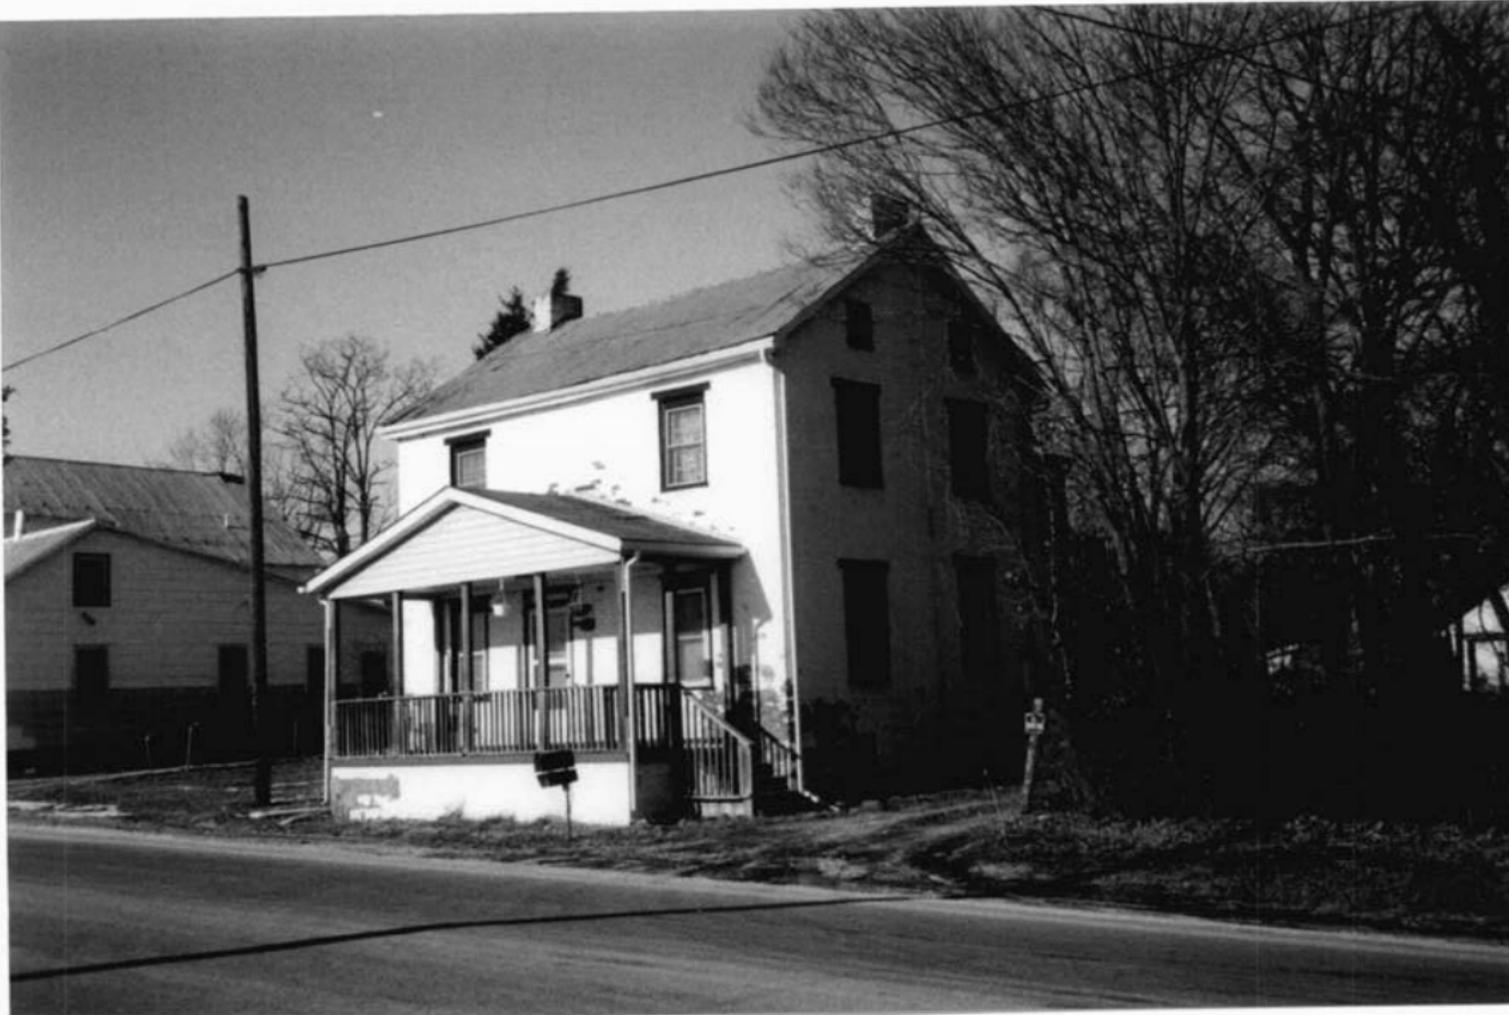
4/8

Blacksmith shop

(1) The Blacksmith Shop is located at 12310 Taneytown Pike, Bridgeport, MD. It is an I-House built in the mid-nineteenth century. The building with running bond brickwork rests on a stone foundation. There are chimneys at each gable end. A modern gable-roofed open porch spans three-quarters of the main façade. The building consists of a two-story main block with a two-story rear ell as well as two one-story additions on the rear elevation. The main block is a modest I-House three bays wide and two bays deep. The brick walls are painted white. One of the rear additions is constructed in concrete and the other is covered in aluminum. It is conceivable that the blacksmith shop was located in the aluminum-clad addition. Elements that compromise its integrity and render this structure ineligible for the National Register of Historic Places are: the addition of a modern porch on the front façade; the replacement of a window with sliding doors in the rear addition; and the addition of a one-story concrete extension on the rear.

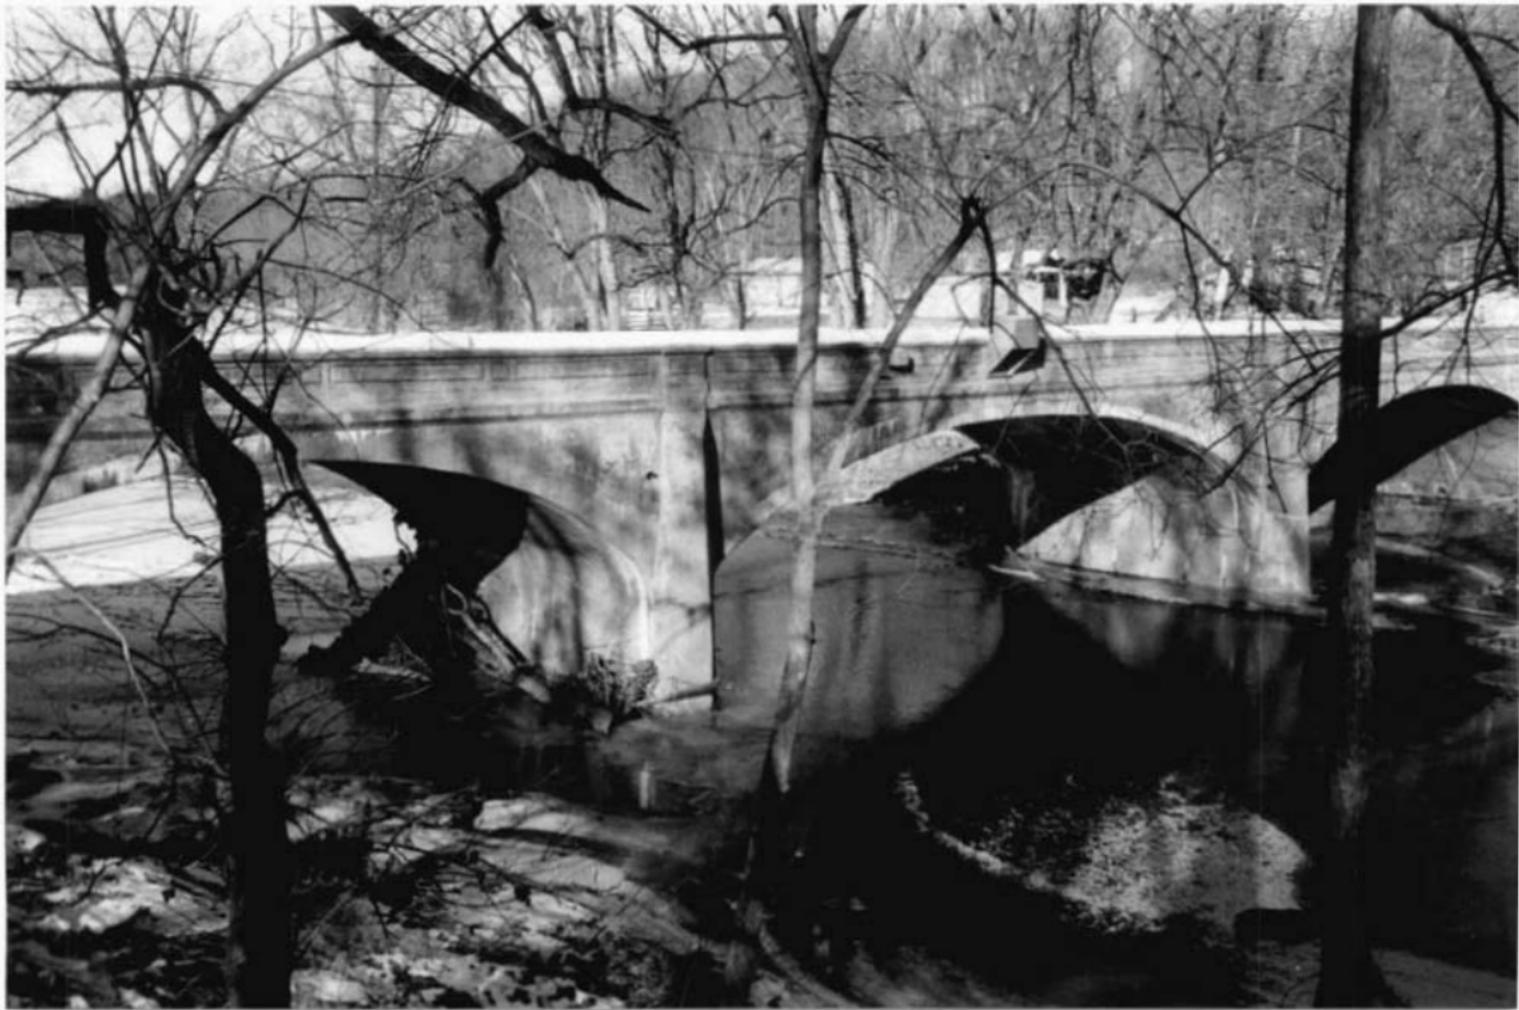
5/E

Bridge no. 100685 over  
Monacacy R. on Tavertown  
Pike

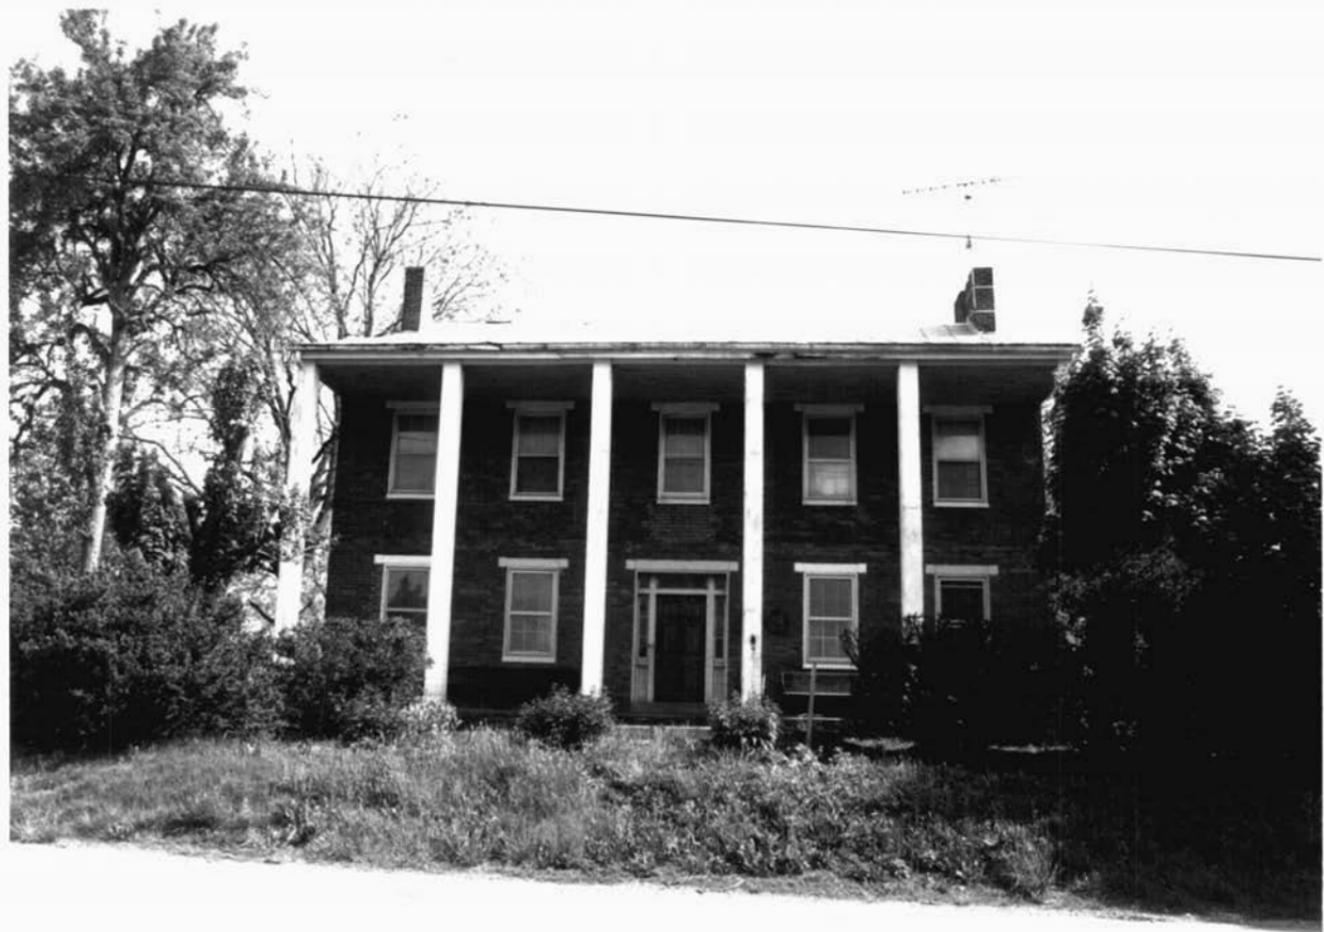
2/6

Salin elevation

The main (south) elevation has a 5 bay facade with a center entrance. The door opening has corner block lintels, sidelights and a transom. Windows are 6/6 with corner block lintels. A "southern colonial style" open porch is full facade width and full height. The porch has a stone foundation and a brick floor. The north elevation is covered by the rear ell except for one bay which has a 4/1 window on the first floor and a 6/6 window on the second floor. A door to the cellar is in the foundation level. There are random glazed headers in the brickwork. The west gable end has two widely spaced bays. Symmetrically placed windows are 6/6 lights with corner block lintels and soldier course lintels. Two attic windows are 4 light fixed with corner block lintels. The east gable end has the same openings as the west but also is decorated with random glazed headers.

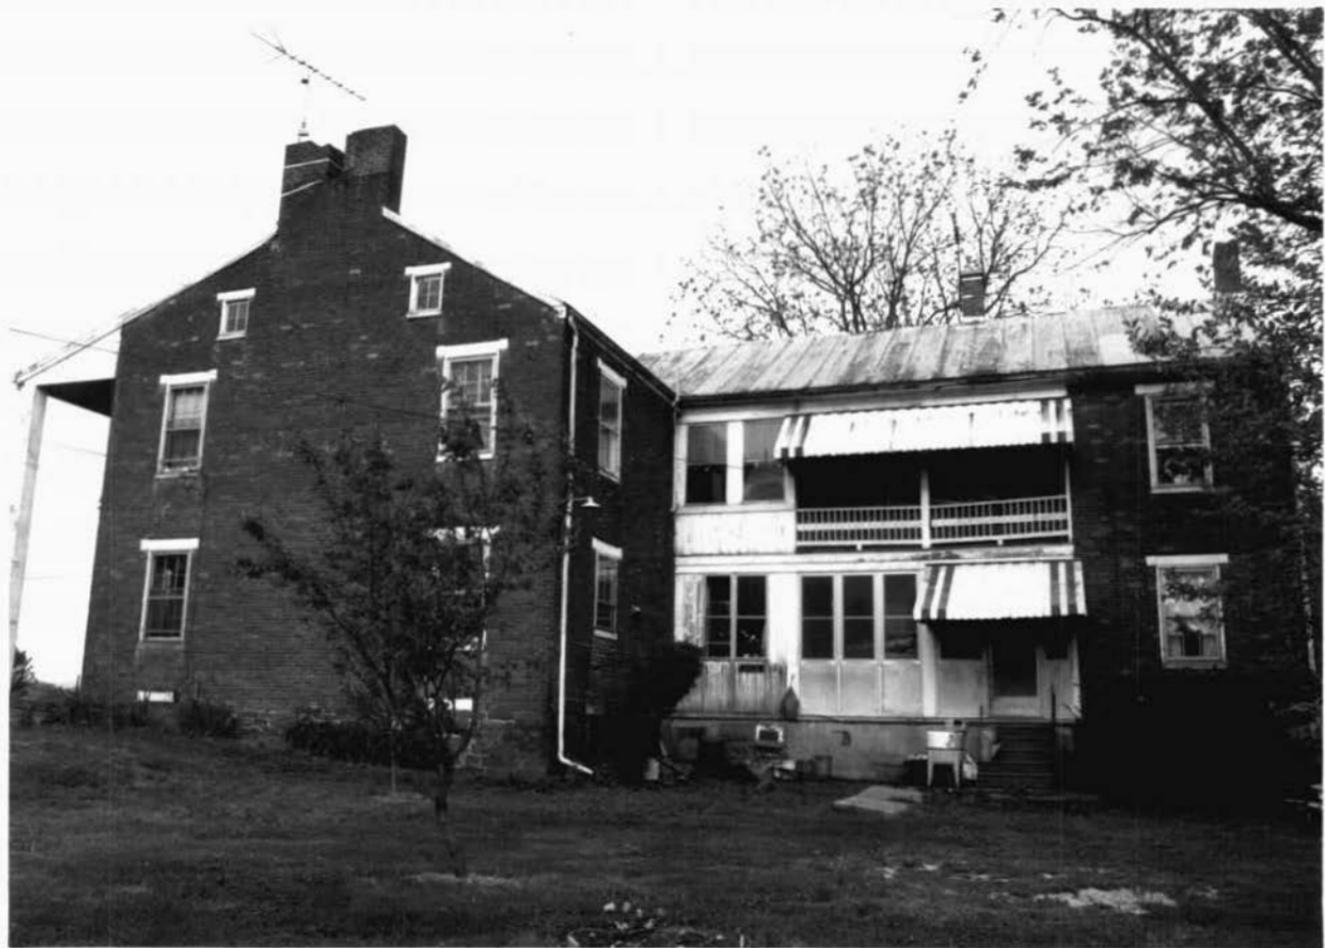
3/6

East elevation

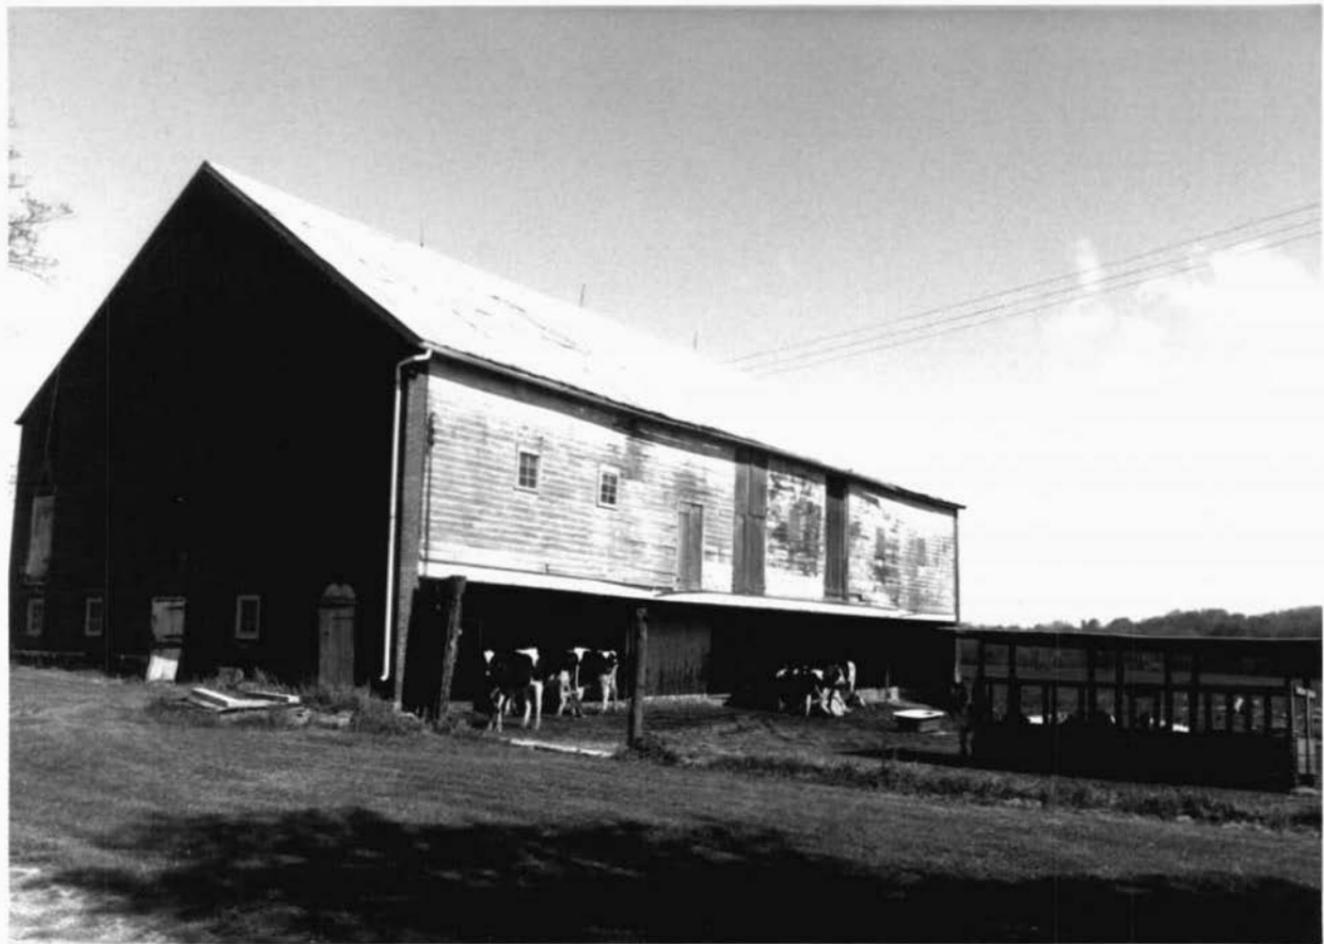
Bank Barn - southeast corner view

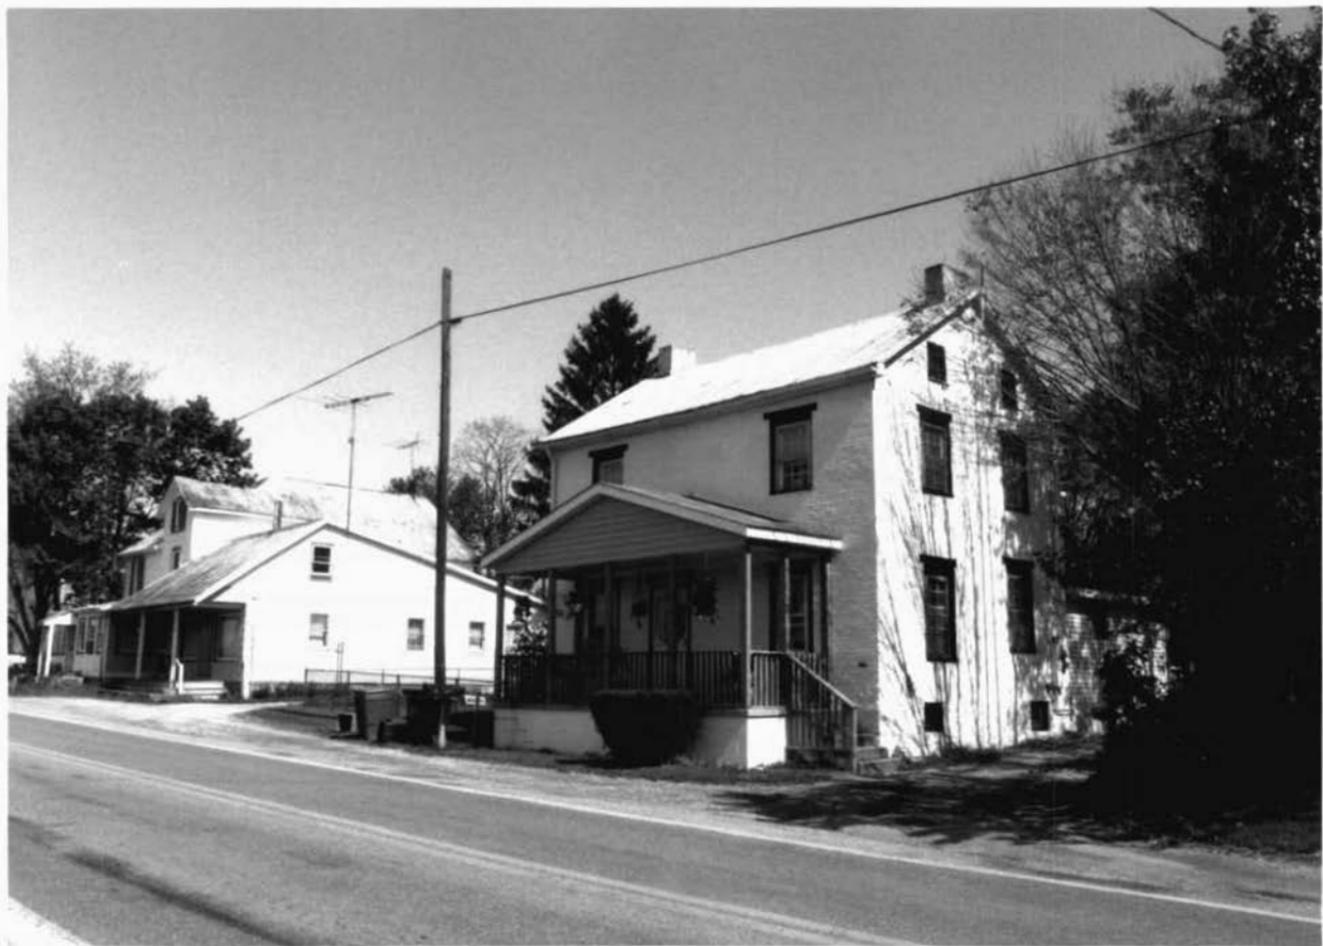
Soth elevation

The main (south) elevation has three asymmetrical openings on the first floor with two 6/6 windows and an off-center door. The second floor has two 6/6 windows with flat wood lintels. A new front gable roofed porch covers the facade. The east and west gable ends have 6/6 windows and two 4 light fixed attic windows.
