INVENTORY FORM FOR STATE HISTORIC SITES SURVEY

HISTORIC Brandenburg Store and House
 AND/OR COMMON

STREET & NUMBER 12529 Fingerboard Road (MD 80)
South Side of Route 80 6th E D 9
 CITY, TOWN _____ CONGRESSIONAL DISTRICT
 _____ VICINITY OF Kempton Frederick
 STATE _____ COUNTY
M 98 P102

Survey No. F-7-41

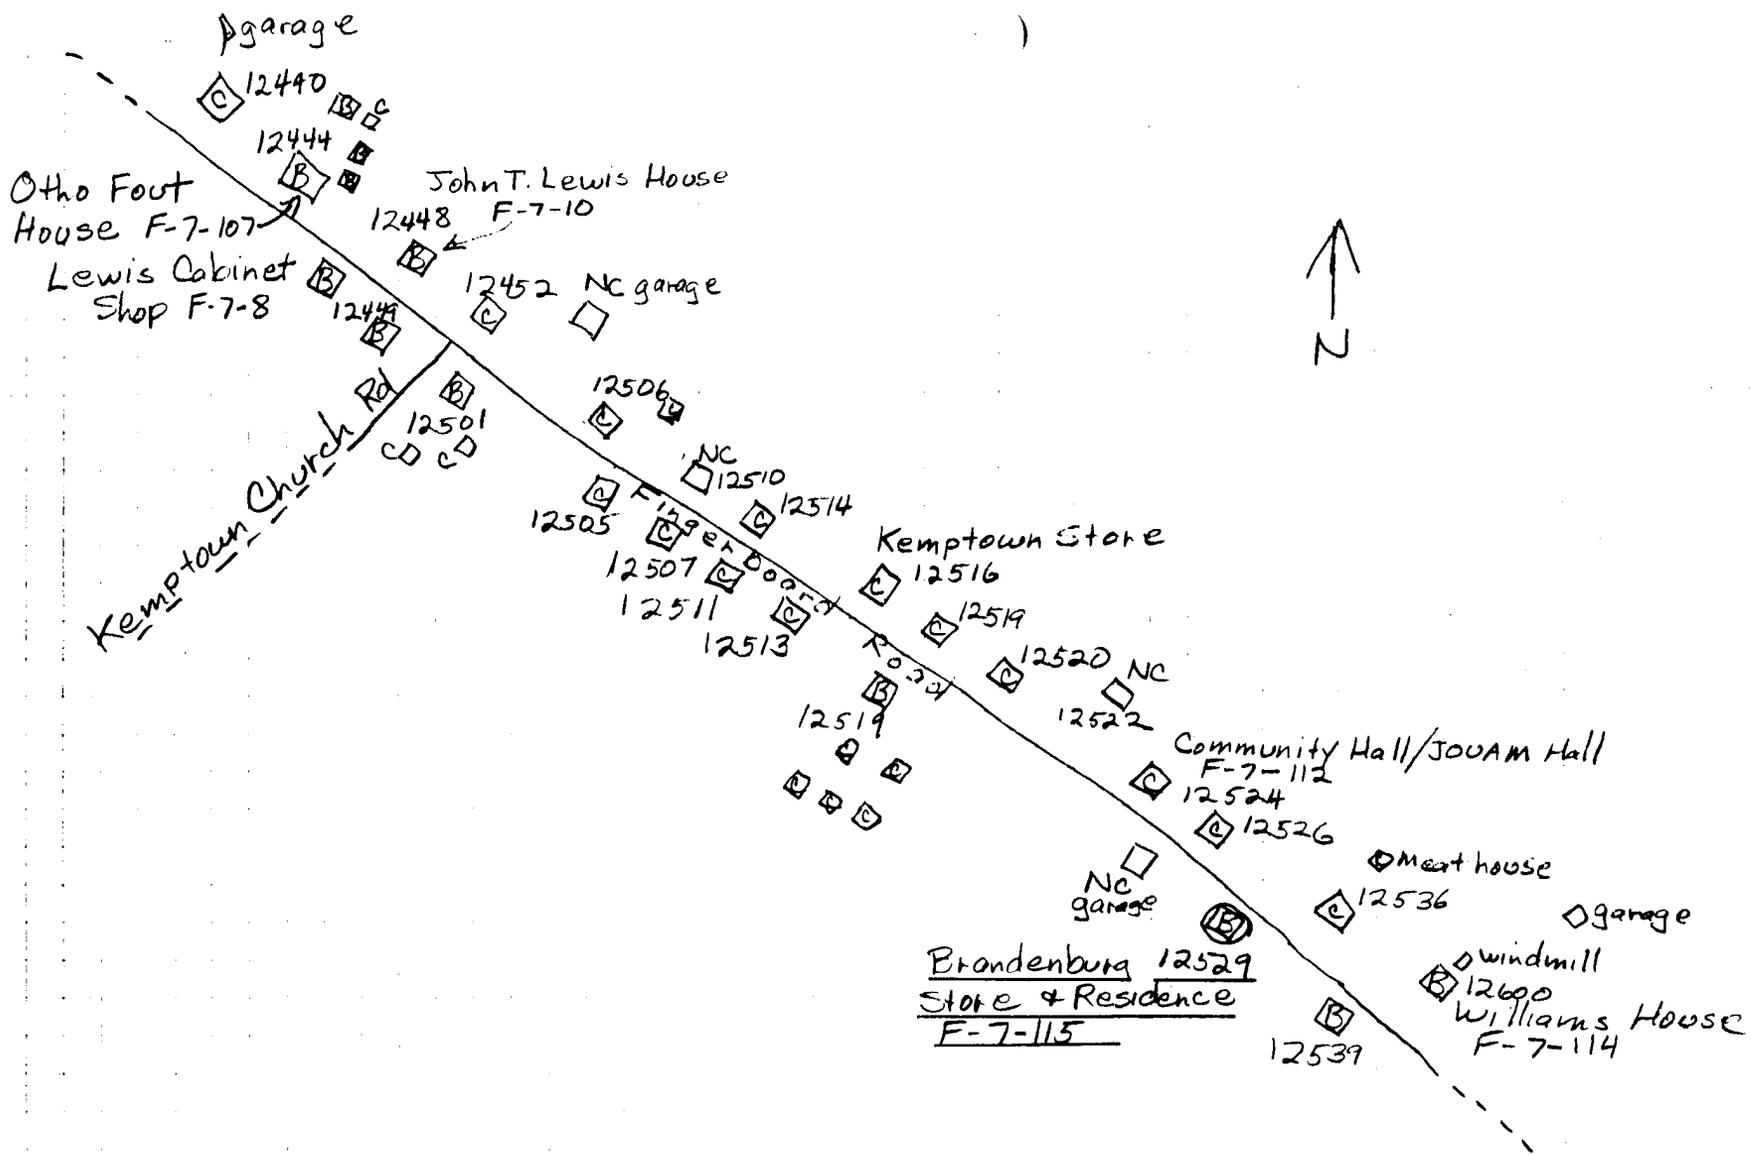
Brandenburg Store and Residence
 F-7-115

F-7-41
 Kemptown Survey District
 Frederick County

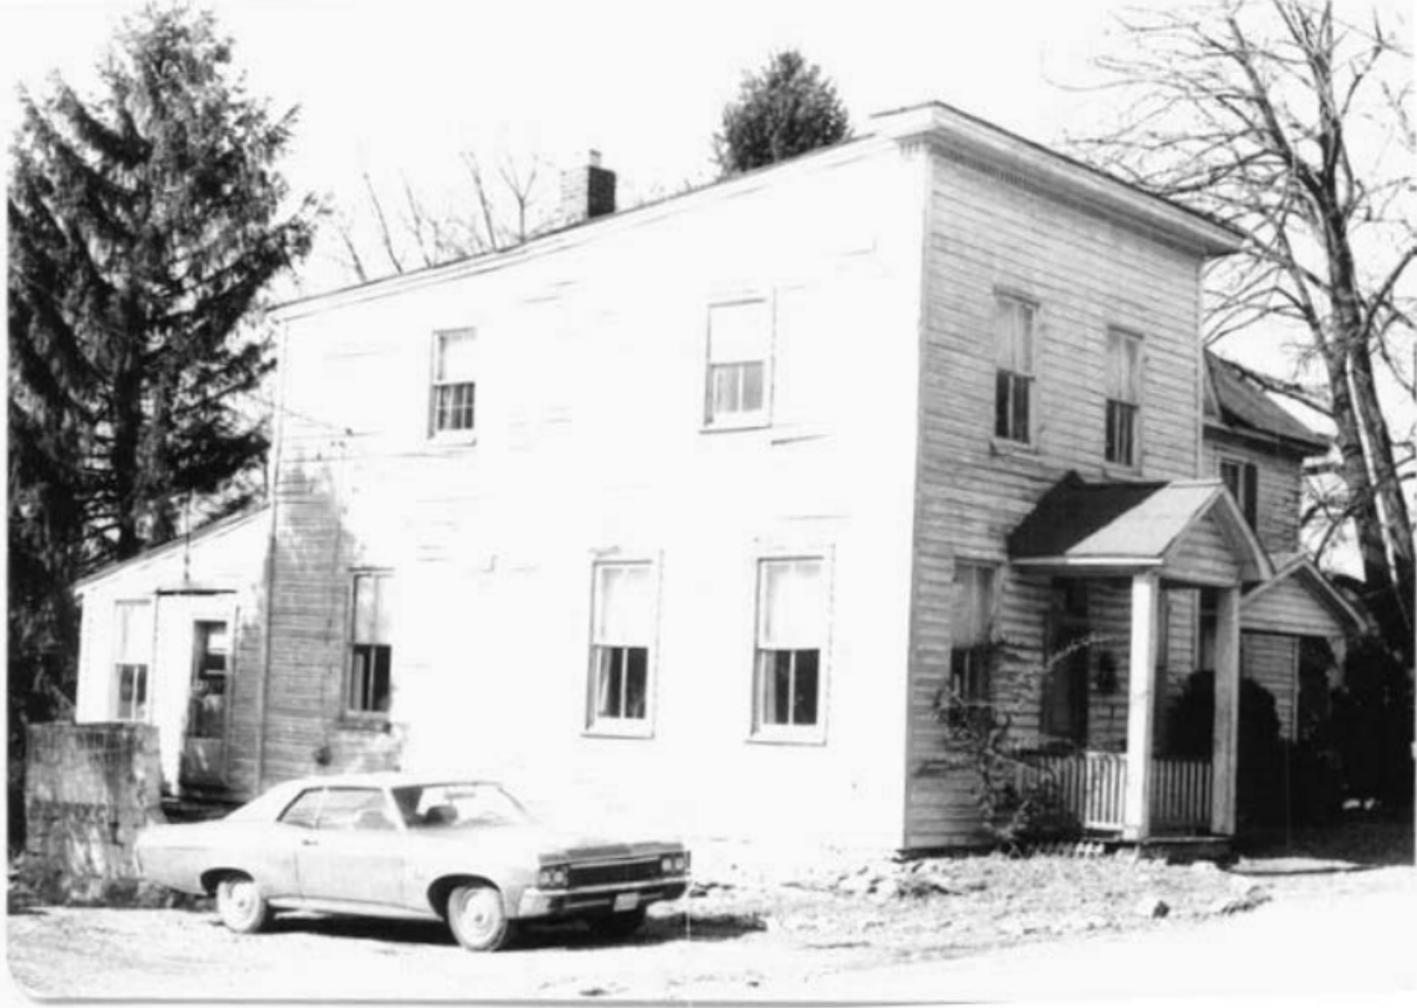
NE VIEW

The store, located to the northeast side of the house, is a two story shed roofed frame building, which is related to the Brandenburg House. The building is three bays wide, a modern door with entrance porch and railing is located in the second bay. Double hung 2/2 windows with plain trim occupy the first and third bays on the first level and both bays on the second level. The tin roof is completed with a plain cornice except on the north side of the building where the cornice is boxed with a decorative frieze. Three 2/2 windows with plain trim occupy the first level on the east side, two identical windows are located on the second level. A frame shed addition two bays wide and deep is located to the rear of the store on the south side. One 2/2 window with plain trim is located on the first and second level on the west side of the store. The building is constructed on a low random stone foundation. One replaced brick chimney is located to the center rear of the store.

BRANDENBURG STORE AND HOUSE

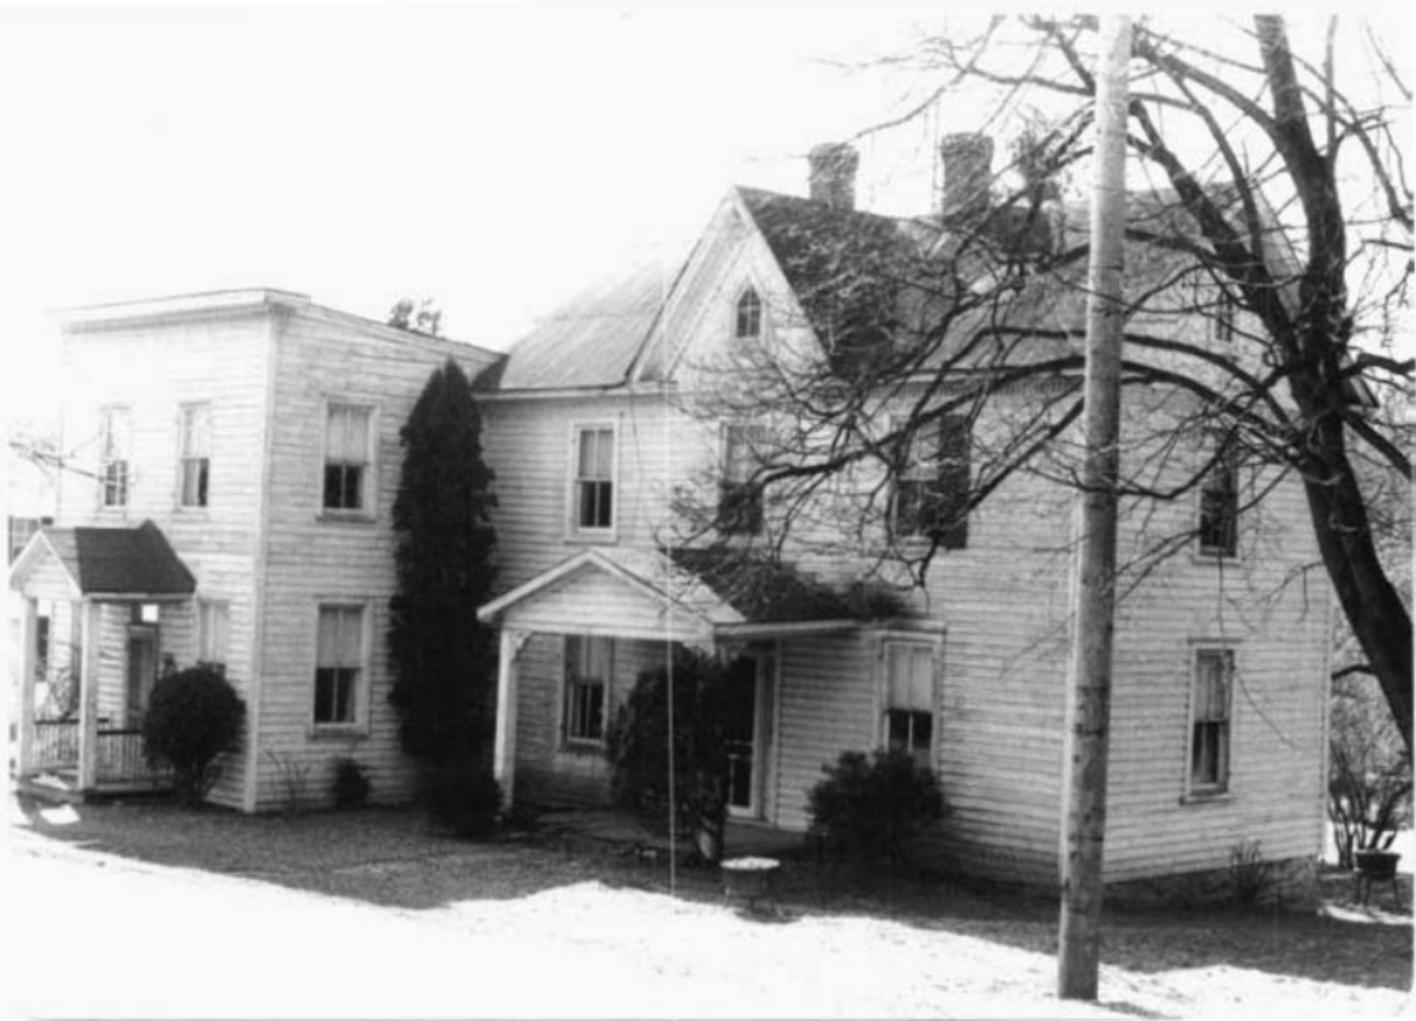
NW VIEW

The principle facade is three bays wide. The main entrance, a four panel door with screen door is located in the second bay. A wide pedimented entrance porch situated between the first and third bays extends from the front of the building. Two 2/2 windows with plain trim are located in the first and third bays. Shutters, probably louvered and similar to the one remaining example on the second level were once attached to the windows but are now missing. Three 2/2 windows occupy the second level; one louvered shutter remains on the window in the third bay.

BRANDENBURG STORE AND HOUSE.

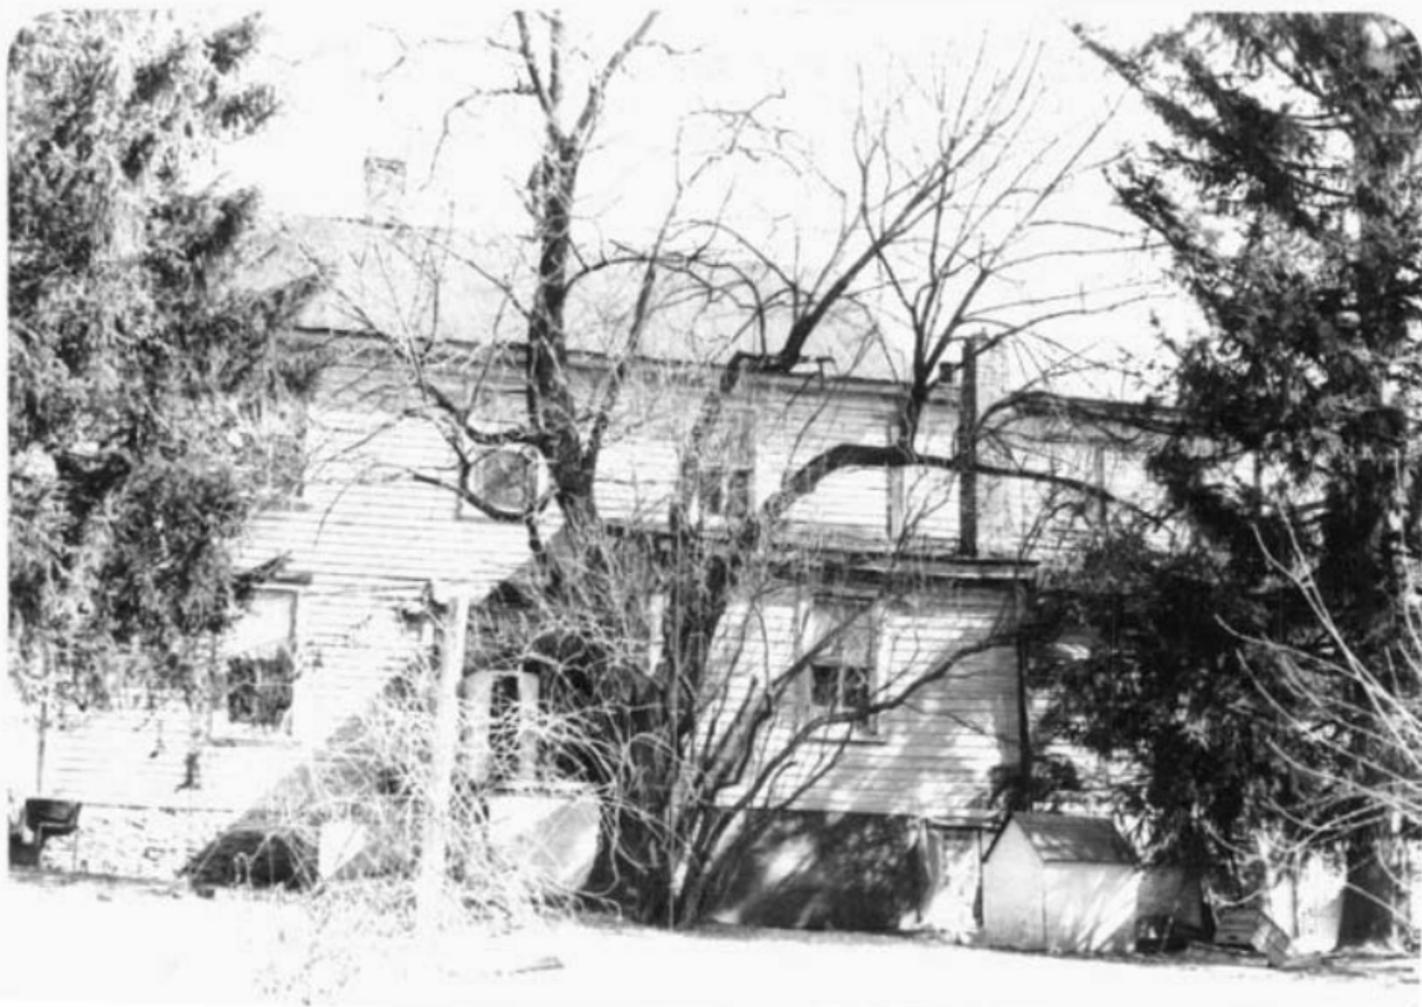
South VIEW

A small triangular window is located in the center gable. The replaced tin roof is finished with a boxed cornice with return and denticulated frieze. Two corbeled brick chimneys are located on either side of the center gable. A 2/2 window is located on each level of the west side. A small triangular window is located in the center of the side gable. Alternate rows of shingle siding with staggered butts are located in the top of each gable on the house. The southside of the building is three bays wide; two 2/2 windows with plain trim occupy the first and second bays from the southwest corner and an original frame shed addition extends from the rear. A 2/2 window is located on the south side of this addition and a modern cinder block porch juts out from the west side. A six foot brick chimney rises from the southeast corner. The house is built on a low random stone foundation and is in a fair state of repair. A large open yard lies to the south side of the building.

BRANDENBURG STORE AND HOUSE
