F-8-66

St. John's Reformed Church

Woodsboro, Maryland

# Maryland Historical Trust State Historic Sites Inventory Form

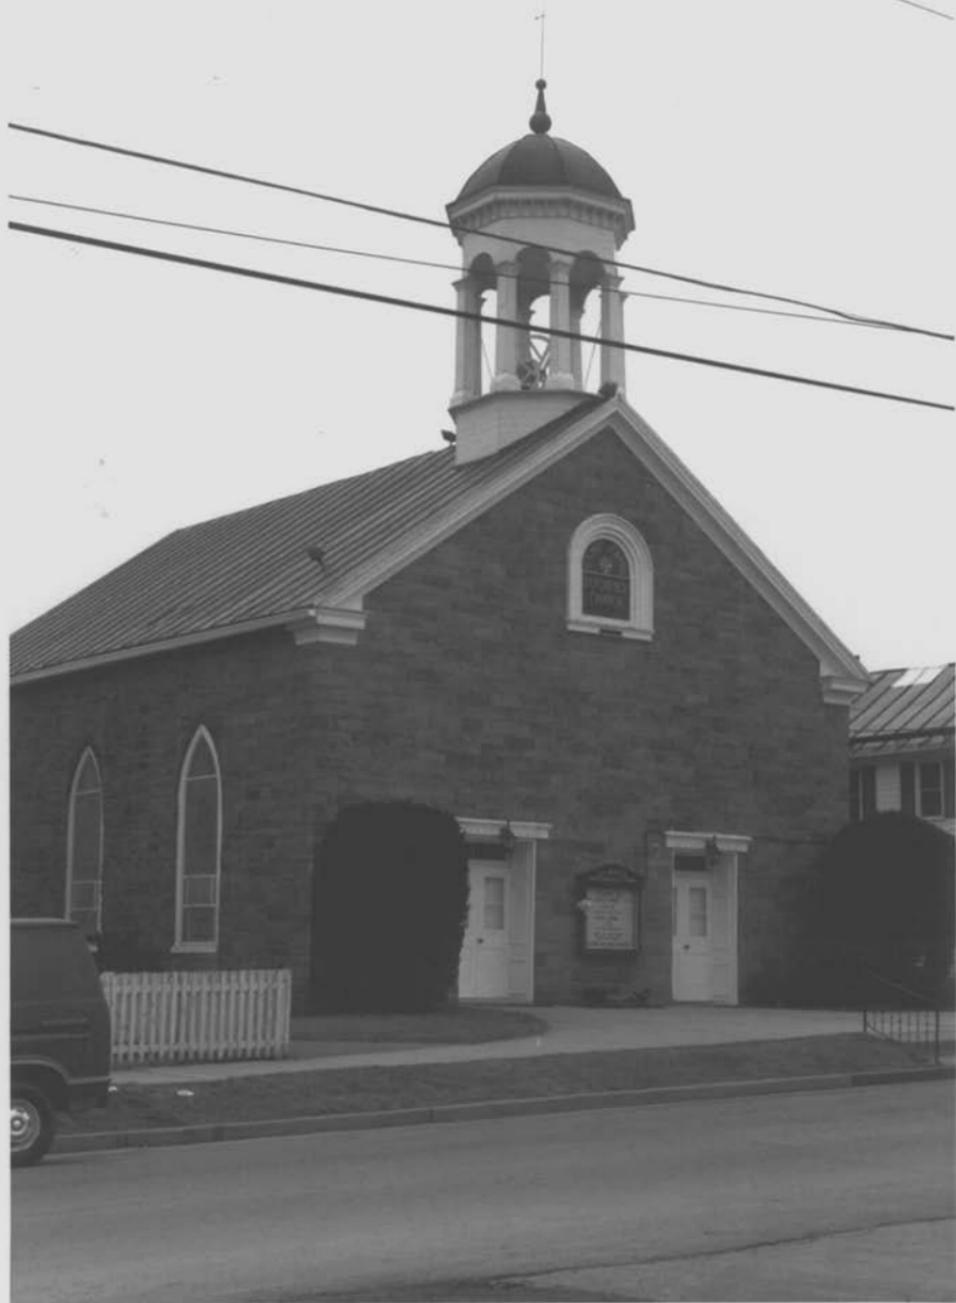
1/2

West elevation

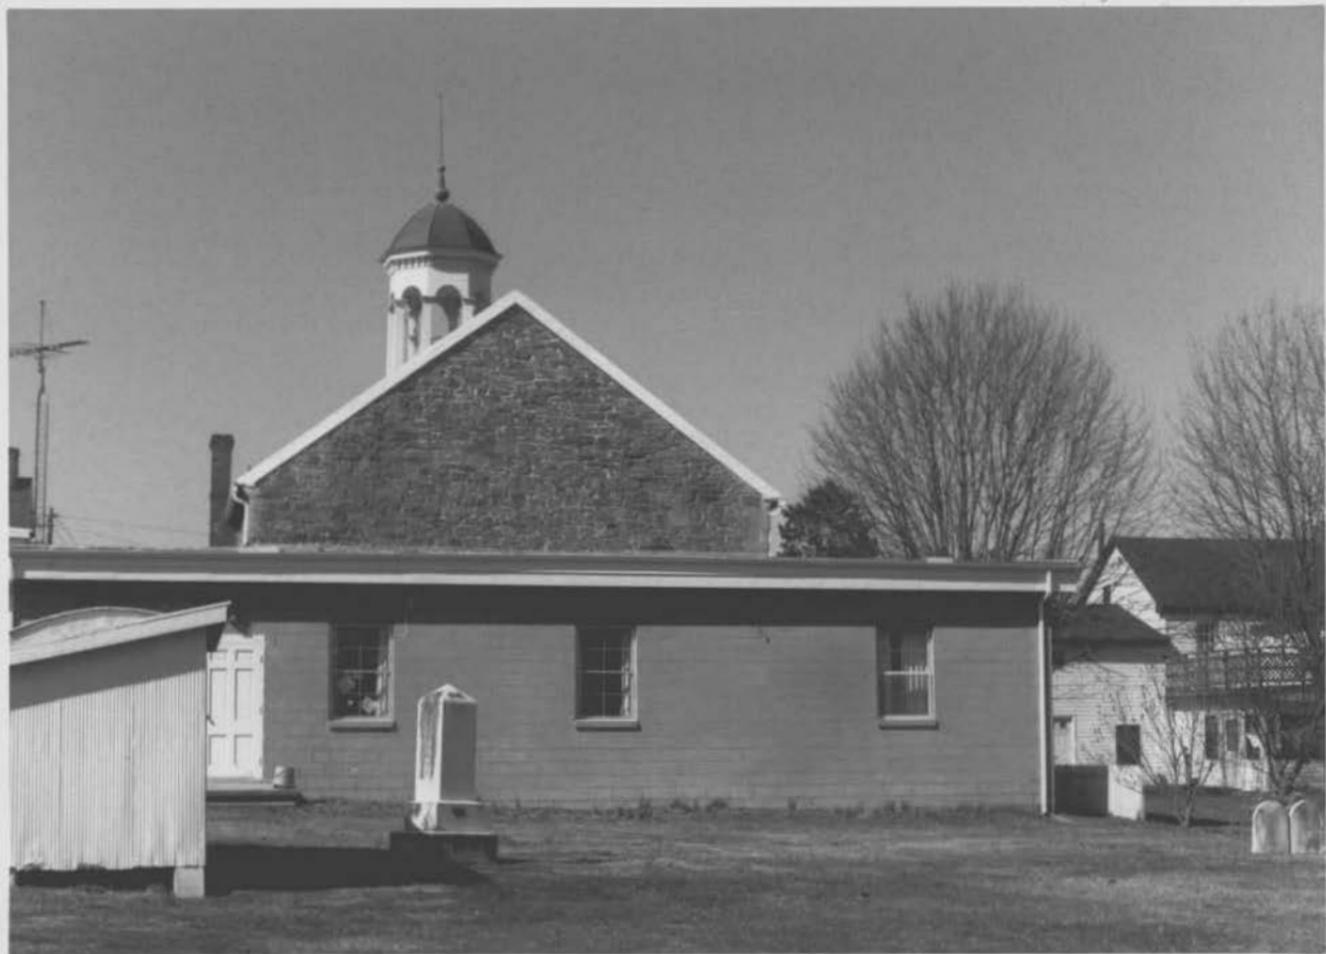
2/2

A 2 story concrete block addition abuts the church on the east wall, extending beyond the length of the church on each side. It is vinyl sided on the second floor. The upper stories of the church rise above the addition showing a coursed rubblestone elevation with no openings.

East elevation
