F-8-79

"Lucky Discovery"

Woodsboro, Maryland

Maryland Historical Trust State Historic Sites Inventory Form

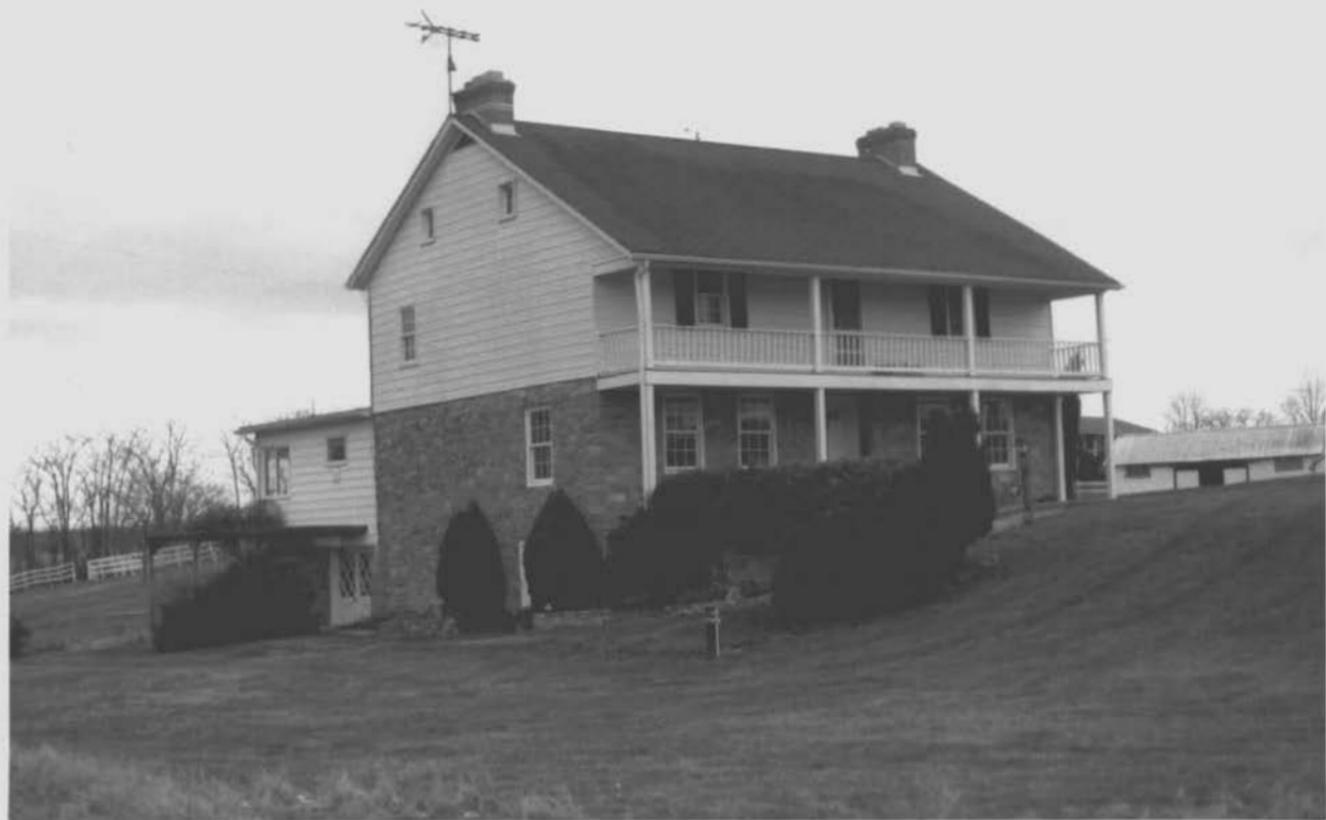
1/4

The first story is composed of uncoursed rubble fieldstone with heavy mortar; the second story is brick but has been sheathed in aluminum siding. The side gable roofline of composition shingling is widely pitched. Two interior end brick chimneys with three ceramic pots each sit on the ridgeline. Fenestration throughout the elevations consists of 6/6 replacement windows. The front facade has symmetrical openings with center door placement and 6/6 replacement windows. A two story porch with square columns covers the full facade. The second floor has a center door symmetrical to the first floor door allowing access to the porch. A two part addition extends from the rear (south) elevation: a 1 story stone section with a tall brick chimney, 1 bay wide and deep, has a gable roof of composition shingling running north to south; an aluminum sided section is approximately 28 years old and encloses a modern kitchen with an open deck extending from the back door. The east elevation includes the main block of the building and the two bays of the kitchen addition. It contains a side door into the basement that has a stone arch above its replacement. Both east and west elevations have 6/6 replacement windows positioned assymetrically.

East Elev.

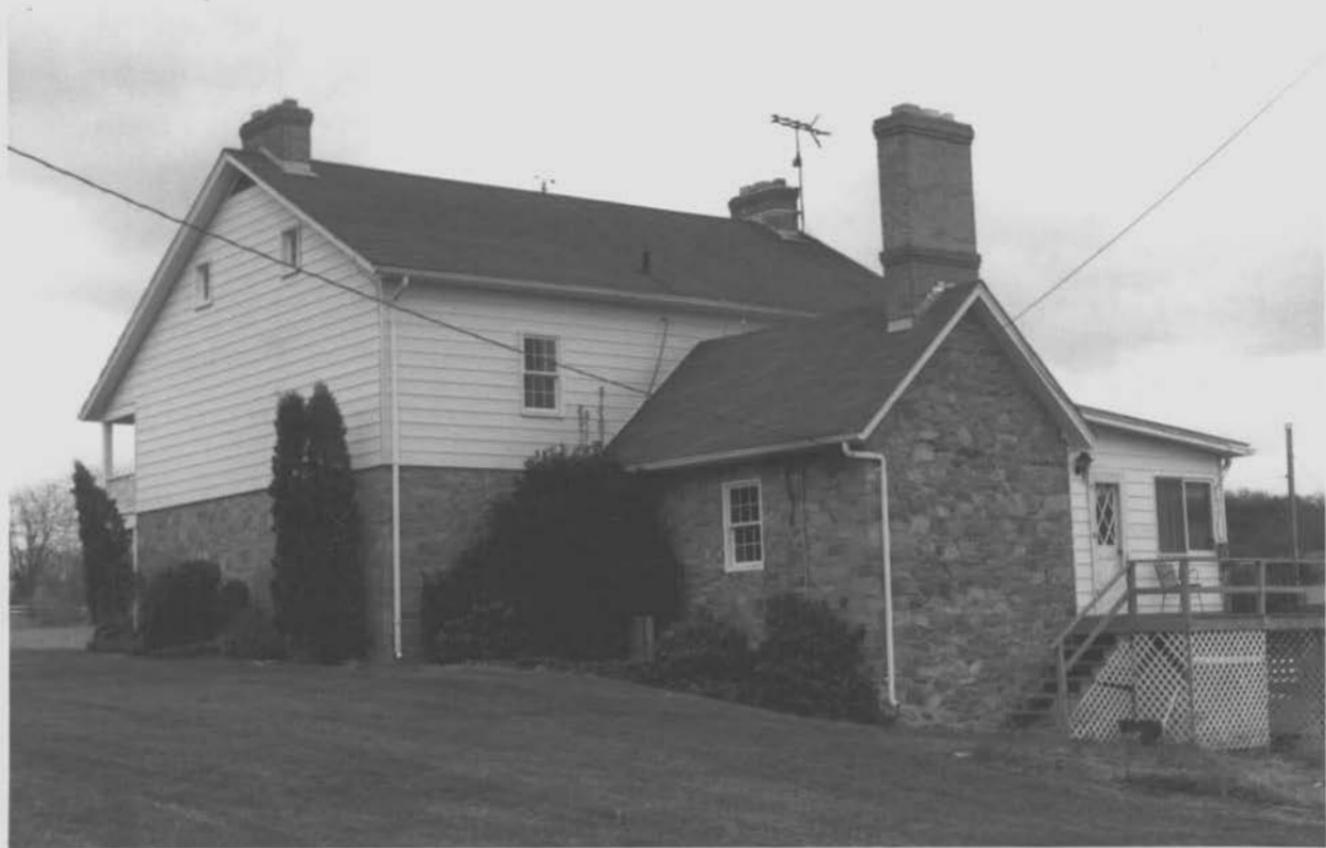
2/4

West Elev.

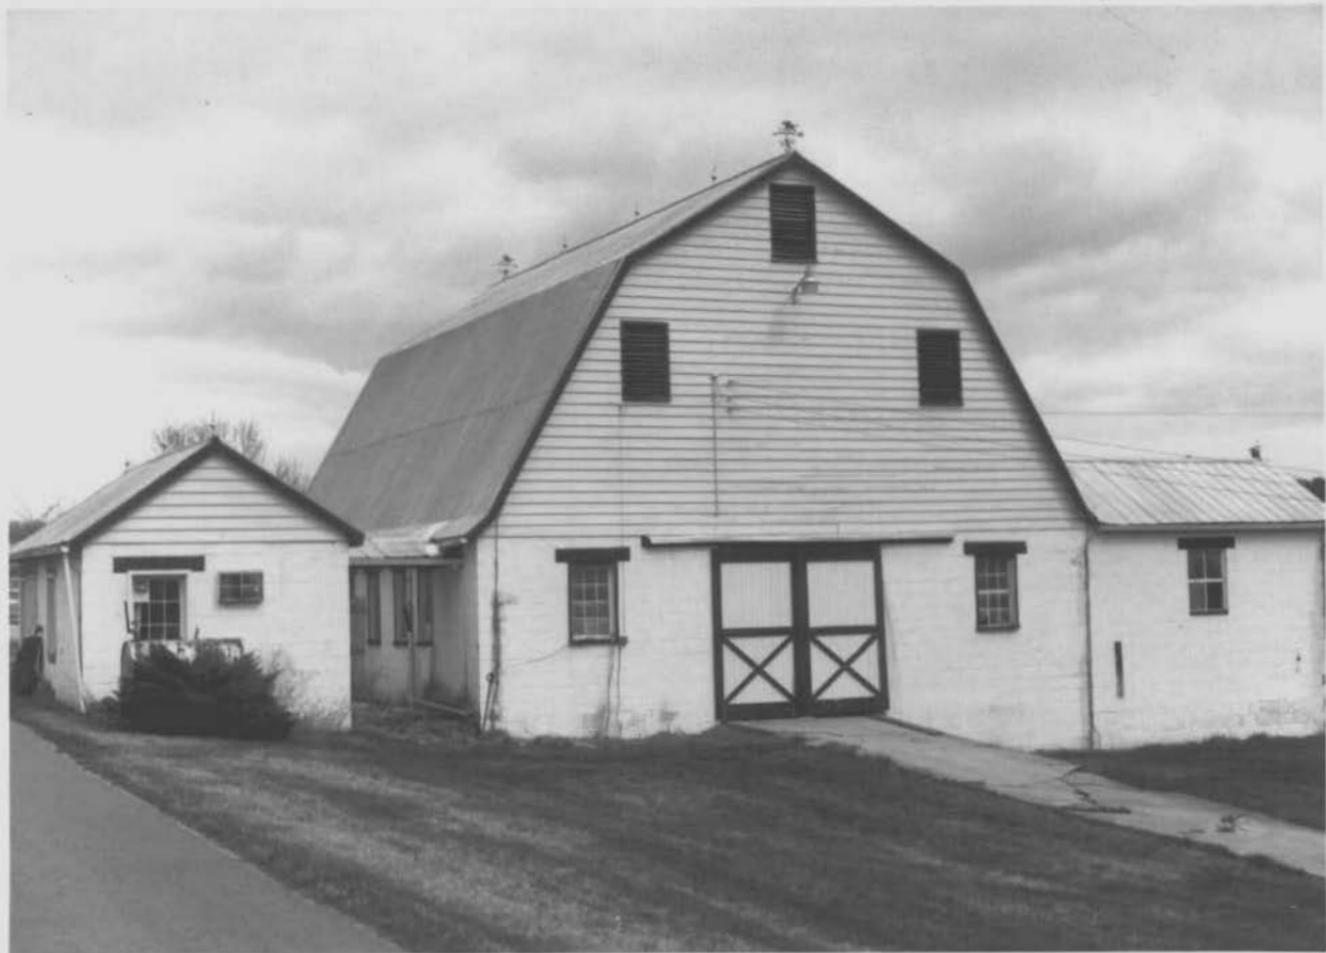
3/4

Outbuildings on the property are mainly to the west of the main house. A 1 story springhouse lies to the east of the house and faces west. It is of fieldstone with frame gable ends of wide clapboards. Its gable roof is composed of standing seam tin. A corral of concrete block lies directly west of the house. A concrete shed with a standing seam roof built on a stone foundation is adjacent to the corral. A 1 story aluminum outbuilding also is aligned with the other buildings. A concrete barn with a gambrel roof of standing seam tin lies to the northwest of the main house. It has five 5 light fixed windows in a ribbon along its east elevation. Its principal facade faces north and contains a sliding door, louvered windows and a hood at the peak of the roofline. The eaves of the roof are flared. An arched window lies beneath the hood of the facade. The gambrel end is of clapboard. A 1 story concrete block dairy is attached to the barn at its south wall. A pond lies directly south of the house.

The property was most likely associated with agriculture from its beginnings although no original agricultural outbuildings remain. An early twentieth century dairy barn testifies to later agricultural pursuits that may have been more crop-oriented initially. A stone springhouse is probably the oldest outbuilding that may date to the house's origins.

Dairy Barn / East Elev.

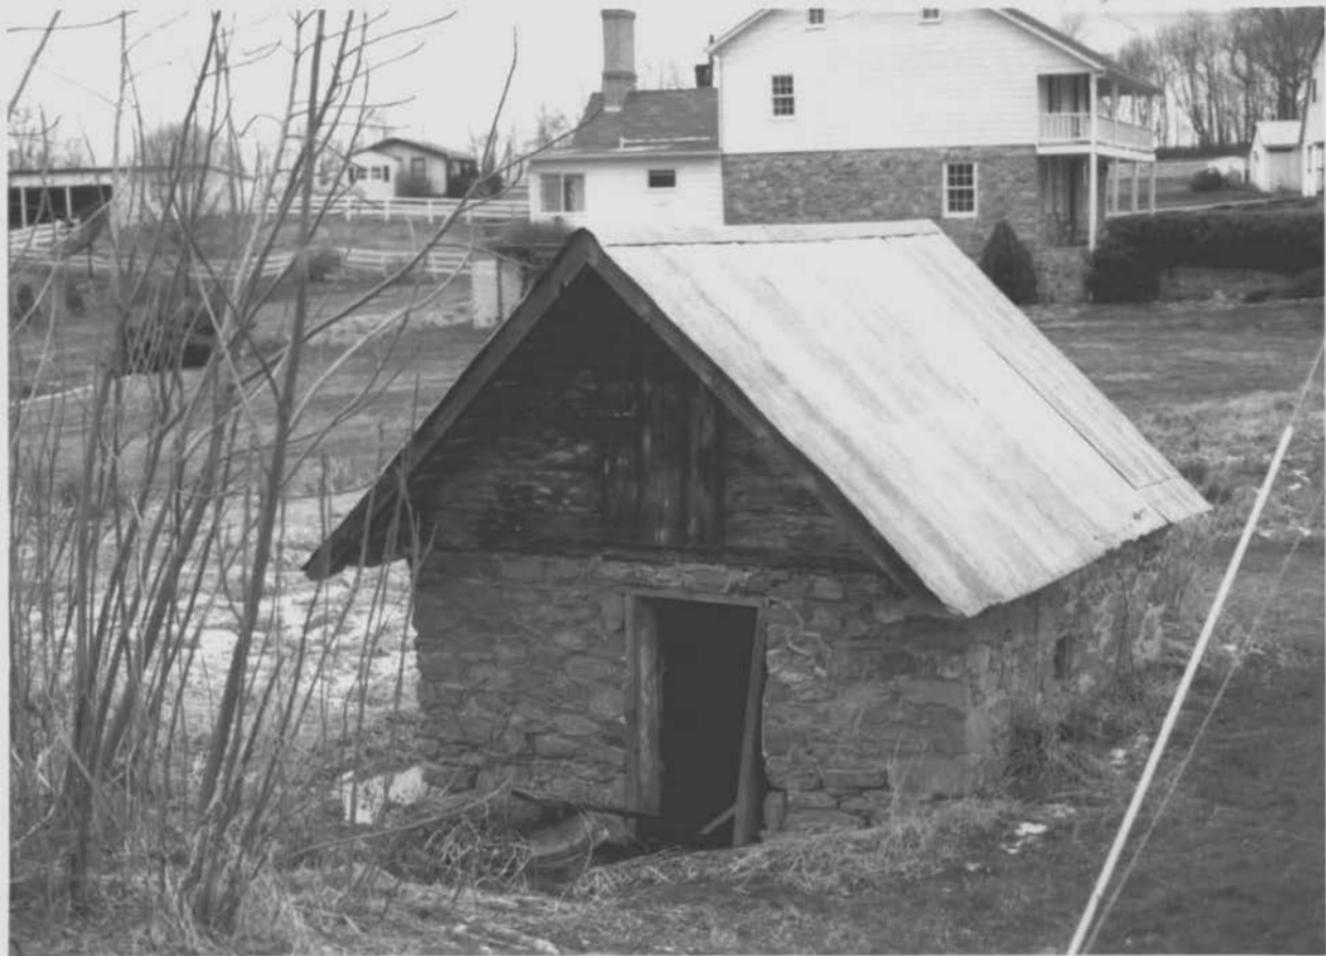
4/41

Stone springhouse / South Elev.
