F-8-82

Legore Quarry Workers Housing - San Diego Road

Woodsboro, Maryland

# Maryland Historical Trust State Historic Sites Inventory Form

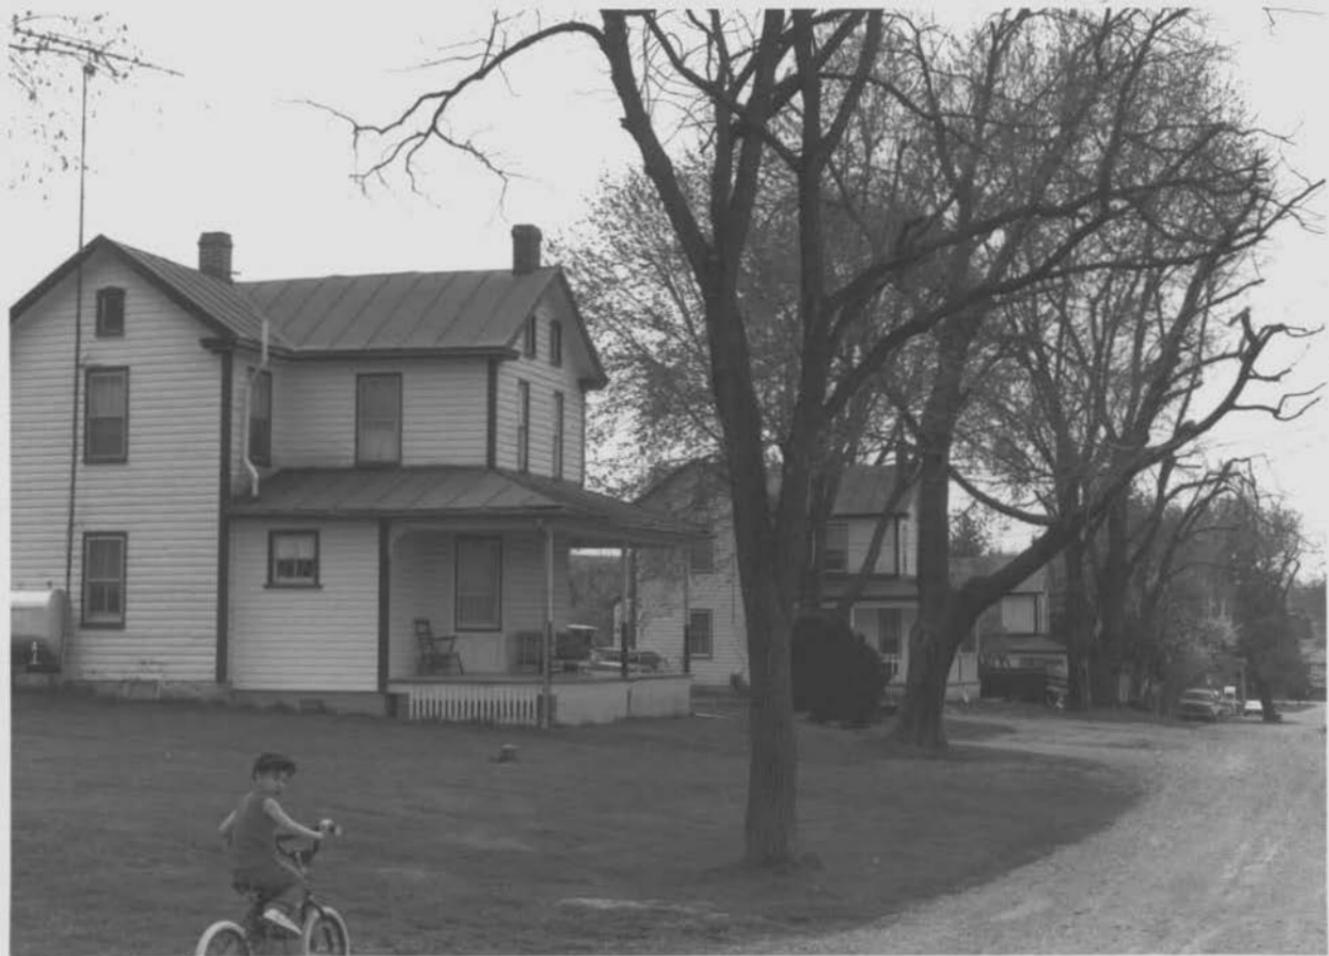
1/2

General view from northwest

The Legore Quarry Workers Housing - San Diego Road is a row of seven identical plan two-story frame houses built about 1900 on the south side of Oak Hill Road near the intersection with Woodsboro Pike (Maryland Route 194). The principal elevations face southwest toward San Diego Road, a private road.

The setting of the houses is at the northeast edge of the quarry operation. The unpaved San Diego Road separates the evenly spaced houses from tailing dumps which screen views of the quarry from the houses.

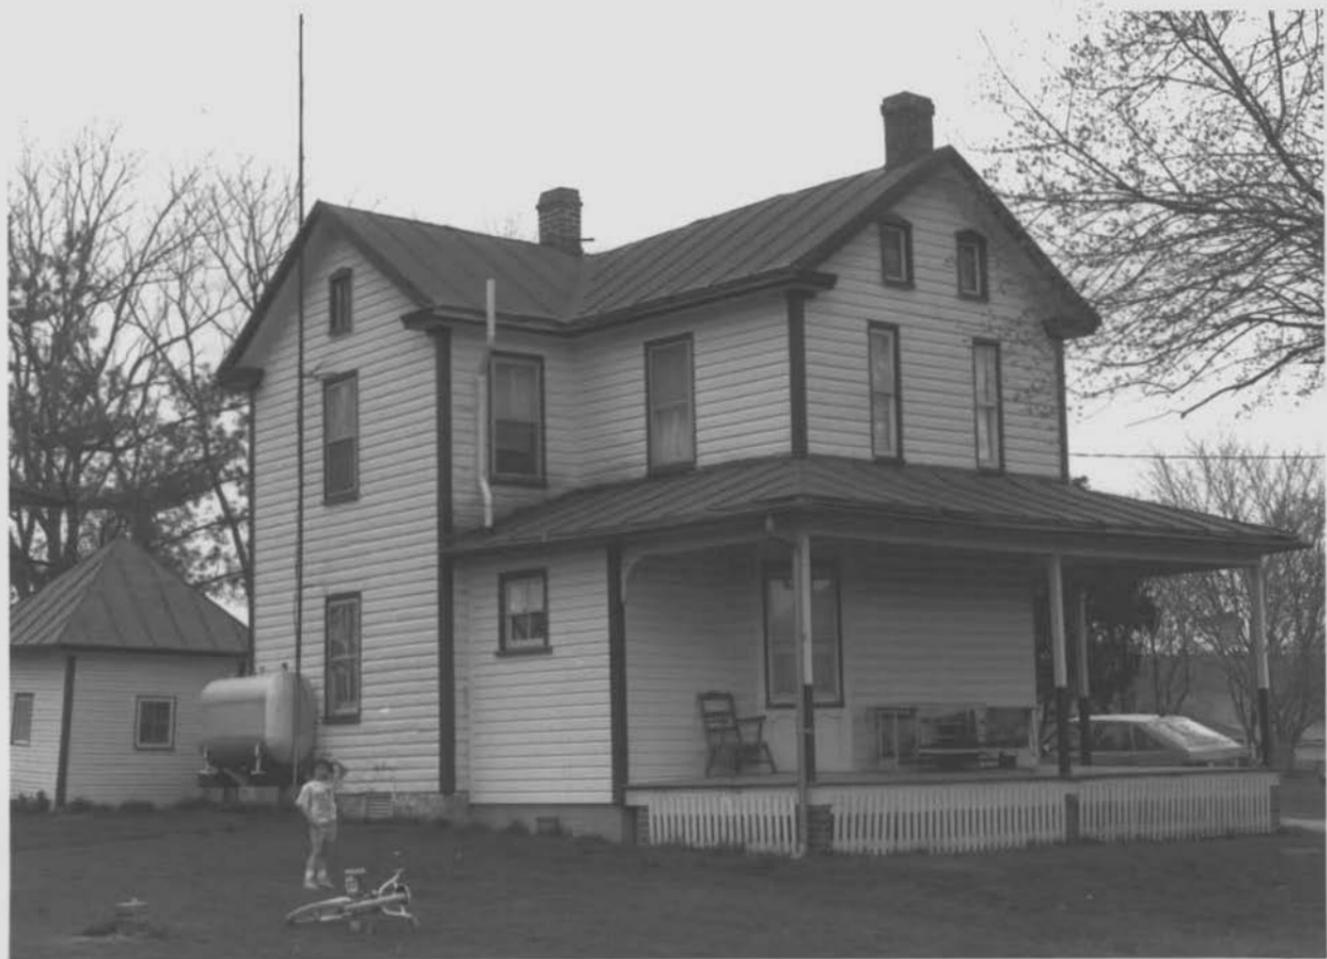
Representative house - northwest corner view  
2/2

Each house has a T-shaped plan, with the bottom leg of the T a gable facade on the street elevation. A one-story porch wraps around the gable end on three sides. White painted german siding, green corner posts and trim, and red standing seam tin roofs are common to all the houses. Stone foundations are visible at each house. Two interior brick chimneys rise above the roofs. Most sash is 2/2, but some individual alterations are present. The porches are also slightly different, primarily in the railings. Most have no porch balustrades, but at least two have plain square post railings. One has scroll-sawn brackets.
