G-I-A-112

Christian J. Otto Farm
New German
Private

INVENTORY FORM FOR STATE HISTORIC SITES SURVEY

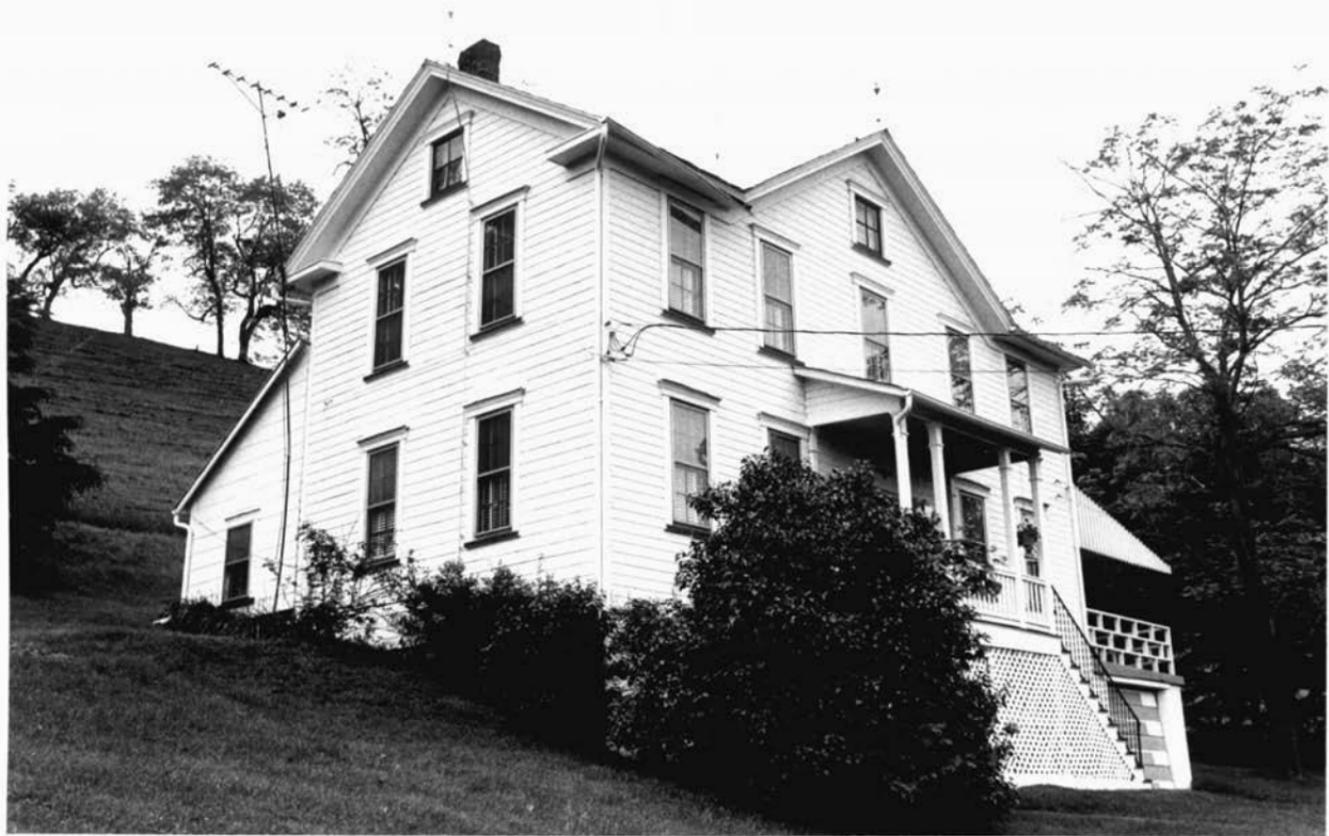
G-I-A-112

The facade (NE elevation) has a symmetrical 5 bay, center door arrangement with a central cross gable and a one bay entrance porch. 4/4 sash windows with plain board surrounds and molded drip boards light the first and second floor levels, while a four-pane casement with a similar surround pierces the gable. The entrance porch sits on a high foundation, four square posts with molded capitals supporting its shed roof.

The southeast endwall is pierced by four 4/4 sash windows, two per floor, and a four-pane casement in the gable. A concrete block garage with a sheltered patio above it has been added to the northwest endwall. The door that leads from the patio into the house may possibly be original but the windows on this wall have been altered. The first floor window has been reduced in size, and the two second floor windows have had their original sash replaced with 3/1 lights.

Facade: SE & NE elevations

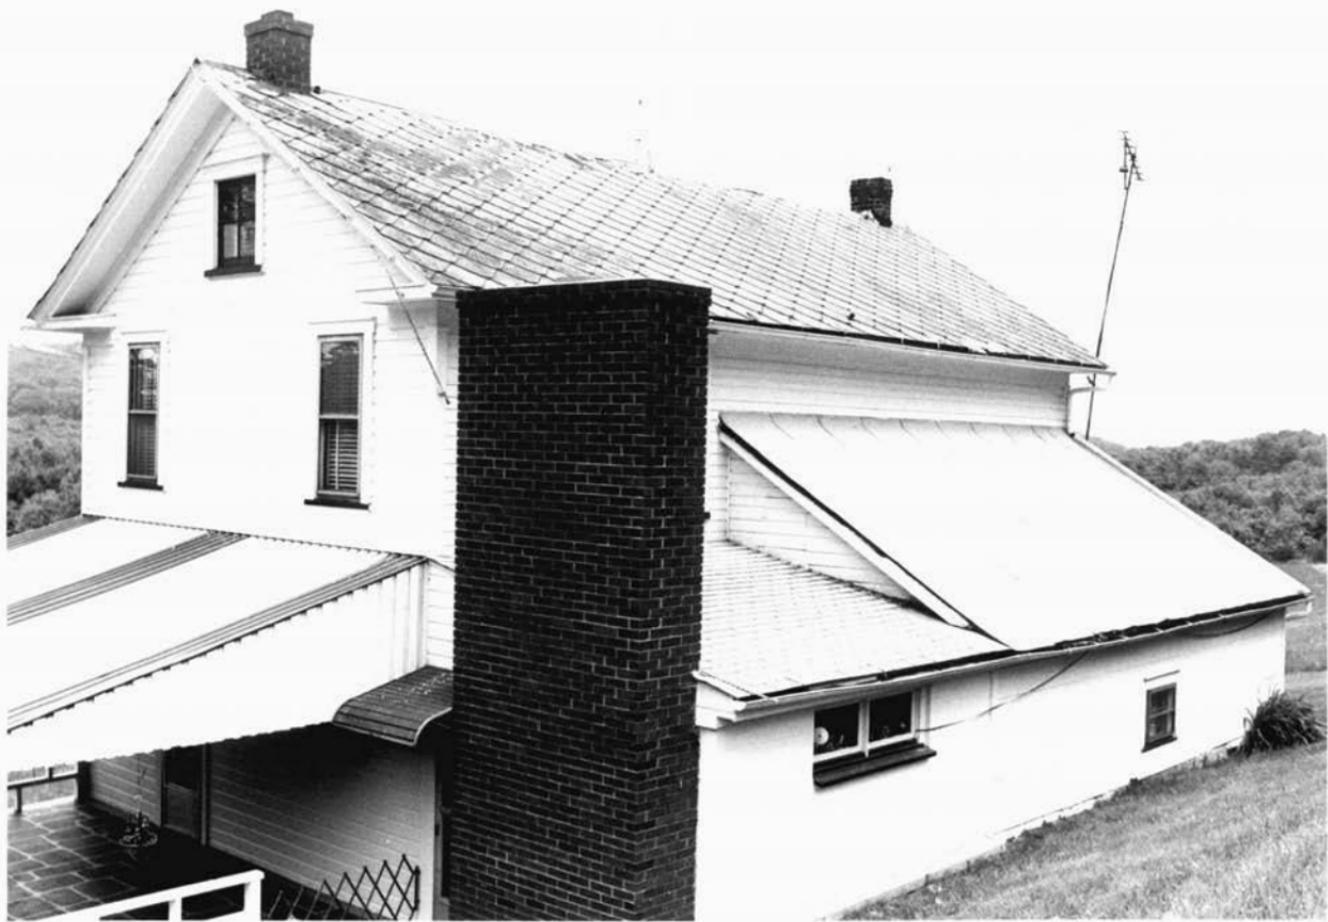
G-I-A-112

The rear wall of the building is masked by a 1½ story, shed-roofed frame addition and a one story, shed-roofed, concrete block addition.

Rear: NW & SW elevations
