G-I-A-168

John Ogg Farm  
New Germany  
Private

INVENTORY FORM FOR STATE HISTORIC SITES SURVEY

Continuation #7 Description

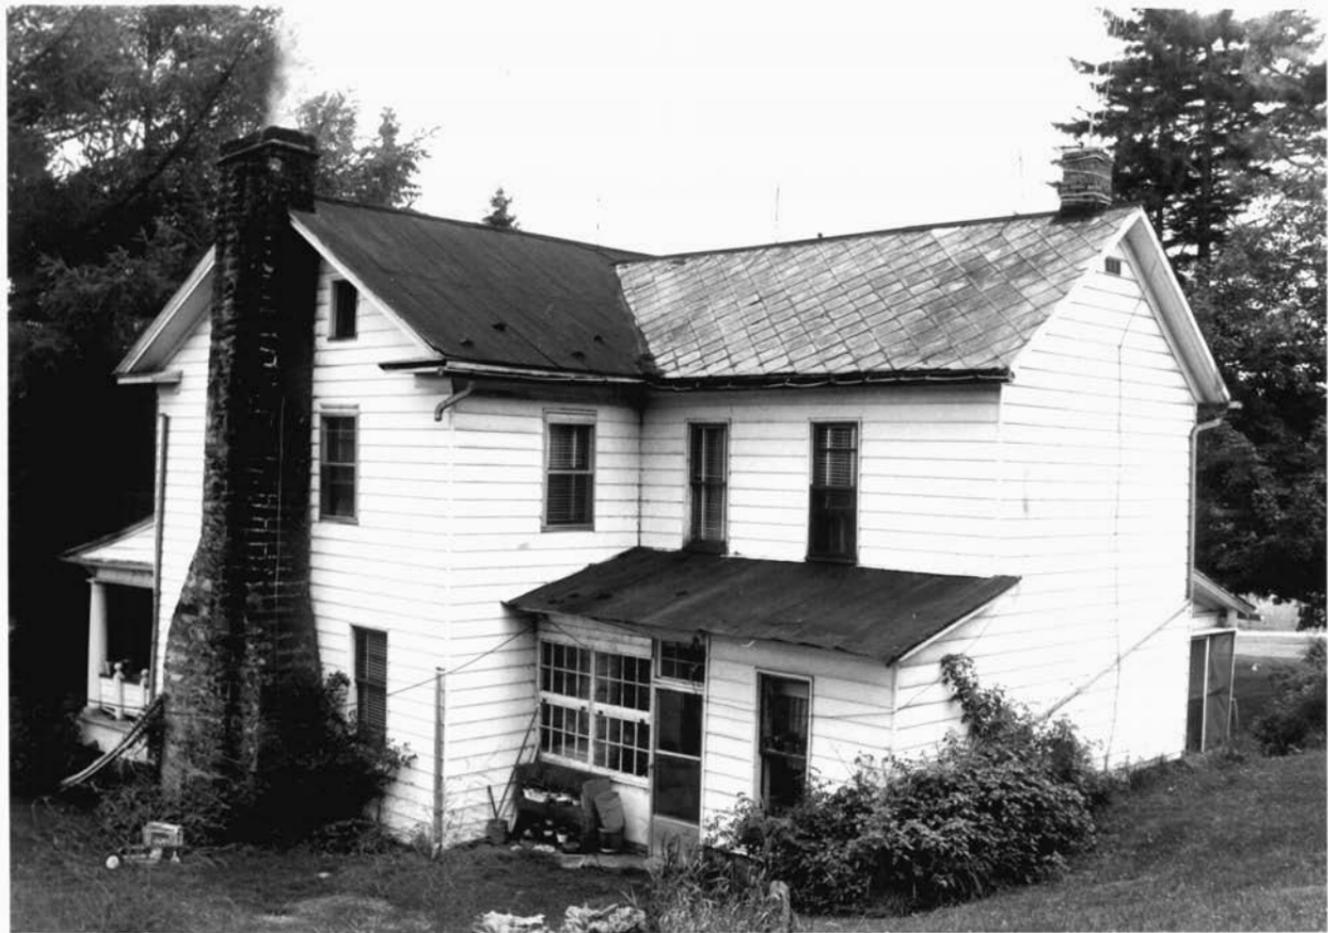
G-I-A-168

The rear wing, which measures two bays long by one bay wide, projects from the center of the west elevation creating a T-plan. Elongated 1/1 sash windows light its north and south walls, while an interior brick chimney rises through the center of its unfenestrated enwall. Shed-roofed porches shelter the full length of both north and south elevations.

Rear - N & W elevations

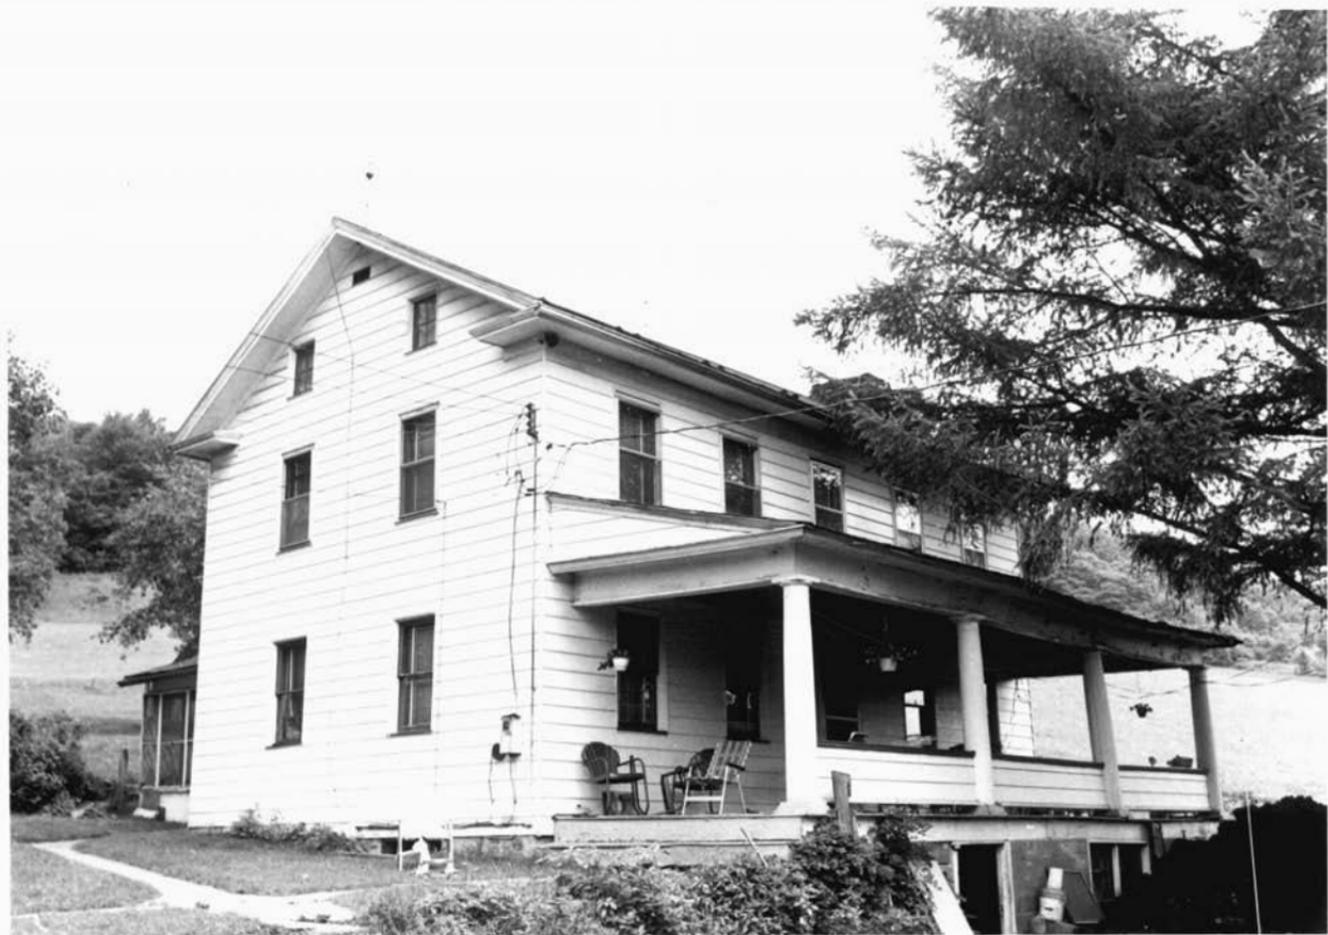
G-I-A-168

The facade (E elevation) has a symmetrical five bay, center door arrangement and a full length porch. The windows on this elevation, as well as the other elevations on the main block, are 1/1 sash replacements. Its shed-roofed porch, with four Tuscan column supports, appears to be a twentieth century addition.

The stone chimney on the north endwall is a shouldered stack made of rock-faced ashlar. Sash windows flank the chimney on the first and second floor levels, while two small casements pierce the gable. The south endwall has two sash windows per floor and two four-pane casements in the gable, as well. A box cornice with partial gable end returns outlines the eaves.

Facade - E & S elevations

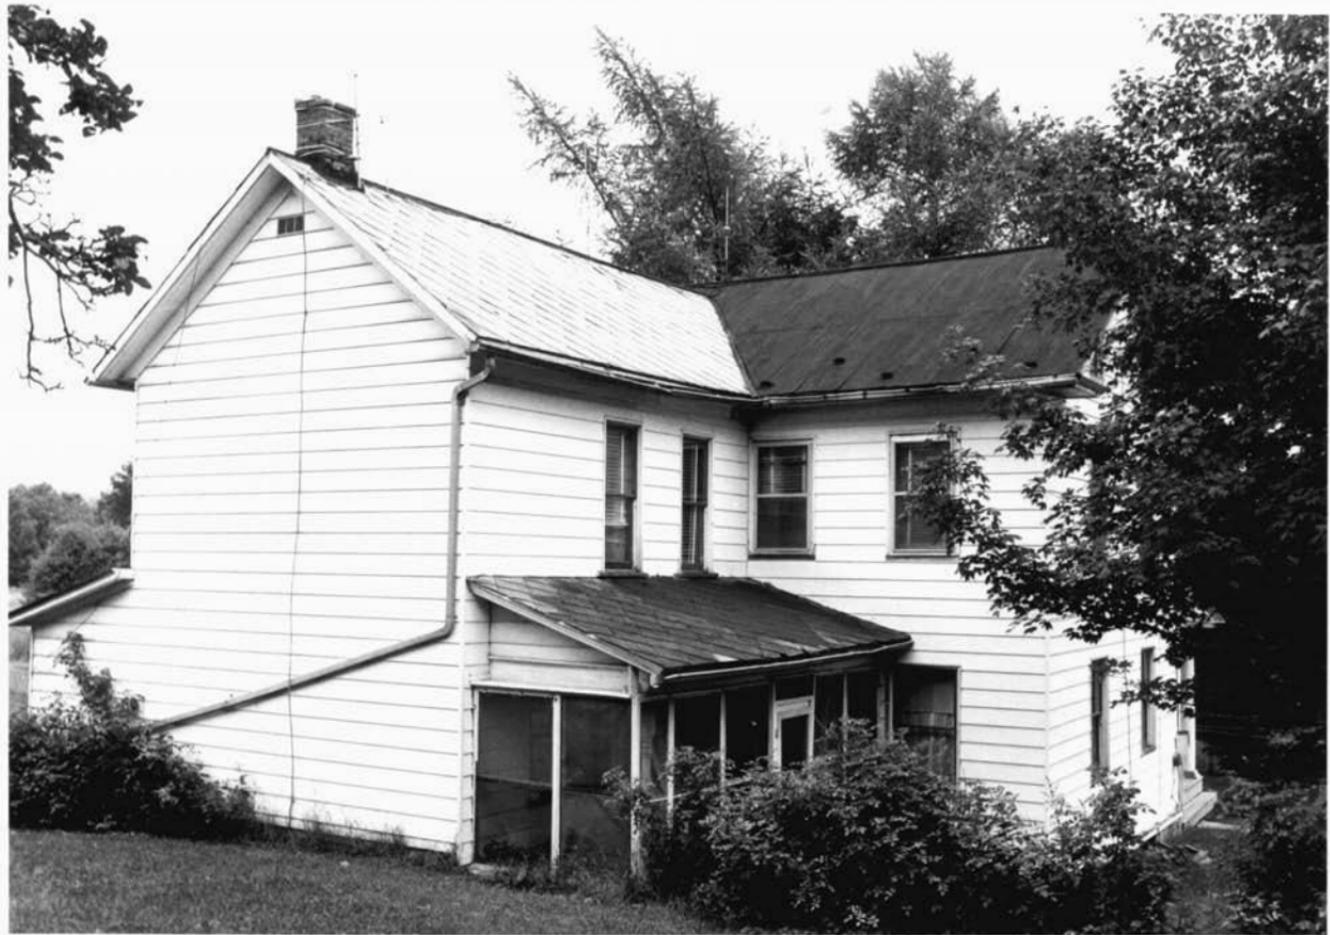
G-I-A-168

Rear - S & W elevations
