Howard Michael Farm
Barton
Private

G-I-C-022
MAGI #1201505635
ML

INVENTORY FORM FOR STATE HISTORIC SITES SURVEY

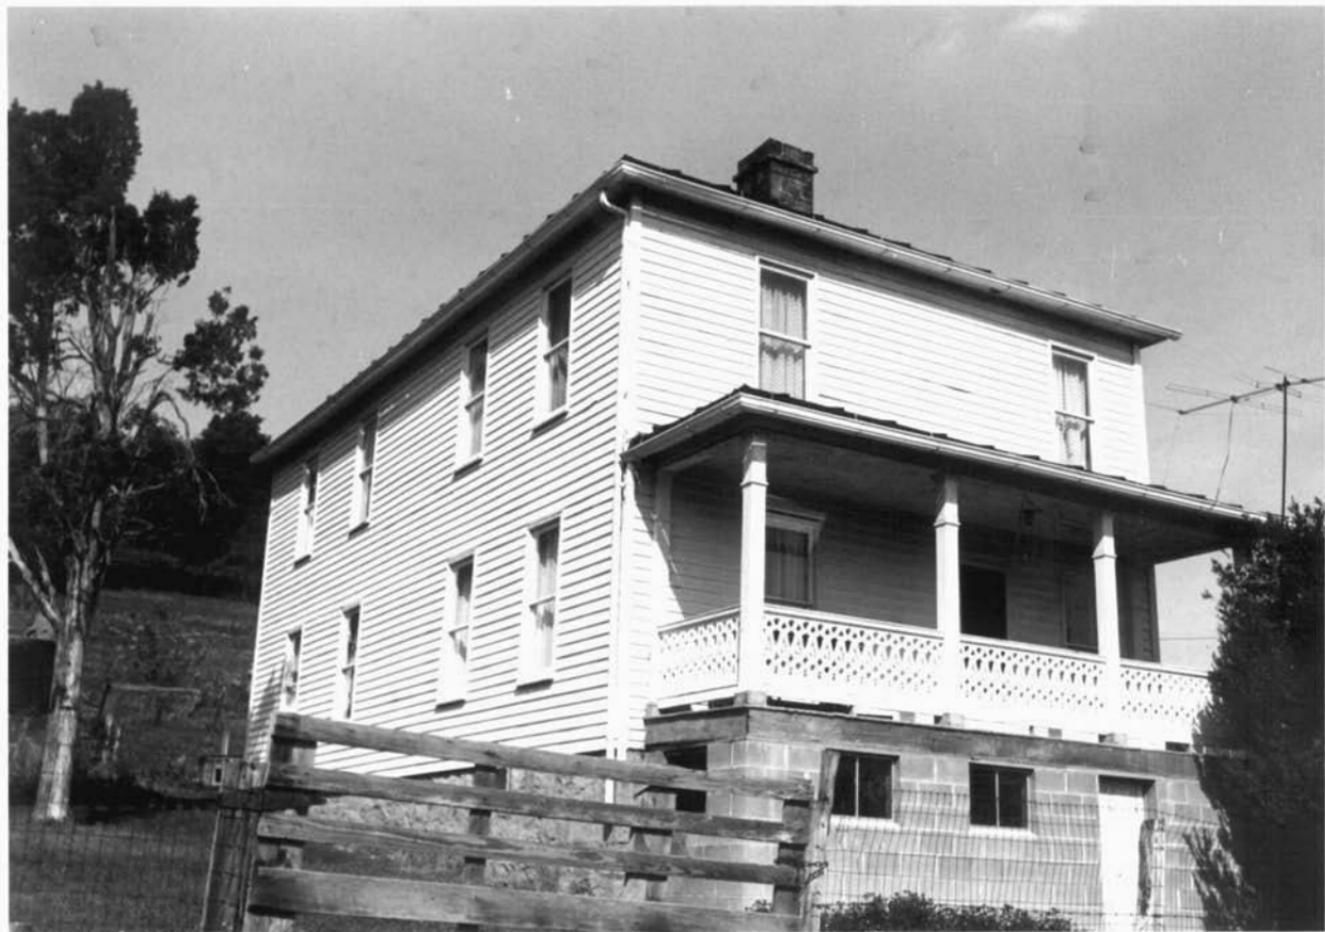
G-I-C-022

Facade: NE elev.

The house is a frame, two story, gable-roofed building with its facade oriented to the northeast. Its basic configuration is an ell-plan with a three bay by two bay main block and a two bay by one bay rear ell. The facade is asymmetrically arranged; the first floor has three bays with the door placed off center; the second floor's center bay is unfenestrated. A porch extends the full length of the facade and another extends the length of the northwest elevation on the rear ell.

The facade porch rests on a cinderblock foundation and has a tongue and groove floor. The four square columns and two pilasters that support its hipped roof are connected by a jigsaw railing. The rear porch rests on a square post foundation with plank flooring. Four chamfered posts and two pilasters are the supports for a hipped roof. Three rows of board between the posts serve as the railing. Both the facade and rear porch roofs are covered with standing seam metal.

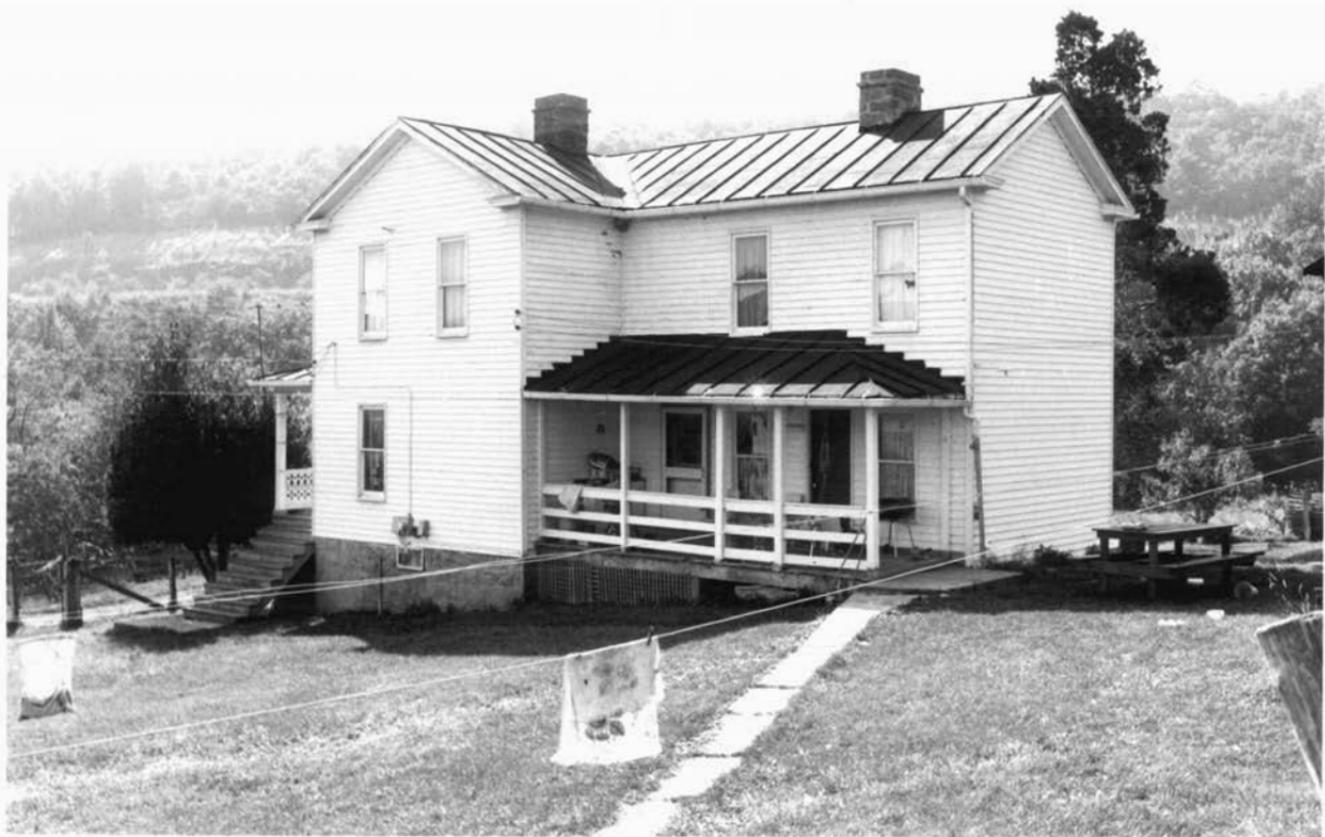
3-I-C-022

rear wing: NW porch
