Maryland Inventory of Historic Properties Number: G-IT-A-136

Name: Old Morgantown Rd over Buffalo Run

MARYLAND INVENTORY OF HISTORIC BRIDGES
HISTORIC BRIDGE INVENTORY
MARYLAND STATE HIGHWAY ADMINISTRATION/
MARYLAND HISTORICAL TRUST

SHA Bridge No. G 76 Bridge name Old Morgantown Road over Buffalo Run

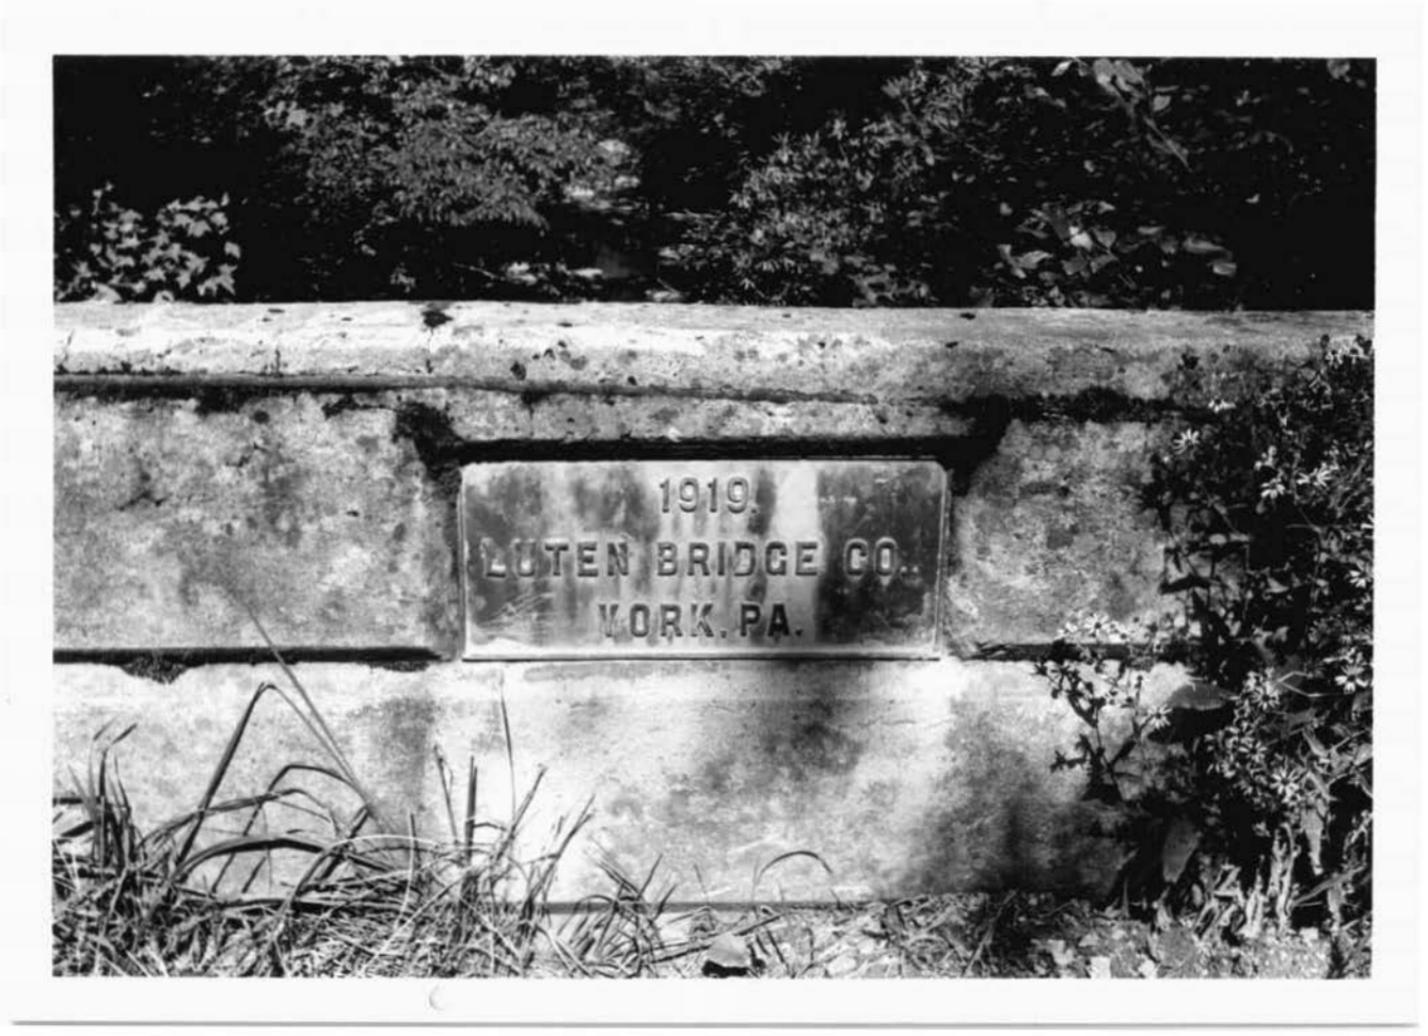
Manufacturer's plate

1919
LUTEN BRIDGE CO.
YORK, PA.

The manufacturer's plate on the S wall of the bridge identifies it as the work of Daniel S. Luten, a bridge fabricator of York, PA.
